PUBLISHED PROJECT REPORT PPR1032

Forensic Examination of Critical Special Geotechnical Measures

M Duffy-Turner (Coffey Geotechnics Ltd), M G Winter (Winter Associates Limited), I M Nettleton (Coffey Geotechnics Ltd) and G Butler (Coffey Geotechnics Ltd)

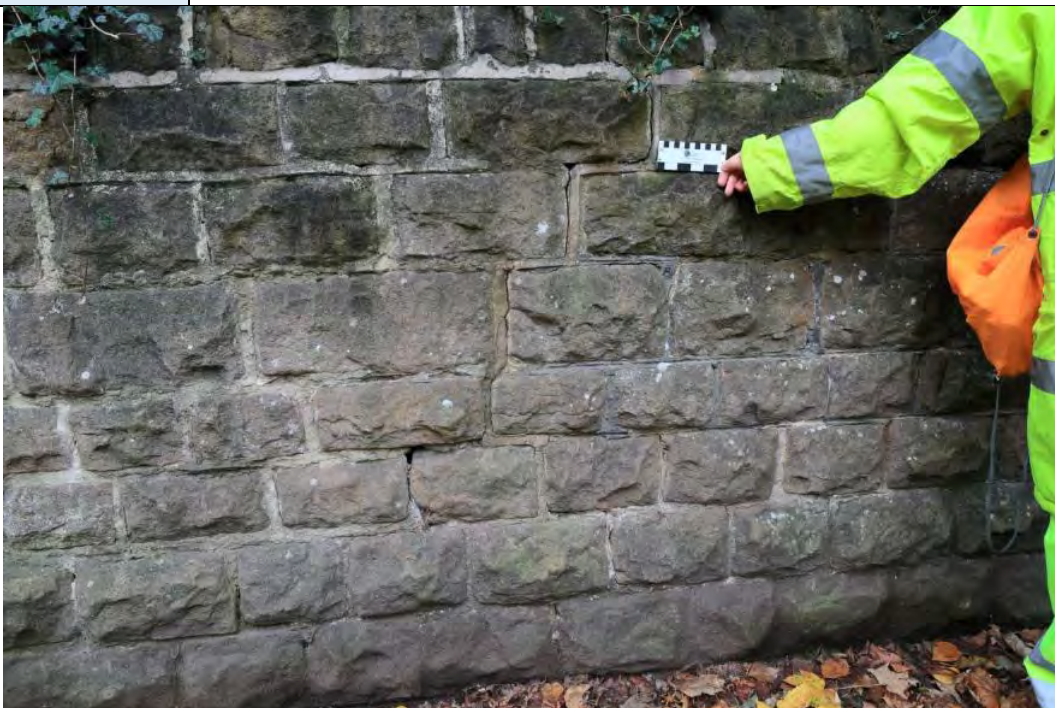
<p>Evidence of global cracking: Global cracking was observed (although typically localised), bulging and outward leaning of the wall was observed towards the western end.</p>	
<p>The stability and linkages between adjacent blocks: The wall is mortared and pieces of mortar and stone blocks/ bricks were observed to be missing in places. Cracks have been re-mortared in places.</p>

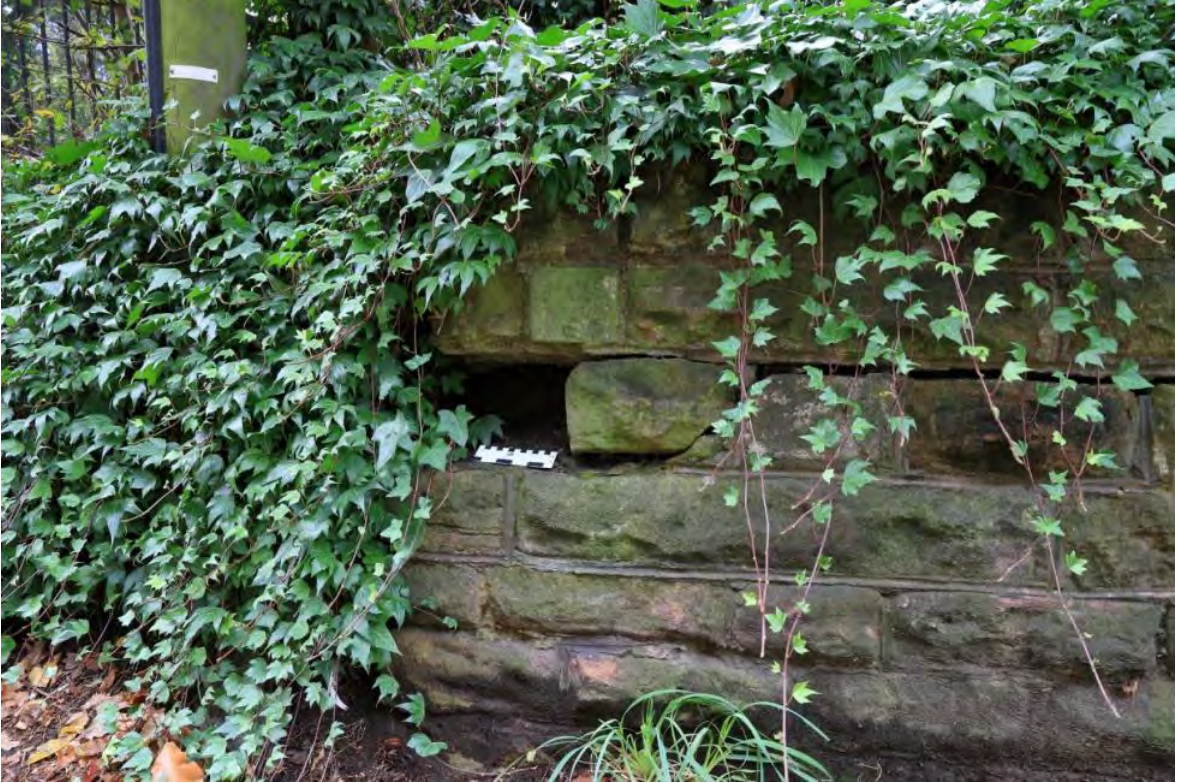
<p>At the far west of the wall where the stone wall becomes brick, there is a section approx. 1.4m wide which has no mortar at all.</p>	
<p>The stability of the individual elements (blocks) e.g. damage to blocks sufficient to compromise stability:</p> <p>Bulging of the wall was observed towards the western end. It was also leaning out towards the footpath in areas.</p>	
<p>Additional Comments:</p> <p>Questions to be answered – were these originally free-standing walls? Likely they were never originally built to retain material behind them.</p> <p>Who owns the walls? The brick sections appear to block former driveway accesses.</p>

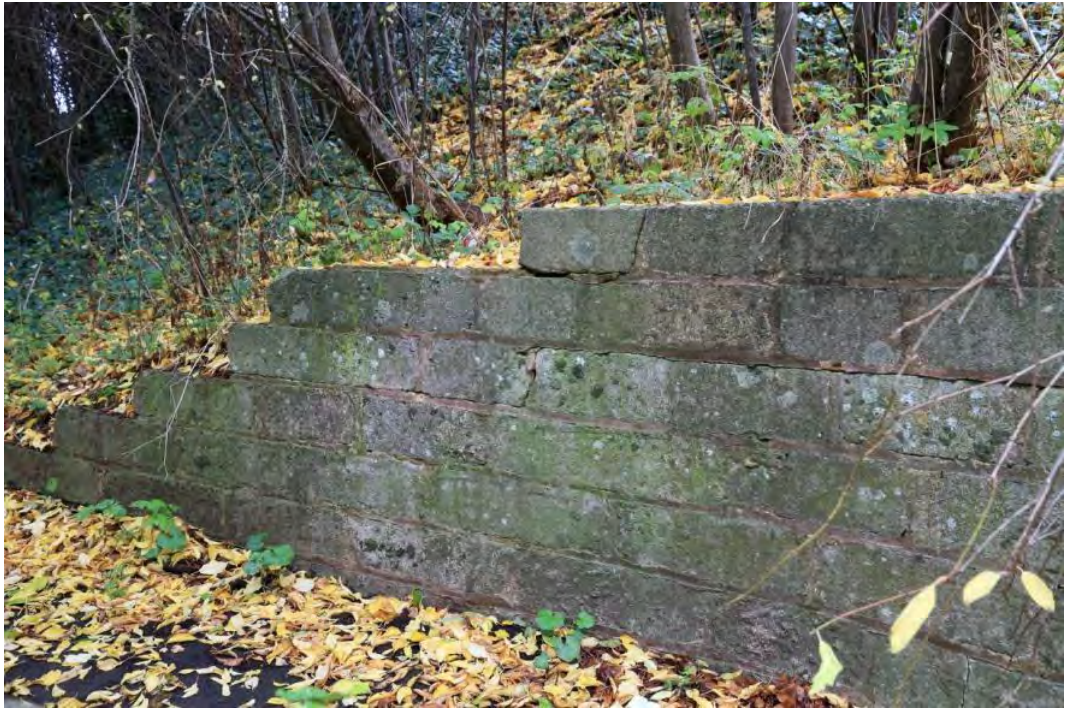
<p>Evidence of global cracking:</p> <p>Significant cracking but largely restricted to the top two courses and deeper only locally.</p>	
<p>The stability and linkages between adjacent blocks:</p> <p>The wall is mortared and pieces of mortar were observed to be missing in places. Cracks have been re-mortared.</p> <p>It was observed that the top course of the wall appeared to have deteriorated the most (in between the coping and top row), with mortar missing almost continuously.</p>

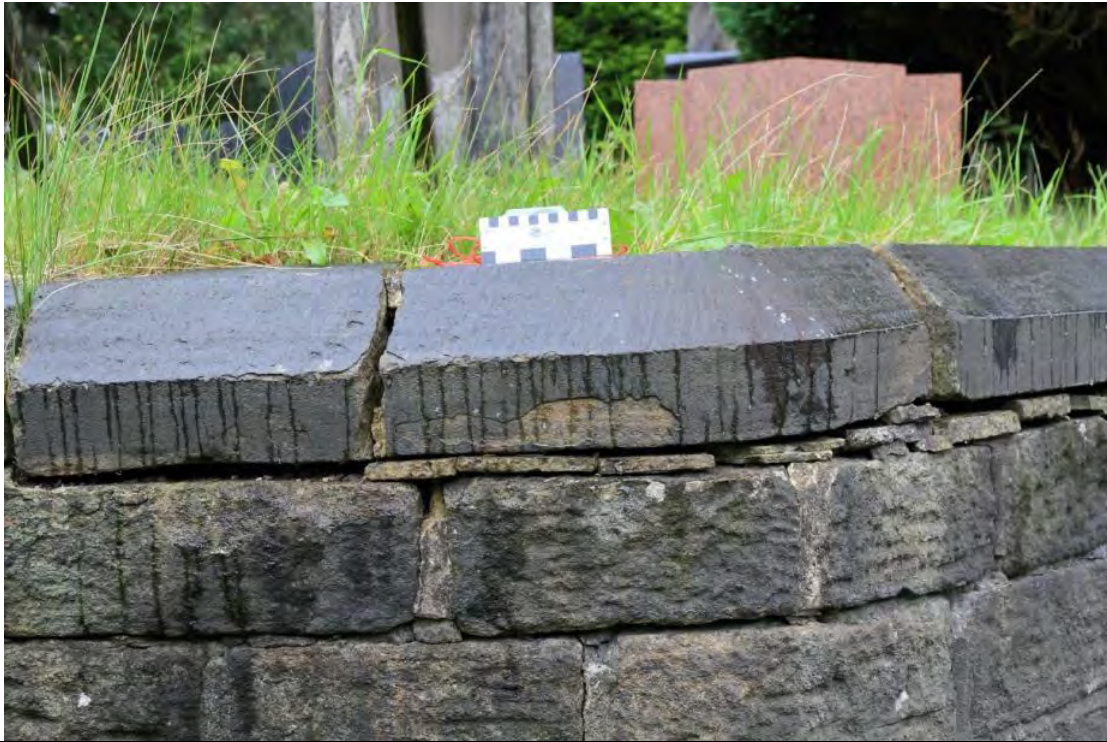
<p>Evidence of global cracking: Significant cracking but largely restricted to the top two or three courses and deeper only locally.</p>	
<p>The stability and linkages between adjacent blocks: The linkage between the blocks for this retaining wall is mortar. This is missing in places and has been replaced in localised areas. Observation indicated that the mortar in the worst condition was that in and immediately below the coping.</p>

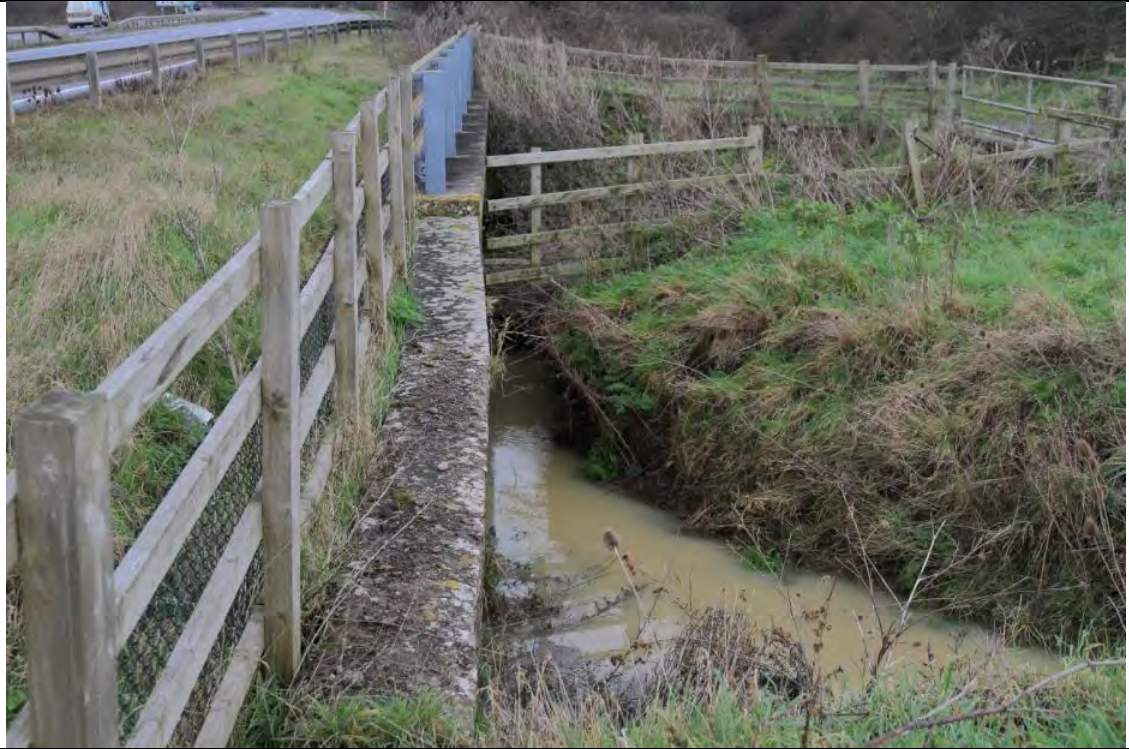
<p>The stability and linkages between adjacent blocks:</p> <p>The mortar was in poor condition with numerous areas suffering cracks through the mortar and loss of mortar (see photo below). The western part of the wall showed significant signs of deterioration of the mortar with a complete loss of mortar observed in the lower and upper-mid sections.</p>

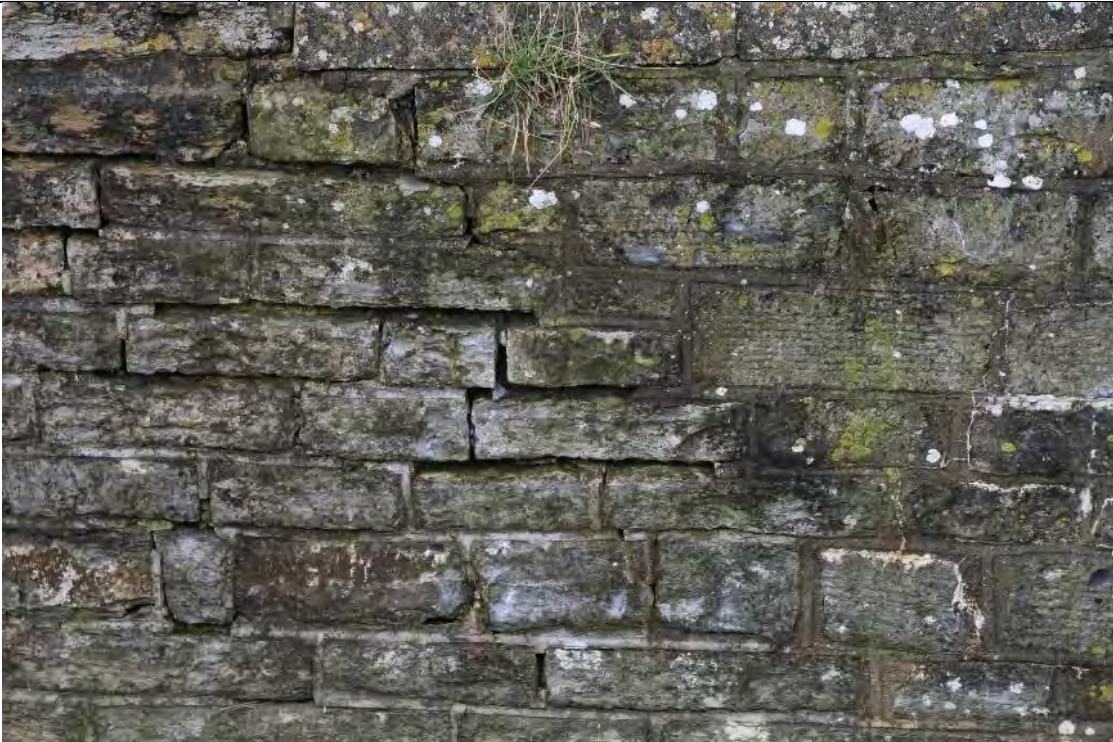
<p>The stability of the individual elements (blocks) e.g. damage to blocks sufficient to compromise stability:</p> <p>Although the blocks themselves weren't showing significant signs of deterioration, the loss of mortar and possibly the sinking of the wall is leading to significant distress.</p>	
<p>Additional Comments:</p> <p>There was a triangle feature (made of the same sandstone) built into the western section of the wall. It is unclear what this is for.</p>

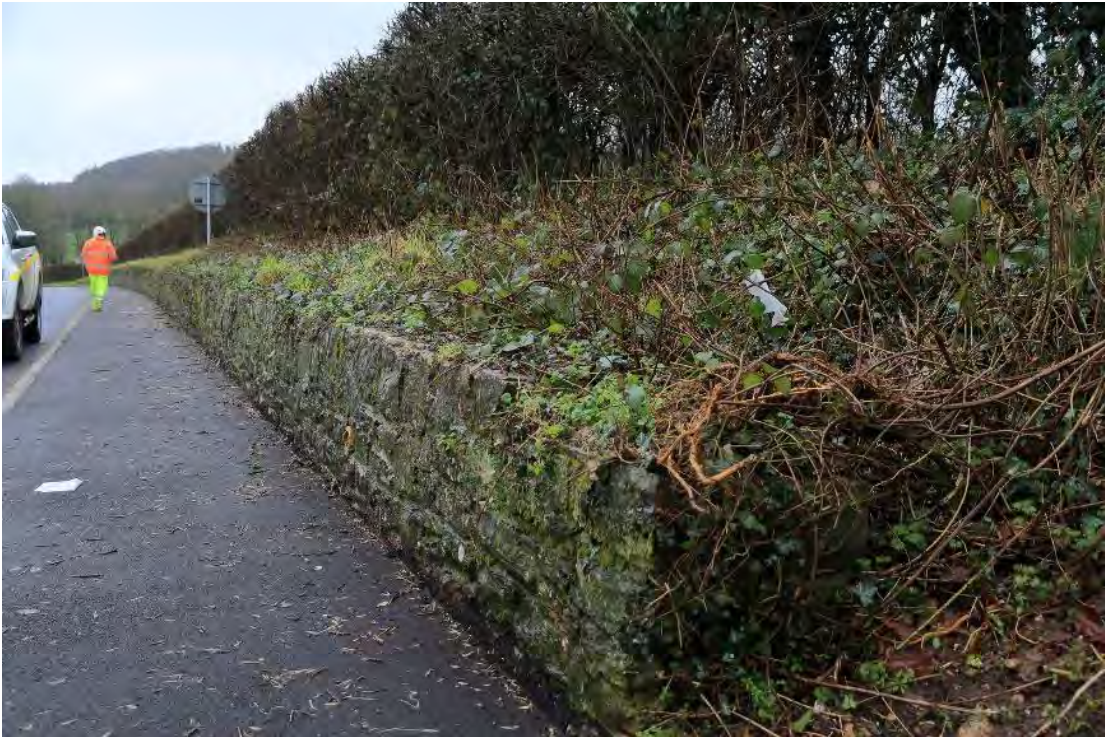
<p>Information pertaining to drainage / watercourses / salt spray: 80mm internal diameter clay pipe weepholes were present through the wall every 6m. These were occasionally partially blocked with soil but appeared to be working with stone gravel washed out onto the footpath (see photo below).</p>

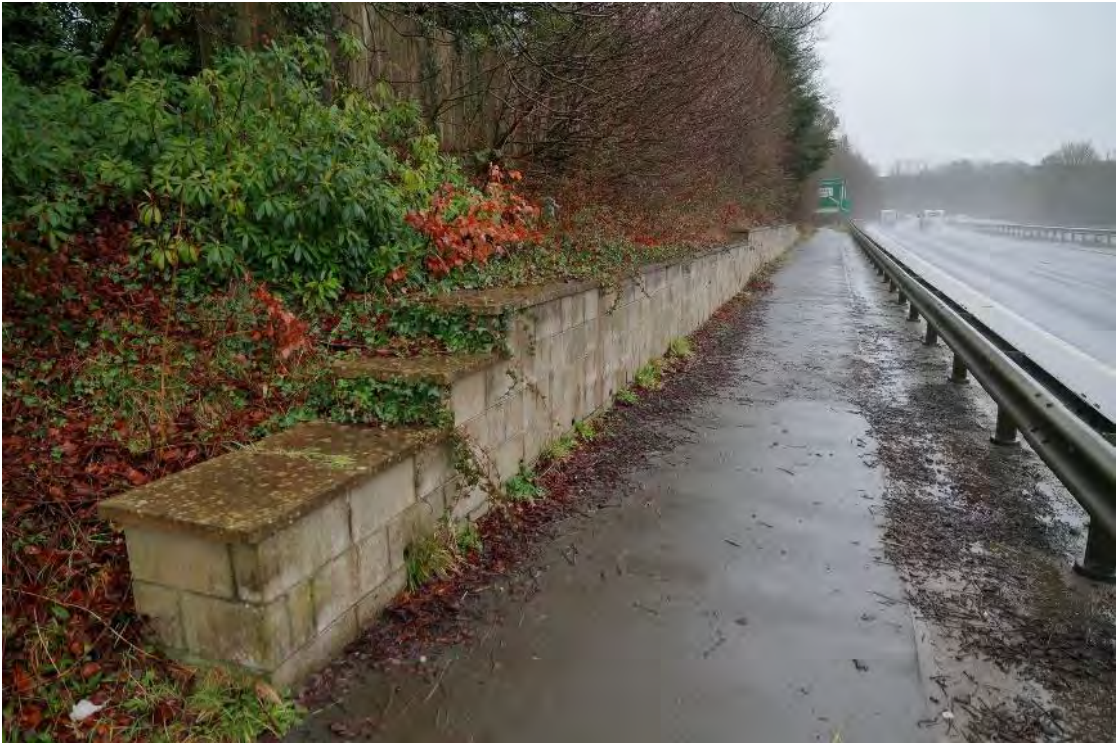
<p>Information pertaining to drainage / watercourses / salt spray: 50mm diameter polypipe weepholes were present through the wall and appeared to be active with fines washing through them (see photo below).</p>

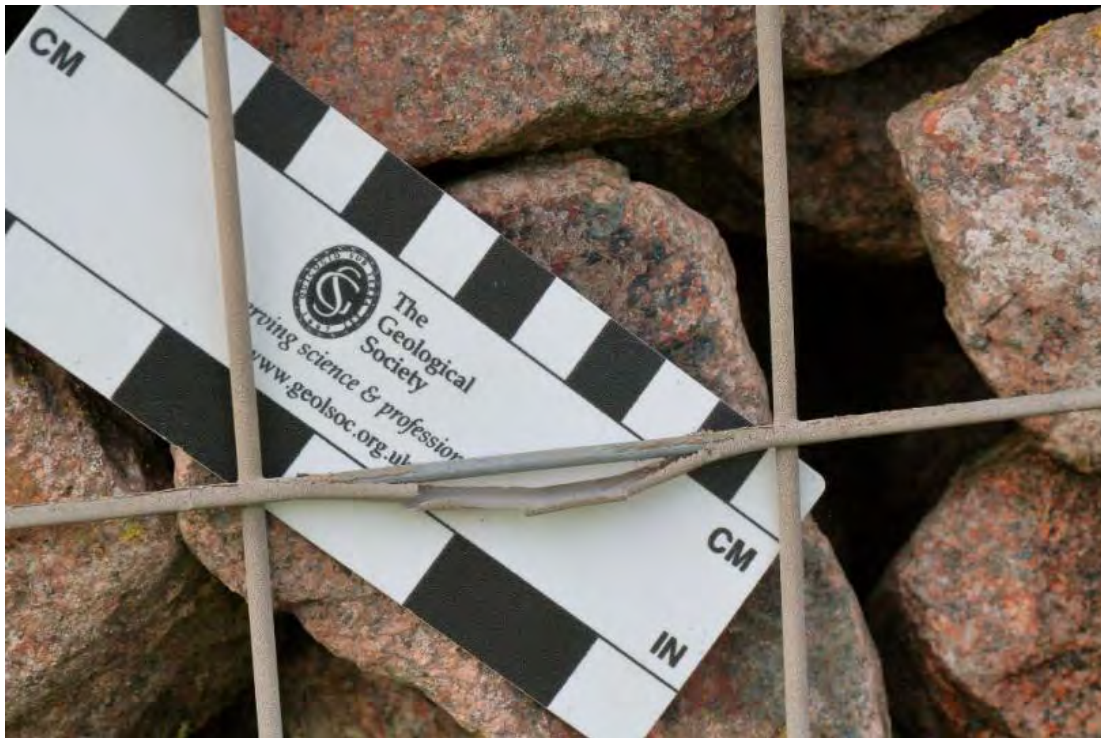
The gabions have been filled with a clean, hard and durable rock type (looks like granite) which has not undergone any significant weathering. There were some blocks that were undersized and able to fall through the apertures.

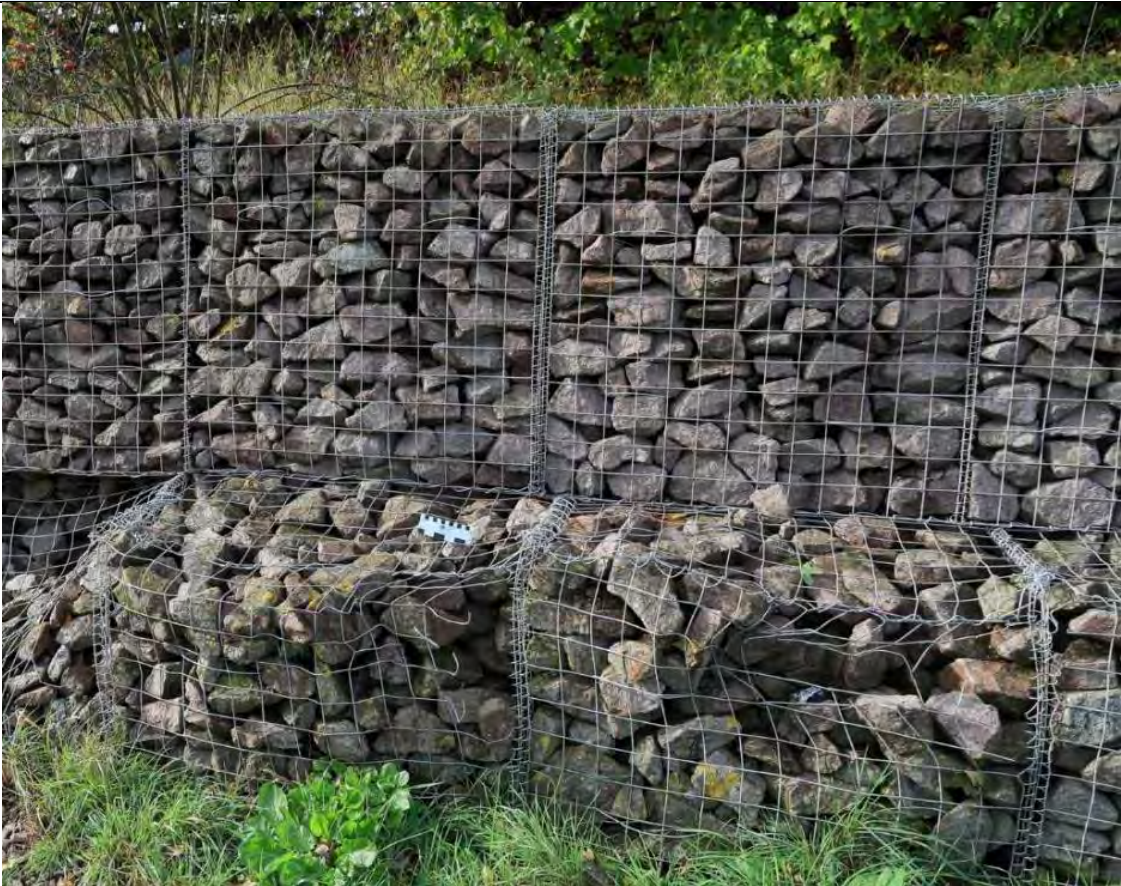
<p>Additional reinforcement has been added to the baskets by tying wire around three apertures and feeding it back into the fill material.</p> <p>The stability of the individual elements (gabions) e.g. damage and distortion of baskets:</p> <p>The gabions were distorted along its full length on the lower row. The upper row of baskets looked well put together.</p>

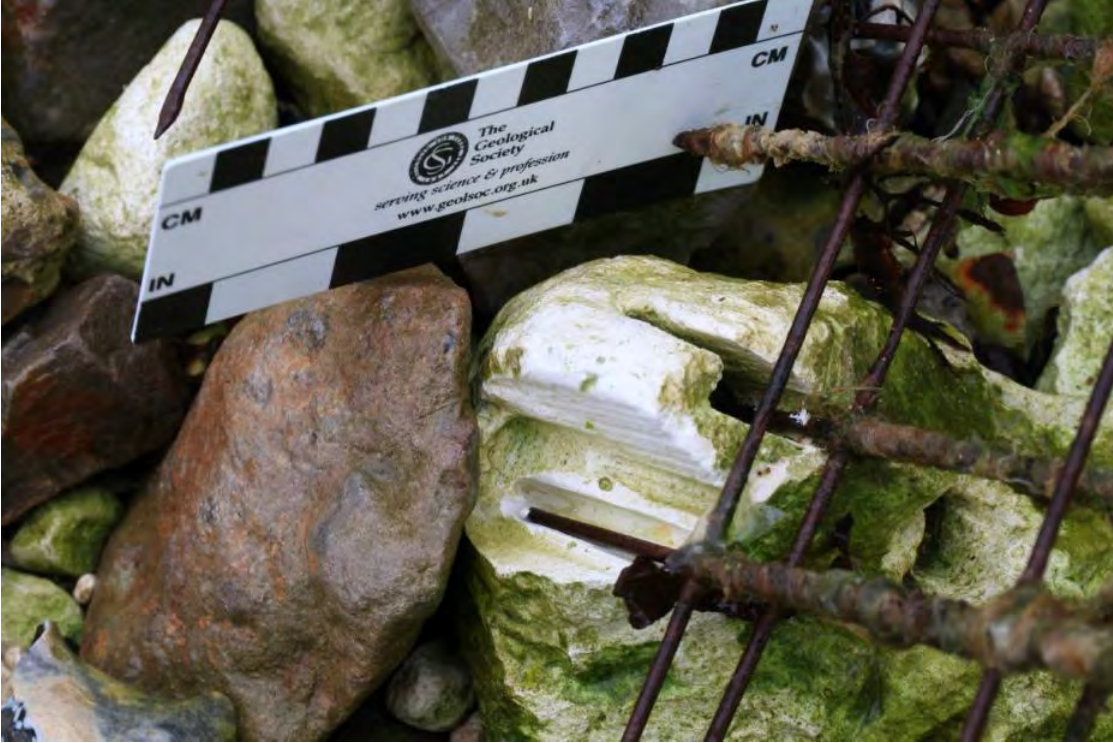
<p>In some locations the mesh components have corroded completely and detached from the revetment. It is assumed that some of these will have been washed out to sea and others were found lying around the beach area. These are hazardous to people, dogs and marine life as the edges of the mesh are very sharp and rusty.</p>

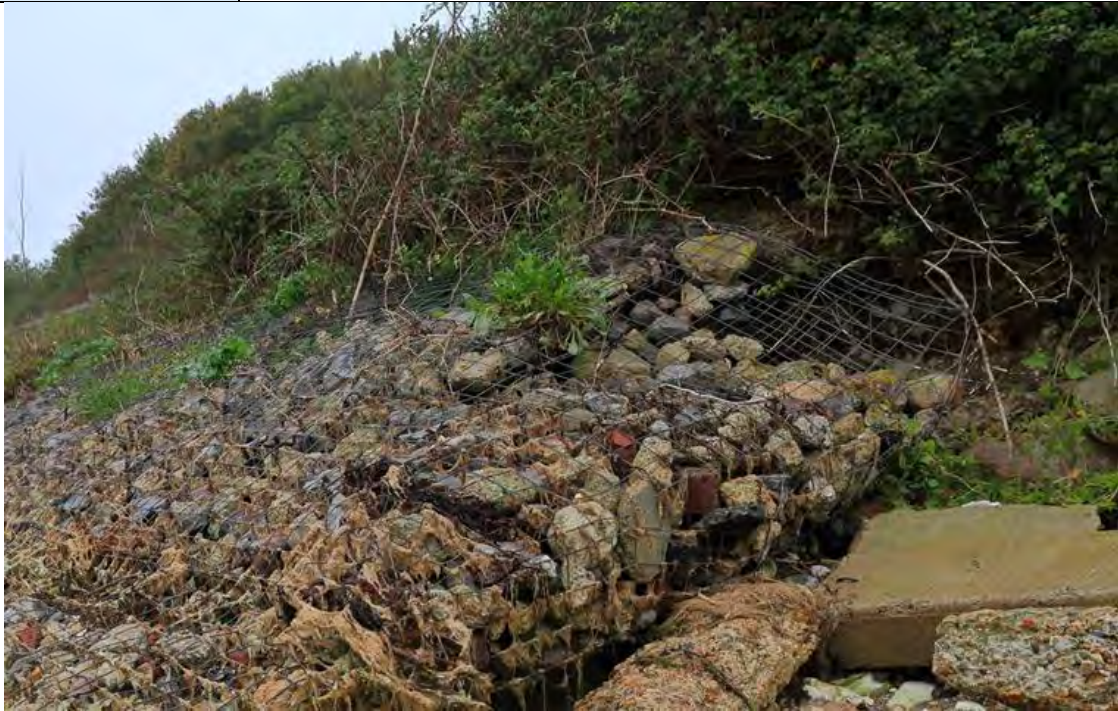
<p>The stability of the individual elements (gabions) e.g. damage and distortion of baskets:</p> <p>The baskets are extremely distorted across the whole length. The bottom layer has in some parts completely disappeared, the top section is being undercut and starting to pull apart.</p>	
<p>Additional Comments:</p> <p>On part of the stretch of gabion revetment, armourstone has been placed on top of the mesh. This does not appear to have been built up properly as an armourstone wall, rather blocks placed individually, potentially to hold the mesh down. These could prove dangerous as they could fall down and potentially take the gabion baskets down with them.</p>
