The effectiveness of the utility reinstatement specification

Prepared for Traffic Policy Division, Department of the Environment, Transport and the Regions

M H Burtwell and C C Spong

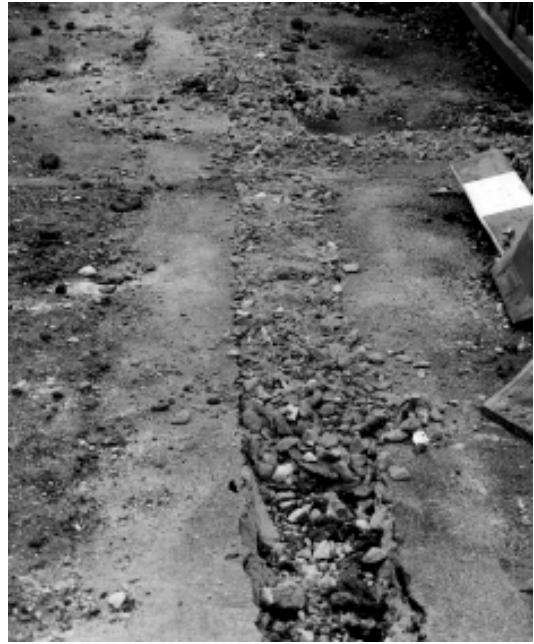
Plate 3 Poorly graded material

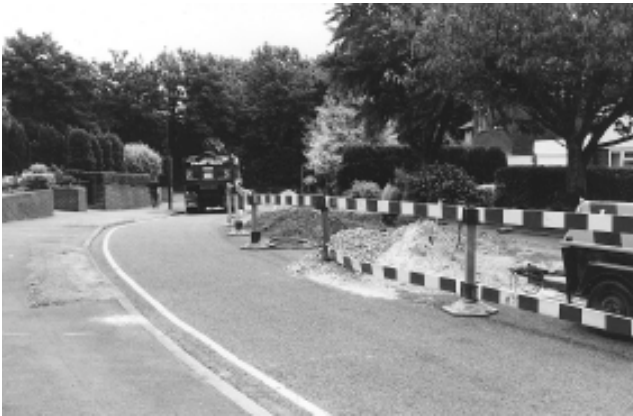
Plate 1 Poor material stockpile storage

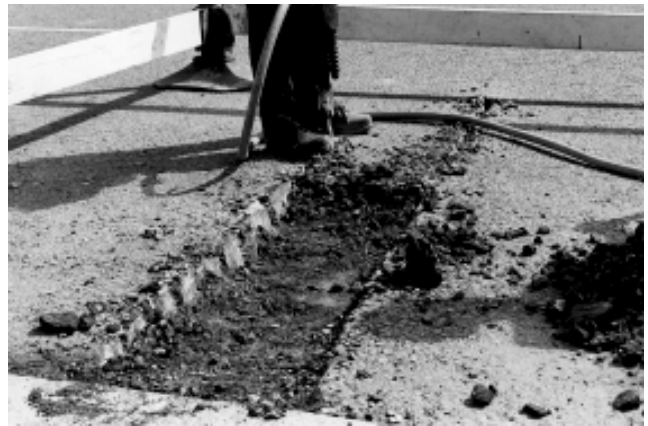
Plate 4 Increased risk of consequential damage

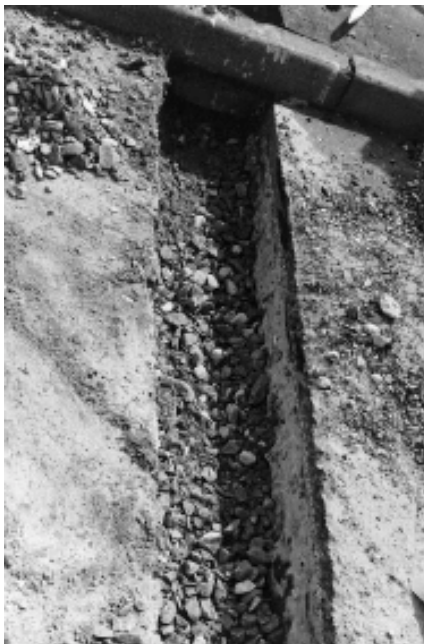
Plate 2 Poorly compacted Type 1 sub-base material

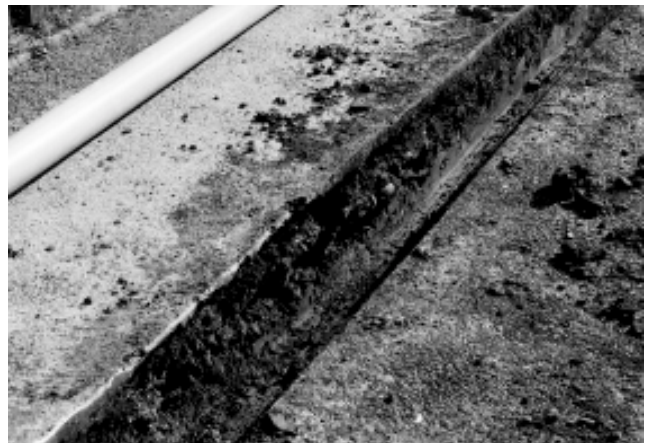
Plate 5 Undercutting increases the risk of poor compaction

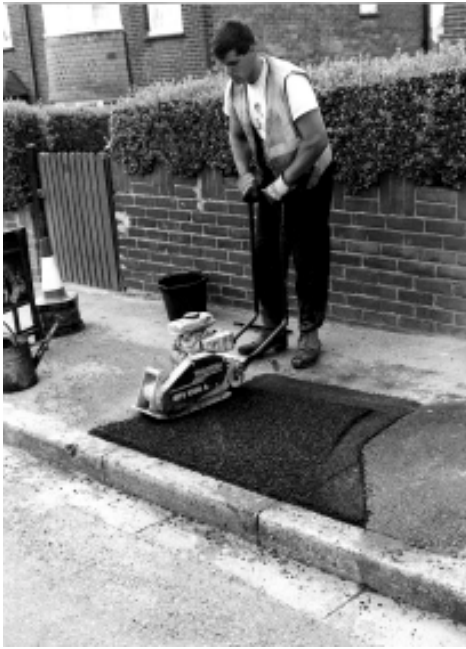
Plate 6 Unsuitable compaction plant

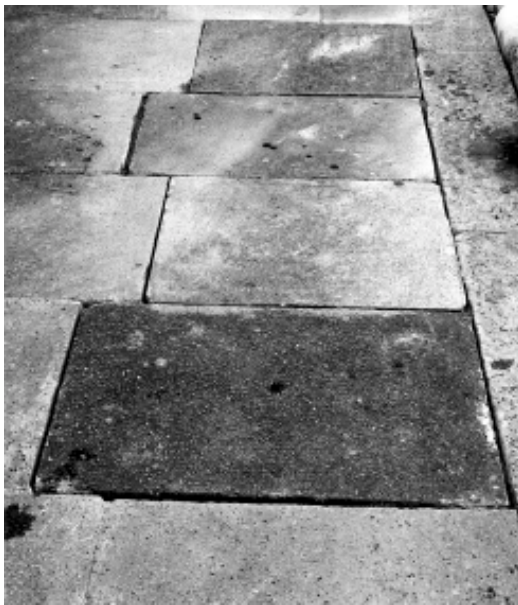
Plate 7 Absence of jointing sand between flags

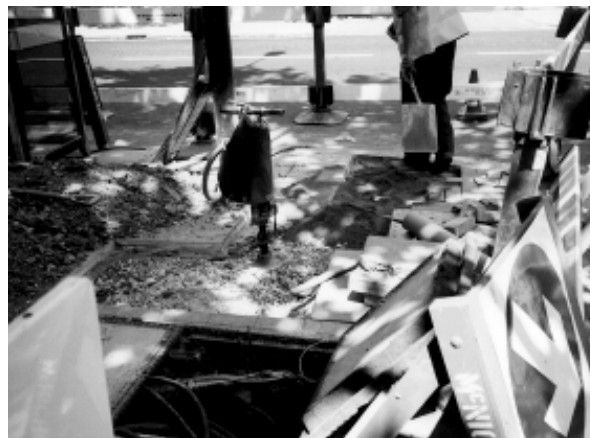
Plate 15 shows general untidiness on site which makes contamination of materials more likely. The operatives are also using unsuitable compaction plant. Plate 16 shows a poor quality final reinstatement where the finished surface is poor and damage has been caused to the surrounding surface.

Plate 15 Untidy working practice, unsuitable compaction plant

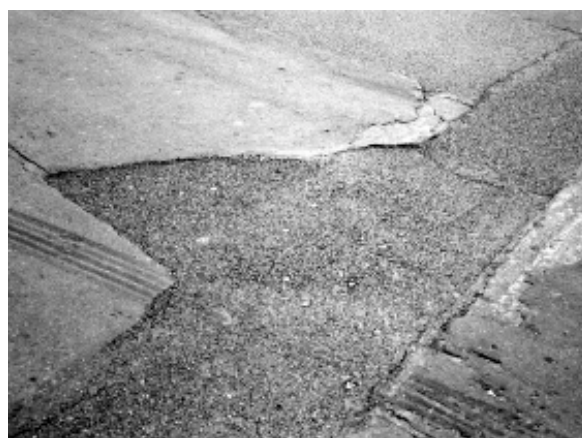
Plate 16 Poor quality final reinstatement

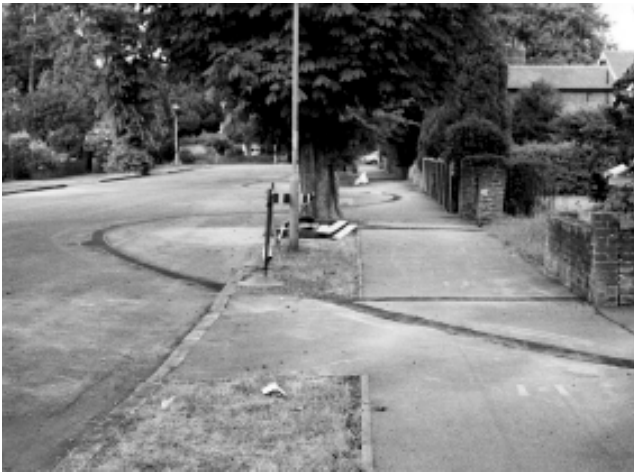
Plates 17 and 18 show reinstatements weaving from the footway to the carriageway in an attempt to avoid damaging tree roots. This is inefficient and makes it more difficult for future undertakers to excavate either the footway or carriageway without encountering other apparatus.

Plate 17 Avoiding damage to tree roots (poor planning)

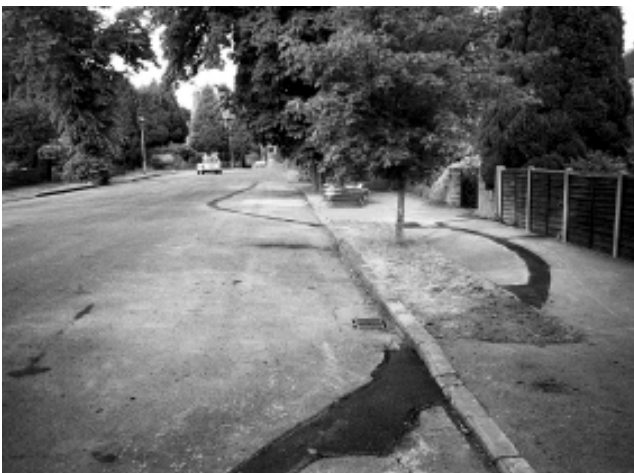
Plate 18 Avoiding tree roots (poor planning)

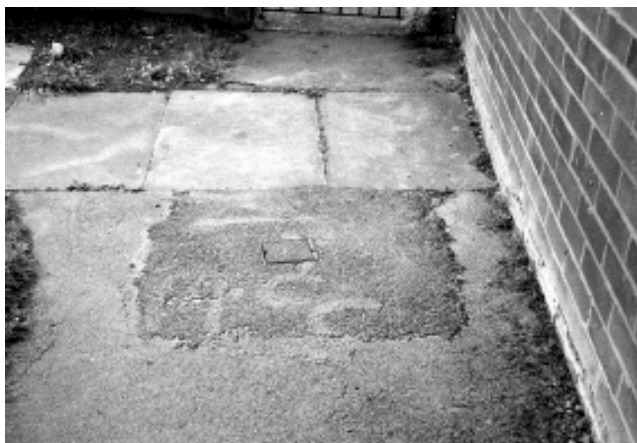
Plate 23 Site 006

The site was revisited after 15 months and a 7mm edge depression was found to be present. Although within the intervention limits set out in the Specification, this depression may worsen with time.

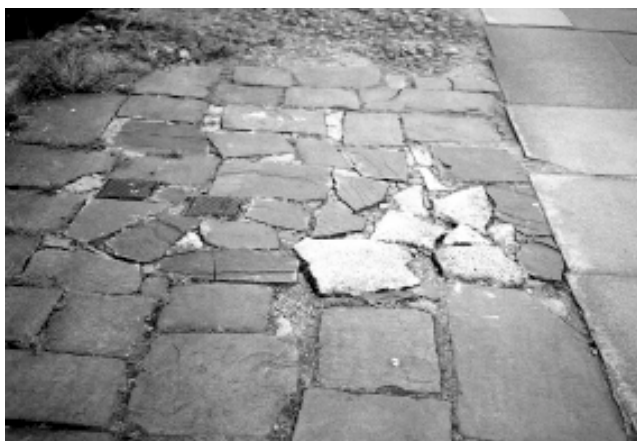
Plate 24 Site 016

The site was revisited after 15 months and was found to be in a poor state. The reinstatement had a 10mm edge depression (ie. equal to the intervention limit set out in the Specification) and there was severe surface cracking, severe edge gaps/cracks and severe fretting. The problems with this site are probably due to the poor local condition and are compounded by the use of incorrect compaction plant.

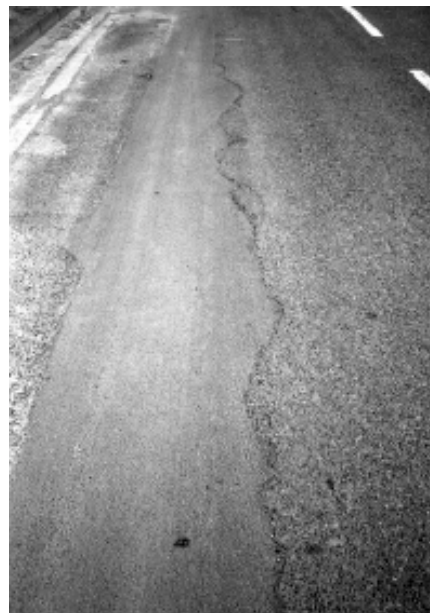
Plate 25 Site 047

The site was revisited after 11 months and was found to have a 3mm edge depression; well within the intervention limits in the Specification. The surface regularity appeared unsatisfactory and the texture of the surface did not match that of the adjacent surfacing. The reinstatement had minor surface cracking, minor edge gaps/cracks and minor surface fretting. Although these three defects do not exceed the intervention limits set out in the Specification, the lack of compaction may mean that the condition of the reinstatement will worsen as it is trafficked.

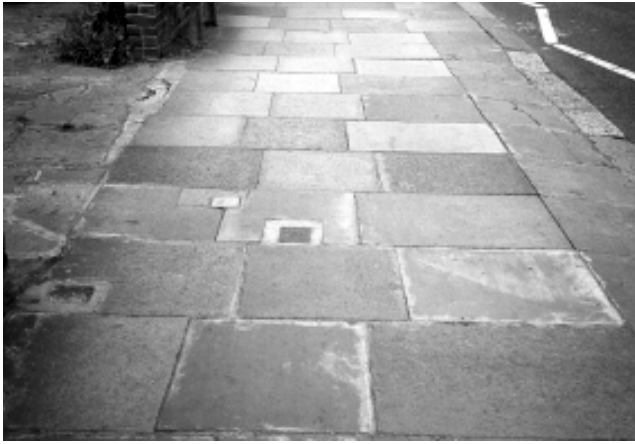
Plate 26 Site 074

The site was revisited after 9 months and was found to have a 8mm edge depression and there was moderate surface cracking. Although within the intervention limits set out in the Specification, the condition of the reinstatement may worsen with time.

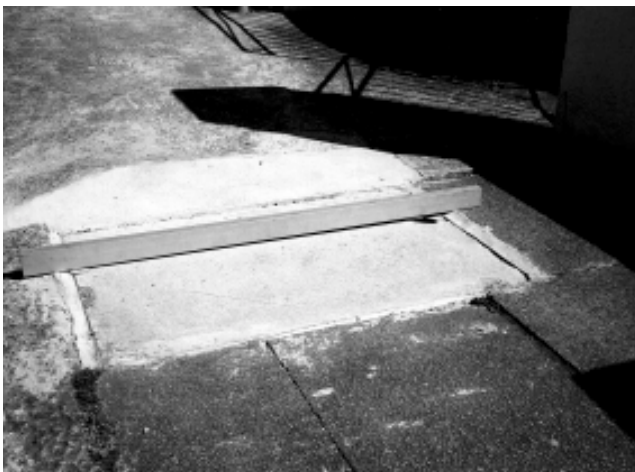
Plate 27 Site 097

The site was revisited after 10 months and was found to have a 8mm edge depression. There was also minor surface cracking and minor edge gaps/cracks. Although within the intervention limits set out in the Specification, the condition of the reinstatement may worsen with time.

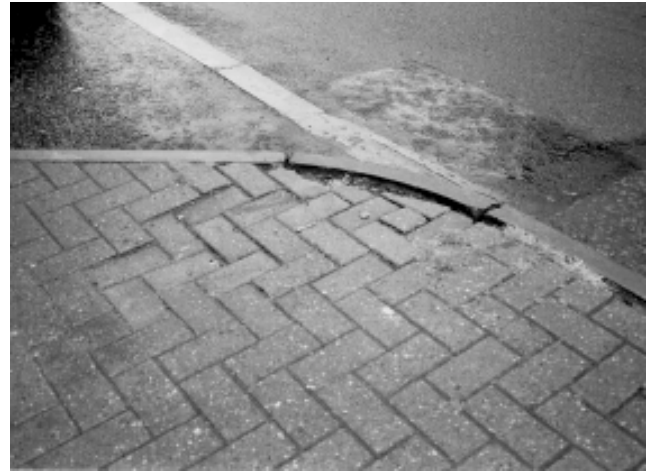
Plate 28 Site 155

be in a poor condition. The reinstatement had a 15mm edge depression (ie. greater than the 10mm intervention limits set out in the Specification), a 8mm surface depression and there were also severe edge gaps/cracks. The poor condition of this reinstatement is probably due to the presence of water in the trench and compounded by the insufficient compaction passes and unsuitable layer thickness.

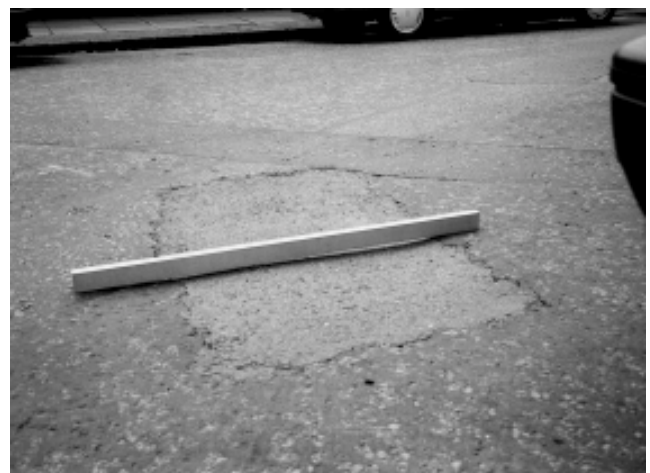
Plate 29 Site 157

The site was revisited after 12 months and was found to be in a poor condition. The reinstatement had a 15mm surface depression (ie. outside the 12mm intervention limit set out for a 500mm wide reinstatement in the Specification) and there were moderate edge gaps/cracks. The poor condition of this reinstatement may be due to the insufficient number of compaction passes and incorrect material thicknesses.

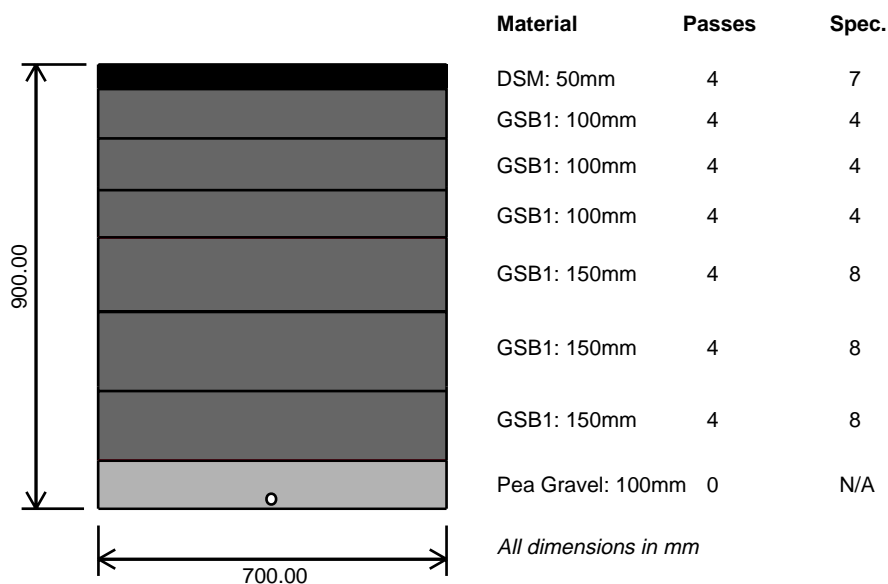
SITE 006:

OTHER SIGNIFICANT DETAILS
Backfill material poorly graded and moisture content too high. Insufficient passes.
