## **PUBLISHED PROJECT REPORT PPR908**

# **Managing Hazardous Slopes**

High Resolution Panoramic Imagery for Monitoring Purposes

Report prepared for:	Transport Scotland		
Project/customer reference:	TS/TRBO/SER/2012/12/35		
Copyright:	© Queen's Printer for Scotland		
Report date:	May 2019		
Report status/version:	Issue 1		
Quality approval:			
M G Winter

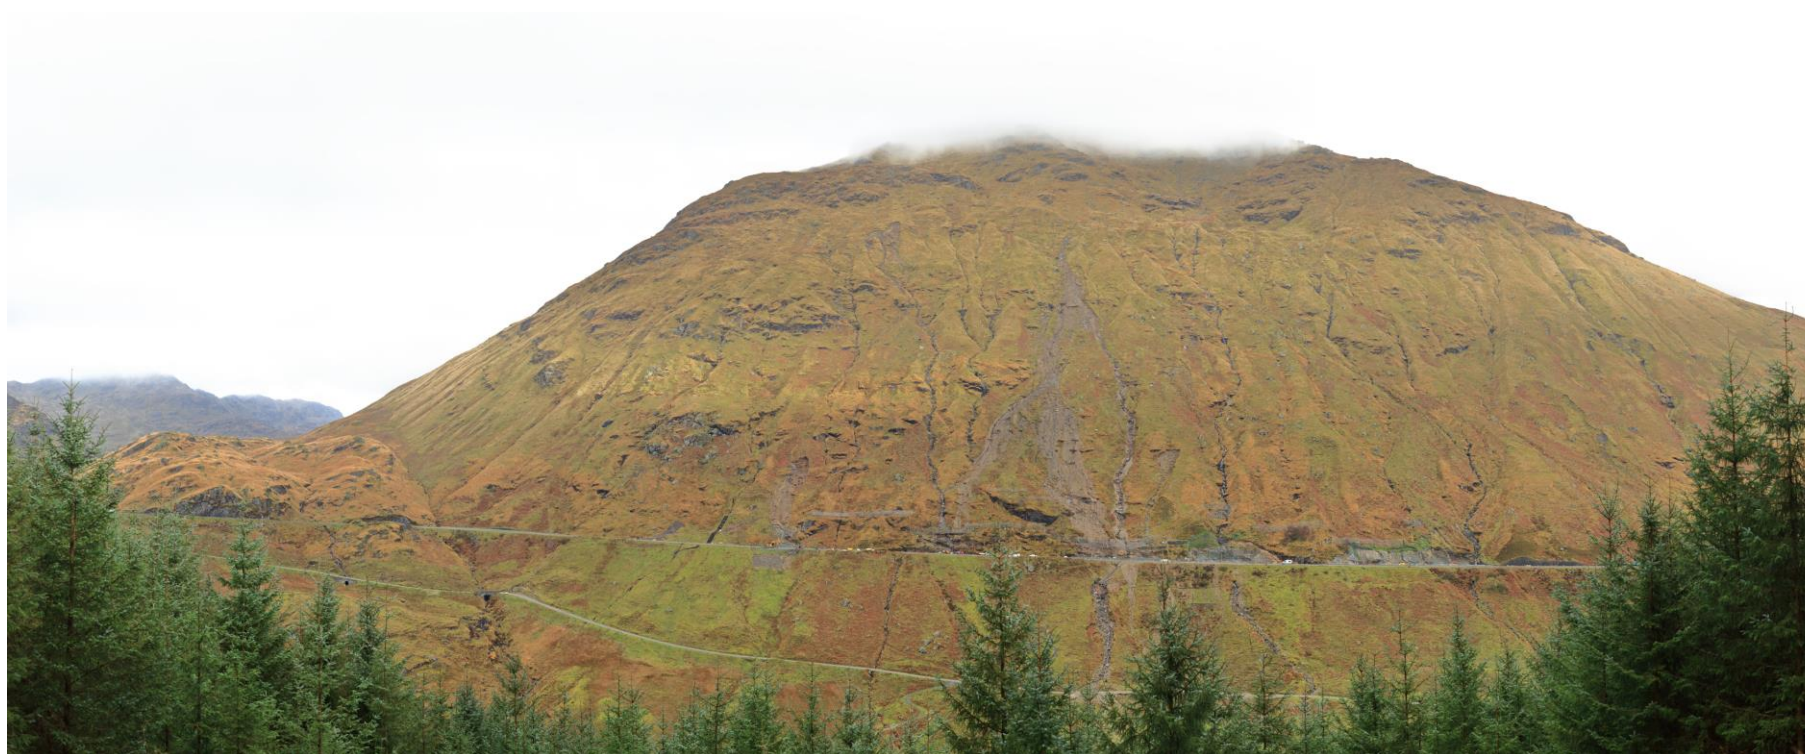
**Figure 3. High resolution panoramic image for Station A83 RabT Pano2a for 2019-10 post-event (image dated 30 October 2018)**

The type of imagery that can be captured is illustrated as panoramas in Figure 3 to 11 for each of the nine stations at the A83 Rest and be Thankful and A85 Glen Ogle sites. These panoramas are generally for October 2018 post-event captures, but earlier in May 2018 for A83 RabT Pano5 and earlier in October 2018 for the A85 Glen Ogle stations.

Figure 12 is a detail from one of the 104 original images that were used to form the A83 Glen Ogle Pano2a panorama (Figure 3) and the level of detail that can be clearly seen is described in the associated figure caption.

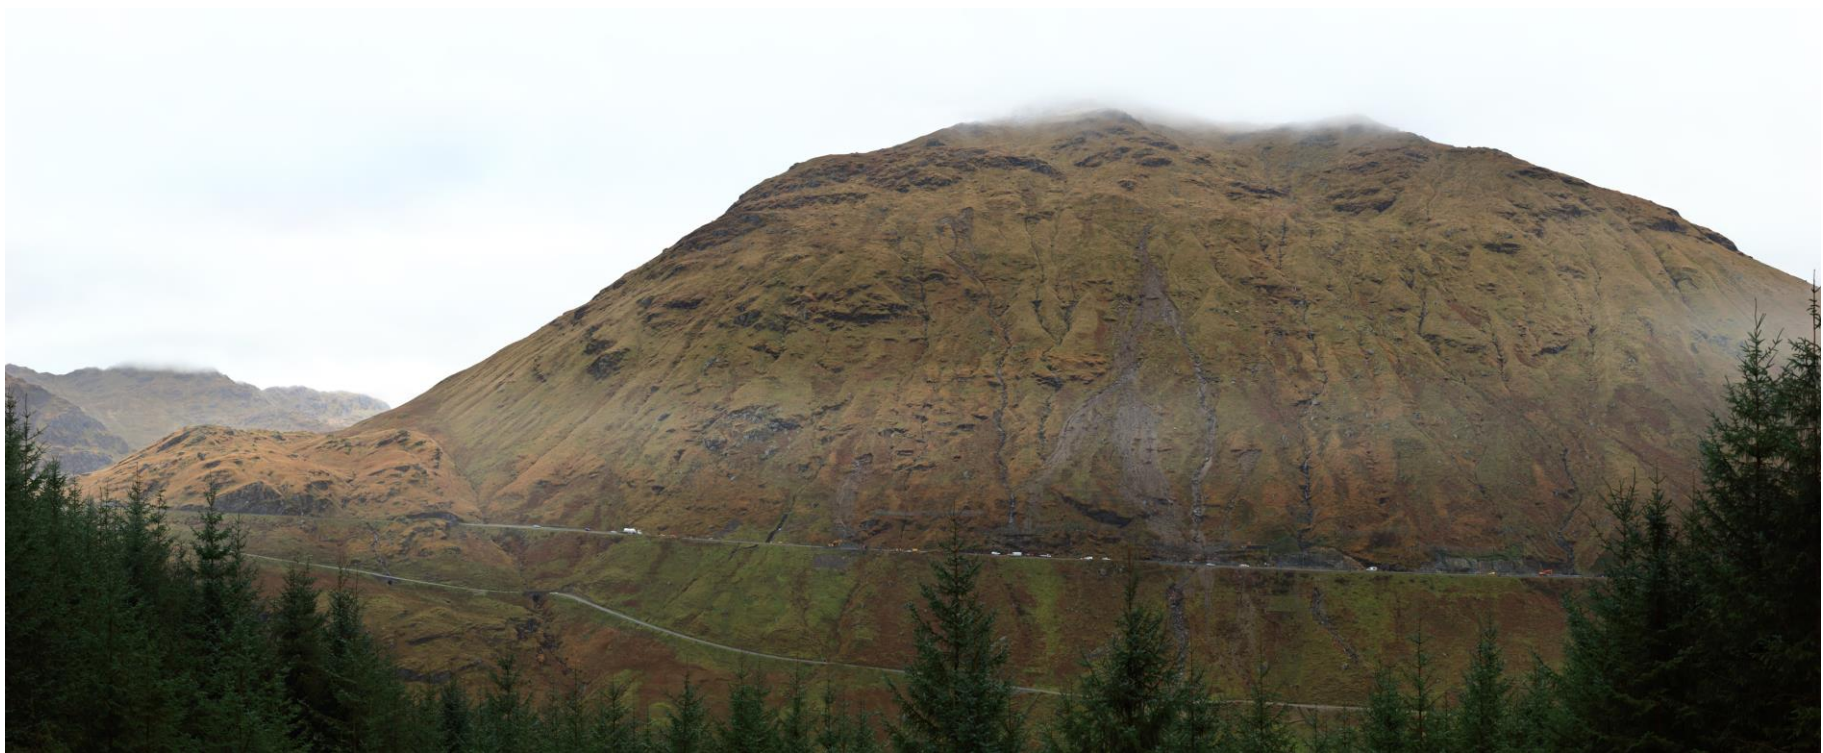
**Figure 4. High resolution panoramic image for Station A83 RabT Pano2b for 2019-10 post-event (image dated 30 October 2018)**

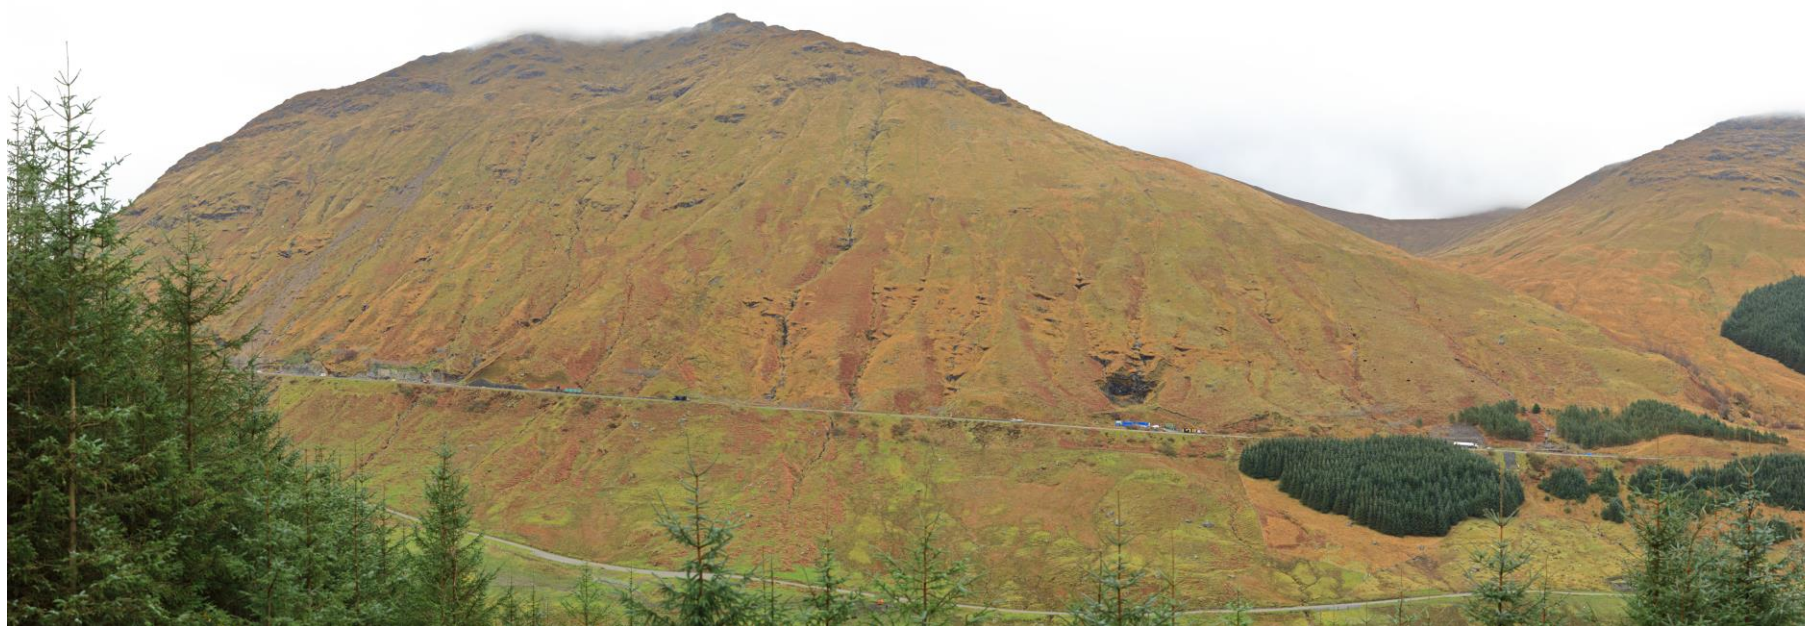
**Figure 5. High resolution panoramic image for Station A83 RabT Pano3a for 2019-10 post-event (image dated 30 October 2018)**

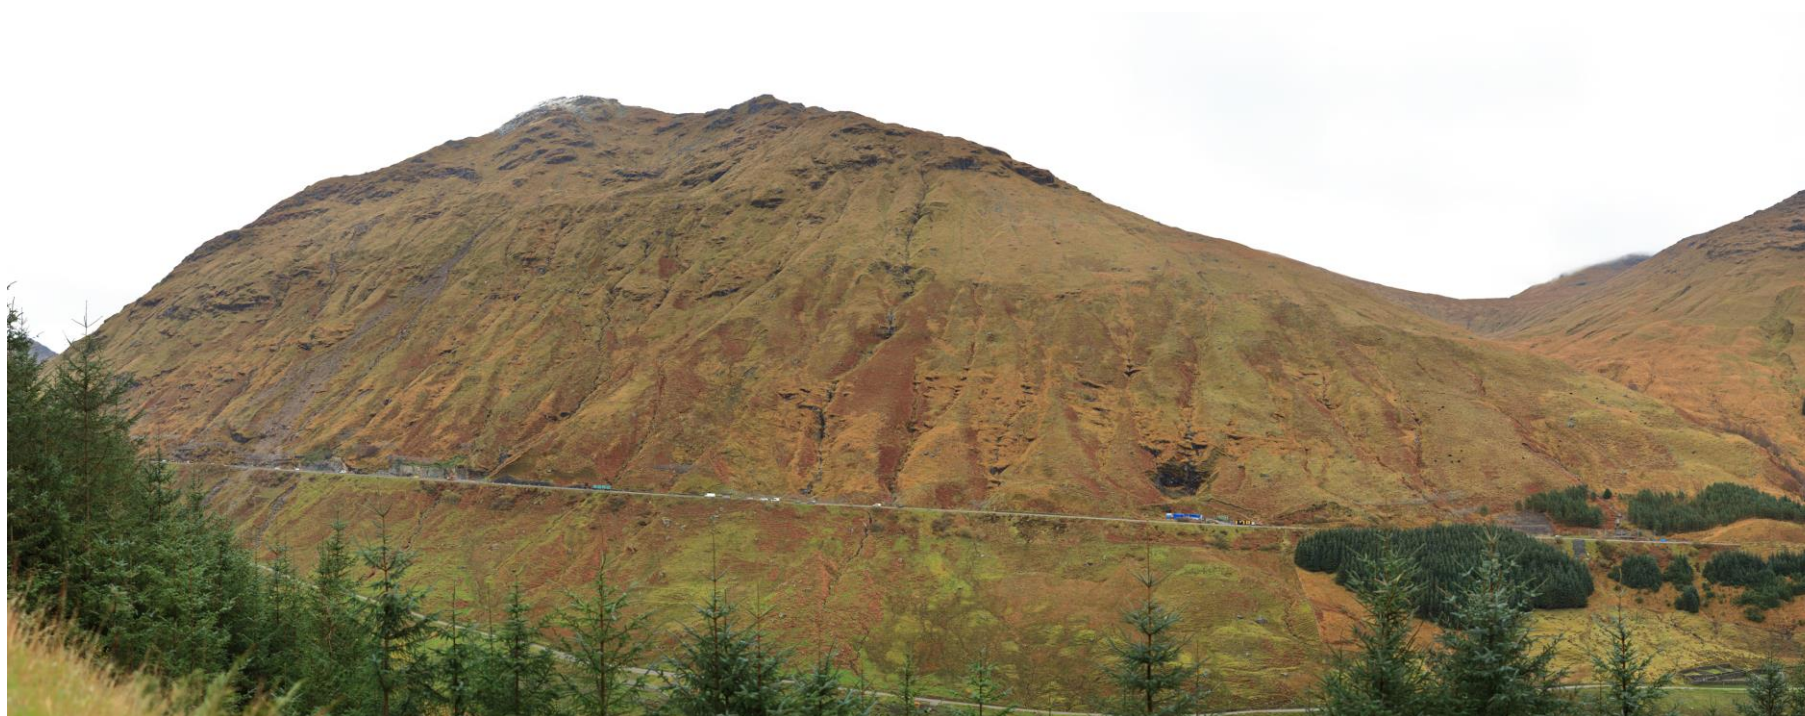
**Figure 6. High resolution panoramic image for Station A83 RabT Pano3b for 2019-10 post-event (image dated 30 October 2018)**

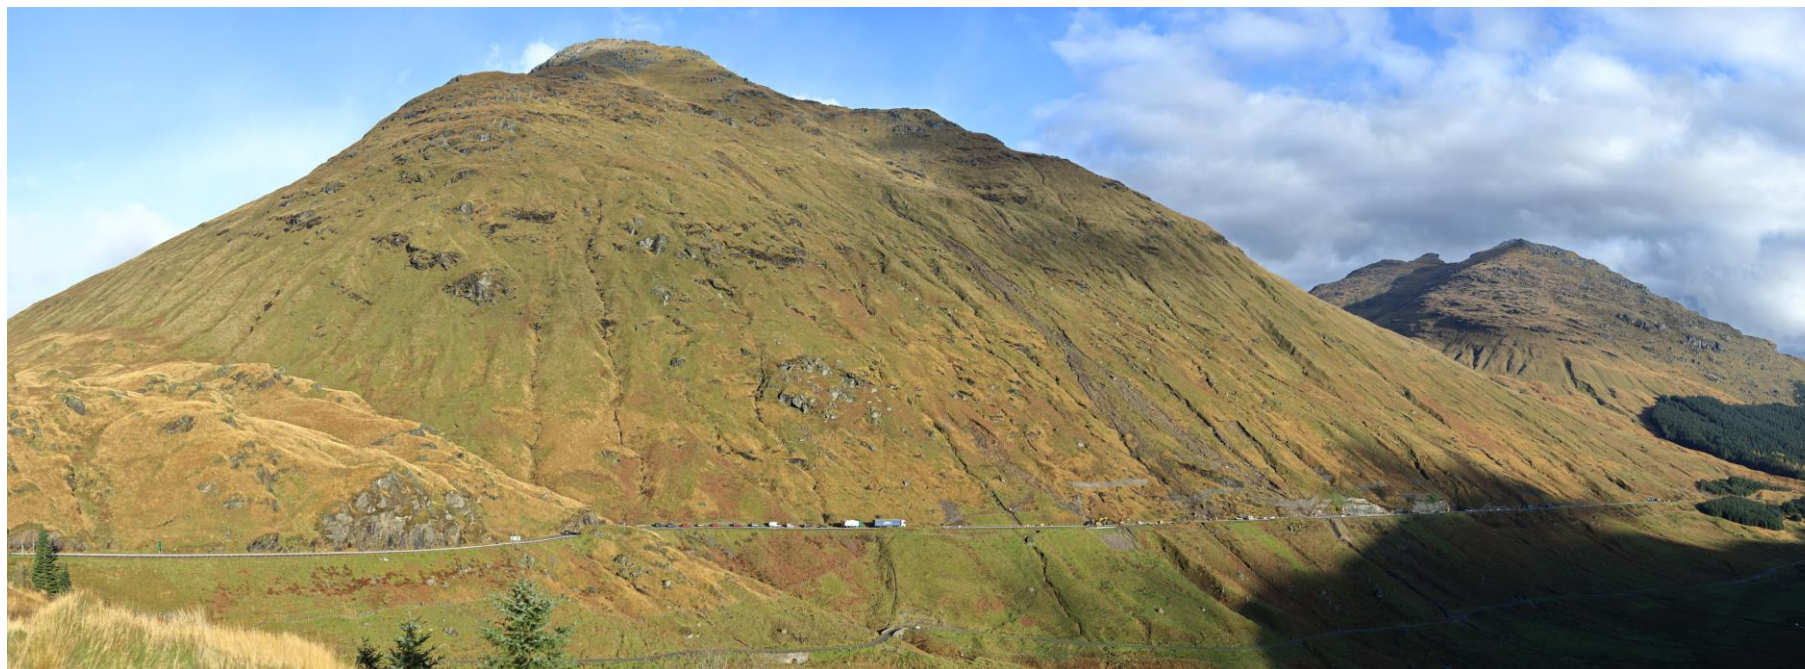
**Figure 7. High resolution panoramic image for Station A83 RabT Pano4 for 2019-10 post -event (image dated 30 October 2018)**

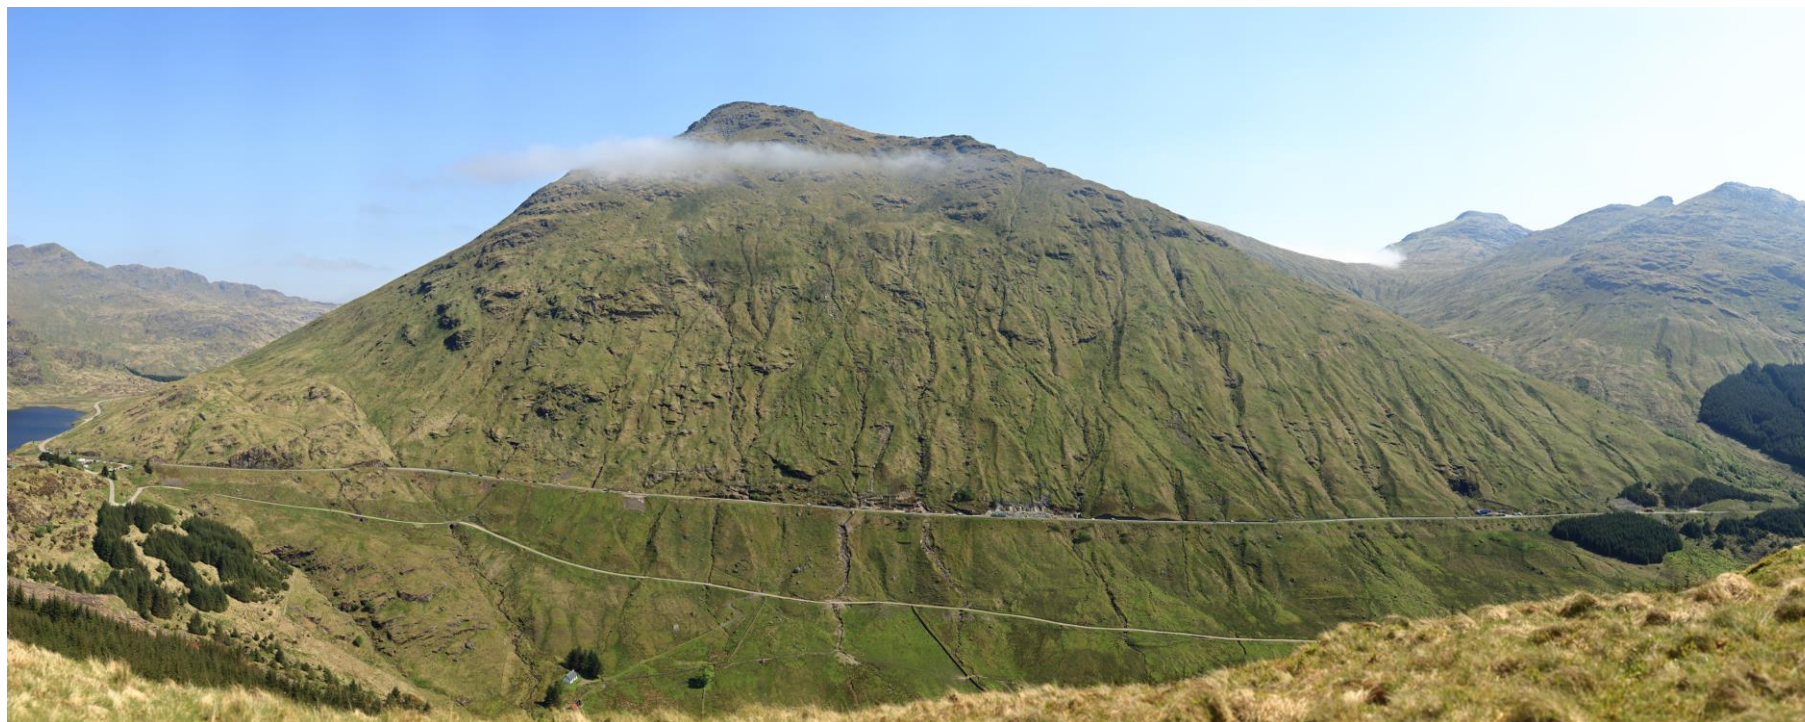
**Figure 8. High resolution panoramic image for Station A83 RabT Pano5 for 2018-05 (image dated 24 May 2018)**

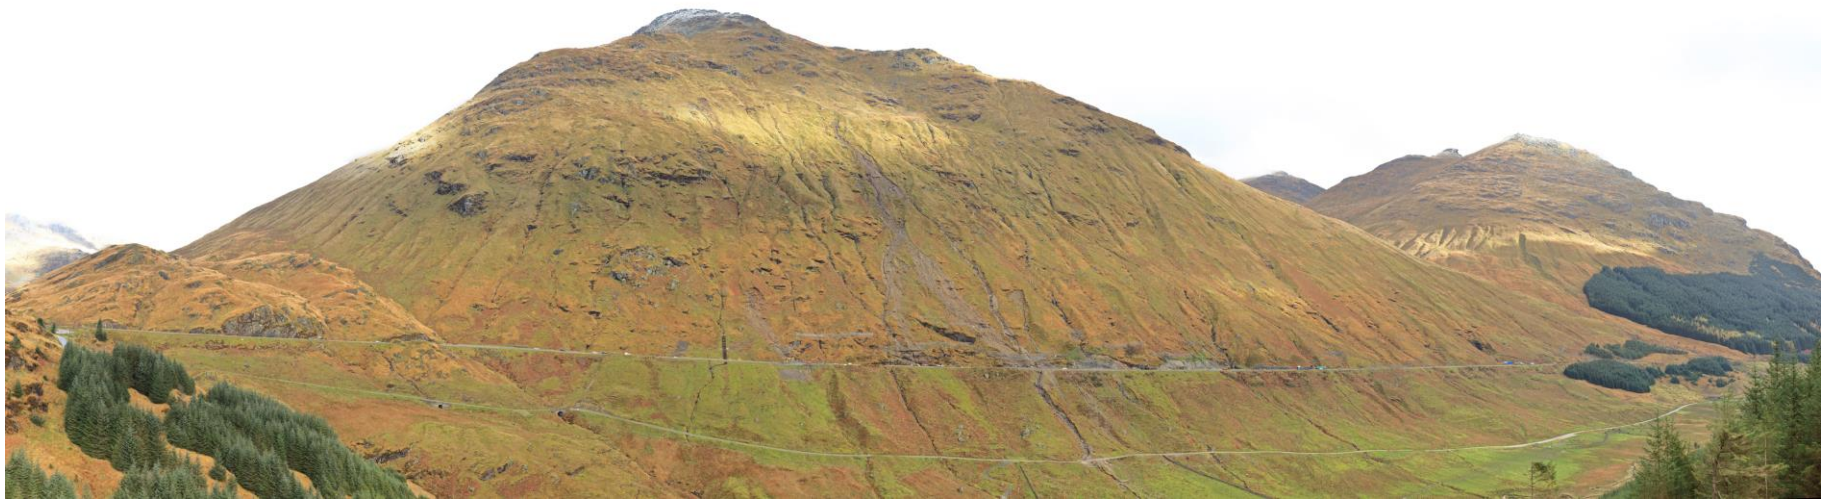
**Figure 9. High resolution panoramic image for Station A83 RabT Pano6 for 2019-10 post-event (image dated 30 October 2018)**

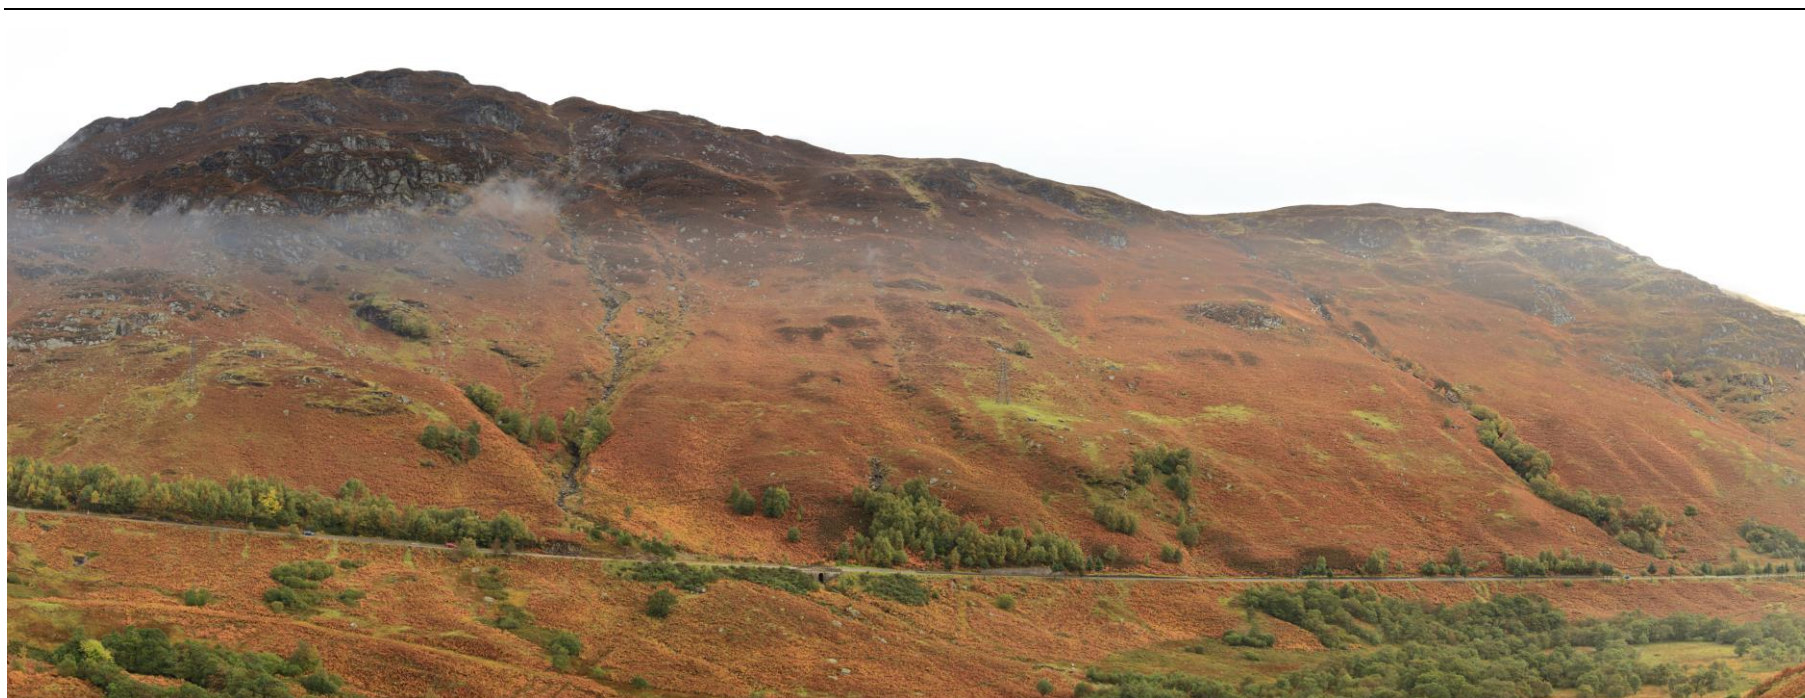
**Figure 10. High resolution panoramic image for Station A85 GO Pano1 for 2018-10 (image dated 3 October 2018)**

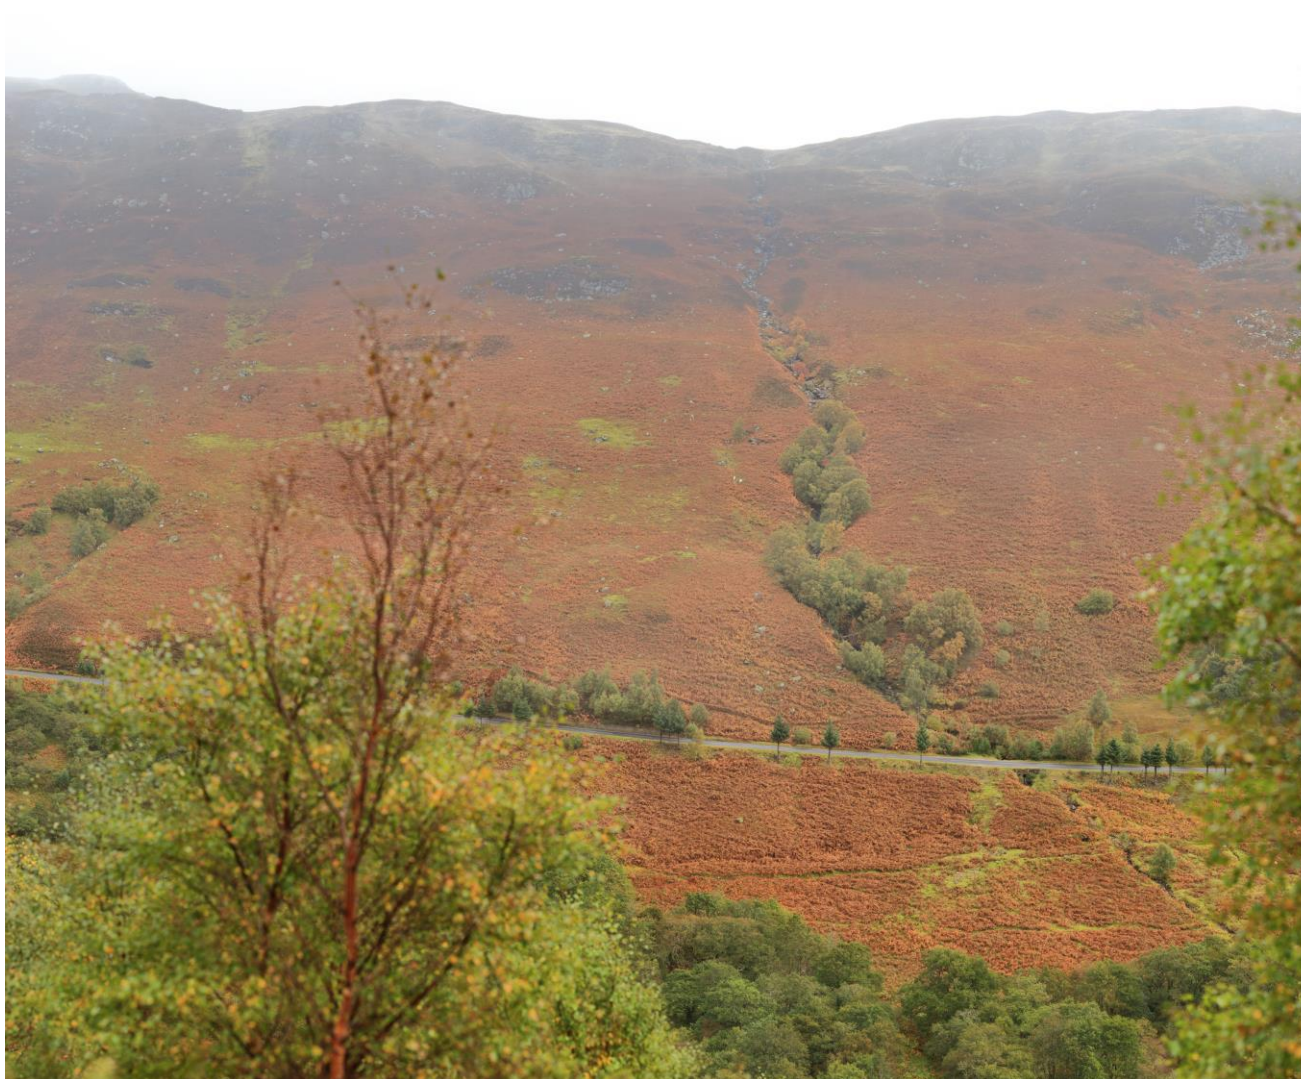
**Figure 11. High resolution panoramic image for A85 GO Pano2 for 2018-10 (image dated 3 October 2018)**

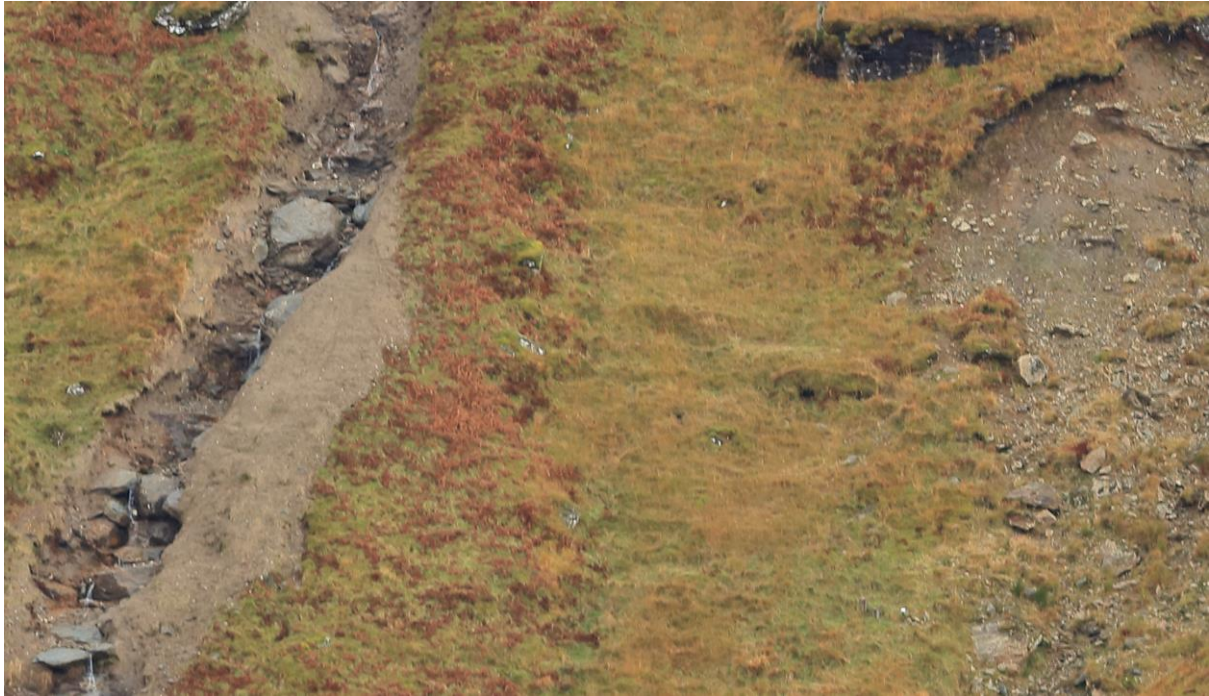
**Figure 12. Sample of one of the 104 original images that form the A83 RabT Pano2a 2010-30 post-event panorama (Figure 3) illustrating the ability to capture detail. Fresh evidence of debris flow can be seen to the left of the picture and the loss of material can be seen to the left of the channel while evidence of nascent levee structures can be seen to the right of the channel. Individual clasts of a few centimetres to 10 centimetres can be clearly seen.**

**To the right of the picture evidence of past/older movement is clear with evidence of revegetation in the scar being clearly visible. The image is resolved at 66.7%, 300ppi and measures 19.71cm by 11.37cm (image filename: A83 RabT Pano2b-2 2018-10-30\_054A4878.TIF; image dated 30 October 2018)**

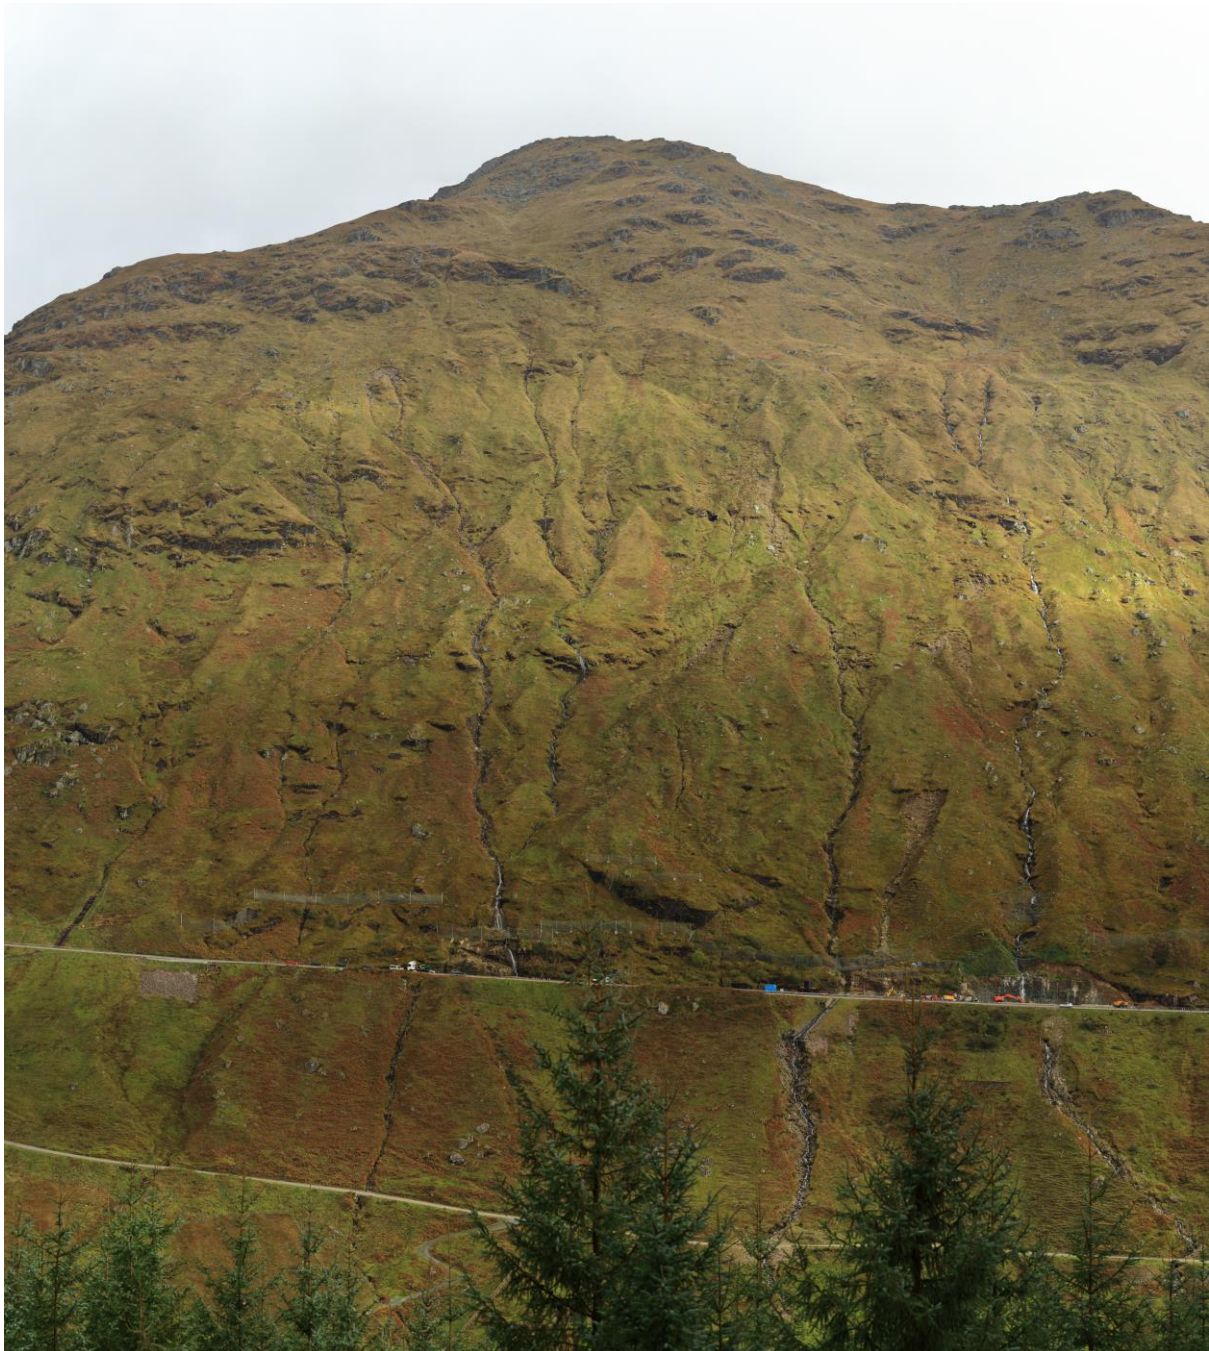
**Figure 13. Central section of the A83 RabT Pano2a 2010-30-02 (pre-event) image showing the SW-facing slope of Beinn Luibhean prior to the failures of 9 October 2018**

Perhaps more importantly a time-series of imagery is provided through a period of relative quiescence and before and after significant events such as those of October 2018. The October 2018 survey coincided with the period just before these events (Figure 13) and the opportunity was taken to undertake further surveys as soon as possible after the events, thus providing very useful before-and-after imagery (Figure 14). It is clear from Figures 13 and 14, even at the highly reduced resolution presented here, that even quite subtle differences can be readily discerned from the before and after images.

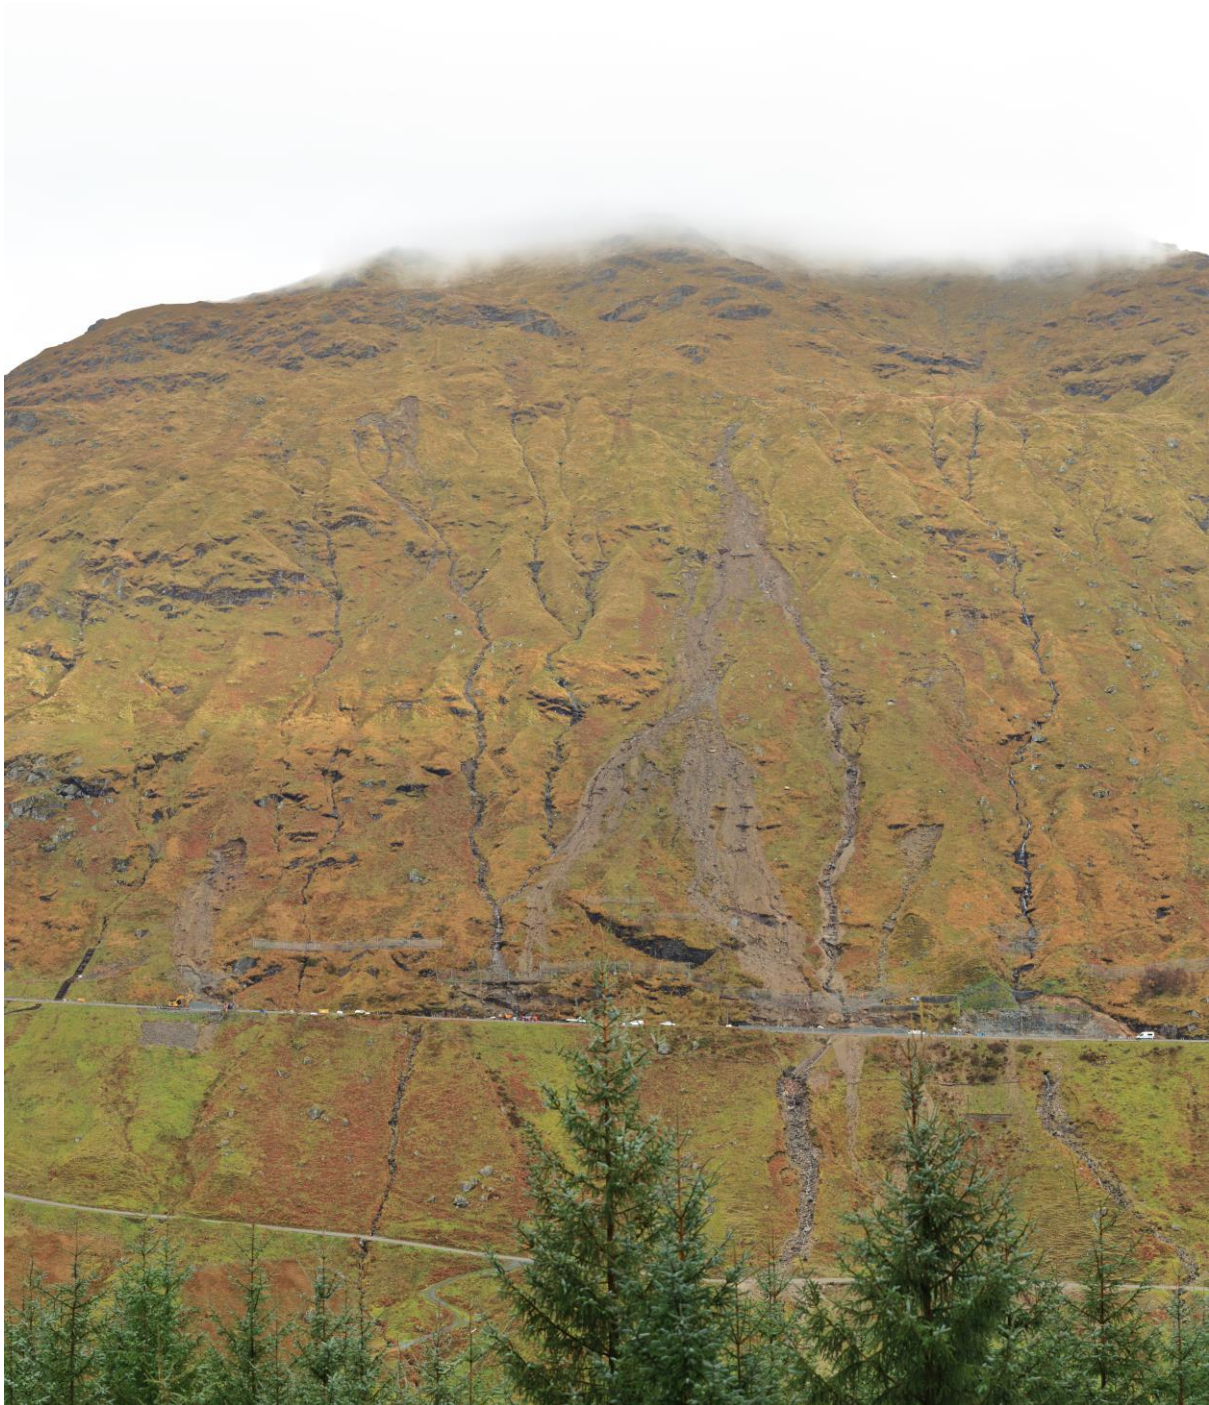
**Figure 14. Central section of the A83 RabT Pano2a 2010-30-30 (post-event) image showing the SW-facing slope of Beinn Luibhean and the failures of 9 October 2019**

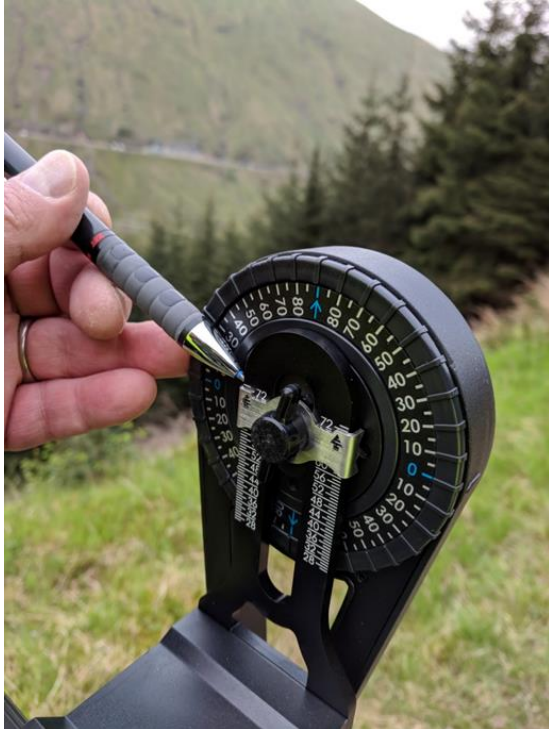
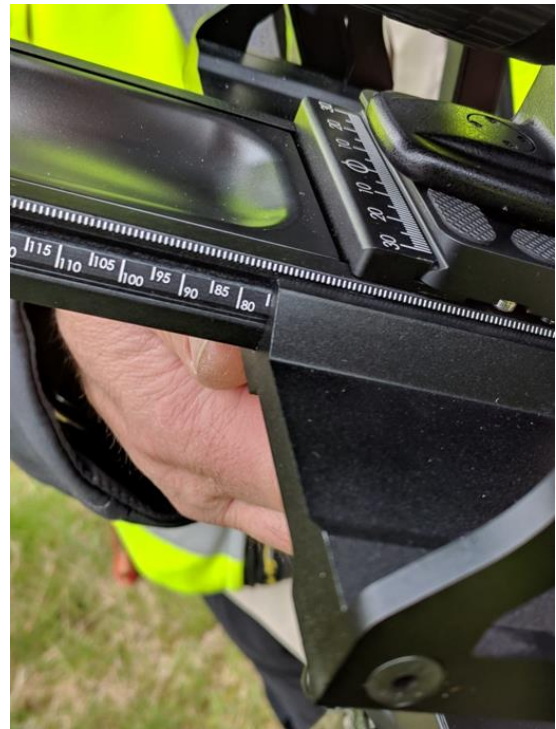
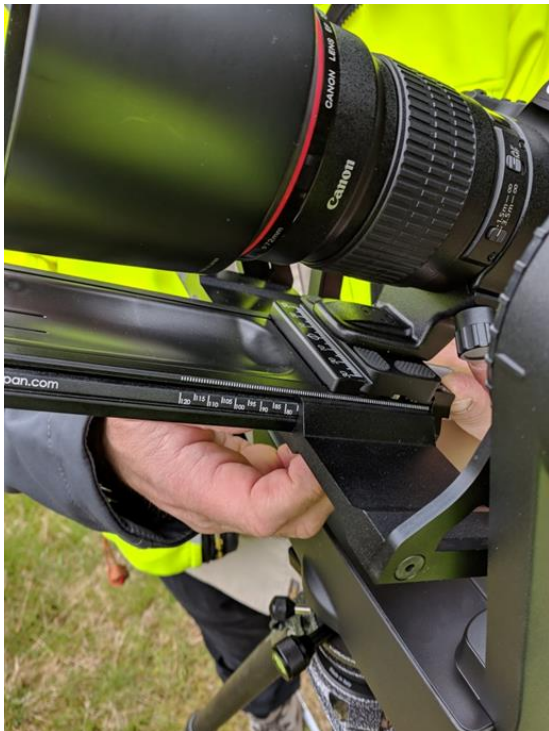
The images and text below illustrate the basic setup of the GigaPan Epic Pro V. The dimensions shown on the vertical and horizontal scale adjusters are important but it should be noted that these are specific to the Canon EOD 5DS and Canon EF 200mm f2.8L USM MkII camera and lens combination.

### GigaPan physical positions:

Horizontal 75mm

Vertical 72mm

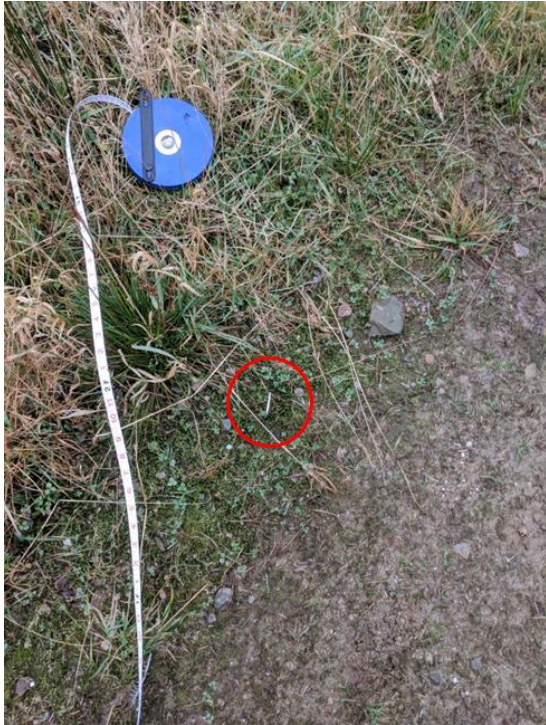
## C.2 A83 RabT Pano2b

11m south of centre line of survey plinth at the edge of the road.

NN 23170 06548 (223169 706548)  
resolved on map as NN 23170 06548.

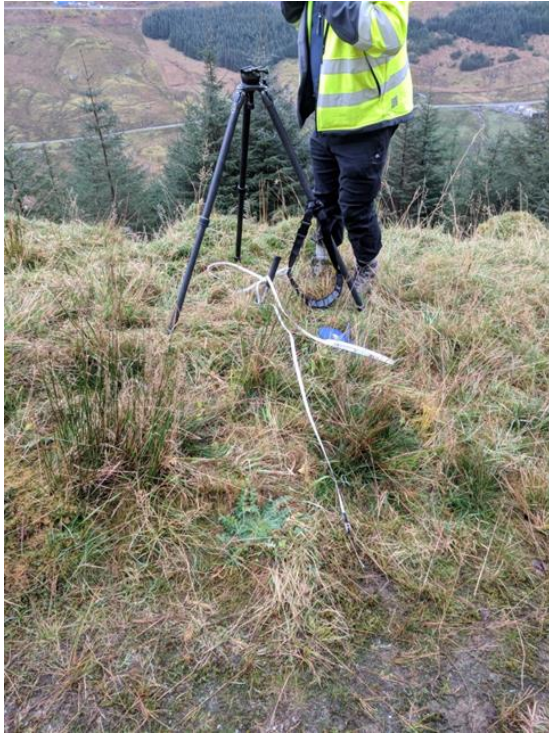
## C.4 A83 RabT Pano3b

4.5m south of SW corner of survey station,  
1.5m in from edge of forest track/pin.

NN 23571 06090 (223571 706090)  
resolved on map as NN 23571 06099.

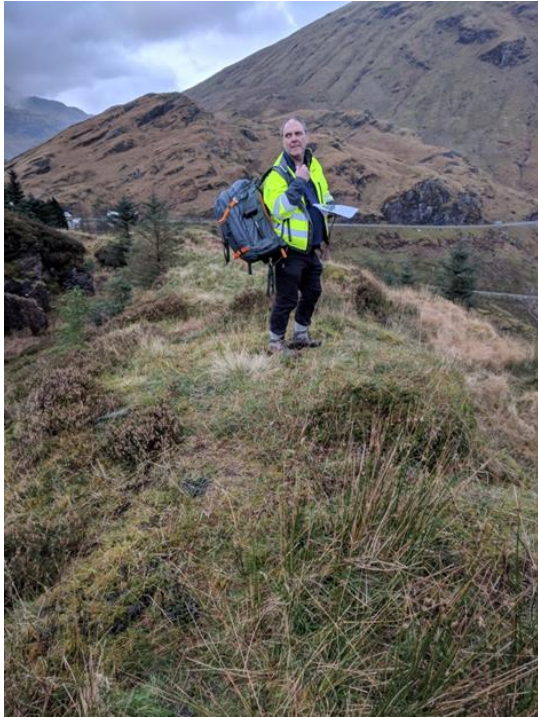
## C.5 A83 Pano4

East of telecommunications mast adjacent to B828.

NN 22968 07162 (222968 707162).

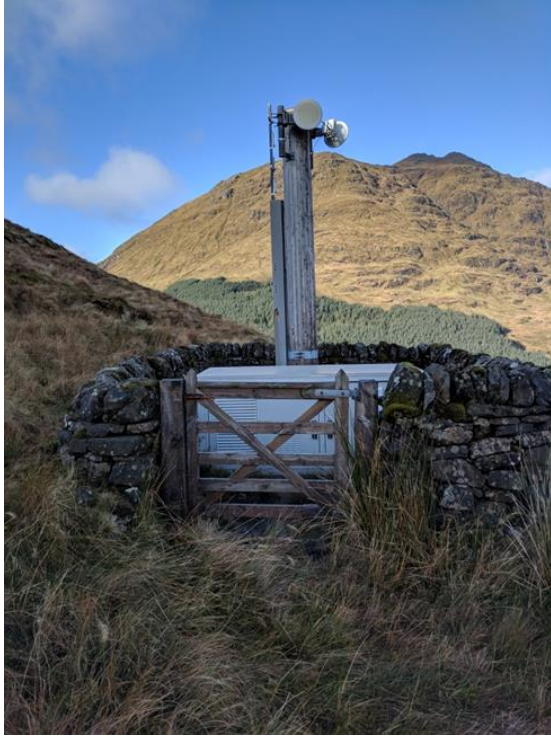
## C.6 A83 Pano5

2.5m east downslope of SE corner of compound.

NN 22964 06382 (222964 706382).

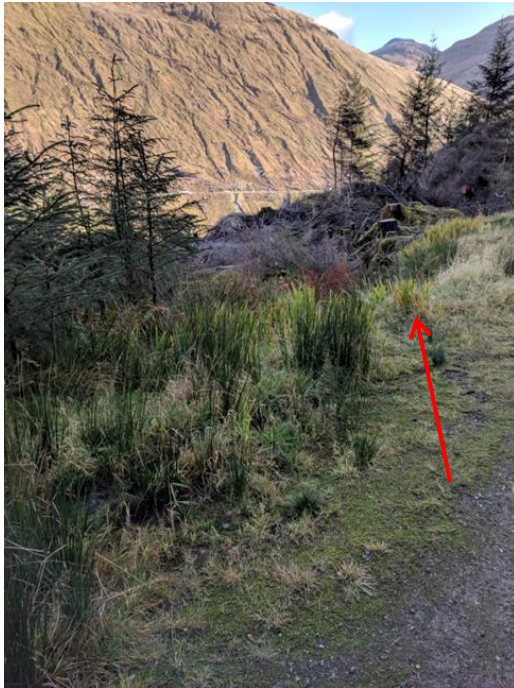
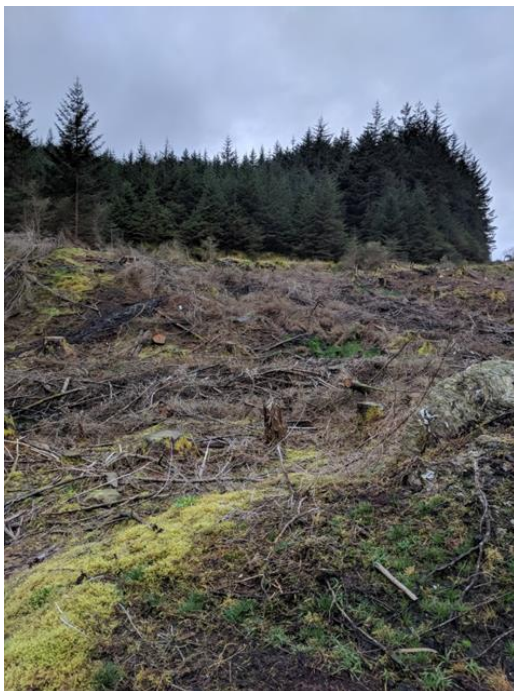
## C.7 A83 Pano6

Bearing 247° Pano6 to mast at top of forest track. Tripod centred on top of/to rear of outcrop. 1.4 m in front of peg with red ribbon (towards Beinn Luibhean).

NN 22965 06820 (222965 706820) resolved on map as NN 22965 06820.

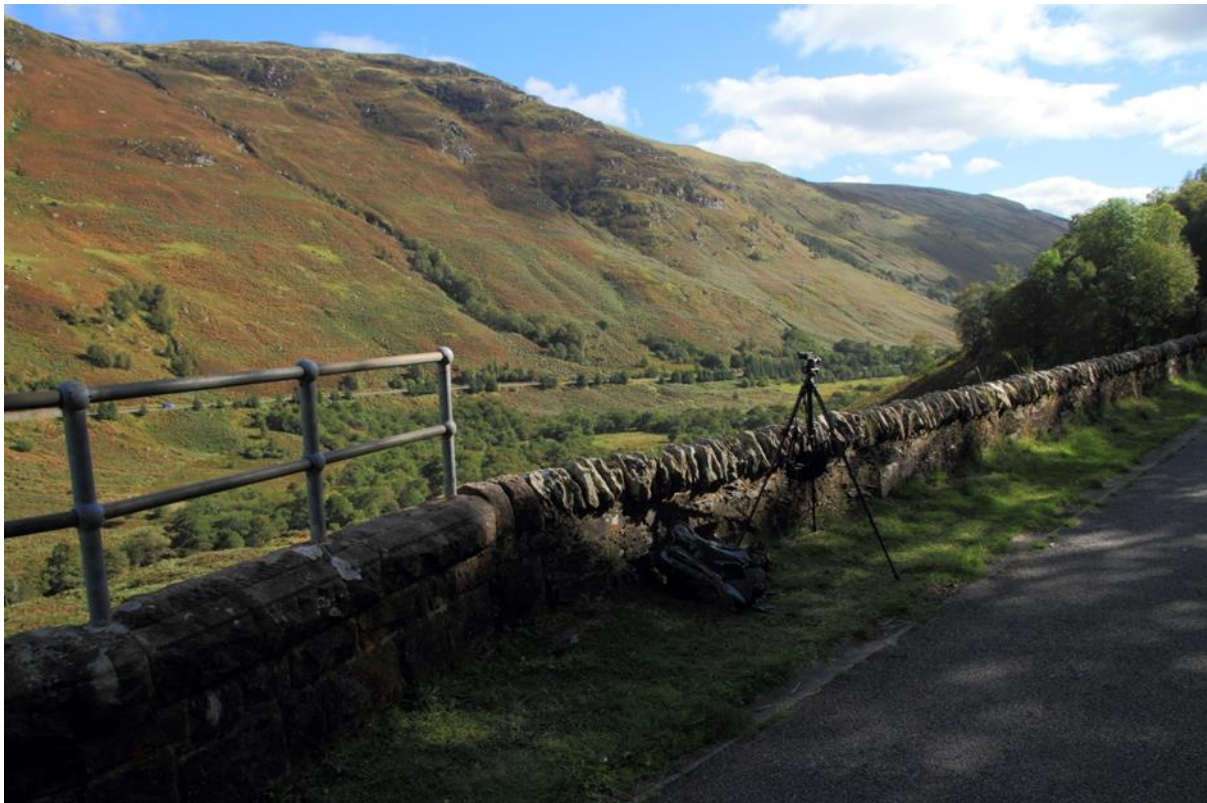
## **C.8 A85 GO Pano1**

2m south of end of viaduct railing immediately butted up against wall. (Note use 2.5 sections of tripod rather than the usual 2.)

NN 57127 23353 (257127 726353).

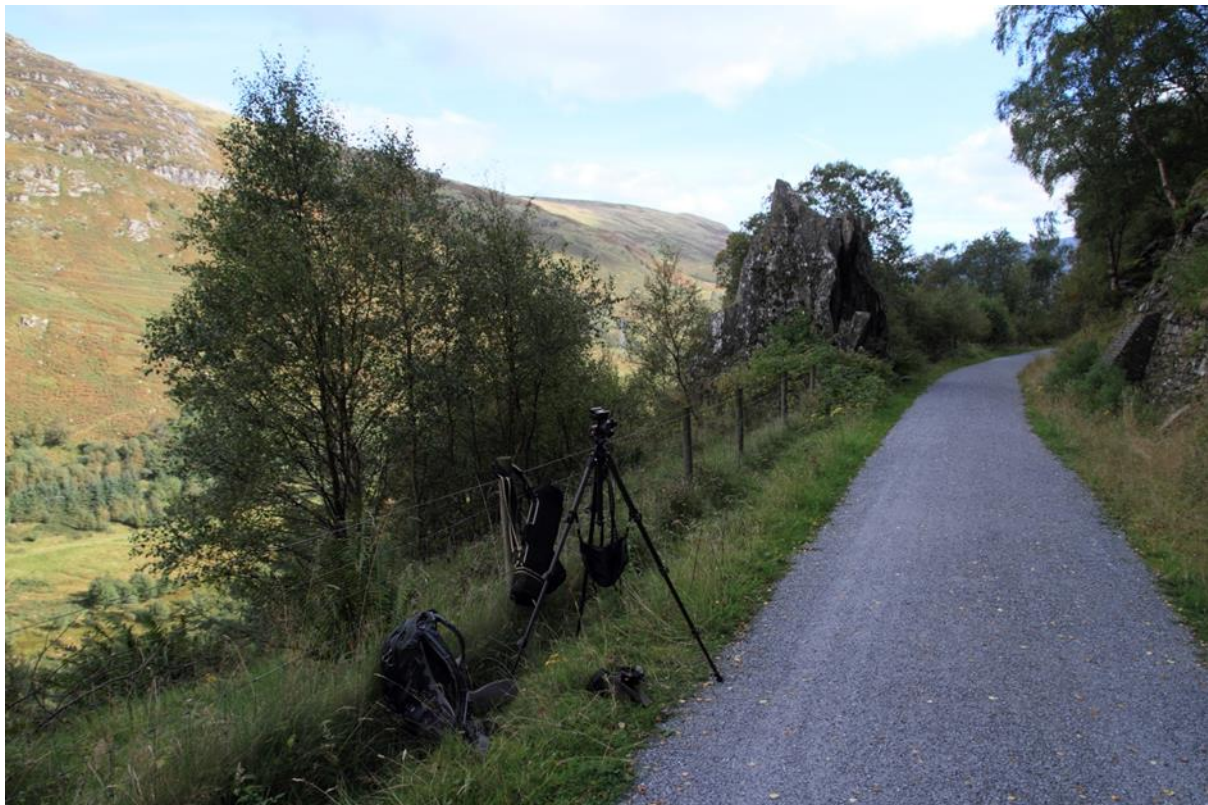
## C.9 A85 GO Pano2

Just before/to N of large boulder/outcrop on east side of old railway line. Location is about 1m N of fifth short fence post from boulder (there are two taller posts adjacent to the boulder that are not counted). (Note use 2.5 sections of tripod rather than the usual 2.)

NN 57417 26140 (257417 726140).
