PUBLISHED PROJECT REPORT PPR073

FRICITION TESTS ON CONTAMINATED ROAD SURFACES

by R F Lambourn and H E Viner (TRL Limited)

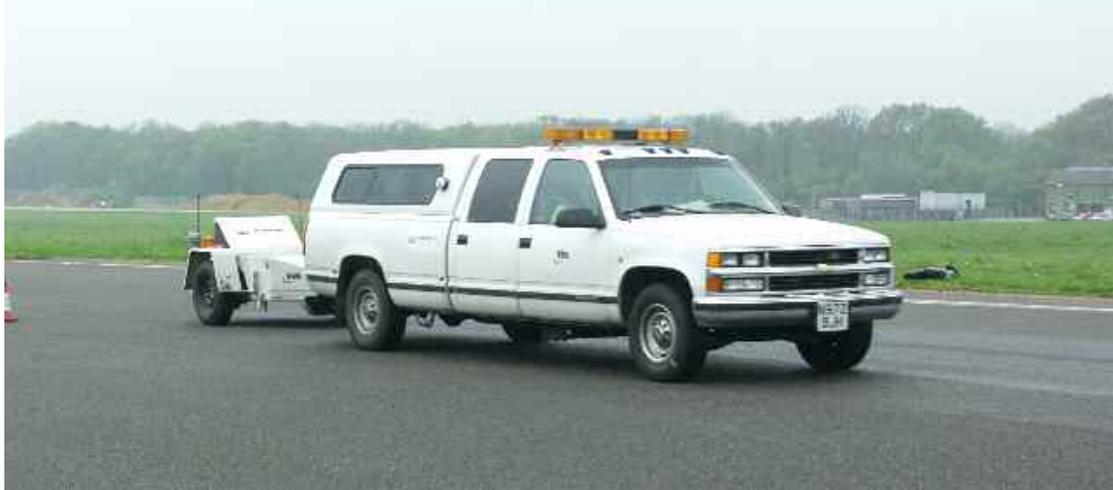
Figure A1 KJ Law Pavement Friction Tester on the Asphalt Surface

The Pavement Friction Tester (PFT) is a locked-wheel friction tester consisting of a towing vehicle and purpose built test trailer fitted, for this study, with ASTM standard smooth tyres (ASTM E524-88). This equipment is common in the United States and is used in England by the Highways Agency for research. It is shown in Figure A1. For each test, the vehicle was driven onto the test surface at the target speed and the test wheel brakes were applied, under computer control, until the wheel locked and for approximately 1 second afterwards. The vehicle speed, test wheel speed and the horizontal and vertical forces on the test wheel were recorded every 0.01 second during each test.

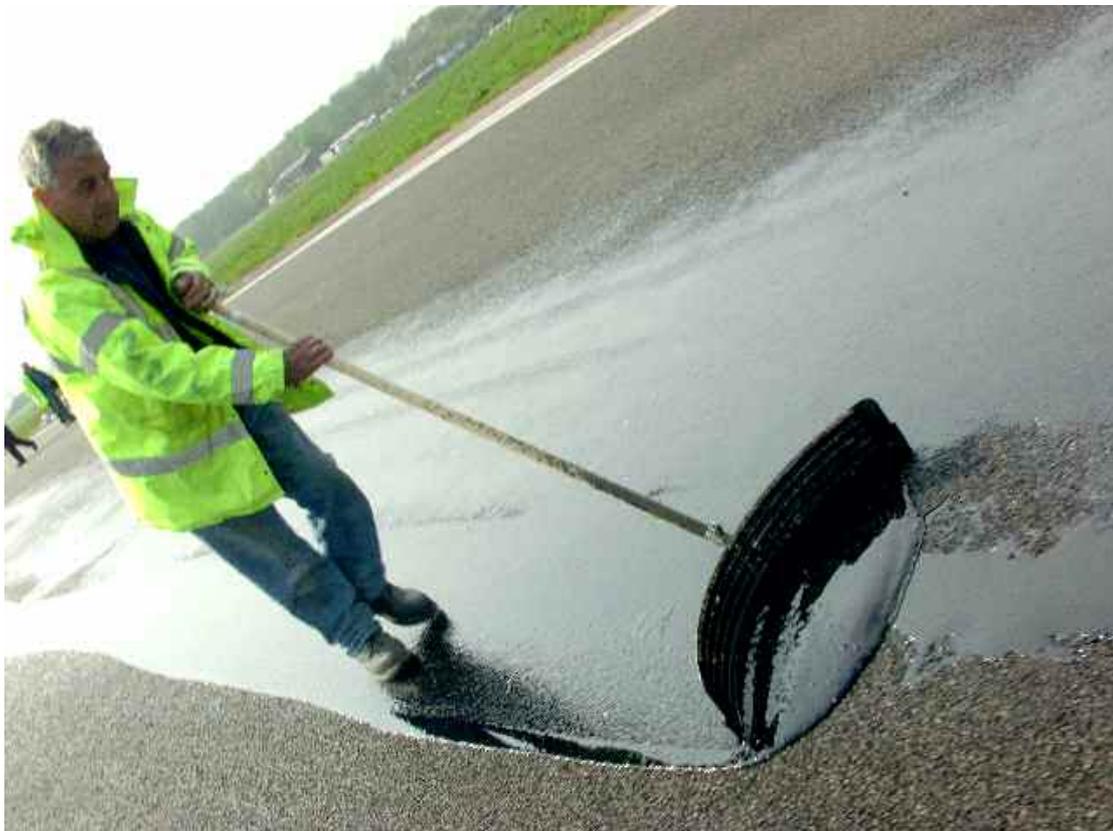
This was used waste engine oil. It was spread liberally onto the asphalt surface: however, a consistent thickness of coating could not be maintained. Figure A2 shows it being spread.

Figure A2 Waste Engine Oil being spread on Asphalt

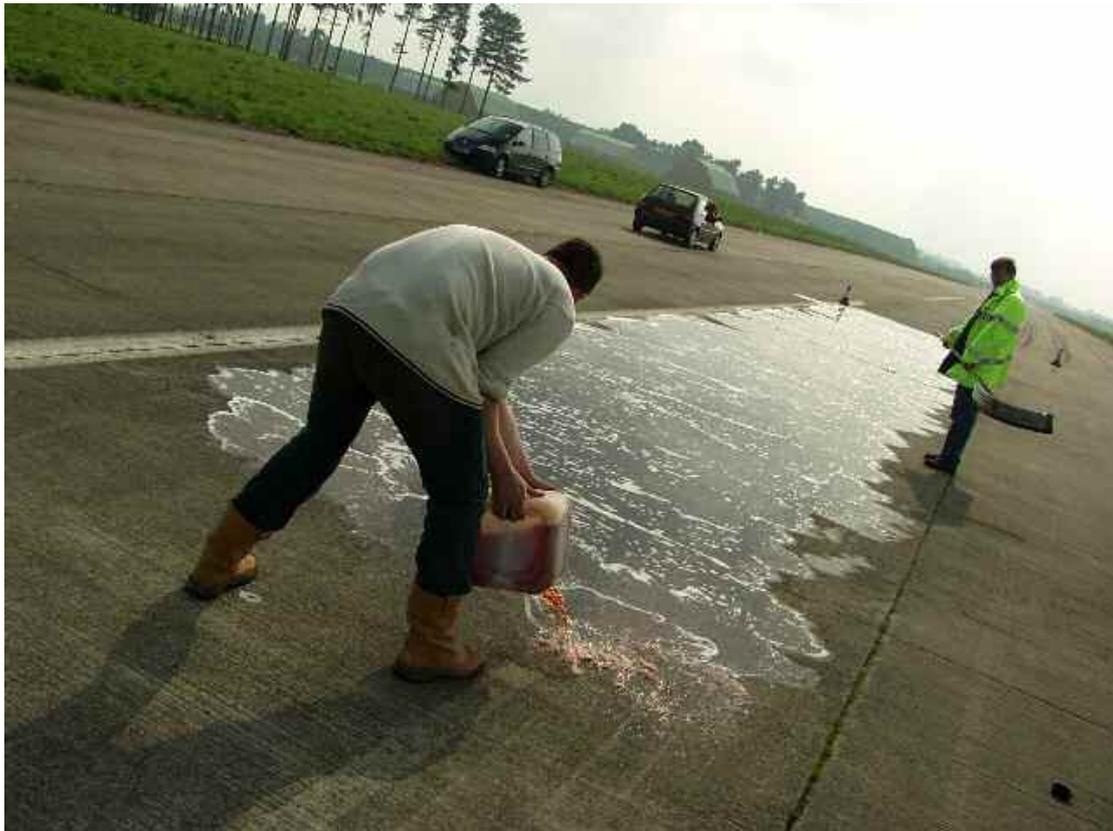
This was ordinary diesel fuel, and was poured liberally over the concrete surface (Figure A3). Again, the depth of contaminant varied somewhat during the tests.

Figure A3 Diesel Oil being spread on Concrete

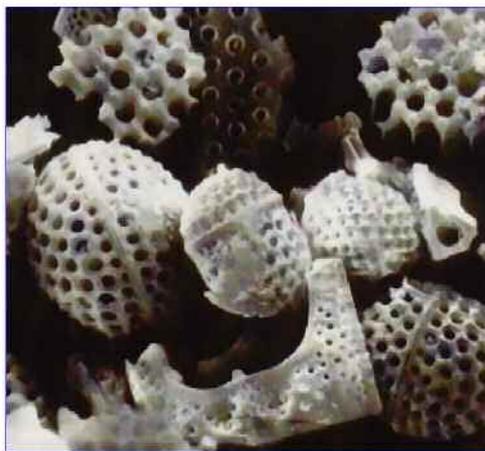
This was Steetley diatomaceous earth, a naturally occurring material composed of the fossil remains of microscopic organisms (diatoms). Because of the large surface areas and cavities within the particles, this material is highly absorbent. It was spread copiously over the area that had previously been contaminated with diesel or engine oil, following the recommended procedure for use. A photomicrograph of the material is shown in Figure A4, while A5 shows it spread on the engine oil, together with the Peugeot skid car.

Figure A4 Photomicrograph of Steetley Diatomaceous Earth

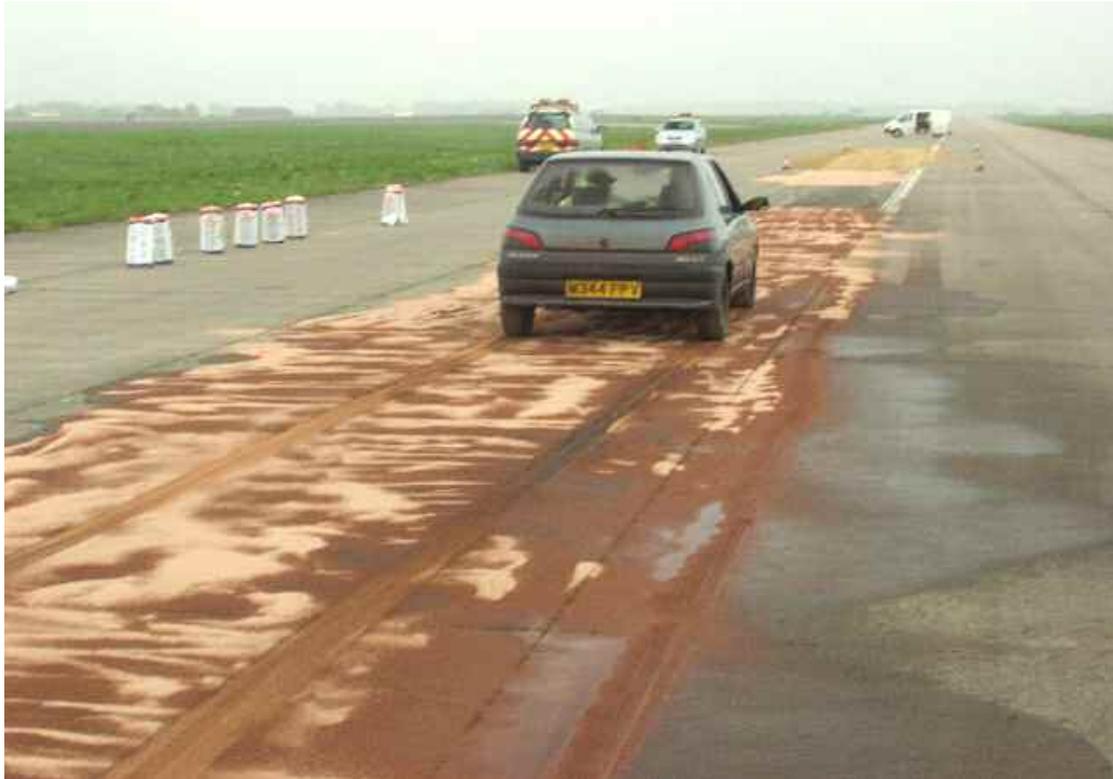
Figure A5 Absorbent spread over engine oil, together with Peugeot skid car

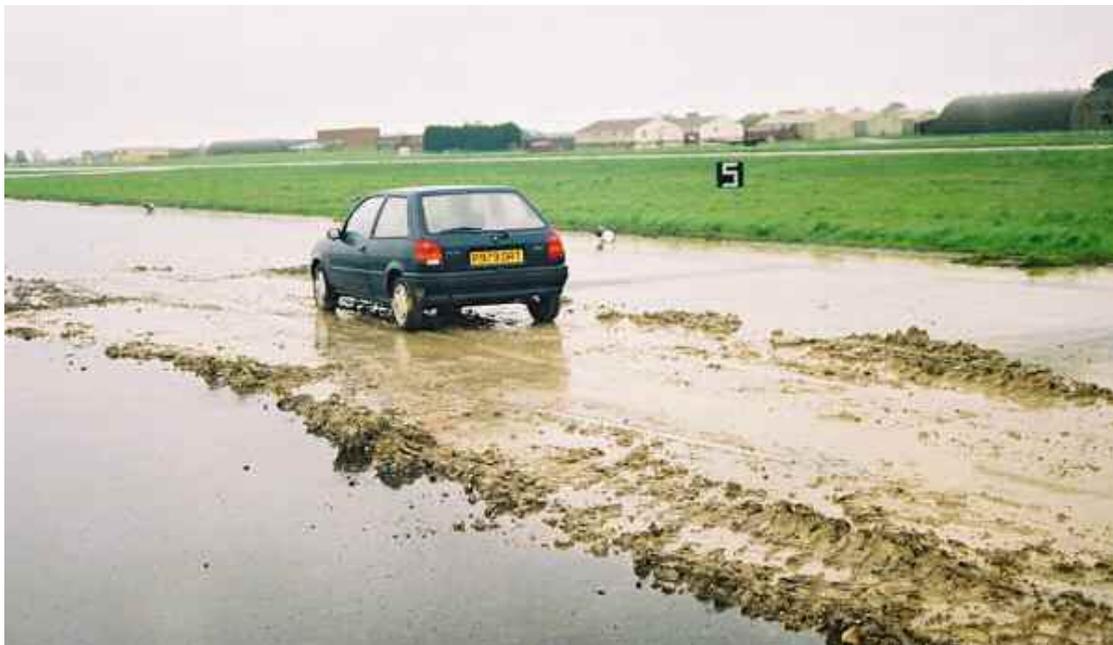
Clay was dug from the Bentwaters site and deposited thickly on the test surfaces. It rained throughout the tests on this material, and it was therefore additionally wetted. Figure A6 shows it spread on asphalt, together with the Ford skid car.

Figure A6 Clay on Asphalt, with Ford skid car

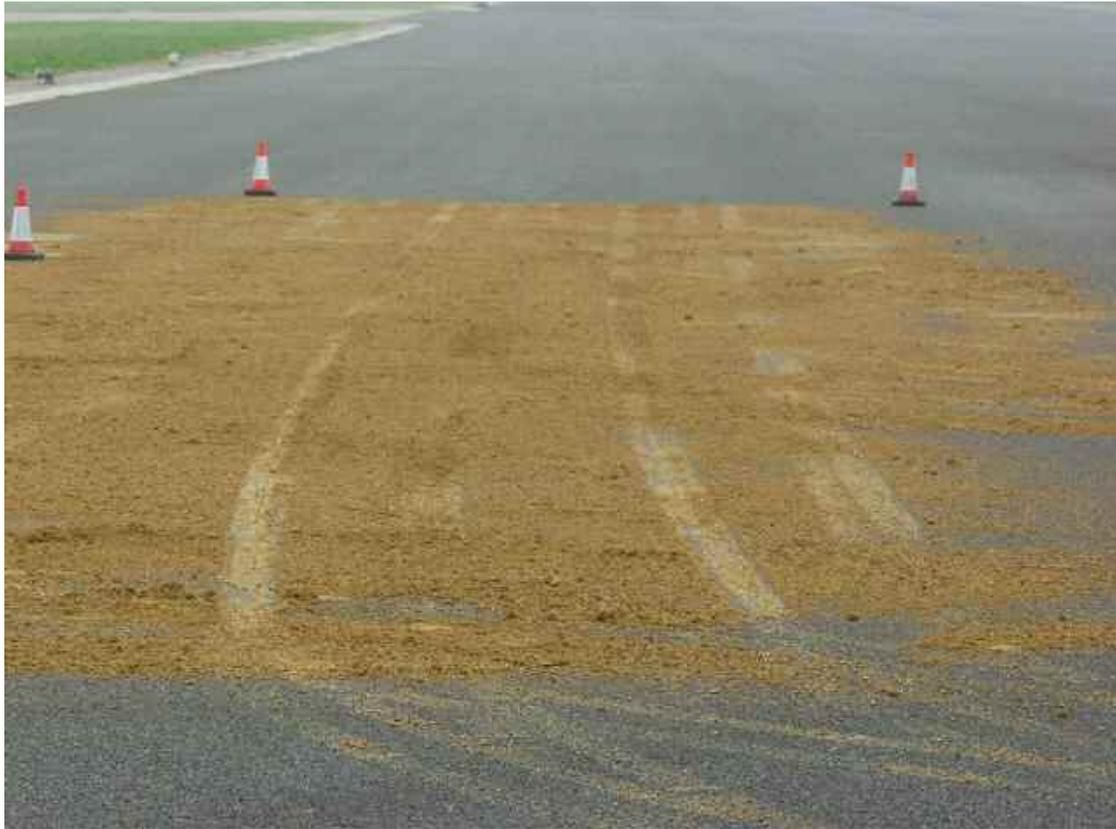
Figure A7 Coarse sand on Asphalt (with braking marks from skid cars)
