## **PUBLISHED PROJECT REPORT PPR2073**

Trial of laser-based compliance  
requirements for ride quality and texture  
depth of newly laid asphalt surfaces

M J Greene

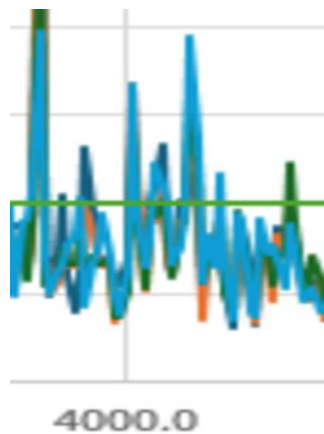
**Figure 4 Variations in RI replicated across all four laser lines**

As with the texture depth data, the RI data were found to be consistent between individual measurement runs and also highly detailed. For example, Figure 4 shows that what might at

first be considered as “noise” in the data is often repeated in all four measurement lines and this consistency indicates genuine variations in surface roughness.

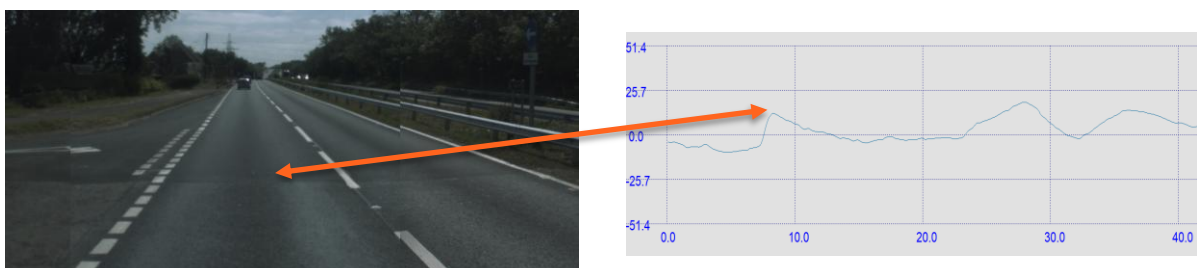
**Figure 5 Unevenness at the transition joint at the start of a site**

Figure 5 shows the transition joint at the start of a site and the associated step in the raw profile measurement at that point. Such “bump” like features were frequently seen and were highlighted to be of particular concern in the road user perception study (Browne et al., 2023).

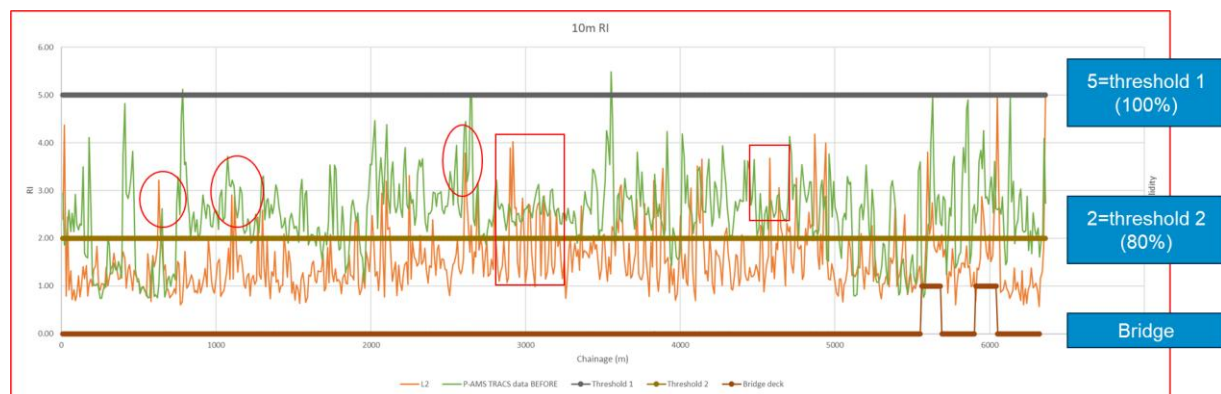
**Figure 13 Example of where spikes in RI either remained after resurfacing or were introduced as a result of the works**

The final observation from the in-depth analysis was that in some cases the roughness of a length of pavement either remained high or even increased following resurfacing. Figure 13 shows the 10m RI values along Lane 2 of a site both before (green) and following resurfacing (red). It can be seen clearly that, in general, the RI values have reduced as a result of the works. However, at some locations, high RI values remain after resurfacing (highlighted by the ellipses in the figure) while at others the RI values have increased (highlighted by the rectangles).

Visual assessment of the surface at the location of poor profile that was present both before and after maintenance showed that these resulted primarily from construction joints; it may just have been a coincidence that the before and after joints occurred in the same place.

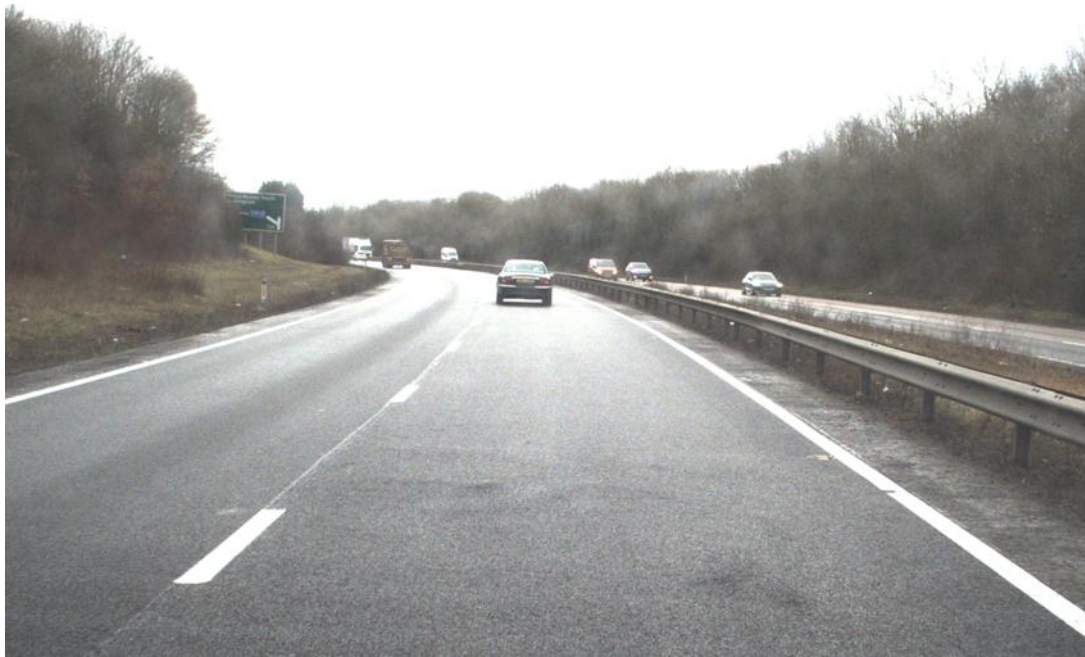
**Figure 14 Area of roughness that was not present before resurfacing**

Where poor profile is present that was not present before the maintenance, the visual assessment indicated that this could be a result of poor workmanship or the introduction of construction joints that had not been present previously. For example, Figure 14 shows the roughness of the surface at the location of poor profile around chainage 2800m of the site (first rectangle in Figure 13).
