Safety evaluation of Compact MOVA Signal Control Strategy – final report

PUBLISHED PROJECT REPORT PPR466

Prepared for: Project Record: PPRO 04/16/10

Department for Transport, Traffic Management Division

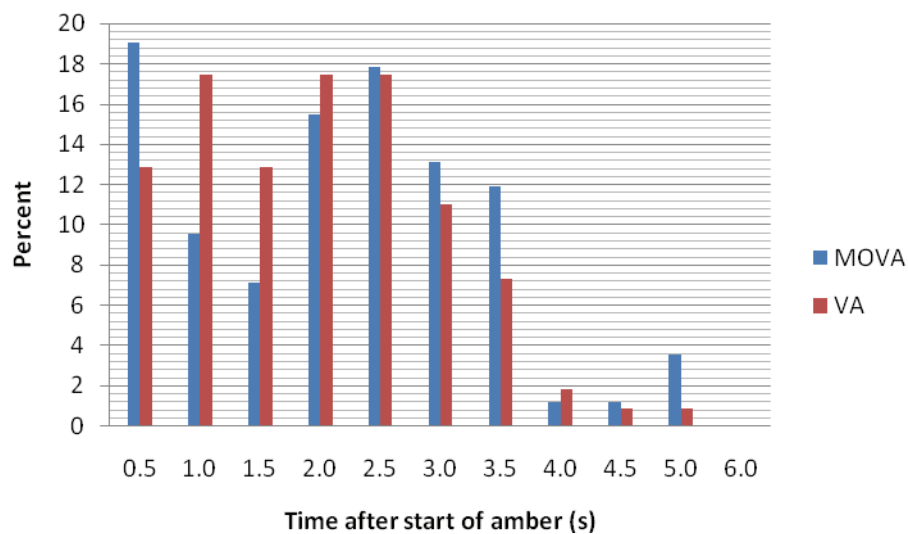
Chart 3.1. Time drivers crossed the stop line after the onset of amber at Feltham site

The time that drivers crossed the stop line after the onset of amber at the Feltham site is given in Chart 3.1, and the distance from the stop line at start of amber in Chart 3.2

In terms of red-runners there were slightly fewer under VA, although the result is not statistically significant. One reason for this is because the X-detectors were closer to the stop line than the distances recommended thus hampering the operation of MOVA at the site. There would have been few, if any, vehicles that were included in the stop and delay optimisation part of the MOVA process.

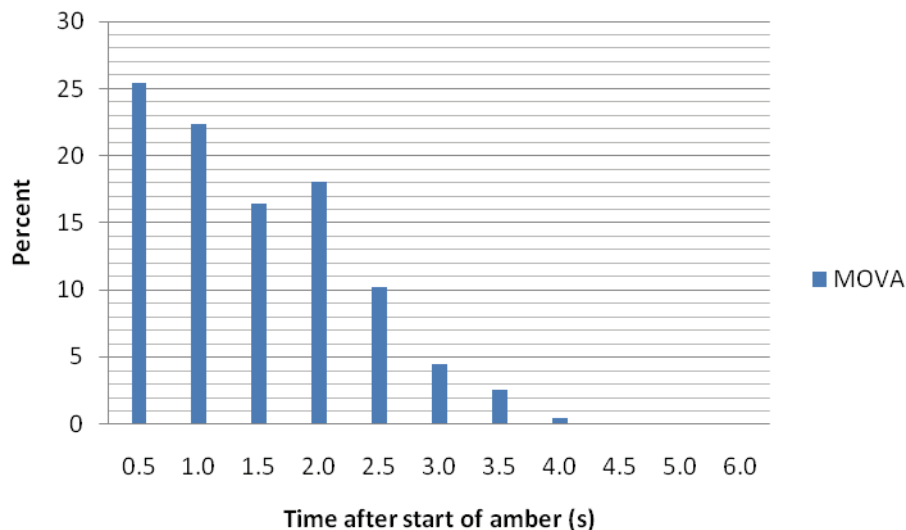
Chart 3.4. Time drivers crossed the stop line after the onset of amber at Ewell Road Puffin

For the Ewell Road site the time that drivers crossed the stop line after the onset of amber is given in Chart 3.4, and the distance from the stop line at the start of amber, is given in Chart 3.5.

The data presented in Charts 3.4 and 3.5 are for MOVA only because, as previously mentioned, it was not possible to run VA at this site. Only 13 vehicles out of the 421 that crossed after the start of amber actually crossed after the start of red. All but two of those crossed within the first half-second of red.

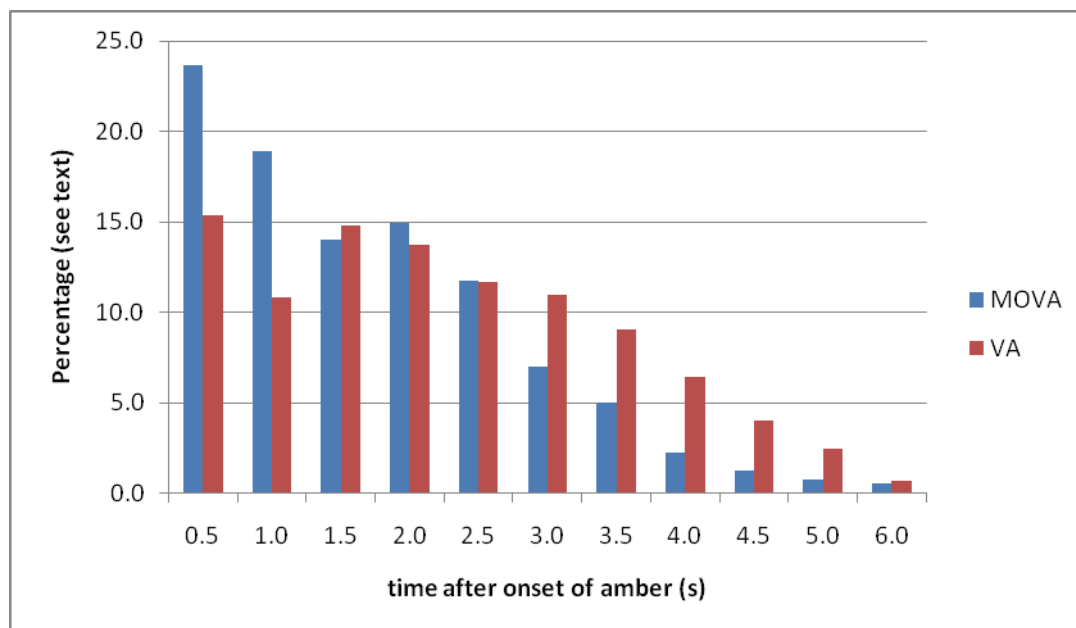
Chart 3.10: Overall vehicle stopping behaviour

In terms of the number of red-runners, Compact MOVA has shown clear signs that it can reduce their number compared with VA. Taking all the sites together (Chart 3.10) shows that, overall, Compact MOVA did reduce the number of red-runners and this was at a high statistical significance. At Lechlade, red-running was reduced by over 50%; at Hackney Road by Cremer Street, under Compact MOVA only 1 vehicle out of 60 ran the red, whereas under VA it was 15 out of 74. The number of red-runners and the extent of the red-running at the Ewell Road site was also very small. These three sites had the X-detector locations at the distances recommended by TRL – the remaining similarly specified site (Hackney Road by Dawson Street) had very few red-runners under either strategy so any differences between them would not have shown up.

At the Feltham site, the X-detectors were placed closer to the stop line than ideal for this trial. The evidence suggests that such detector placement may have lead to a similar level of red running under MOVA and VA, where as the other sites suggest Compact MOVA might have given an improvement had the detectors been placed at the slightly more distant location recommended by TRL, although there will always be some degree of site specific behaviour which means the benefits may not occur at every site. It has also been observed that, at the Lechlade site, even though red-running was significantly reduced by MOVA, the amount of red-running was still quite high.
