## **PUBLISHED PROJECT REPORT PPR743**

### **An Extended and Updated Technical Evaluation of Wig-Wag Signs at the A83 Rest and be Thankful**

**Prepared for:** Transport Scotland,  
**Project Ref:** TS TR MFA 2012-021

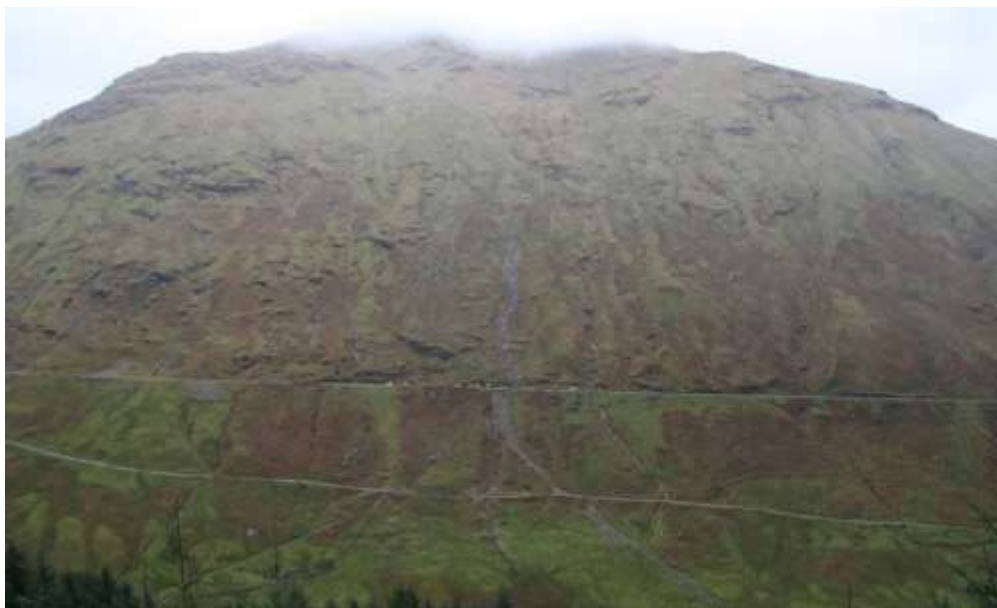
**Figure 3. View of the hillside above and below the approach to the Rest and be Thankful from the east (from NGR NN 23160 06559 on the opposite side of Glen Croe). Not only can the event dated 28 October 2007 be clearly seen but evidence of numerous past events can be seen on the surrounding hillside.**

The events of August 2004 are described by Winter et al. (2006). These events are by no means unique and further debris flows have affected both the A9 and the A83, for example, since August 2004. The event pictured at the A83 in Figures 3 and 4 occurred at around 0330 hours on Sunday 28 October 2007. Figure 3 illustrates the event and the surrounding hillside; the photograph is taken from the opposite side of the valley and evidence of numerous past events can be clearly observed. Figure 4 illustrates the event in more detail and it is clear that the system of mass movement comprises two discrete but related events. The flow above the road commenced with a relatively small slide (or slides) into an existing drainage channel. This then triggered the movement of a large amount of marginally stable material in and around the stream channel depositing an estimated 400 tonnes of material at road level. This material blocked the open drain which carries water along the upslope side of the road to a series of culverts beneath the road. While the material from above the road had limited impact upon the slopes below the road, water diverted from the drain was channelled across and over the edge of the road causing some significant undercutting of the slope below and associated deposition further down the hill as can be seen in Figure 4.

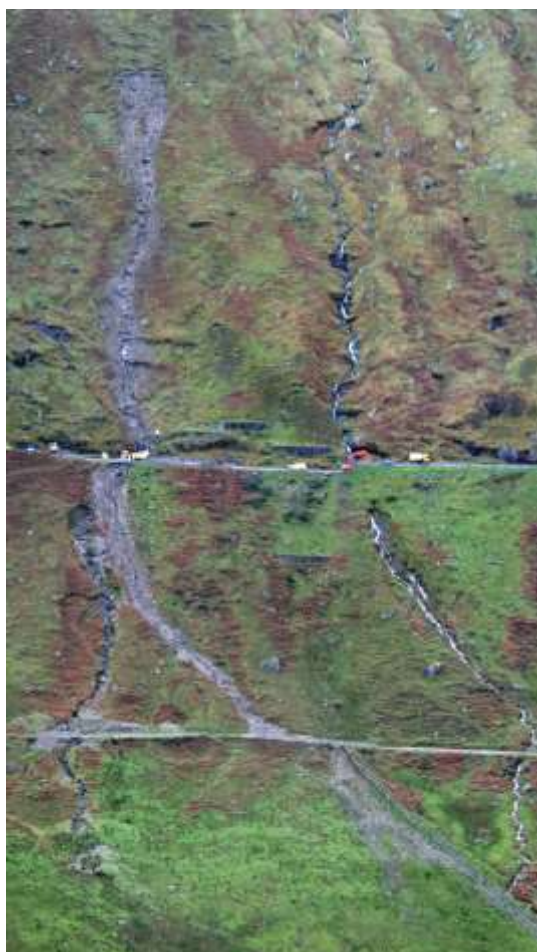
**Figure 4. View of the debris flows above and below the A83 on the approach to the Rest and be Thankful (from NGR NN 23160 06559 on the opposite side of Glen Croe). The head scar is at approximately 370m AOD, the A83 at 240m AOD and the old road at 180m AOD.**

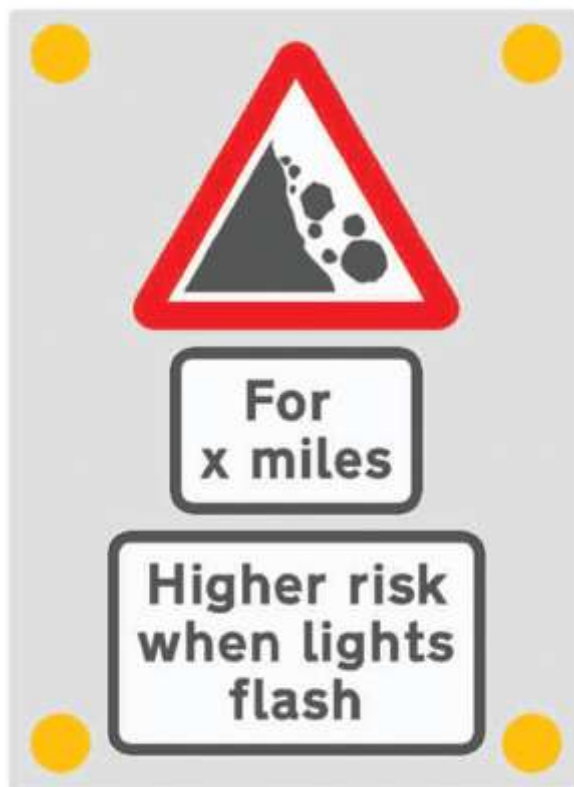
**Figure 6. Standard design of landslide wig-wag warning sign.**

The installation of trial wig-wag signs was one of the options recommended by Winter et al. (2009) as part of the overall management strategy. The wig-wag signs (Figures 6 and 7) provide both permanent geographical signing and temporal warning of potential landslides as part of a landslide risk reduction strategy (Winter, 2014).

The design of the wig-wag signs used in this setting incorporates both a static landslide warning sign and lights that flash during periods of heavy rainfall, to indicate an elevated risk of landslide (Figures 6 and 7). Such signs are commonly used to indicate the presence of school crossings or ice, both of which have a clear temporal aspect and are

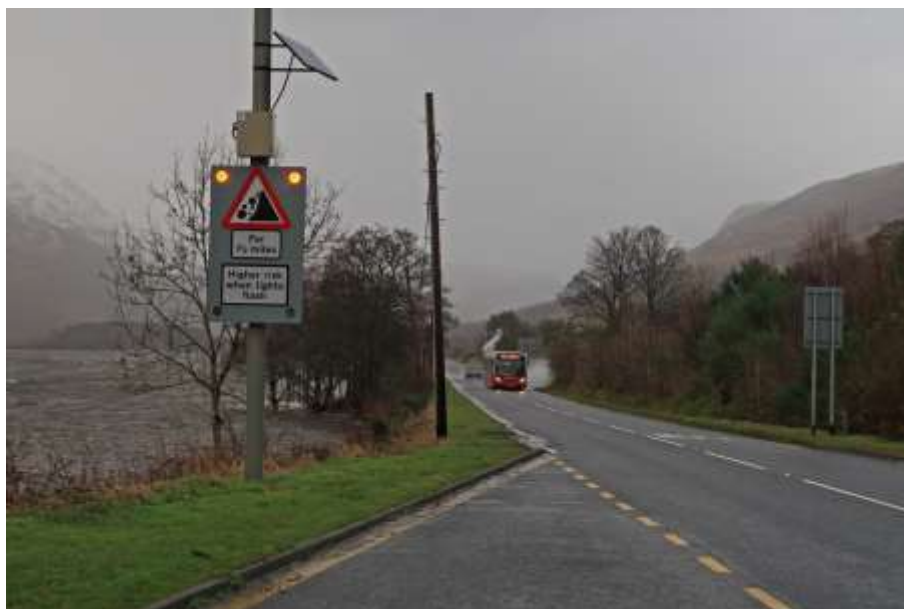
**Figure 7. Wig-wag warning sign in operation.**
