PUBLISHED PROJECT REPORT PPR813

Crush measurements obtained from two dimensional photographs using Photogrammetry.

Simon Lane and Stephen Jowitt

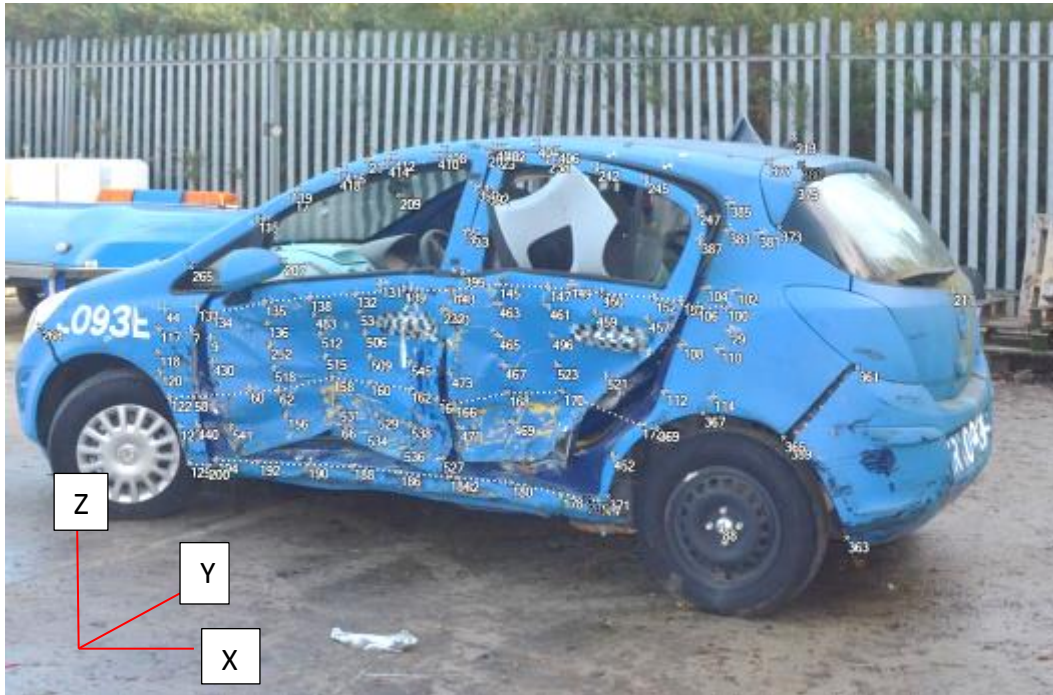
The image in Figure 3 below shows the crushed side of the vehicle with the referenced points and crush profile lines visible.

Figure 3 – Showing the Corsa with the referenced photogrammetry points

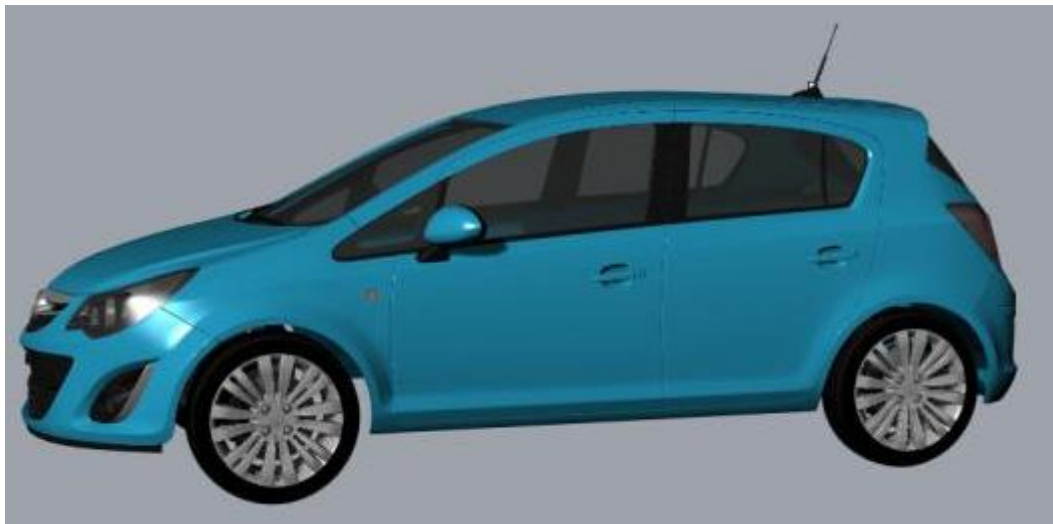
For the purposes of this exercise, a 3D exemplar model of the vehicle was purchased (Figure 4) and was loaded into the Rhino 3D CAD software. This method was adopted as an alternative to measuring profiles of the side structures of an undamaged vehicle. This computer model is used to create an outline, which is then exported as a dxf.

Figure 4 – Image of the 3D model in Rhino

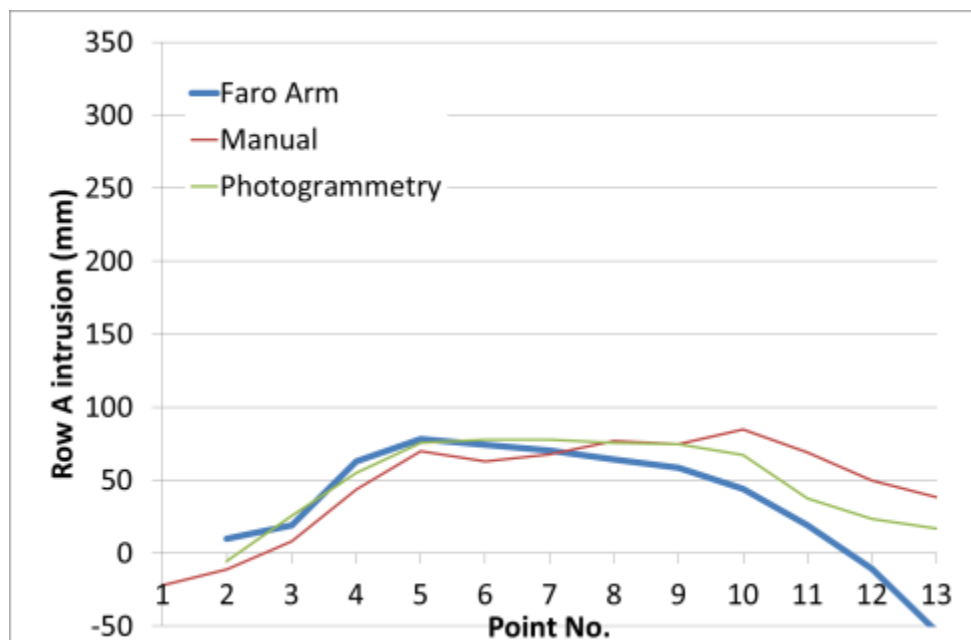
The graph in Figure 8 below shows the crush profile determined by the three methods for Row A, when viewed from above.

Figure 8 – Image showing the results of the three methods for Row A

It is seen that, in general, the photogrammetry measurements compare better to the Faro Arm measurements than do the manual measurements that were taken for this project.

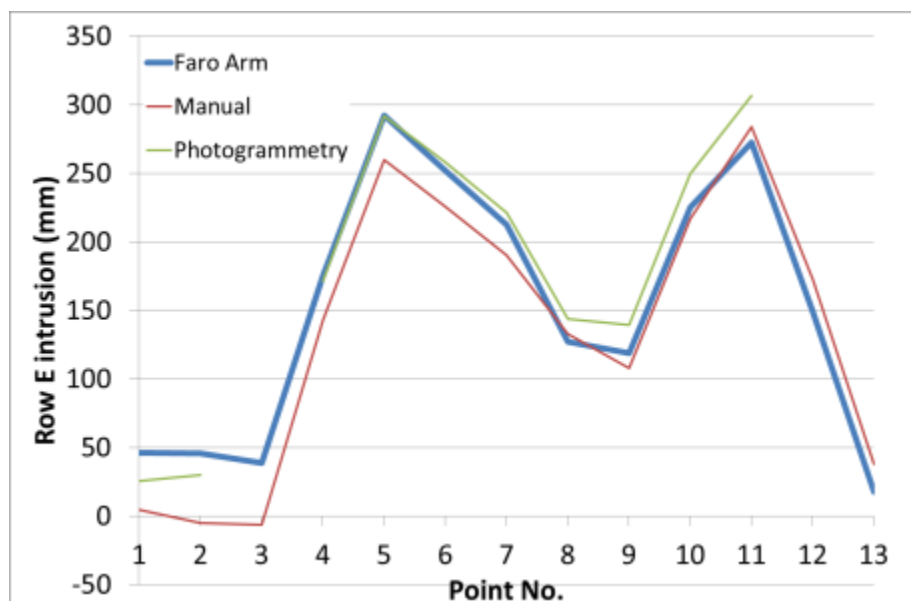
The results for Row E are shown in Figure 9 overleaf.

Figure 9 – Image showing the results of the three methods for Row E

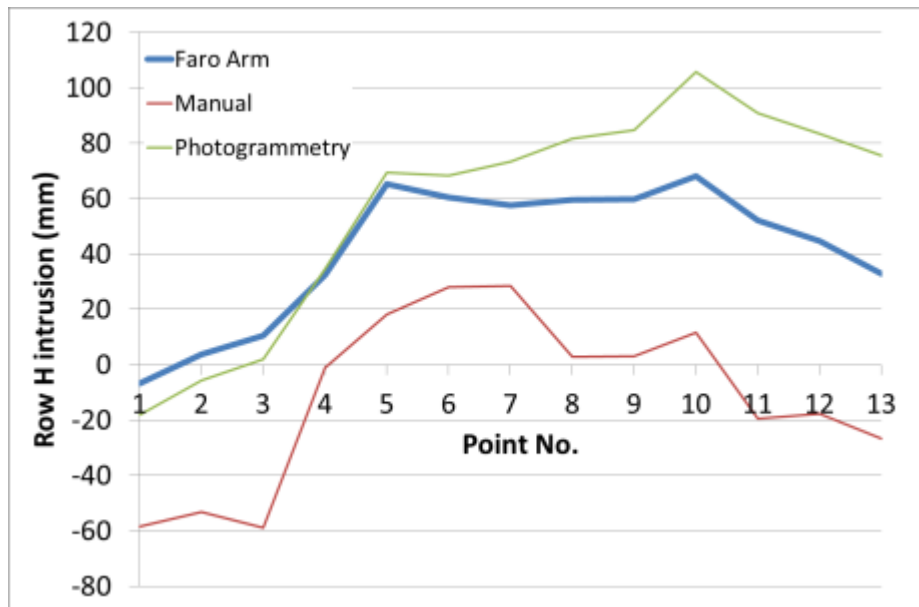
The results for Row H are shown in Figure 10 below.

Figure 10 – Image showing the results for the three methods for Row H

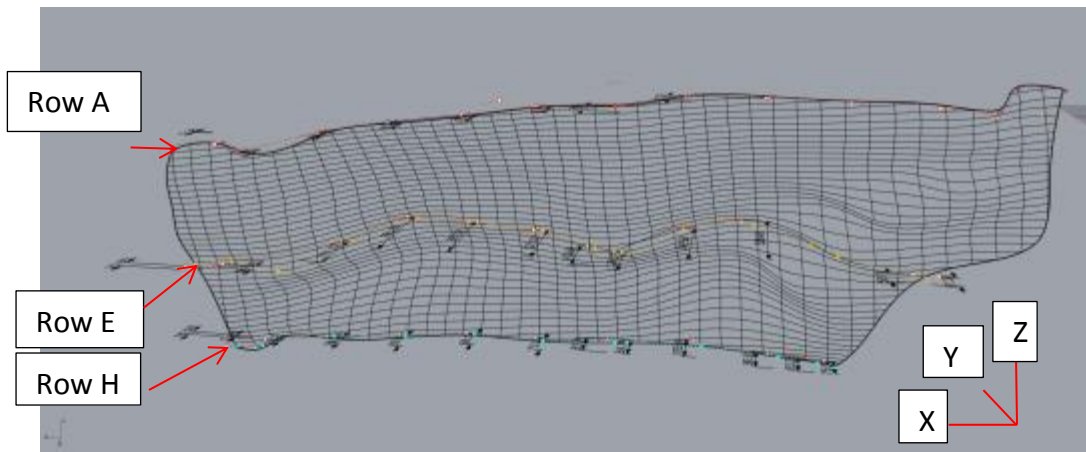
The FARO arm and the PhotoModeler profiles have been merged together to show that the target points match closely, as shown in Figure 12 overleaf. The white squares are the points created in PhotoModeler. It can be seen that they closely match the majority of the FARO Arm measured points.

Figure 12 – Image showing the Faro Arm profile with the Photomodeler profiles for Rows A, E and H
