## **Trials on platform edge tactile surfaces**

**by T Savill, G Davies (TRL)  
A Fowkes, C Gallon (Cranfield University)  
and B Simms (Consultant)**

## **TRL REPORT 179**

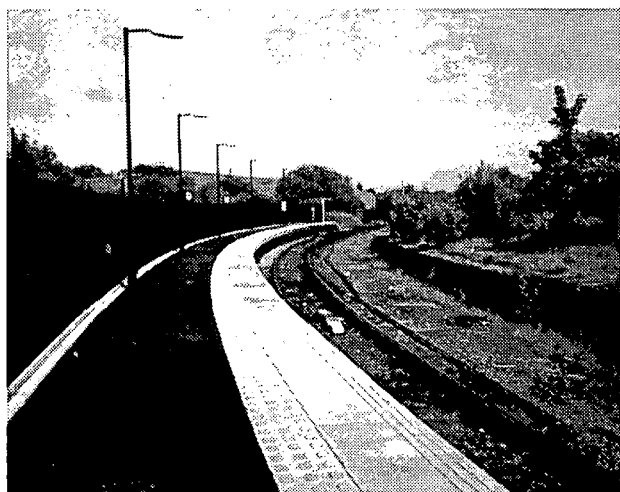
**Plate 2. Lozenge surface at Earlestown Station**

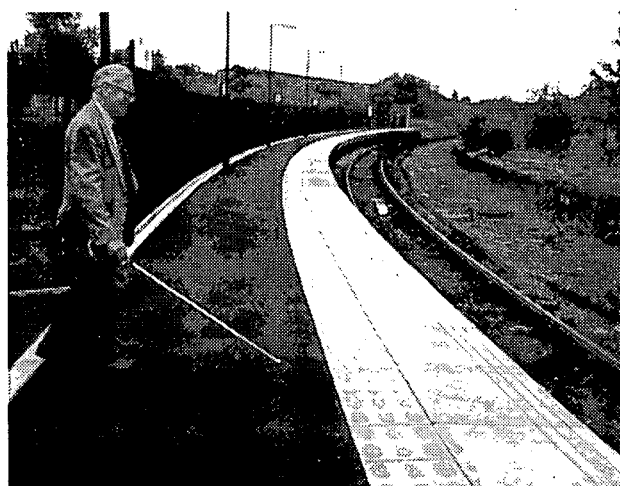
**Plate 3. Participant approaching lozenge surface**

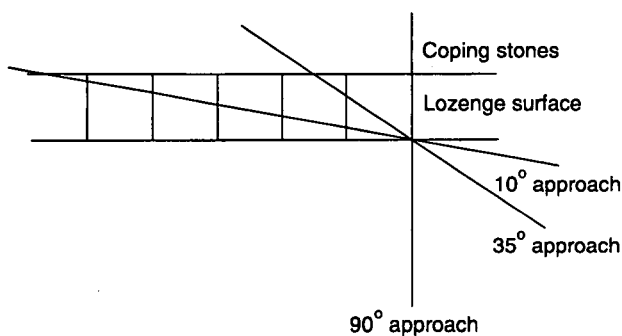
**Fig.8 Angled approaches to the Lozenge surface**

After walking straight towards the platform edge on both the control and lozenge platforms, participants then approached the lozenge surface at two angles, one at 10 degrees and one at 35 degrees (see Figure 8). Half approached at 10 degrees first, from either the right or left-hand side. On these approaches, the participants were guided by the experimenter to ensure they approached the tactile surface at the desired angle. Mobility aids were not used in these conditions because it was difficult to use a mobility aid and be guided by the experimenter at the same time. It also gave an opportunity for all respondents to try to detect the surface underfoot. The instructions were:

degrees as on their first approach (see Figure 8). In this condition, however, the participants were told the platform had a tactile surface and that they were to stop walking when they detected it. Notes were made of where they stopped, whether they needed to be restrained and how many steps they took on the surface. The participants were also asked how they knew when to stop.

The participants were first taken to a marked position at a distance of approximately 4.5 metres from the edge of the platform (see Figure 8). Half the participants started at the lozenge platform and half at the control platform. The experimenter read the following instructions (these were identical for the first approach to the lozenge and control platforms):

When led along the platform at 10 and 35 degree angled approaches to the lozenge surface most of the participants stopped on the lozenge surface (43 (90%) at 10 degrees and 42 (88%) at 35 degrees). Three people walked onto the surface at a ten degree angle of approach without stopping compared with four people at 35 degrees. It should also be noted that, at the ten degrees approach, four people took four steps on the surface before stopping. Two people took six steps on the surface without detecting it underfoot. Thus, some people failed to detect the surface underfoot even after taking several steps on it or having stood on it in a previous condition.
