# New surface course specification for Scotland

M J McHale, I Carswell and P Roe

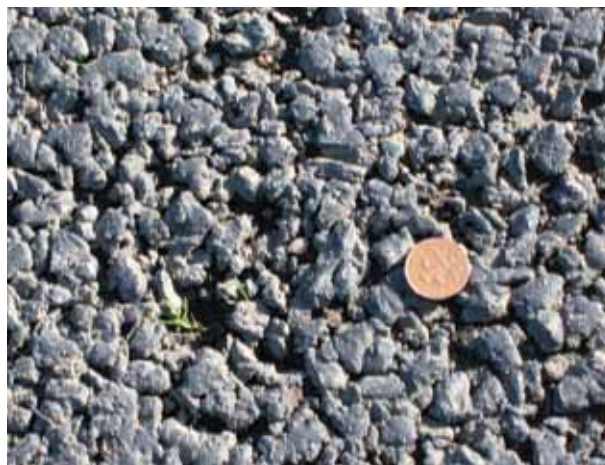
Figure 3.2 Surfacing deficient in fine aggregate (Site TAC8)

Aggregate loss was the most commonly observed defect. Two main types were observed. The first related to new materials that appeared open in texture owing to a lack of fine aggregate or mortar. These materials were generally serviceable at the time of the inspection, but deemed to have poor long-term durability (Figure 3.2). It is considered that more permeable mixtures will allow greater access to water, resulting in the potential breakdown of the binder/aggregate matrix under trafficking.

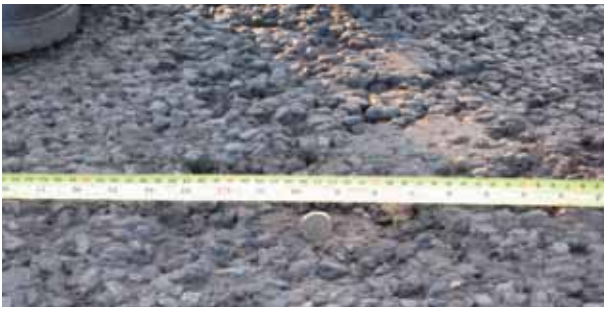
**Figure 3.3** Surfacing showing excessive material loss (Site TSMA33)

The second type of aggregate loss observed is commonly described as fretting. This is where both coarse and fine aggregate are seen to be lost from the mix under the action of trafficking (Figures 3.3–3.5). In general, the severity of fretting was often related to the level of trafficking and type of site, i.e. highly stressed sites were more prone to fretting. Fretting can be a swift process and this was witnessed at Site TSMA33 (Figure 3.3) where the material was only six months old.

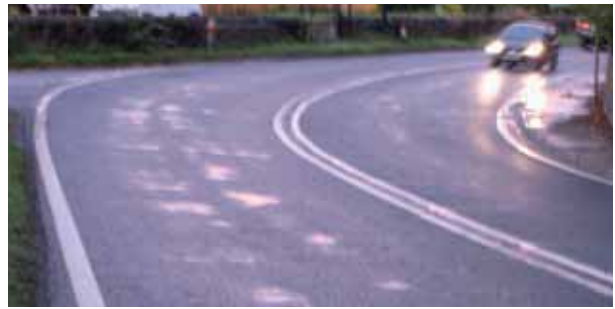
**Figure 3.7** General flushing of material (Site TSMA11)

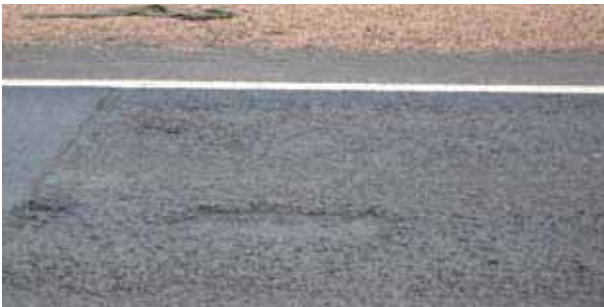
**Figure 3.4** Fretting of surface (Site TAC3)

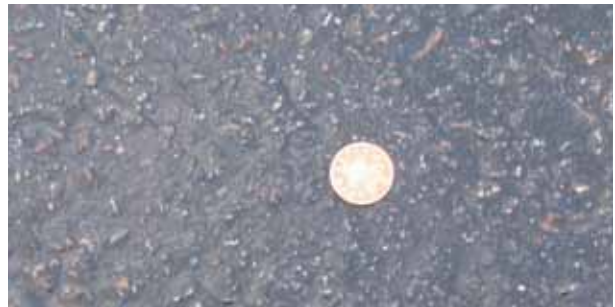
**Figure 3.8** Low surface texture depth (Site TSMA6)

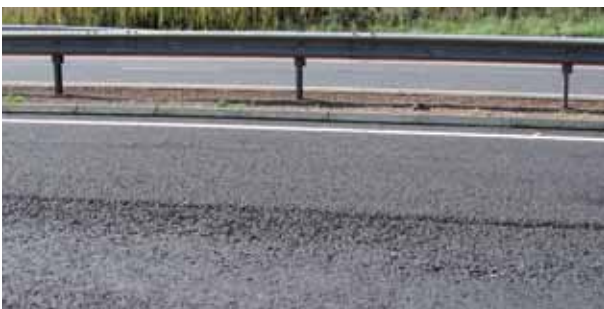
**Figure 3.5** Fretting of surface (Site TAC4)

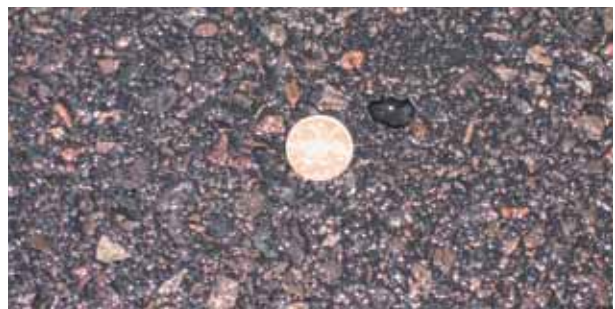
**Figure 3.9** Treated surface – after water jetting (Site TSMA8)

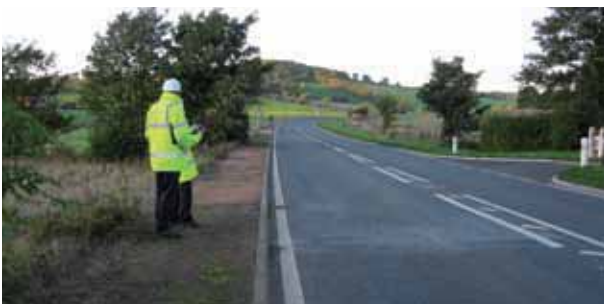
**Figure 3.6** Discrete area of low texture depth (Site TAC6)

It is important that a surfacing provides an adequate level of macrotexture (or texture depth) in order to limit the loss of skid resistance at higher speeds. A number of sites exhibited areas of low texture depth. In certain instances, the incidence of low texture depth was confined to small discrete areas (Figure 3.6), but on other sites the defect was widespread (Figures 3.7–3.9). A loss of texture depth is often described as flushing or fatting-up, particularly where the loss is due to excess mortar being present on the surface. Figure 3.9 shows a low surface texture depth site that has been treated using a high-pressure water treatment to alter its surface characteristics by removing the binder.

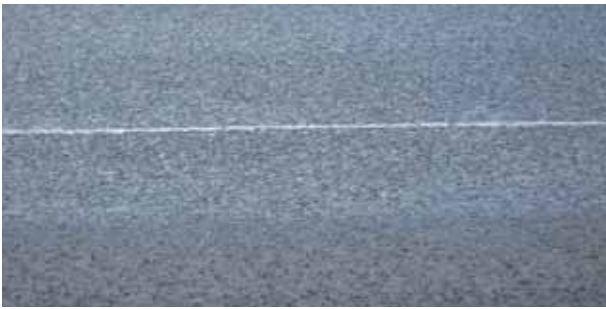
**Figure 3.10** Good joint at Site TSMA12 (ten years)

Factors that can influence the overall quality of the surfacing include material manufacture, transportation and installation. A visual inspection, in itself, cannot categorically attribute the cause of poor quality, but it can assess the quality of workmanship associated with parts of the installation process. The most serious defects noted were related to the construction of joints. All asphalt surfacing joints are potential areas of weakness because they are likely to be less well compacted and can allow increased access to water penetration. It is important that joints are well constructed and sealed (Figure 3.10). On several sites that had been in service for several years, it was noticeable that joints were often the first place to show signs of deterioration (Figure 3.11), and subsequent deterioration often emanated from these points.

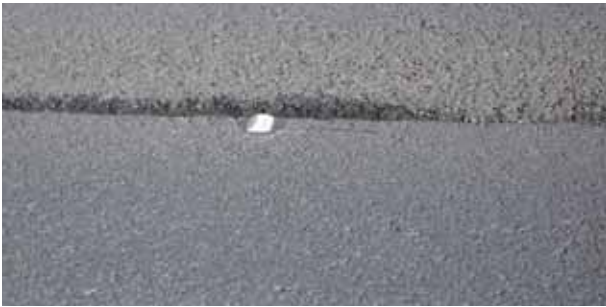
**Figure 3.11** Fretting of joint at Site TAC4 (five years)

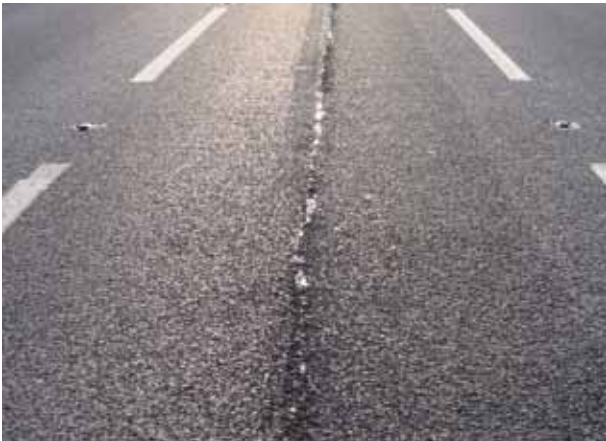
**Figure 3.12** Poor joint construction at Site TAC9 (one year)

One site that was only one year old showed particularly poor joint construction and one sawn transverse joint showed no evidence of having being sealed (Figures 3.12 and 3.13).

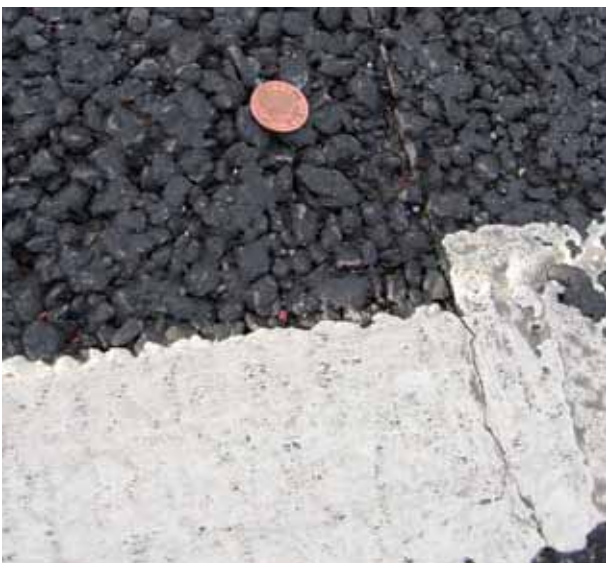
**Figure 3.13** Sawn joint not sealed at Site TAC9 (one year)

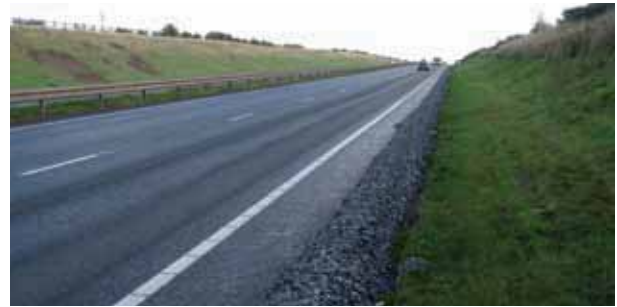
**Figure 3.14** Site TSMA12 (ten years)

Several sites were assessed as having a good visual condition for their age. One site in particular showed no significant defects and had been in service for ten years (Figure 3.14). There was a trend to suggest that schemes constructed as part of larger new construction contracts had performed well (Figure 3.15). However, there were also examples of smaller maintenance schemes that were assessed as performing well with little or no significant defects (Figures 3.16 and 3.17), demonstrating that thin surfacing systems could perform successfully in Scotland.

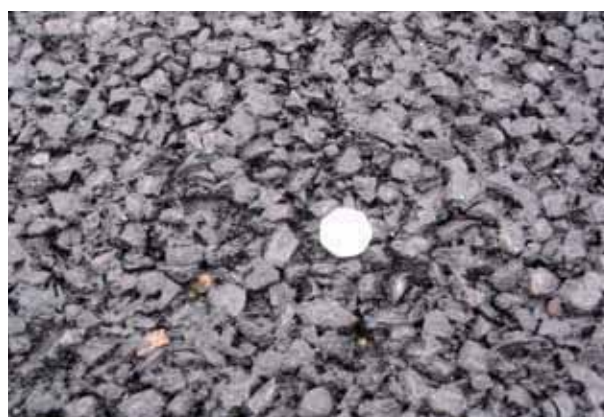
Figure 5.3 Open texture

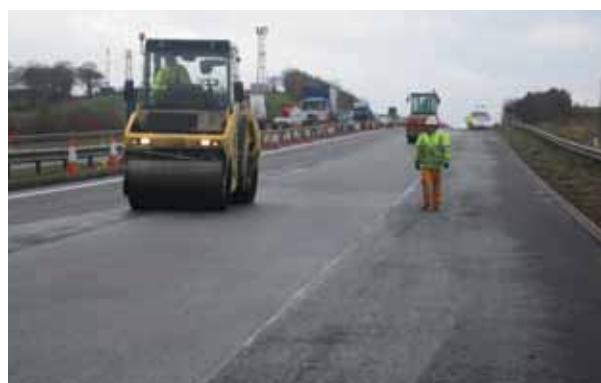
**Figure 7.2** Newly-laid surfaces – 0/14 mm SMA (background) and 0/10 mm SMA (foreground)

The trial panels were laid over two days in November 2008. The first four panels were laid without grit on 10 November 2008. The first material to arrive was 0/14 mm SMA followed by 0/10 mm, 0/8 mm and 0/6 mm materials. The ambient air temperature was 5 °C with a wind speed in the range of 9–25 km/h. A satisfactory and uniform surface texture was achieved under the cold and breezy conditions, although there were signs of some closing-up of the macrotexture under the rolling of the 0/10 mm mix. The contract required that the surfacing materials were to be laid without transverse joints. The change in material appearance from 0/14 mm to 0/10 mm can be seen in Figure 7.2.

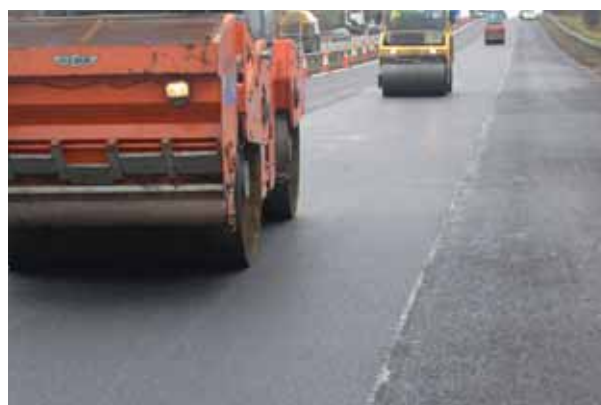
**Figure 7.3** Compaction process

Three 8–10 tonne vibratory tandem rollers were used to compact the material. The tandem roller operating closest to the paver compacted the material without vibration, but vibration was used when compacting the material adjacent to the longitudinal joint. The materials had the appearance of being durable (i.e. rich in binder) but no significant signs of flushing during compaction were noted (Figures 7.3 and 7.4).

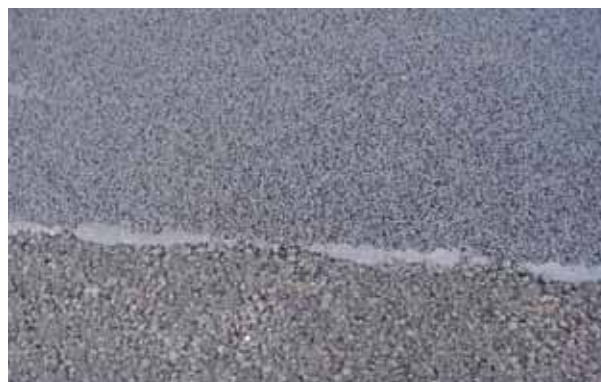
**Figure 7.4** Rich-looking 0/6 mm SMA

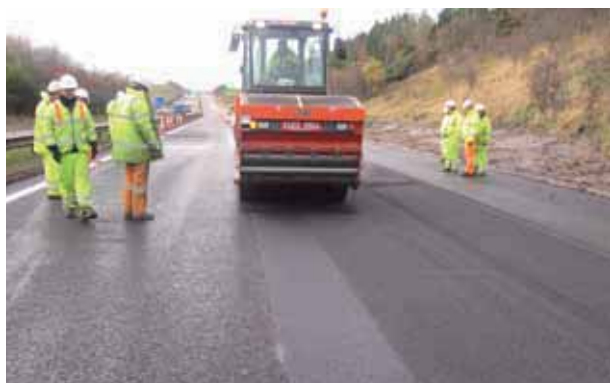
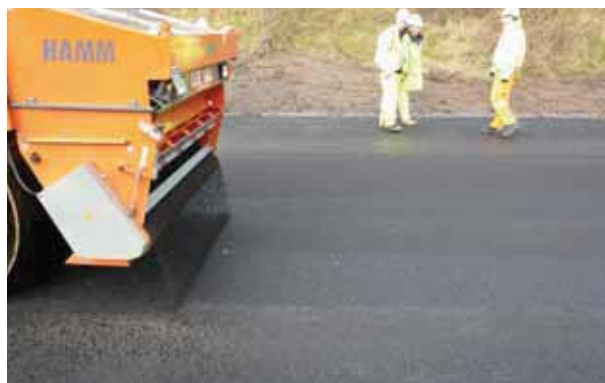
**Figure 7.5** Gritting process

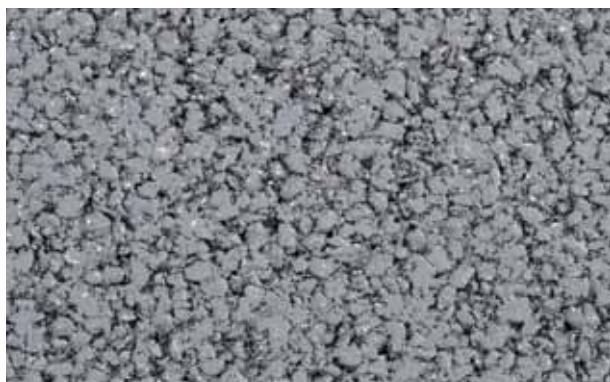
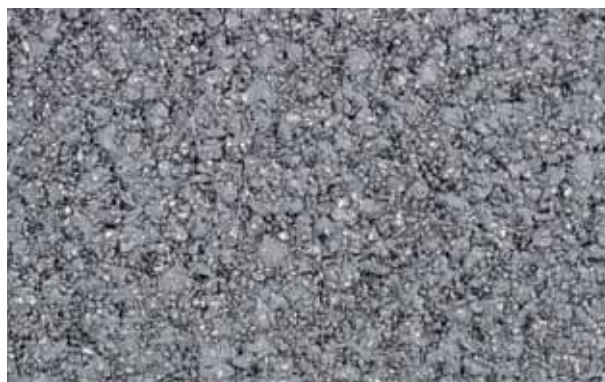
**Figure 7.6** Close-up of 0/14 mm SMA before gritting (left) and immediately after gritting (right)

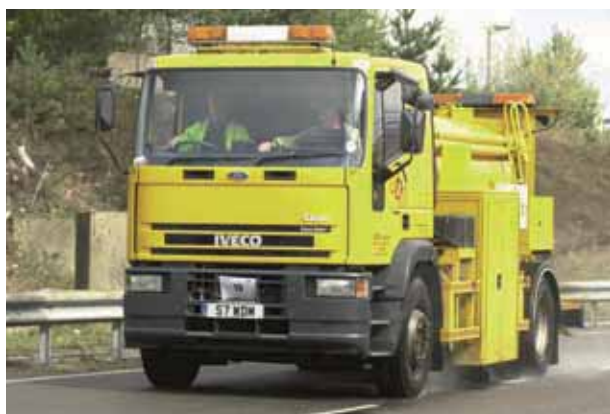
**Figure 8.1** The SCRIMtex measures the SFC and SMTD

The SCRIMtex (i.e. the SCRIM fitted with a device to measure texture; Figure 8.1) measures the SFC and SMTD and is the standard device used to monitor wet skid resistance on UK trunk roads. It uses a special wheel set at an angle to the direction of travel to measure the SFC. It is mounted on the side of the vehicle and lowered on to the road for the tests. The machine also carries a laser sensor to measure the SMTD.

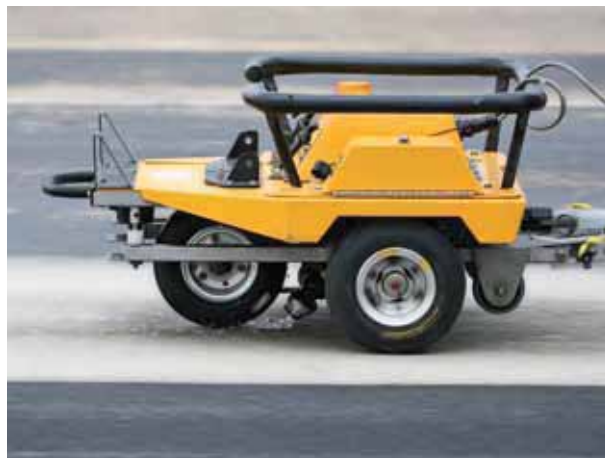
**Figure 8.2** The GripTester

The GripTester (Figure 8.2) is a small trailer that measures the GN with a small test wheel mounted near the centre of the trailer and a gear arrangement to make it rotate more slowly than required for the vehicle speed. The GripTester was included as part of the trial as it has the potential to provide a substitute for SCRIM testing of new surfacing during early life (less than two years old) and is more cost effective to operate.

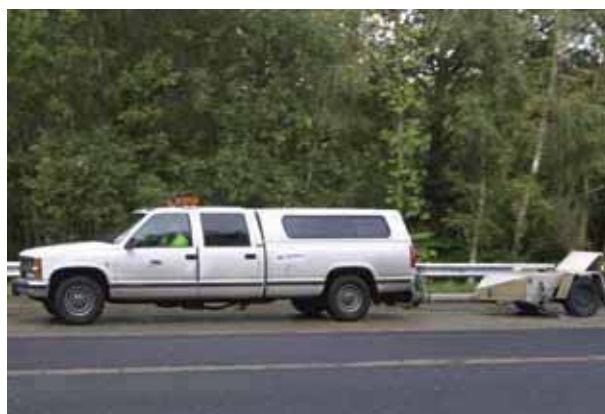
**Figure 8.3** The PFT

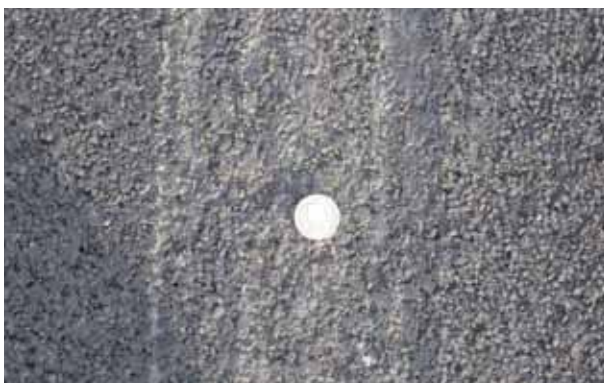
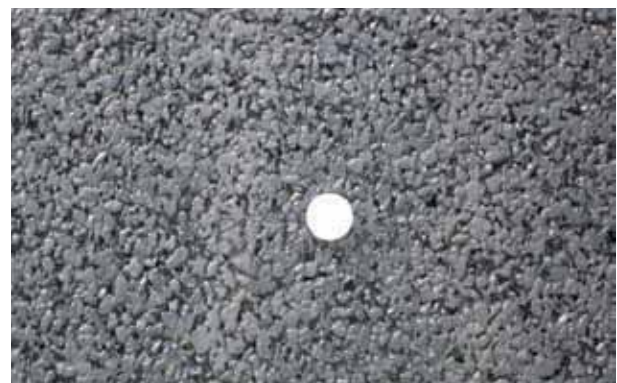
**Figure 8.4** 0/6mm SMA gritted (left) and ungritted (right)

(The marks running from top to bottom near the centre of these pictures are skid marks left by PFT skid tests in these areas)

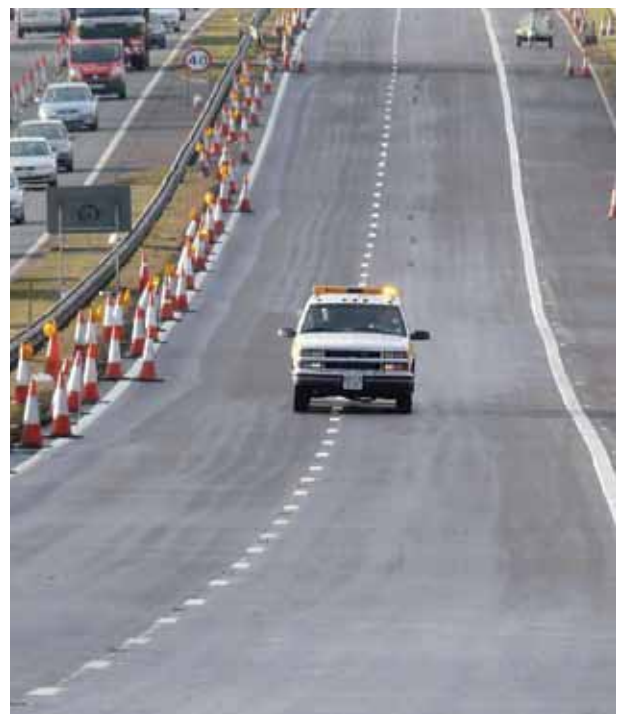
Figure 9.12 The PFT making a test pass to measure dry friction at 20 km/h
