Trials of high-friction surfaces for highways

**Prepared for Quality Services (Civil Engineering) Pavement
Engineering Group, Highways Agency**

J C Nicholls

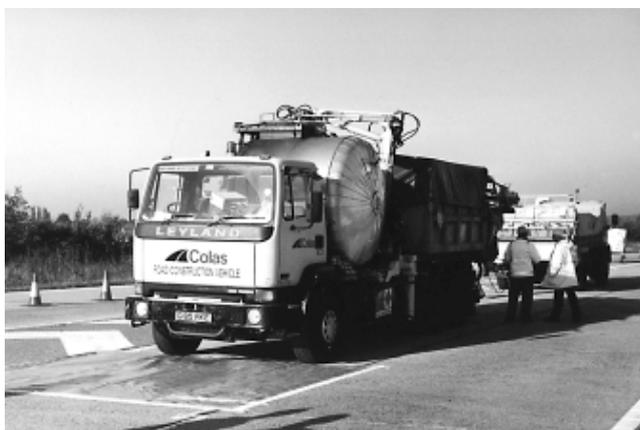
Figure 1 Laying equipment for acrylic-resin system

As yet, only one acrylic-resin based system is known to be marketed. The supplier has developed a machine which includes storage and distribution systems for both the binder and aggregate (Figure 1); however, on larger jobs the calcined bauxite can be distributed from a separate lorry because the storage on the combined machine is relatively limited. When using a separate lorry for the chippings, the binder will not cure until the aggregate and curing agent is placed. However, if the delay is extended, there is the possibility of loss of monomers from the relatively thin layer of uncured binder.

The acrylic-resin system can also be laid by hand, but it is understood that the result is less uniform.

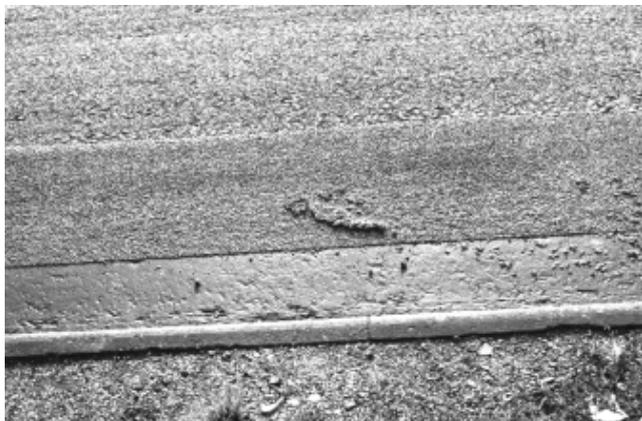
Figure 2 Underlying material showing through acrylic-resin system

The epoxy-resin system and one of the non-trial acrylic-resin system sites in Nottingham looked in reasonable condition, although not as good as one might have expected after only two months on the road. The acrylic-resin system on the trial site showed signs of revealing the underlying material in places (Figure 2). In other places, there were ridges of material, presumably at joints where there is more than one layer, and in some places small 'craters' could be seen (Figure 3). It was considered that, because the curing agent was on the aggregate and the binder had a quick cure once in contact, the unevenness could have resulted from imprecision in spreading. Nevertheless, overall the surface was generally rough, as would be expected of high-friction surface systems.

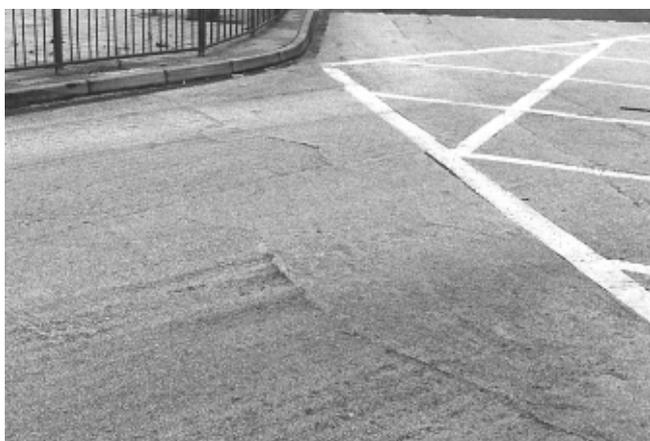
Figure 4 Ridges on acrylic-resin system

Of the acrylic-resin based system on the three non-trial sites, one was similar to the trial site except that there were more ridges (Figure 4); ridges reportedly occur where the high-friction surface system has been hand-applied, which was the method employed at that site. Another non-trial site was variable, but was on a hill which may have exacerbated problems of uniform laying (the adjacent surface dressing was in very poor condition). The remaining non-trial site looked in the best condition of all the acrylic-resin based system sites, including the trial site.

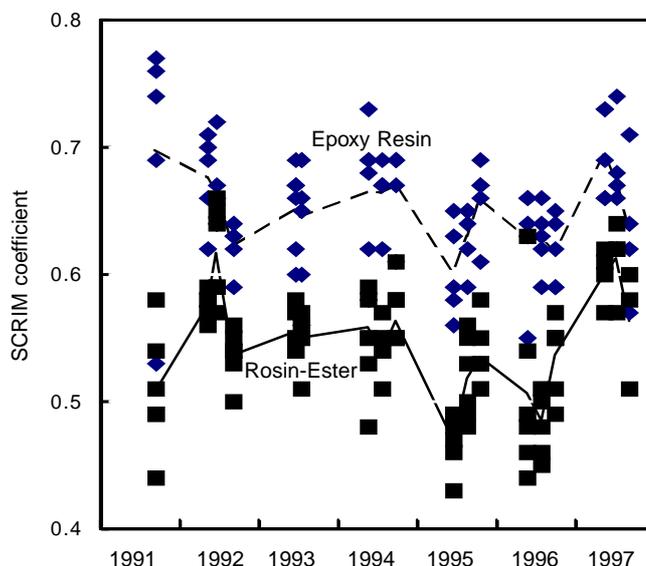
Figure 5 SCRIM results from A5, Warwickshire

The SCRIM coefficients from the A5 for both resins on each date are shown graphically in Figure 5, with separate lines through the mean of the points on a date for each resin. As at Reading, the sections with the epoxy-resin system have a greater SCRIM coefficients than those with the rosin-ester system. This difference starts at about 0.2 but reduces to about 0.1 after a year, presumably because the resin is worn off the calcined bauxite. Given that this ranking order is consistent at all the sites, the difference in performance is considered to be significant.

The results from these two rosin-ester trials indicate that the SCRIM coefficient rises initially as the resin is worn off the aggregate, but remains about 0.1 units lower than the value achieved with the epoxy-resin system. Neither of these findings is surprising because the aggregate is totally embedded in the rosin-ester system, while it is scattered

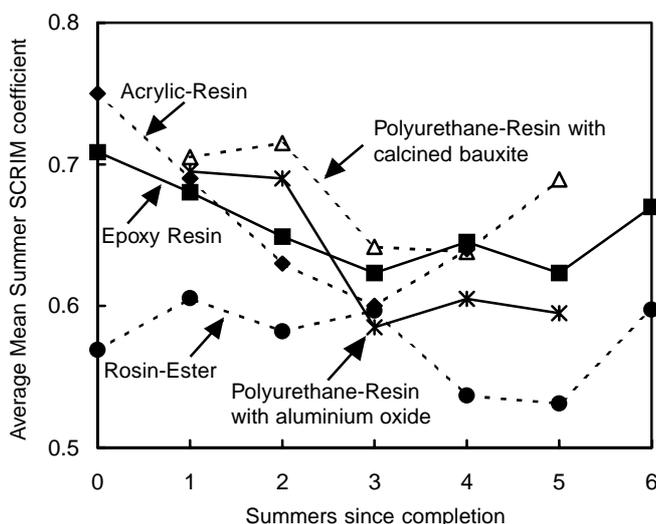
Figure 6 Mean summer SCRIM coefficients

Combining all the data on SCRIM coefficients by taking averages for each binder type (and separating the polyurethane-resins between those with calcined bauxite as aggregate and those with aluminium oxide) and relating them to the number of summer seasons that the surfacing had been in service gives an overall performance as shown in Figure 6. In deriving the number of summer seasons during which a surfacing was in service, it was assumed that any system laid in or before September had experienced at least part of the summer, whilst those laid in October or later had not. Therefore, the base year for the various trial sites are as given in Table 7, with some having different dates for different resins due to the materials being laid in different months.

The SCRIM coefficients are primarily dependant on the properties of the aggregate used, the traffic level on the site and the stress imposed at the site. Therefore, the MSSC levels should be independent of the system. Further, the weather can affect the result (hence the need for a testing season) and, because different sites were applied in

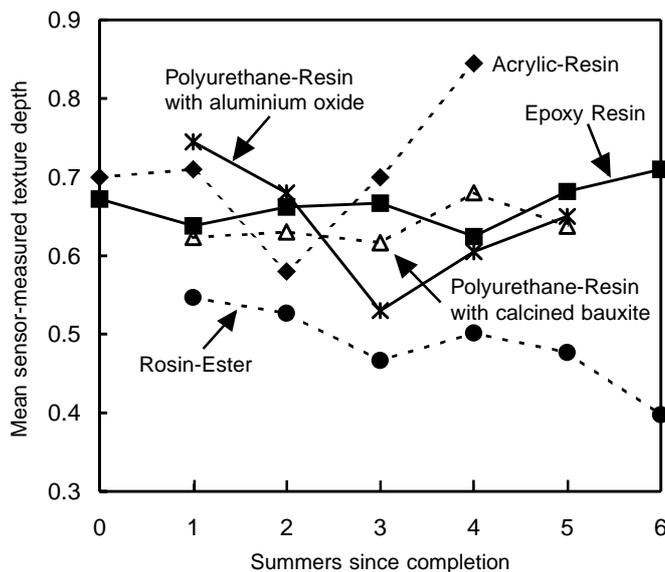
Figure 7 Mean sensor-measured texture depths

Combining all the data on sensor-measured texture depths by taking averages for each binder type (and separating the polyurethane-resins between those with calcined bauxite as aggregate and those with aluminium oxide) and relating them to the number of summer seasons during which they were in service (Table 7) gives an overall performance as shown in Figure 7.

Figure 7 shows that the epoxy-resin and polyurethane-resin systems with calcined bauxite are relatively consistent, whilst the acrylic-resin system with calcined bauxite and the polyurethane-resin with aluminium oxide systems start somewhat higher but then dropped below before recovering, in the case of the acrylic-resin to a

higher value than initially. The rosin-ester starts and ends lower than the other systems and consistently drops further. Overall, the higher texture is achieved with the systems where the aggregate is scattered over the binder compared with the rosin-ester systems, where it is encased; of binders employing the scatter approach, the epoxy-resin and the polyurethane-resin systems are the more consistent. In terms of ranking for sensor-measured texture depth, the epoxy-resin and polyurethane-resin systems are best because they are consistently high, the acrylic-resin system is dropped to third because of its variability and the rosin-ester systems are last because of their relatively low and declining values.

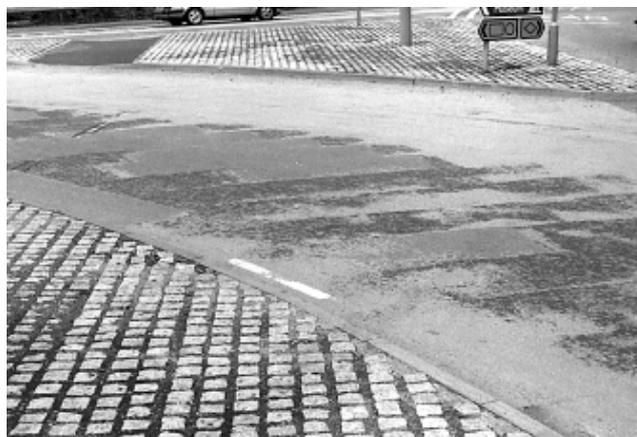
Figure 8 Worn rosin-ester system, after 3½ years

Inspection Panel and the results of laboratory tests (Section 6.2), is supported by observation of sites that are not part of this trial. An example is at the junction of the M42 and A38 near Bromsgrove (Figure 8) where the material was laid in November 1989 and the photograph taken in early 1993, 3½ years later. This section has since been replaced.

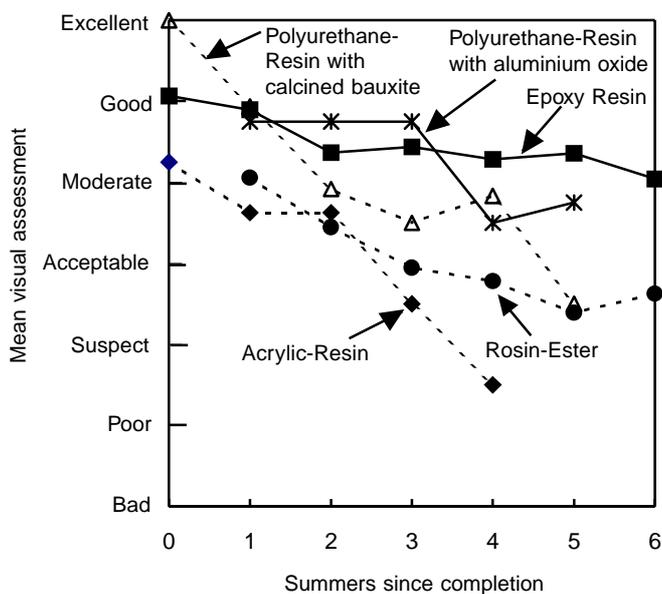
Figure 9 Mean visual assessment categories

Combining all the data on visual assessments by taking averages for each binder type (and separating the polyurethane-resins between those with calcined bauxite as aggregate and those with aluminium oxide) and relating them to the number of summer seasons in service (Table 7) gives an overall performance as shown in Figure 9.

Figure 9 allows an overall ranking of systems to be made from the observations to date in terms of durability. This ranking, ignoring the polyurethane-resin with aluminium oxide as aggregate, is that the epoxy-resin system is best, then the polyurethane-resin system, the rosin-ester system and finally the acrylic-resin system. The polyurethane-resin with aluminium oxide appears to be best of all until the fourth year, but the result is derived from only two sites.

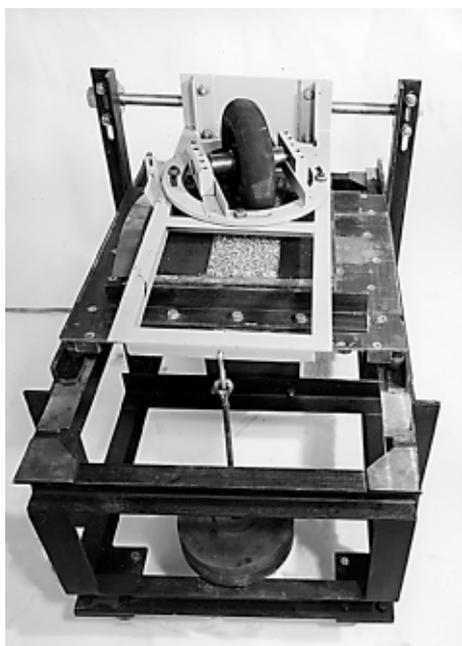
Figure C1 The scuffing wheel-tracking test machine

The Scuffing Wheel-Tracking Test Machine was developed at TRL by modifying the equipment used to measure the resistance to permanent deformation of bituminous mixes, as standardised in BS 598: Part 110 (BSI, 1996). The solid rubber tyre of the deformation resistance test is replaced by a pneumatic tyre of a similar diameter and is mounted at an angle of 20° to the rolling direction. The tyre is inflated to 45 psi. A photograph of the apparatus is shown in Figure C.1 and the test procedure is fully described in Appendix G of TRL Report TRL176 (Nicholls, 1997).

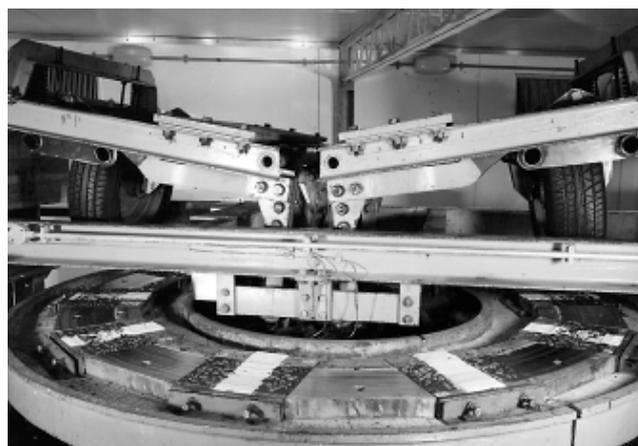
Figure D1 TRL road machine No. 1

The machine has been enclosed in a temperature controlled chamber in which tests can be carried out at any set temperature within the range 0°C to 40°C . The machine, without its environmental chamber, is shown in Figure D.1 and the test procedure is fully described in Appendix H of TRL Report TRL176 (Nicholls, 1997).

The wear test is designed to simulate the wear of extended trafficking using a circular test-track applying loads through vehicle wheels (designated as Road Machine No. 1 and described in Appendix D). Two samples of each material were arranged around the circular table of Road Machine No. 1, the test temperature set to 5°C and the table rotational speed to 10 revolutions per minute. The condition of the various materials was then monitored before and after the test run, which was curtailed after 100,000 wheel-passes when the tyres became shredded by the high-friction surface systems.
