PUBLISHED PROJECT REPORT PPR1032

Forensic Examination of Critical Special Geotechnical Measures

M Duffy-Turner (Coffey Geotechnics Ltd), M G Winter (Winter Associates Limited), I M Nettleton (Coffey Geotechnics Ltd) and G Butler (Coffey Geotechnics Ltd)

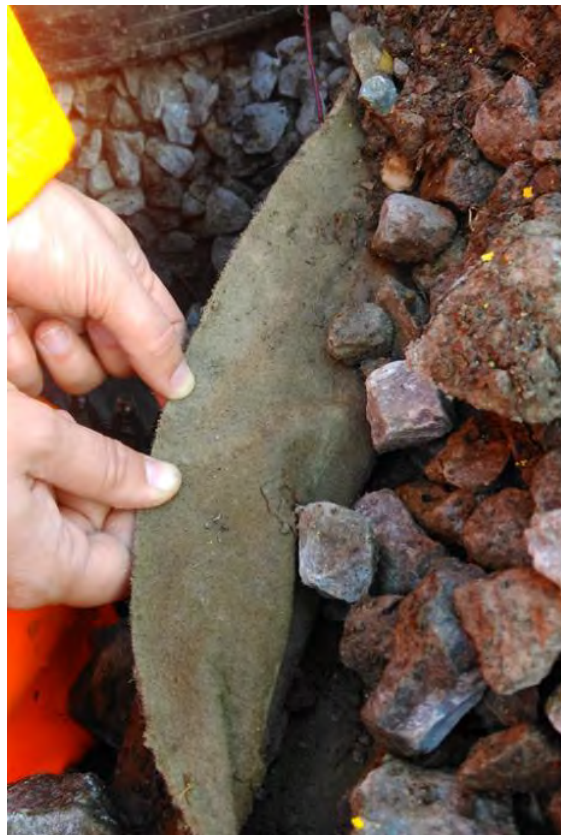
1. Lack of as built records with locations or basis of design.
2. On-site Counterfort Drains not locatable.
3. No 'collector' pipes.
4. Erosion of/adjacent to Counterfort Drains.
5. Clogging (silting up) of filter encountered on site (Figure 3.5). This correlates well with the authors' experiences of the use of standard geotextile filter/separator products being specified and used, based on published or in-house standard design details, often with little consideration of the soils.
6. Build-up of vegetation within the Counterfort Drains leading to a lack of functionality (Figure 3.6).

Figure 3.5: Drain with a smeared geotextile and contaminated granular drainage aggregate (image the authors)

5. Poor construction of Counterfort Drains, Filter Drains and Slope Drains including 'smearing' of geotextile filters and 'contamination' of drainage aggregates and Rock Fill with finer grained material during installation (see also Figure 3.5).

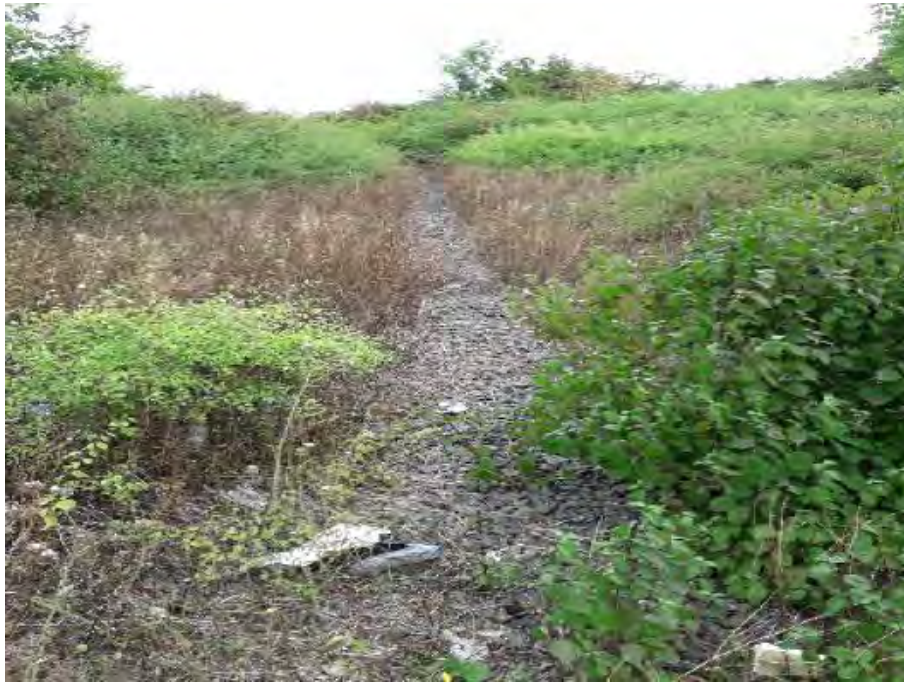
Figure 3.6: Build-up of vegetation within the Counterfort Drain leading to a reduction in functionality along the A14: M1 J19 to A14 J1 (from Kier, 2019)

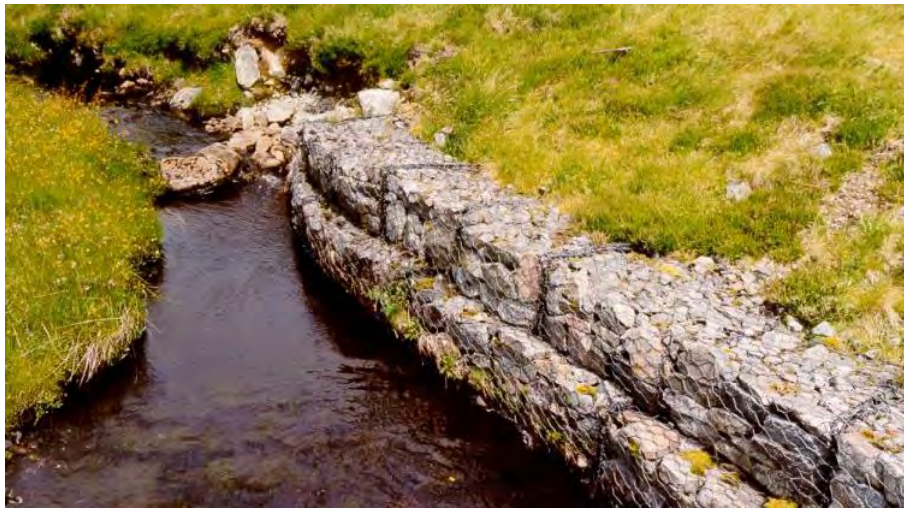
Figure 3.9: Gabion Wall at A835 Loch Dromer showing the embankment being successfully retained by the Gabion Wall, as well as providing bank scour protection, in comparison to the adjacent part of the embankment which is failing (from Winter & Anderson, 2002)

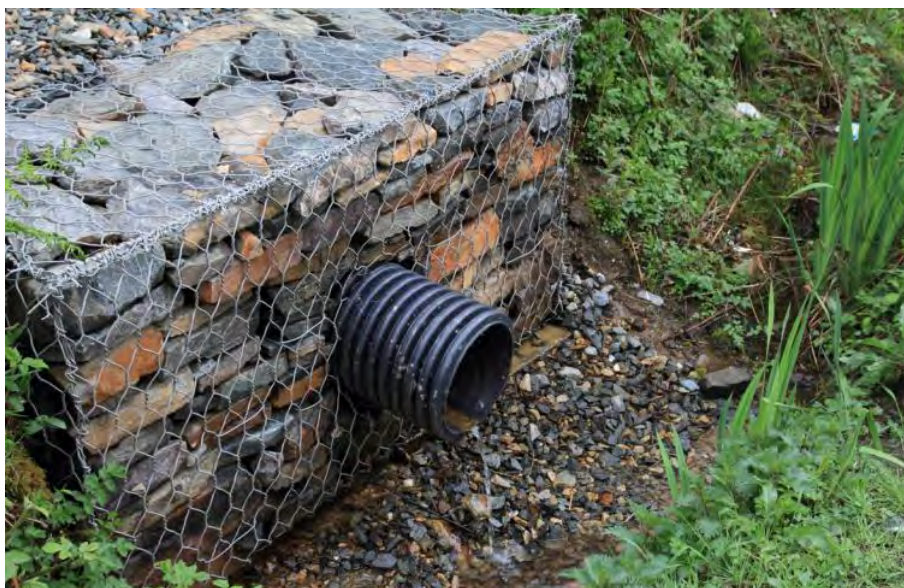
Figure 3.10: Well-constructed gabion basket filled with a stone that has the potential to deteriorate in the environment in which it is placed (image the authors)

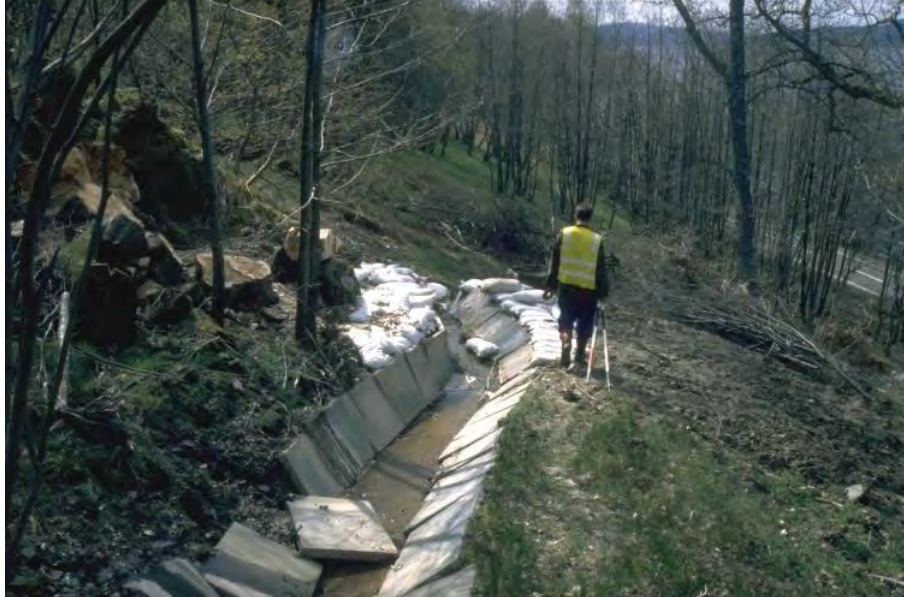
Regrades often incorporate the provision of additional drainage, and as above, the issues regarding ensuring that design is implemented in construction are important as are many of the issues regarding Filter Drains and Counterfort Drains. It is particularly important that the drainage aspect of a Regrade is not viewed as an 'add-on' requiring little to no design or, perhaps even more importantly, construction supervision (Figure 3.13).

Figure 3.13: A particularly poor example of drainage constructed as part of a Regrade (image the authors)

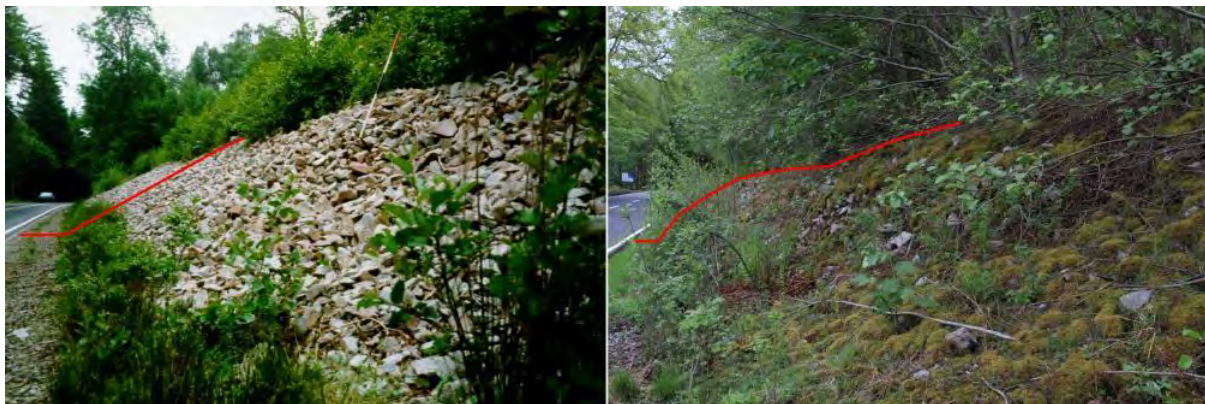
At the same site the removal of a Gabion Wall at the toe of a slope and its replacement with a rock fill bund (Figure 3.14) led to severe deformation and, indeed, the outward movement of the bund towards the carriageway; the total movement was estimated at close to one metre and deformation of the face of the bund to form a broadly sinusoidal profile compared to the as-constructed flat profile was also observed (Figure 3.14).

Figure 3.14: Removal of a Gabion Wall (not pictured) at the toe of a slope and replacement with a Rock Fill bund led to the subsequent movement of the toe bund outwards as well as significant deformation of the surface profile of the bund. Construction of the bund was in 1994 and the images show the bund in June 1999 (Left) when deformation and movement was first noted and after significant deformation and movement (Right) had taken place as of May 2016; the red lines show the approximate shape of the slope and indicate that significant outward movement and toe bulging have occurred (images the authors)

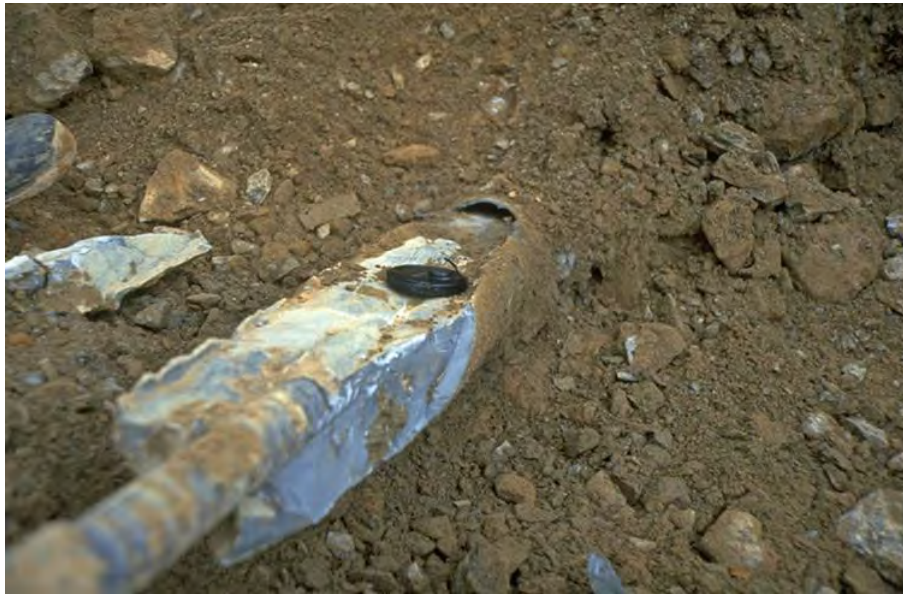
Figure 3.19: Construction of the A74 (M74 Junction 14 to 15) Tinny Bank soil nails trial in 1994/5; the beginning of a grout bulb can be seen in the partially excavated soil nail (cavitation of the grout annulus is also evident) (image the authors)

As early as the A74 Tinny Bank trial in 1994/5 significant bulb formation was noted of the in-situ grout annulus on excavation of the trial nails. This led to questions regarding the mechanism that provided the nail resistance and suggestions that for installations in granular materials anchoring might be more relevant than axial tensile resistance. The major unknown in this is, of course, that the location, and indeed the presence, of a grout bulb(s) is unknown until the nail is excavated (Figure 3.19). The creation of a bulb at the distal end of the nail, rather analogous to an under-reamed pile, was suggested at the time but did not preclude the presence of less distal bulbs being created as part of the construction process and remaining unknown making the design assumptions non-conservative.

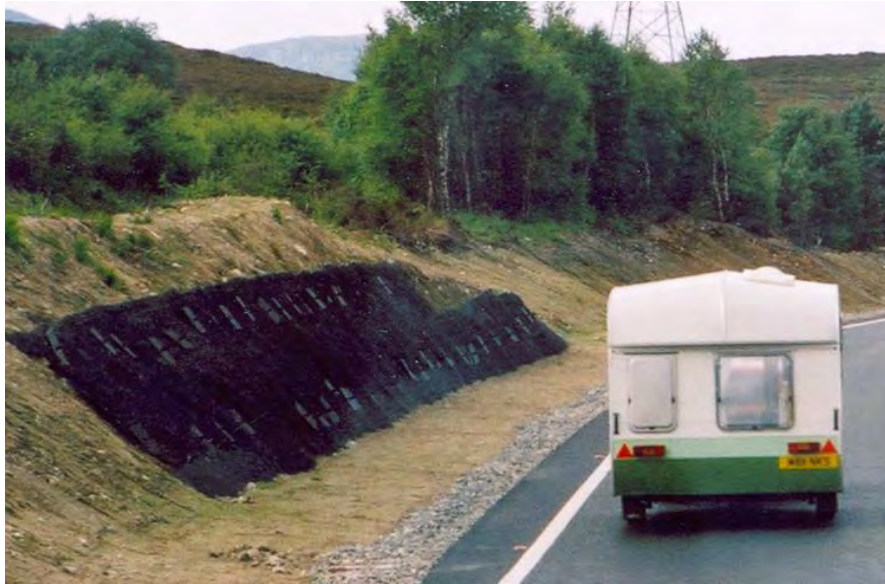
Low height slopes – many examples have been identified of Soil Nails used to stabilise low ($\leq 2\text{m}$) height slopes in situations in which, the restricted land take has clearly driven the solution (Figure 3.20).

Figure 3.20: Example of a low-height Soil Nail reinforced slope (image the authors)

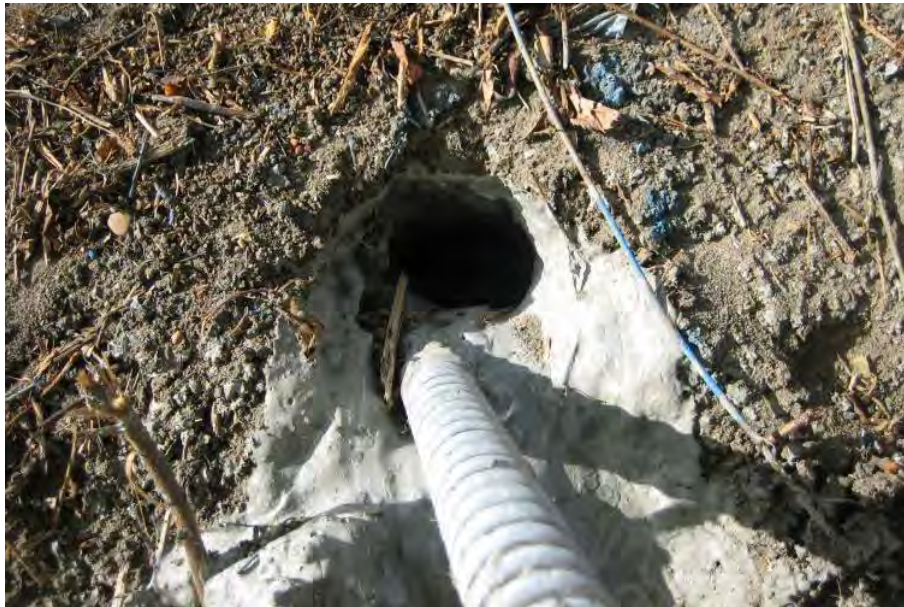
4. The formation of grout bulbs in granular soils, particularly loose materials, potentially invalidating the frictional nature of the design by introducing an anchor block. The position of the anchor block(s) is additionally unknown.
5. Installation of Soil Nails which are not centralised within the borehole (Figure 3.21), often little grout is seen on failed/excavated nails.

Figure 3.21: Soil nail lying on the base of the borehole due to failure to use centralisers. This reduces the grout cover for corrosion protection and potentially reduces the bond strength (image the authors)

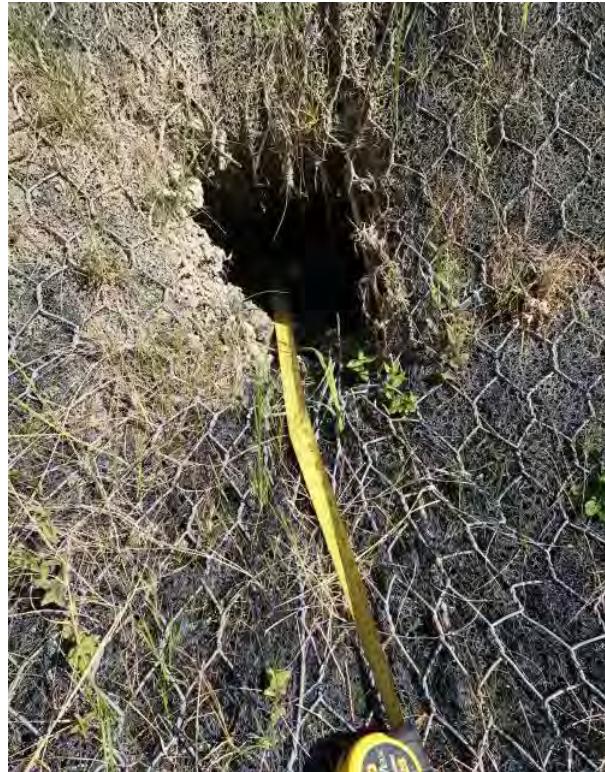
6. Design of steep slopes with soft/meshing faces rather than hard facings. This can lead to unacceptable deformations and in some cases failure where soft facings are not appropriate for the site conditions (e.g. Figure 3.22).
7. Failure to tighten face-plate nuts and/or to apply protective caps.
8. Inappropriate/incorrect design groundwater levels in cut slopes: e.g. assumption that the water table will drop to the base of the newly cut slope which often proves to be incorrect in both the short and long term.
9. Failure to adequately drain slopes to enable soil nailing to be an appropriate solution.

Figure 3.22: Mesh soil nail slope facing where the slope movement forces have caused punching failure of the soil nail mesh facing. The face plate is approximately 600mm back from the facing (image the authors)

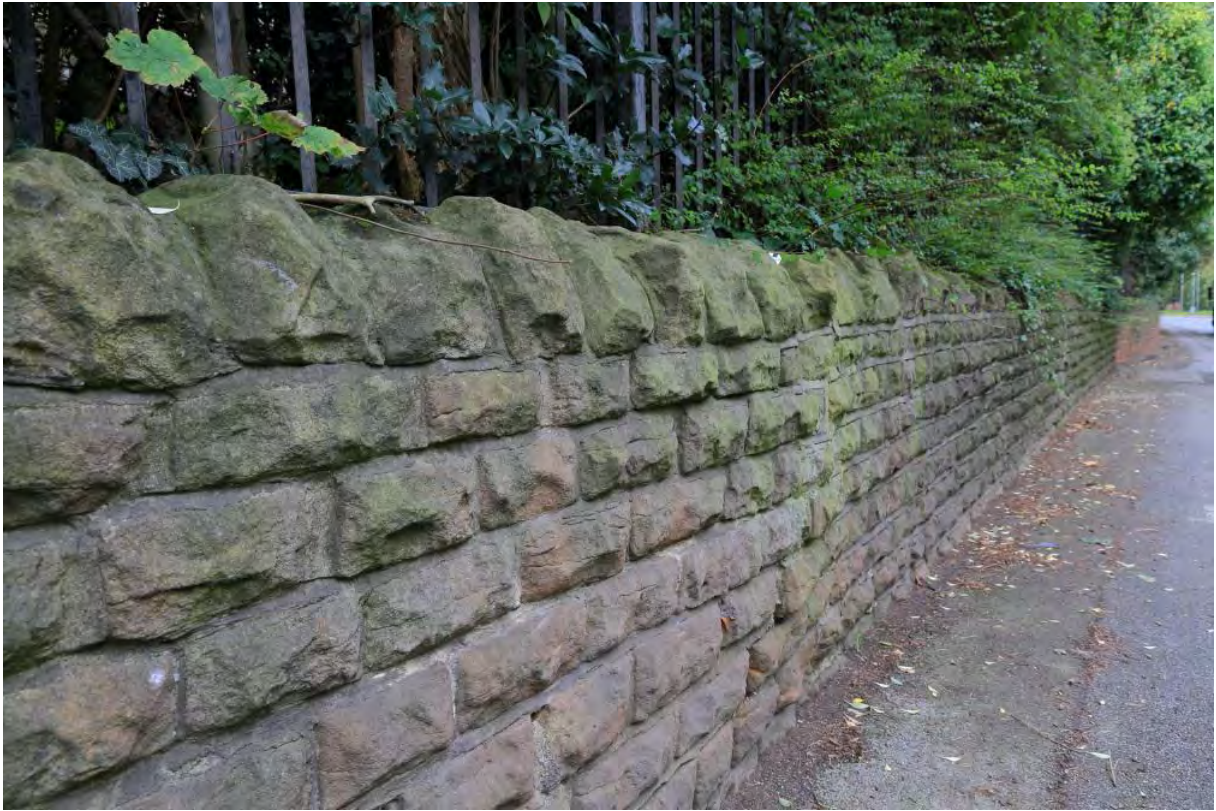
<p>The wall alignment is quite complex with curved sections and change of stratum. The majority of the wall is stone and mortar; however, there are 3 brick and mortar sections also present. It is not understood if the brick sections are previous repairs, blocking up of former accesses or if to facilitate alignment.</p>

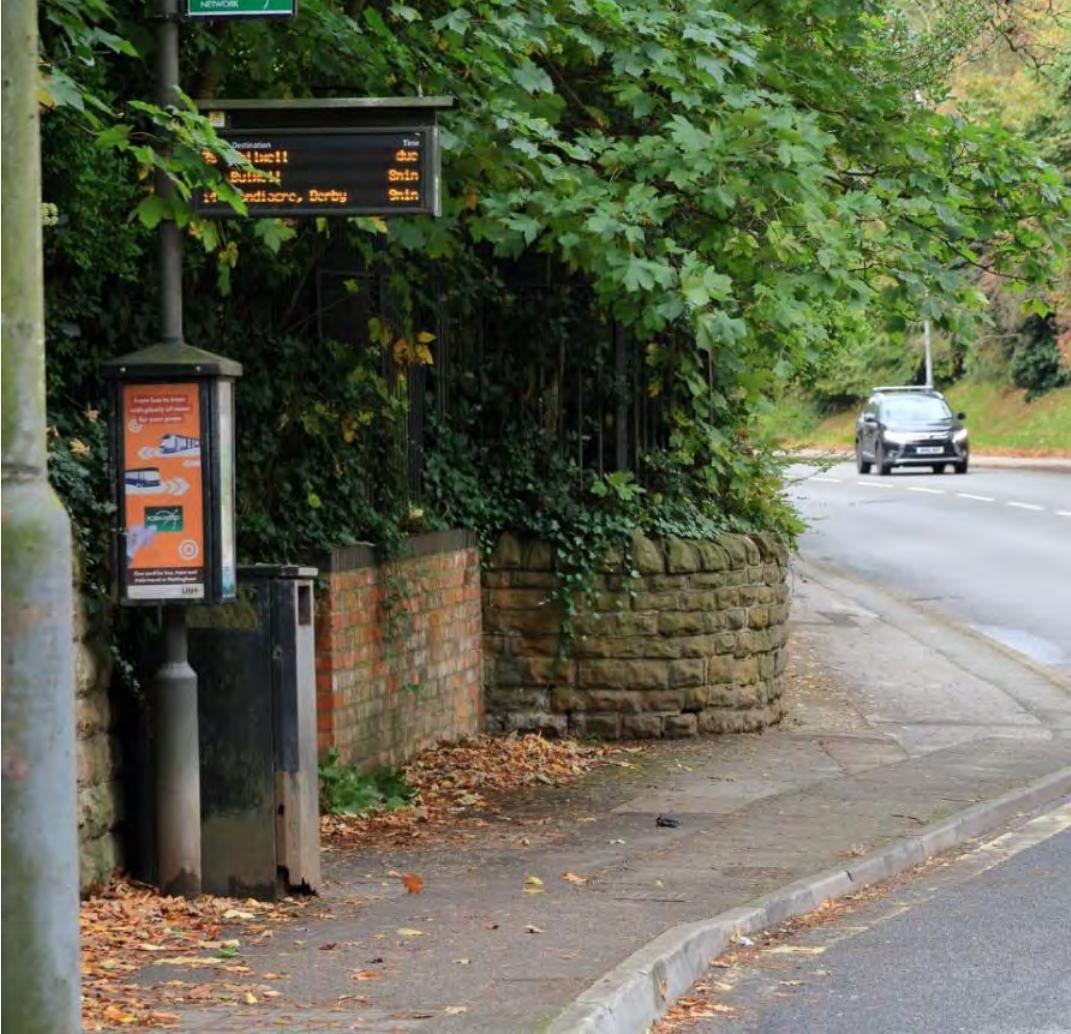
Information pertaining to drainage / watercourses / salt spray: No drainage was observed in the stone sections of the wall; however, weepholes were observed in the longer bricked section spaced approx. every 6m.	
Condition and type of foundation: Unknown

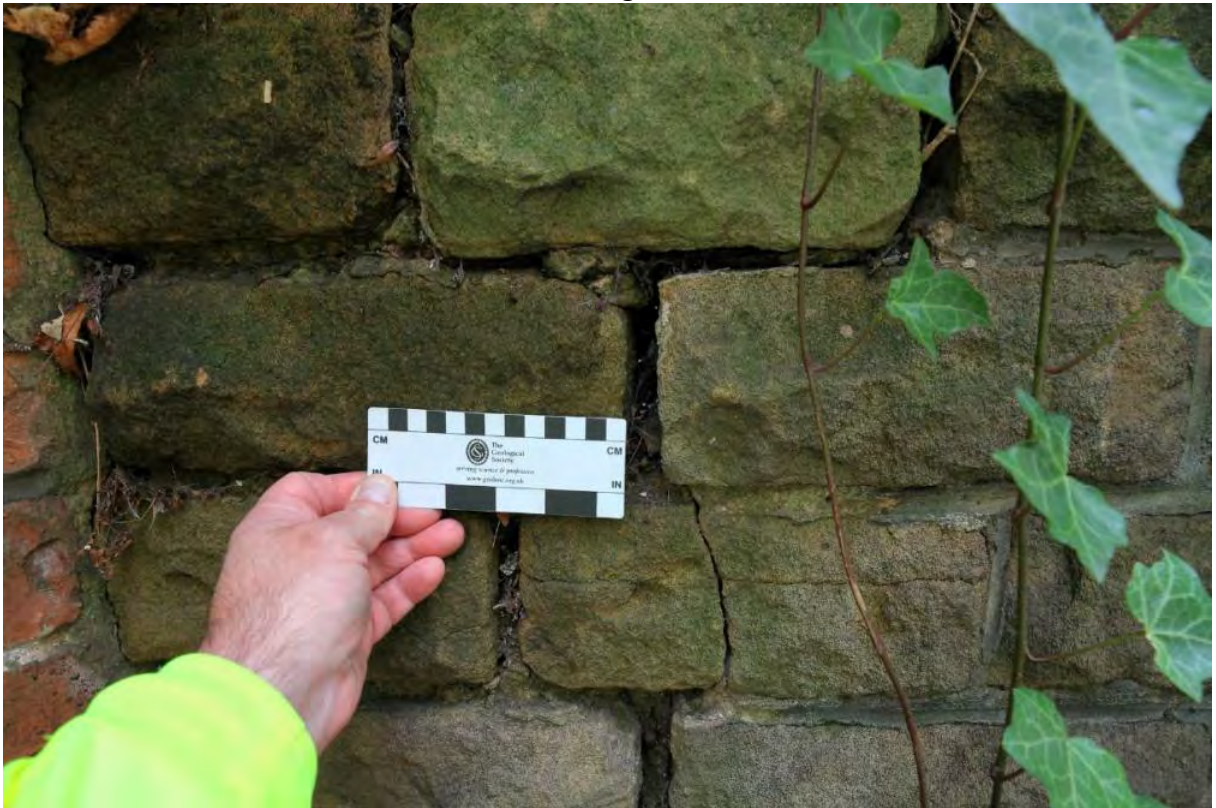
Task 1-1109: SGMs Phase 2	
Block Wall Proforma	
Area / SGM ID:	Area 7 / 9676
Location:	E 453520, N 338574
SGM Type:	Block Wall
Date:	6 th October 2020
Weather:	Dry
Attending site:	Michelle Duffy-Turner (Coffey) & Mike Winter (Winter Associates)
Equipment Used:	Tape measure, distomat, compass clinometer, camera and notebook
Description:	Masonry wall along the A52
The condition of the retained slope where visible: The retained slope was not observed.	
The condition of the elements (blocks), including but not limited to block deterioration: The stone blocks comprised sandstone and in some locations these were observed to be slightly weathered. Cracks were observed through the blocks and more commonly through the mortar. In numerous the mortar was missing.

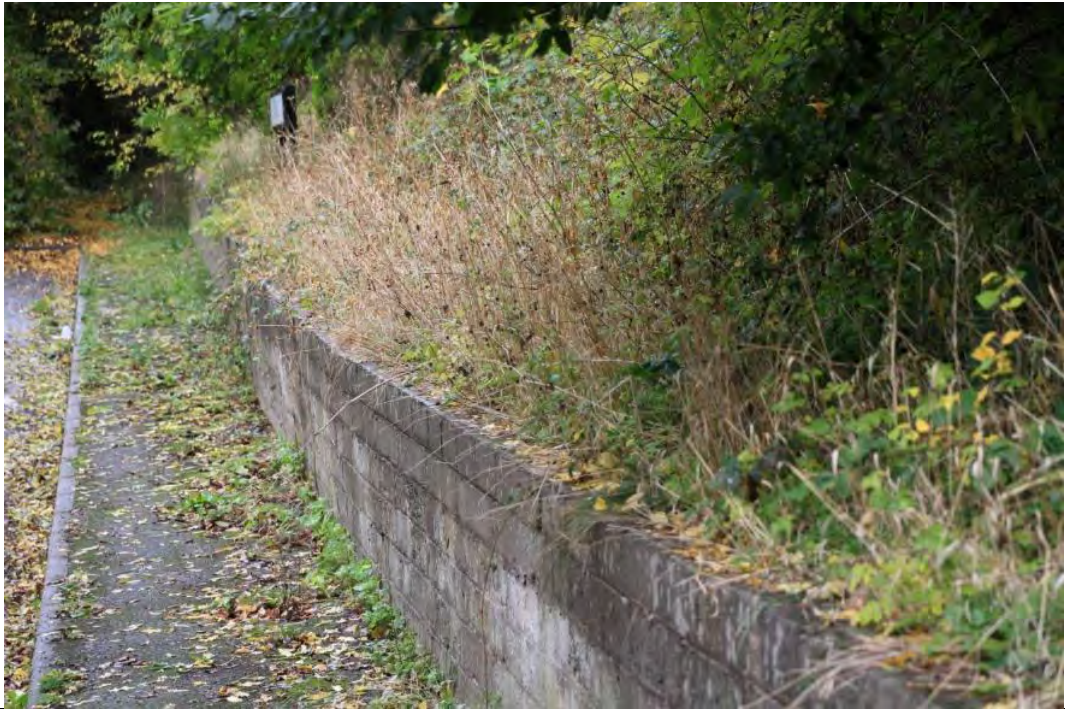
<p>Information pertaining to drainage / watercourses / salt spray: No weepholes or drainage were observed in relation to the wall.</p>	
<p>Condition and type of foundation: Unknown</p>	
<p>The condition of the retained slope where visible: The retained slope was approximately 4.2m high. There were no obvious issues with the retained slope; however, an inspection of the carriageway was not undertaken.</p>

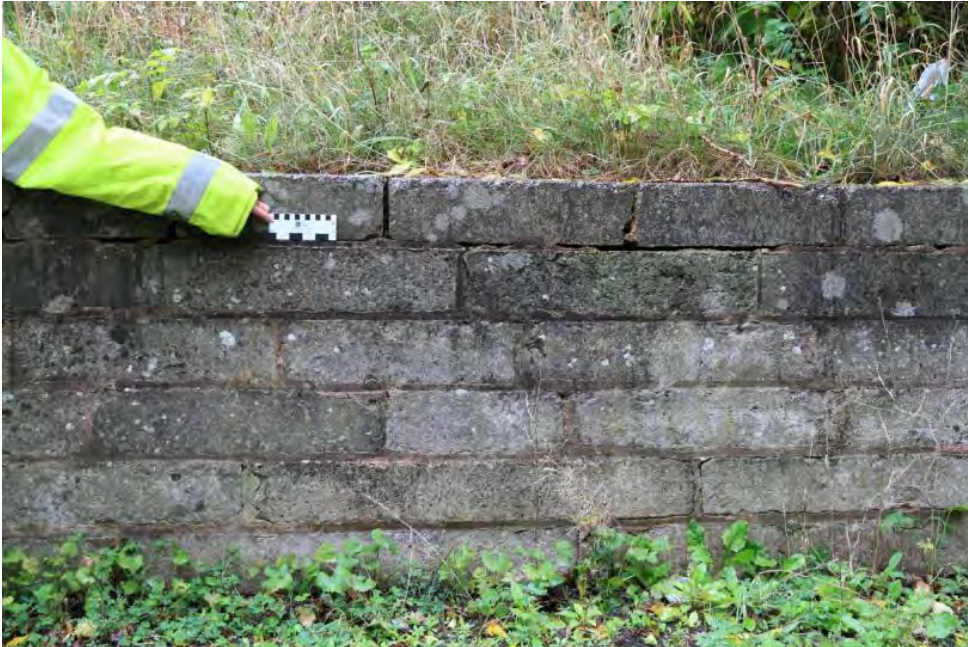
Task 1-1109: SGMs Phase 2	
Block Wall Proforma	
Area / SGM ID:	Area 7 / 7825
Location:	E 457786, N 334693
SGM Type:	Block Wall
Date:	6 th October 2020
Weather:	Dry
Attending site:	Michelle Duffy-Turner (Coffey) & Mike Winter (Winter Associates)
Equipment Used:	Tape measure, distomat, compass clinometer, camera and notebook
Description:	Retaining wall along the A52 embankment
<p>The bottom row shows the second most deterioration across the wall and it is likely this is to do with lack of drainage.</p>

<p>The stability of the individual elements (blocks) e.g. damage to blocks sufficient to compromise stability:</p> <p>Bulging of the wall was observed along the alignment and there was a rotation with the wall overturning by approximately 4°.</p>	
<p>Additional Comments:</p> <p>None</p>

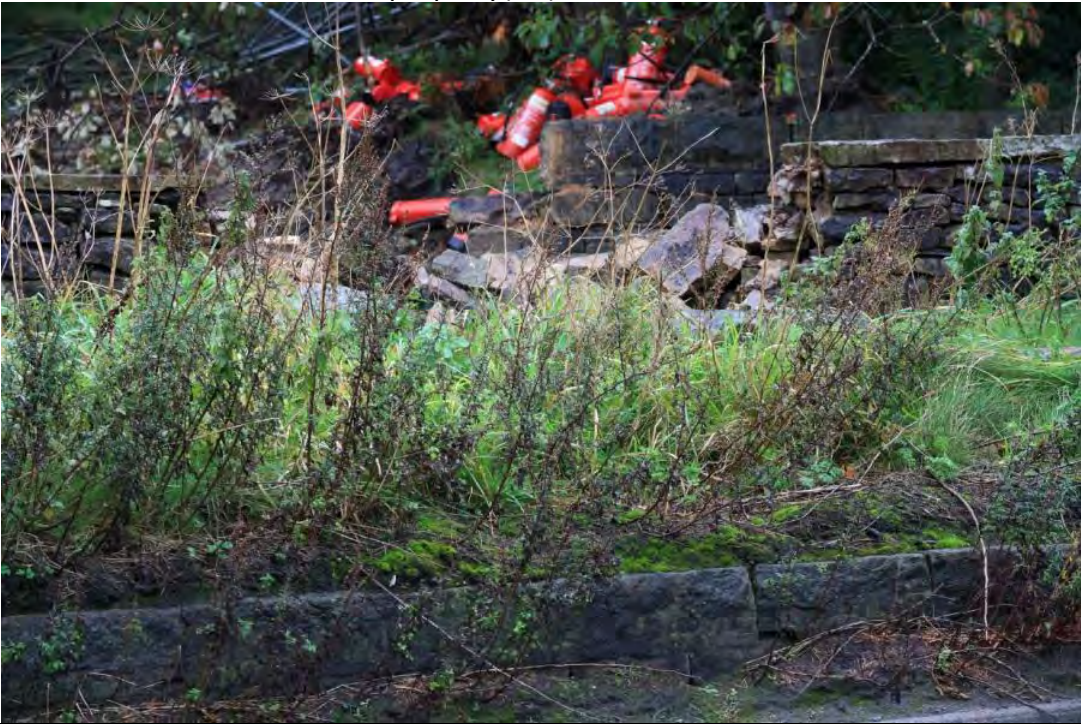
Task 1-1109: SGMs Phase 2	
Block Wall Proforma	
Area / SGM ID:	Area 12 / 9407
Location:	E 407373, N 399305
SGM Type:	Block Wall
Date:	5 th October 2020
Weather:	Raining
Attending site:	Michelle Duffy-Turner (Coffey) & Mike Winter (Winter Associates)
Equipment Used:	Tape measure, distomat, compass clinometer, camera and notebook
Description:	Dry stone wall adjacent to the A628
Condition and type of foundation: Unknown	
The condition of the retained slope where visible: No issues were observed with the retained slope.	
The condition of the elements (blocks), including but not limited to block deterioration: The wall typically appeared to be in good condition; however, the eastern part of the wall had collapsed. Possibly from a vehicle strike (note that the strike would appear to have come from an access track to residential property(ies) set back from the A628.

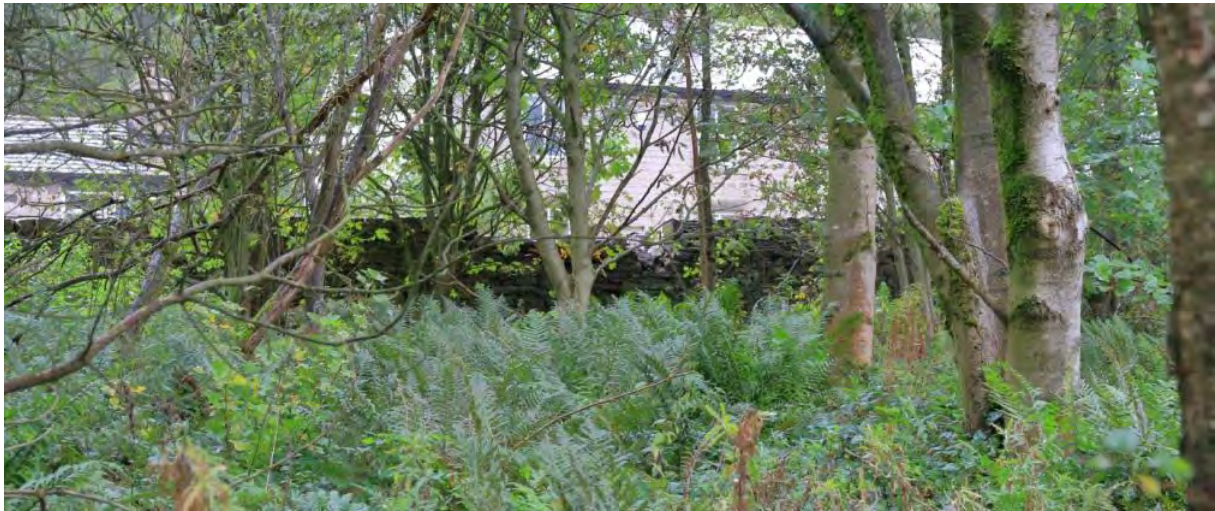
Task 1-1109: SGMs Phase 2	
Block Wall Proforma	
Area / SGM ID:	Area 12 / 9407
Location:	E 407373, N 399305
SGM Type:	Block Wall
Date:	5 th October 2020
Weather:	Raining
Attending site:	Michelle Duffy-Turner (Coffey) & Mike Winter (Winter Associates)
Equipment Used:	Tape measure, distomat, compass clinometer, camera and notebook
Description:	Dry stone wall adjacent to the A628
The stability and linkages between adjacent blocks: The wall is dry stone.	
The stability of the individual elements (blocks) e.g. damage to blocks sufficient to compromise stability: The wall was observed to be collapsed at the eastern end (see photo above). Other parts of the wall were observed to have collapsed but these were set well back from the road in a wooded area.

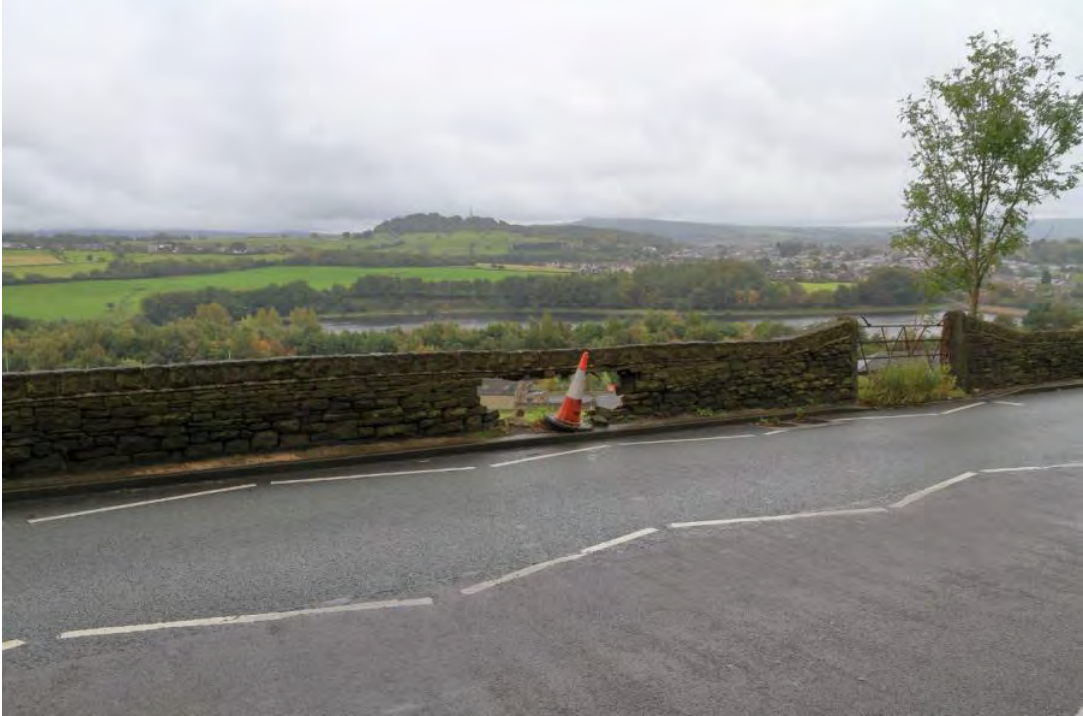
The stability and linkages between adjacent blocks: The wall is dry stone with the mortar in between the coping and the top row of the dry stone wall.	
The stability of the individual elements (blocks) e.g. damage to blocks sufficient to compromise stability: Wall appears in good condition with no obvious instability.	
Additional Comments: As a side note the potential vulnerability of free-standing dry stone and mortared walls can be observed from the (assumed) vehicle damage to a similar wall (possibly and extension of SGM 8923 to the East) observed in the image below.

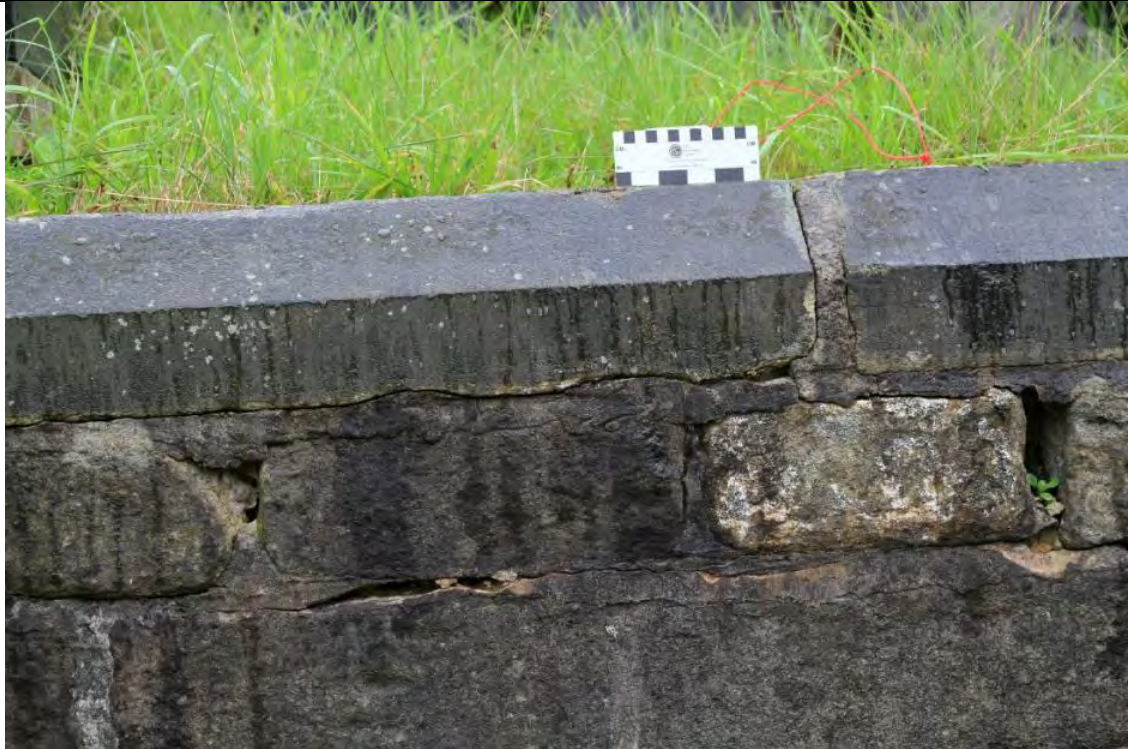
Task 1-1109: SGMs Phase 2	
Block Wall Proforma	
Area / SGM ID	Area 12 / 8885
Location	E 402413, N 397305
SGM Type:	Block Wall
Date:	5 th October 2020
Weather:	Light rain
Attending site:	Michelle Duffy-Turner (Coffey) & Mike Winter (Winter Associates)
Equipment Used:	Tape measure, distomat, compass clinometer, camera and notebook
Description:	Masonry block wall adjacent to the A628
Condition and type of foundation: Unknown	
The condition of the retained slope where visible: No obvious issues observed with the slope (very shallow); however, a close inspection was not undertaken of the cemetery.	
The condition of the elements (blocks), including but not limited to block deterioration: There are a number of cracks in the wall with numerous areas having undergone repair and re-mortaring. The worst affected area is along Chapel Brow with gaps up to 40mm opening up. The wall is opening up especially below the coping. No cracking of the blocks themselves was observed.

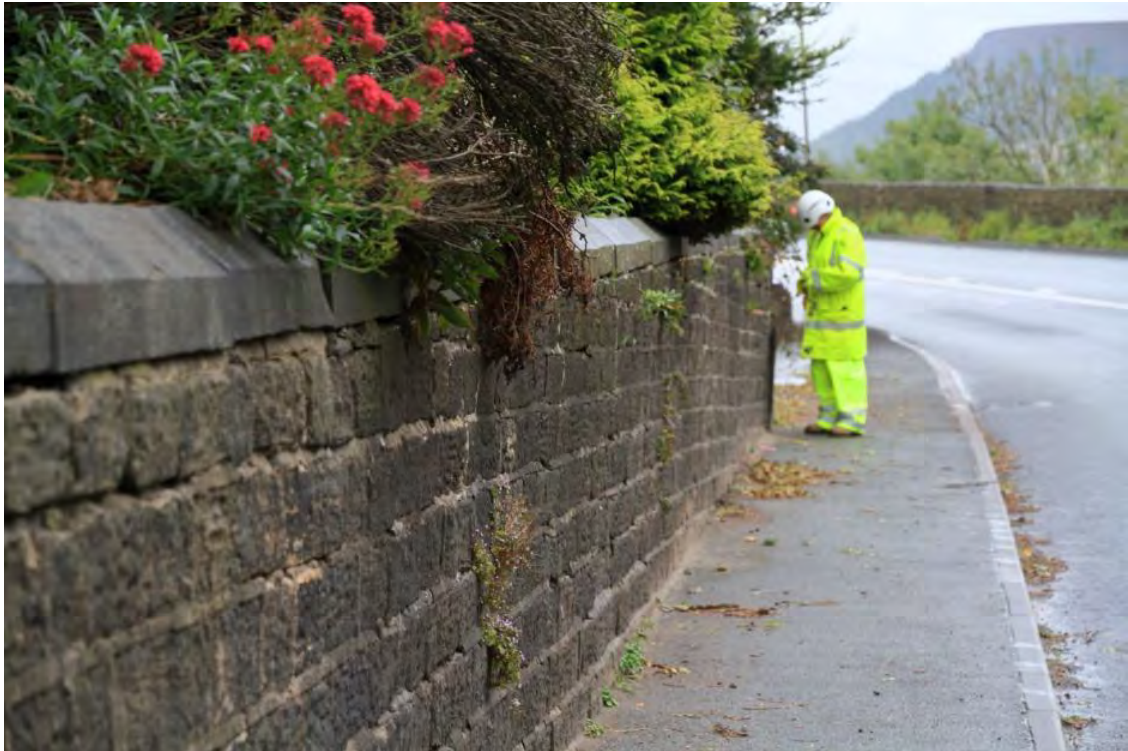
<p>Evidence of global cracking: Significant cracking but largely restricted to the top two or three courses and deeper only locally.</p>	
<p>The stability and linkages between adjacent blocks: The linkage between the blocks for this retaining wall is mortar. This is missing in places and has been replaced in localised areas. Observation indicated that the mortar in the worst condition was that in and immediately below the coping.</p>

Task 1-1109: SGMs Phase 2	
Block Wall Proforma	
Area / SGM ID	Area 12 / 8885
Location	E 402413, N 397305
SGM Type:	Block Wall
Date:	5 th October 2020
Weather:	Light rain
Attending site:	Michelle Duffy-Turner (Coffey) & Mike Winter (Winter Associates)
Equipment Used:	Tape measure, distomat, compass clinometer, camera and notebook
Description:	Masonry block wall adjacent to the A628
<p>The stability of the individual elements (blocks) e.g. damage to blocks sufficient to compromise stability: No cracking to individual blocks was observed.</p>	
<p>Additional Comments: The block courses dip alongside the A628 compared to the current vertical road alignment, while also dipping (up to an estimated 10°) to the horizontal. It is not entirely clear why this should be the case but it may reflect changes to the vertical road alignment and/or that of the cemetery above. This may be the reason that weep holes are not visible alongside the A628/footpath, having potentially been buried during later construction works.</p> <p>This retaining wall is unusual for the area which typical comprise dry stone walls. The sandstone used for the wall is also unusual. It is possible that as it is the wall for a church yard/cemetery it may have been considered a premium form of construction merit worthy of additional cost.</p>

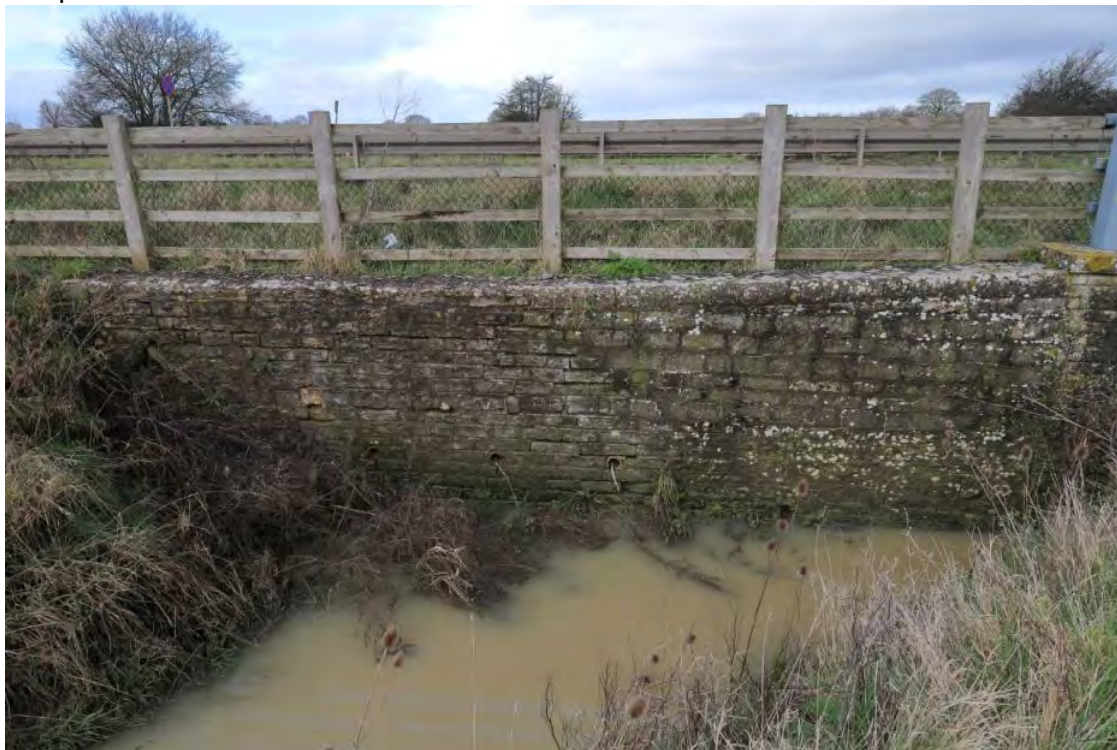
<p>The wall extends to the west (left of the photo above) some distance but the majority of the wall has been buried previously during remedial works. It is assumed that the section of wall shown on the photo above has not been buried due to the presence of the watercourse below.</p>

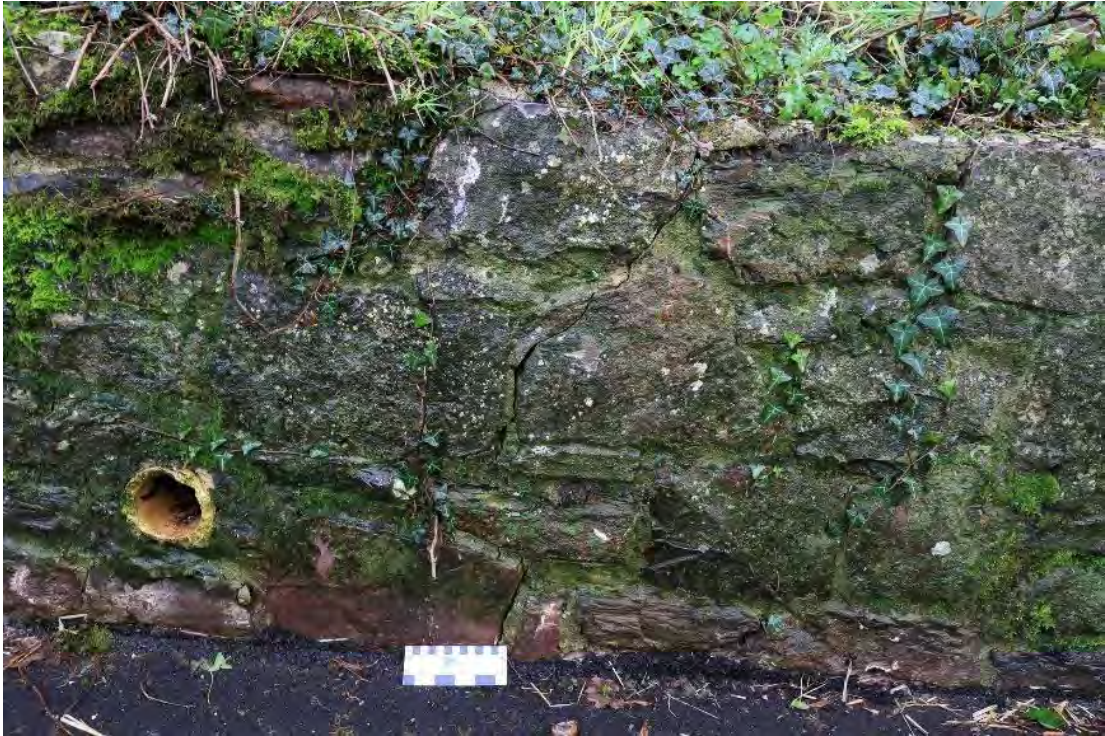
Task 1-1109: SGMs Phase 2	
Block Wall Proforma	
Area / SGM ID:	Area SW / 1306
Location:	E 319613, N 104545
SGM Type:	Block Wall
Date:	28 th January 2021
Weather:	Drizzly
Attending site:	Michelle Duffy-Turner (Coffey) & Mike Winter (Winter Associates)
Equipment Used:	Tape measure, distomat, compass clinometer, camera and notebook
Description:	Retaining wall along the A30
<p>The top course of the wall was quite broken up compared to the lower courses and at the western end the coping stones were missing.</p>

<p>Evidence of global cracking: No evidence of global cracking was observed.</p>	
<p>The stability and linkages between adjacent blocks: The mortar was overall in good condition; however, there were areas where it had cracked and fell out.</p>	
<p>The stability of the individual elements (blocks) e.g. damage to blocks sufficient to compromise stability: No major damage or instability of the block wall was observed.</p>

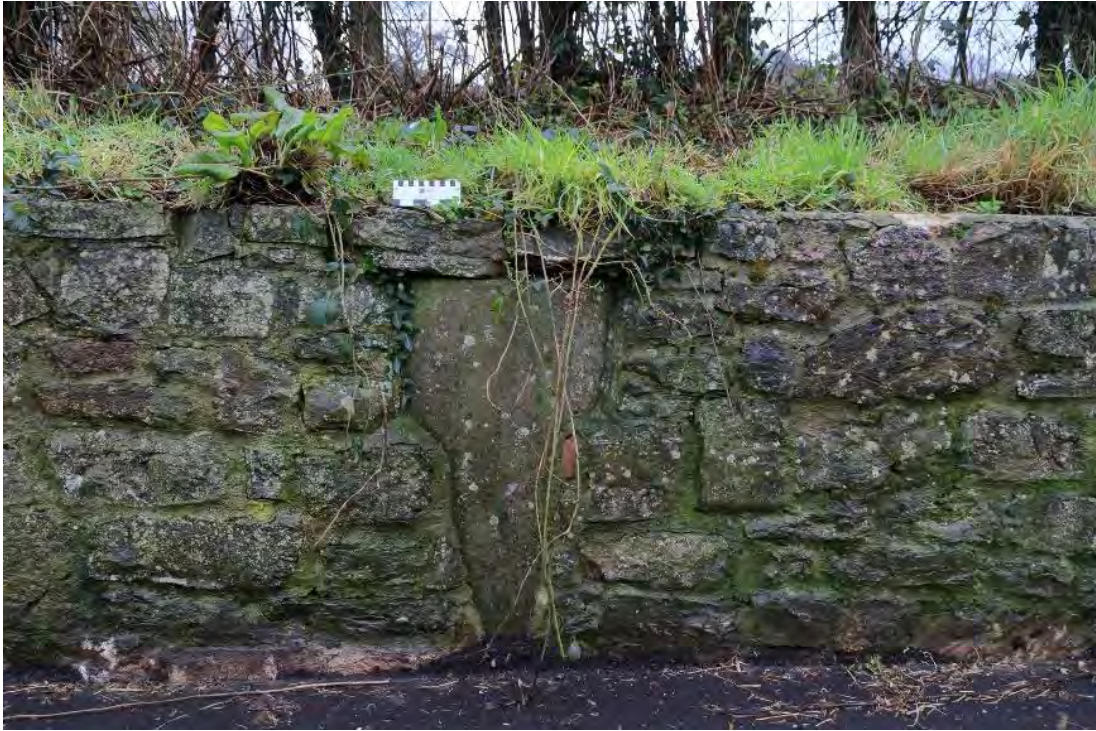
Task 1-1109: SGMs Phase 2	
Block Wall Proforma	
Area / SGM ID:	Area SW / 1306
Location:	E 319613, N 104545
SGM Type:	Block Wall
Date:	28 th January 2021
Weather:	Drizzly
Attending site:	Michelle Duffy-Turner (Coffey) & Mike Winter (Winter Associates)
Equipment Used:	Tape measure, distomat, compass clinometer, camera and notebook
Description:	Retaining wall along the A30
<p>Additional Comments:</p> <p>What appears to be a precast concrete pipe (500mm diameter) was observed in the central section of the wall with the wall constructed around it (see photo below). The purpose of this is not fully clear but it may have been an old foundation for a sign post. There is a crack approximately 500mm long down the middle of the pipe.</p>

<p>The wall is north facing and there was lots of moss and lichen growing on it.</p>

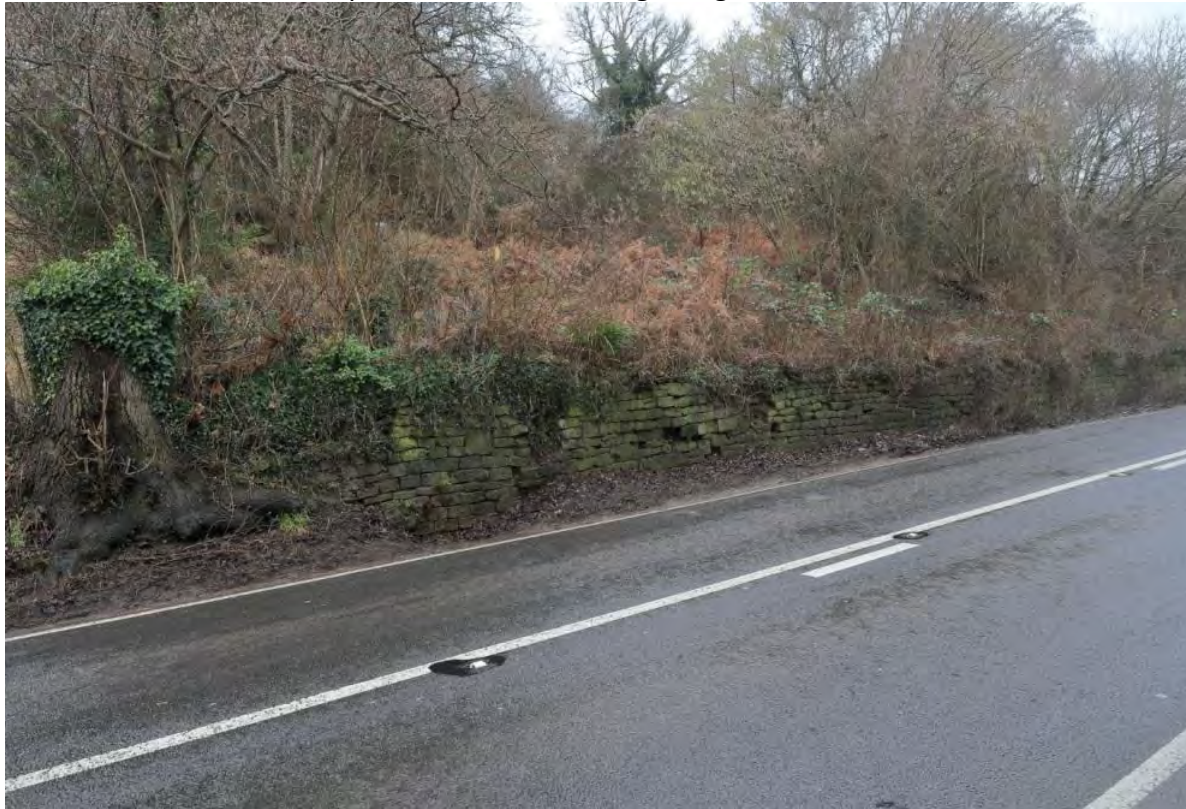
Task 1-1109: SGMs Phase 2	
Block Wall Proforma	
Area / SGM ID:	Area SW / 9077
Location:	E 378323, N 162595
SGM Type:	Block Wall
Date:	28 th January 2021
Weather:	Drizzly
Attending site:	Michelle Duffy-Turner (Coffey) & Mike Winter (Winter Associates)
Equipment Used:	Tape measure, distomat, compass clinometer, camera and notebook
Description:	Retaining wall along the A36
<p>The setting and location of the wall, in particular relative to the carriageway: The drystone wall is approximately 1.5m high and is located along the A36 western cutting to the west of Dundas Aqueduct. The site was accessed via a public footpath and viewed from across the road. The wall extends to the north where access is not possible; however, a drive through this area indicates that similar problems are occurring along other sections of this wall.</p>

<p>Information pertaining to drainage / watercourses / salt spray: No watercourse was observed in the vicinity of the wall; however, gushing water could be heard behind it and there are drains in the road surface which may be connected.</p>

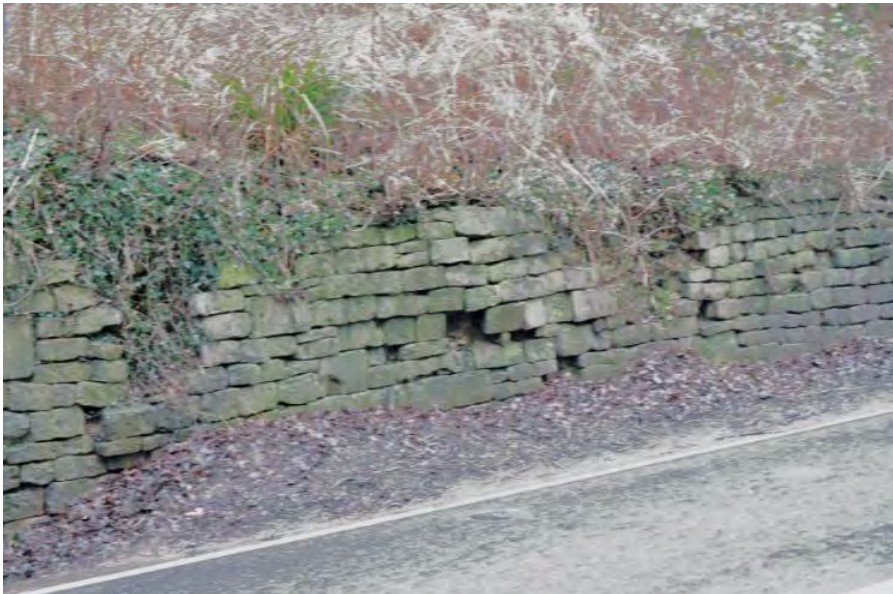
Task 1-1109: SGMs Phase 2	
Block Wall Proforma	
Area / SGM ID:	Area SW / 9077
Location:	E 378323, N 162595
SGM Type:	Block Wall
Date:	28 th January 2021
Weather:	Drizzly
Attending site:	Michelle Duffy-Turner (Coffey) & Mike Winter (Winter Associates)
Equipment Used:	Tape measure, distomat, compass clinometer, camera and notebook
Description:	Retaining wall along the A36
<p>The condition of the retained slope where visible: It is understood that the slopes retained by the wall are areas of historic landsliding and that the A36 has been built upon landslide deposits. These were not assessed during the inspection.</p>	
<p>The condition of the elements (blocks), including but not limited to block deterioration: The wall was comprised of sandstone blocks, drystone so no mortar was present. The majority of the blocks were in good conditions with slight deterioration present and limited cracking.</p>	
<p>Evidence of global cracking: The wall showed significant deterioration with complete sections collapsed and other sections missing blocks (see photo below). The wall was distorted and appeared to be leaning towards the road in places.</p>
