PUBLISHED PROJECT REPORT PPR1032

Forensic Examination of Critical Special Geotechnical Measures

M Duffy-Turner (Coffey Geotechnics Ltd), M G Winter (Winter Associates Limited), I M Nettleton (Coffey Geotechnics Ltd) and G Butler (Coffey Geotechnics Ltd)

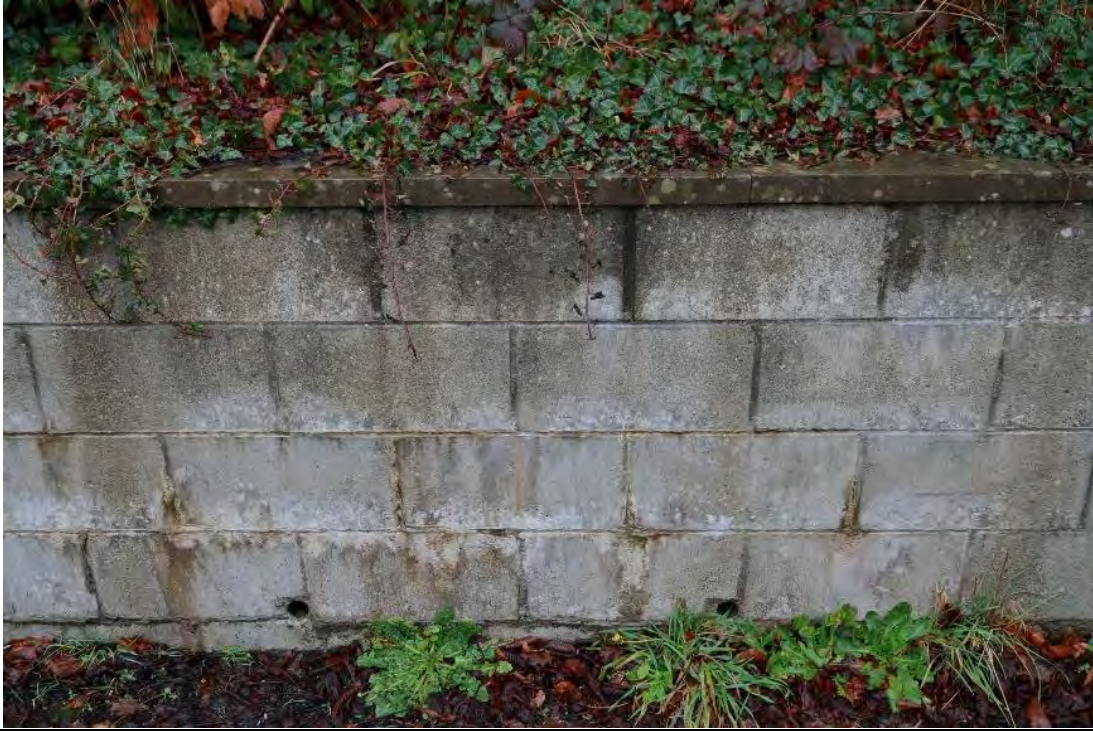
There was significant efflorescence present on the block wall (on both the blocks and mortar). It is possible that this has been caused by salt spray; however, it is set back quite far from the live lanes and a vehicle restraint barrier is located in between the wall and the road. This could possibly be salts leaching out of the mortar and concrete blocks or maybe marine sands have been used (see photo below).

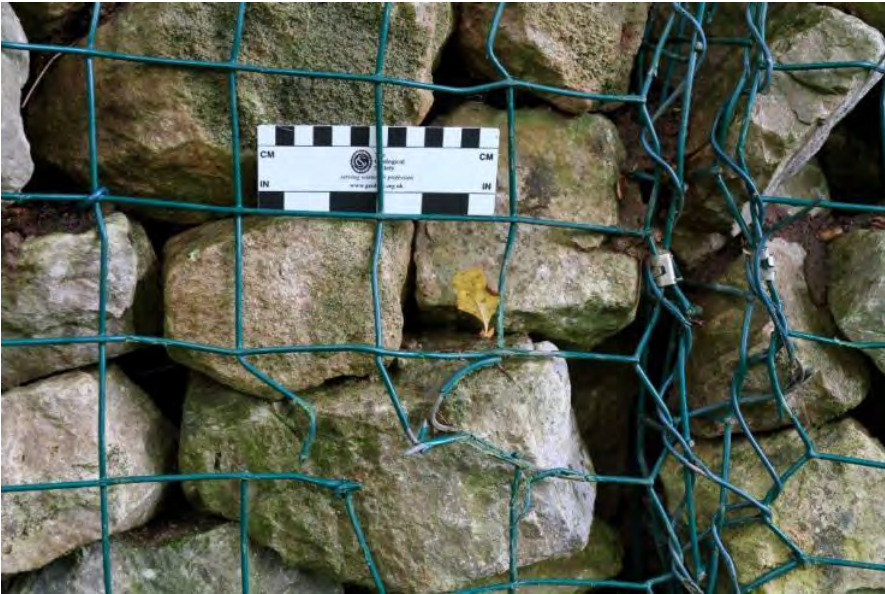
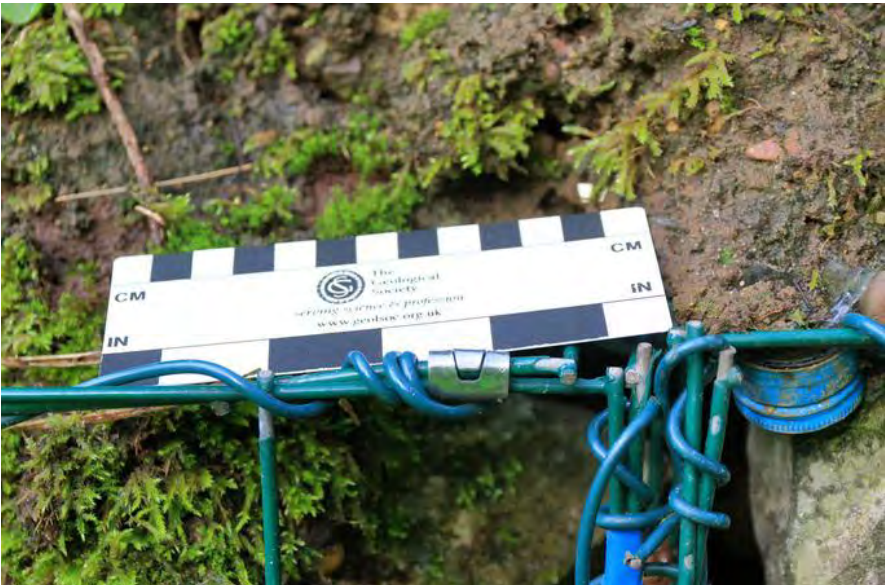
Task 1-1109: SGMs Phase 2	
Gabion Wall Proforma	
Area / SGM ID:	Area 9 / 9117
Location	E 434231, N 275581
SGM Type:	Gabion Wall
Date:	8 th October 2020
Weather:	Dry
Attending site:	Michelle Duffy-Turner (Coffey) & Mike Winter (Winter Associates)
Equipment Used:	Tape measure, distomat, compass clinometer, camera and notebook
Description:	1m high gabion wall at the toe of an embankment
<p>The condition of the elements (gabions), including but not limited to gabion basket wire damage and/or repairs, gabion basket wire corrosion protection (galvanising and/or plastic), gabion fill (including suitability and deterioration):</p> <p>The gabions comprise green plastic-coated weld mesh with apertures 75mm by 75mm. Fill material appears to be a metamorphic rock (possibly gneiss) and is typically angular and sized between 100mm and 200mm. Smaller blocks were observed down to 40mm.</p> <p>There was no corrosion observed on the mesh.</p> <p>In a few locations along the gabion wall, damage to the apertures was observed including bent, peeling and broken wire. This appears to have been cut purposefully, maybe vandalism (see photo below).</p> <p>There were scuffs observed on the plastic mesh covering across the majority of the gabion wall which is likely to have been caused during transportation or construction. These areas may create 'weak' spots when it comes to future corrosion. The majority of the damage was observed at the 'cut ends' of the baskets where it is likely they have been cut on site and on the wrapped wire linking the basket edges.</p>

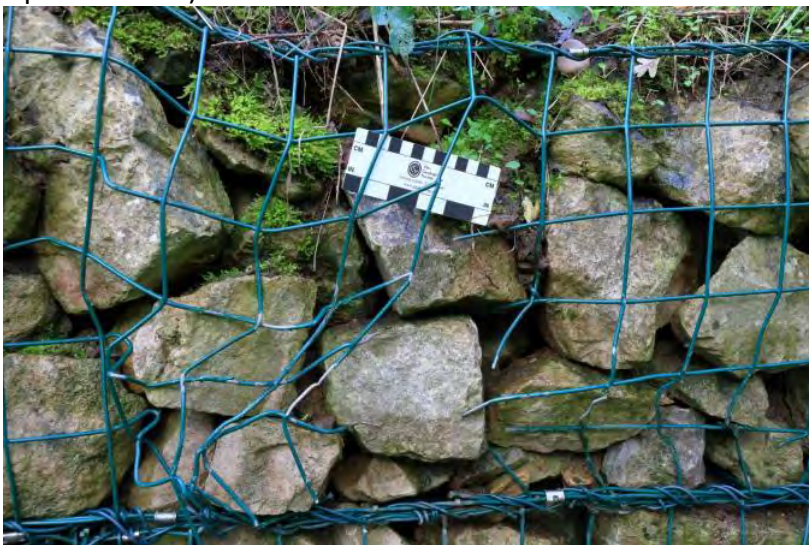
Task 1-1109: SGMs Phase 2	
Gabion Wall Proforma	
Area / SGM ID:	Area 9 / 9117
Location	E 434231, N 275581
SGM Type:	Gabion Wall
Date:	8 th October 2020
Weather:	Dry
Attending site:	Michelle Duffy-Turner (Coffey) & Mike Winter (Winter Associates)
Equipment Used:	Tape measure, distomat, compass clinometer, camera and notebook
Description:	1m high gabion wall at the toe of an embankment
<p>The stability and linkages between adjacent baskets:</p> <p>The baskets were typically fastened (individually) with metal links and wrapped wire along the top and at the sides. Adjacent baskets were tied together with plastic-coated green wire wrapped round the join between the two (see photo above).</p> <p>Additional reinforcement has been added to the baskets (occasionally – not as standard within each one) to maintain basket shape during filling by tying green wire around one cross hair of the aperture and feeding it back into the fill material.</p> <p>The stability of the individual elements (gabions) e.g. damage and distortion of baskets:</p> <p>The baskets are distorted in localised areas (typically ok).</p> <p>In a few locations along the gabion wall, damage to the apertures was observed including bent, peeling and broken wire. This appears to have been cut purposefully, maybe vandalism (see photo below).</p>

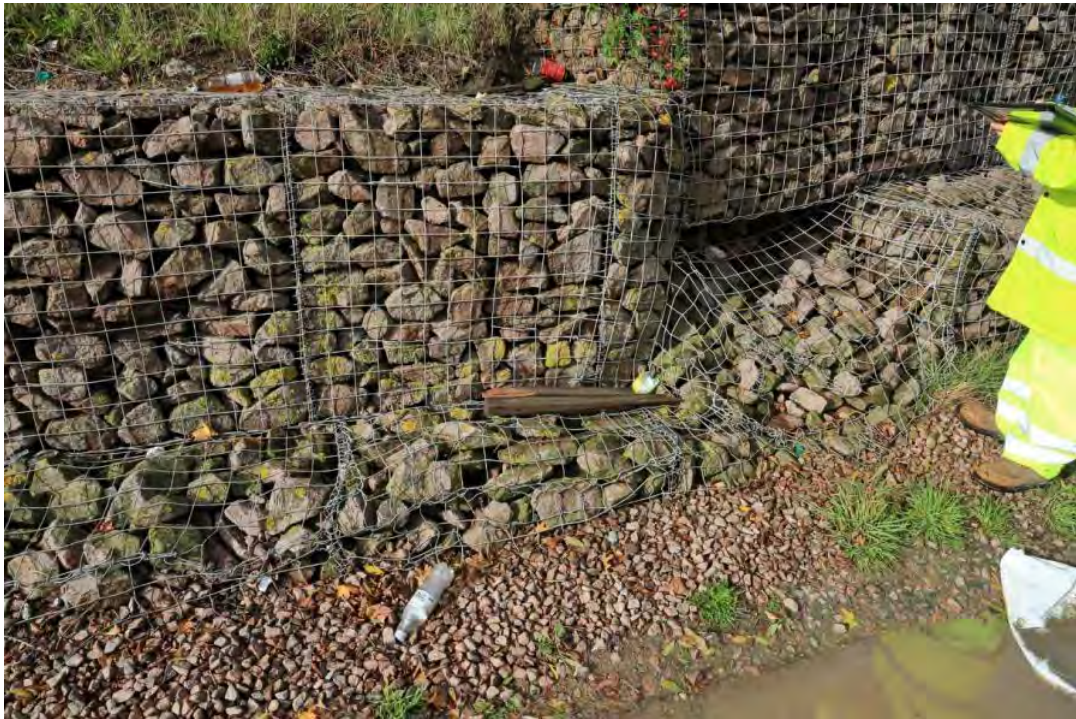
The gabion wall is in disrepair with rips present through the mesh leading to the fill spilling out onto the ground in front. This is evident in the lower part of the wall and is consistent with a vehicle impact(s) along the gabion wall with the corner between the highest and mid height gabions being affected the most.

<p>The stability and linkages between adjacent baskets:</p> <p>The adjacent gabion baskets (horizontal) were typically tied together with stainless steel spirals. These appear to work very effectively where used. The spirals did not appear to have been used to tie the lower baskets top face together which could have provided additional support from vehicle strikes.</p> <p>The lower baskets top and front face were joined by wrapped wire of which the lacing was quite loose. The two rows of gabions were also linked vertically with laced wire.</p>

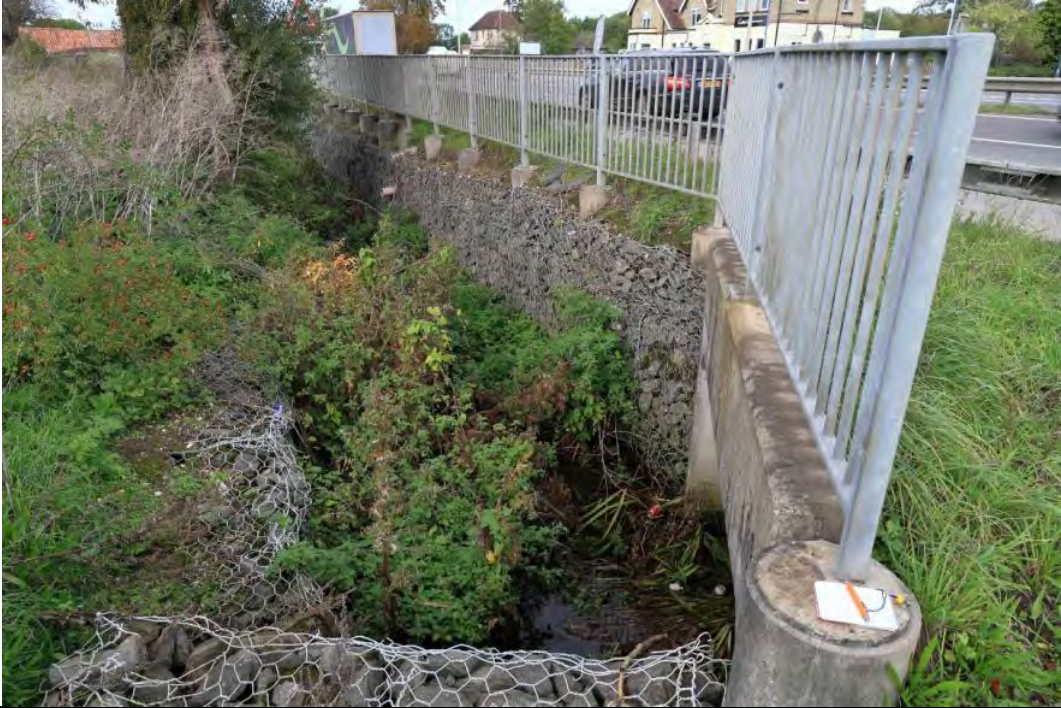
<p>Information pertaining to drainage / watercourses / salt spray: The gabion wall provides the wingwalls for a culvert and lines the channel on the east side (and part of the west). There is a 200mm polypipe protruding through the top row of gabions approximately 4m north of the culvert. There was no water coming out of the pipe at the time of the inspection.</p>

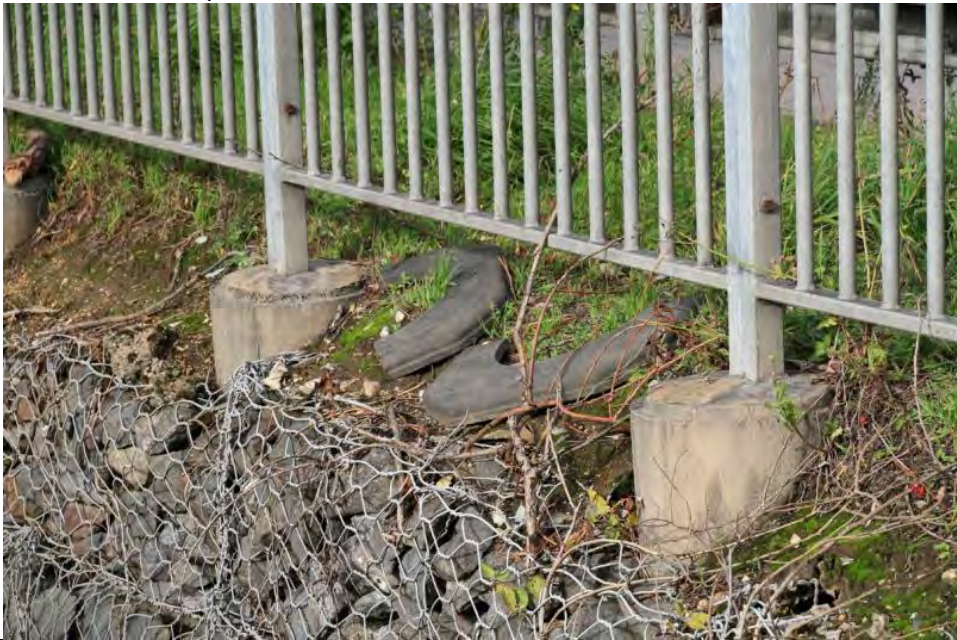
<p>The condition of the retained slope where visible:</p> <p>The gabions obscure the majority of the retained slope. No stability issues were observed.</p>

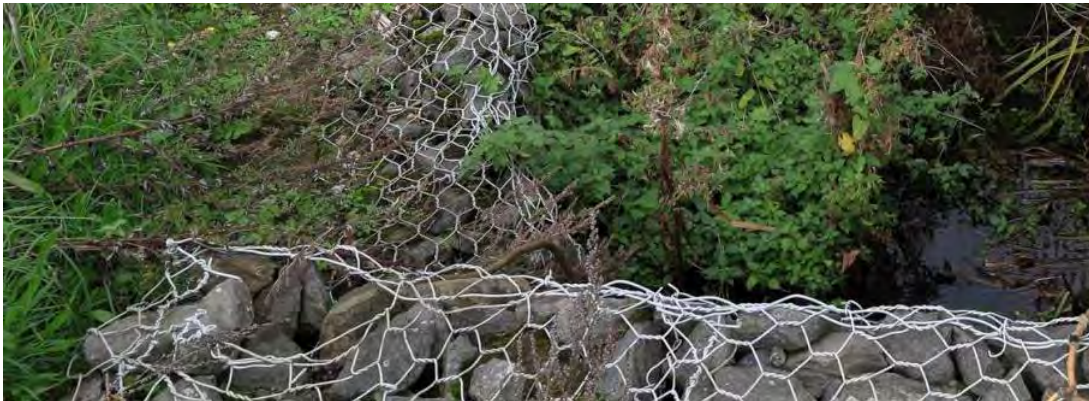
<p>The gabions have been well filled by different rock types (all hard, clean and durable) with sizes typically between 80mm and 200mm.</p>

<p>The stability and linkages between adjacent baskets:</p> <p>The finish of the gabion walls is a bit untidy with some lacing of wires loose and poorly fastened. This does not seem to be affecting the integrity of the wall; however, it would not be acceptable if this was visible to the public.</p>	
<p>The stability of the individual elements (gabions) e.g. damage and distortion of baskets:</p>

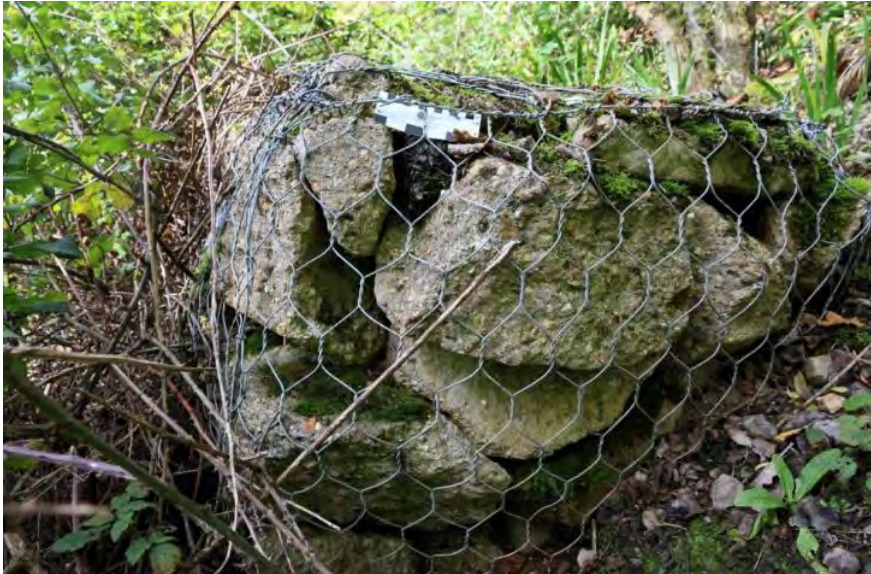
Task 1-1109: SGMs Phase 2	
Gabion Wall Proforma	
Area / SGM ID:	Area 8 / 6082
Location	E 524256, N 271326
SGM Type:	Gabion Wall
Date:	7 th October 2020
Weather:	Dry
Attending site:	Michelle Duffy-Turner (Coffey) & Mike Winter (Winter Associates)
Equipment Used:	Tape measure, distomat, compass clinometer, camera and notebook
Description:	Gabion wall up to 2m high along the A1307 (prior A14) embankment.
<p>The stability and linkages between adjacent baskets: The adjacent gabion baskets (horizontal) were typically laced together with wire. No lacing was observed between rows of gabions.</p> <p>Initial observations suggest that the tops of the gabions have become unlaced; however, closer inspection indicates that the tops are only secured by wire at pinch points as the size of the blocks means it is unable to accommodate a fully closed and laced gabion.</p>	
<p>The stability of the individual elements (gabions) e.g. damage and distortion of baskets: The gabion wall is distorted along its full length. The distortions are visible on the wall globally and also on the individual apertures.</p>

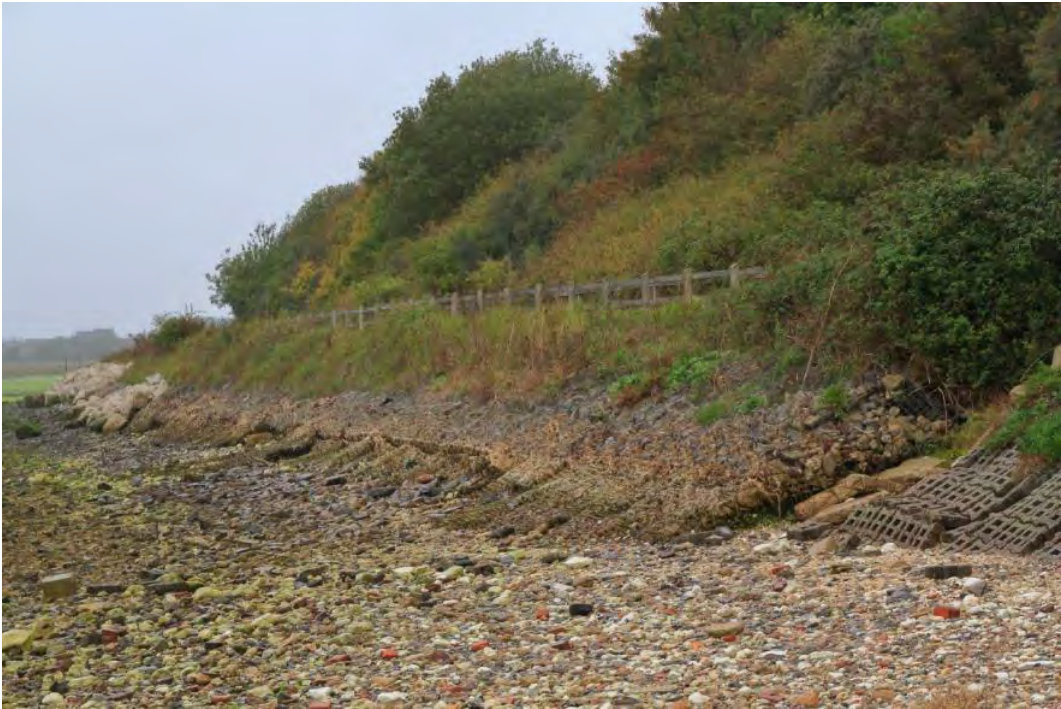
Task 1-1109: SGMs Phase 2	
Gabion Wall Proforma	
Area / SGM ID:	Area 3 / 10197 & 10198
Location	E 469525, N 105476
SGM Type:	Gabion Wall
Date:	8 th October 2020
Weather:	Raining and blustery
Attending site:	Michelle Duffy-Turner (Coffey) & Mike Winter (Winter Associates)
Equipment Used:	Tape measure, distomat, compass clinometer, camera and notebook
Description:	Gabion revetment at the toe of a coastal footpath.
Information pertaining to drainage / watercourses / salt spray: The gabion revetment is located in between the coastal footpath below the A3(M) and Langstone Harbour estuary (the section is known as Chalkdown Lake). This is an estuary environment with the water reaching partway up the gabions during high tide. A culvert was observed in this stretch of coastal protection (this effectively marks the boundary between SGMs 10197 and 10198).	
Condition and type of foundation: Foundations unknown; however, at one location concrete was observed below the gabion revetment. At the edges of the revetments the ground surrounding it is being washed away leaving them undermined.

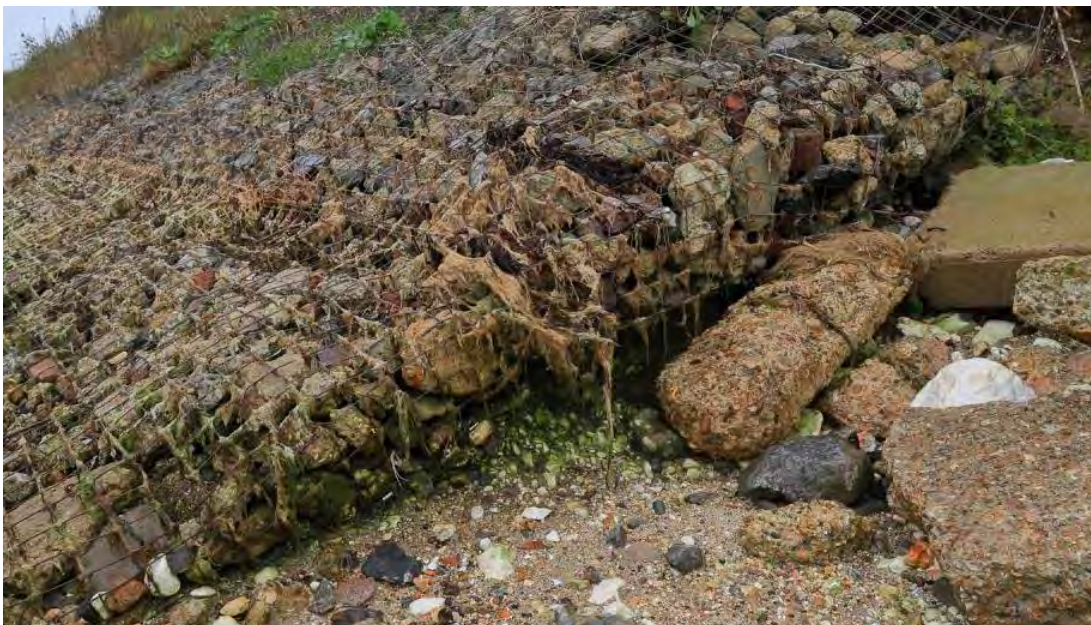
The condition of the retained slope where visible: The gabion revetment obscured the majority of the embankment. There were no obvious concerns relating to the footpath at this location; however, the gabions themselves were in distress.

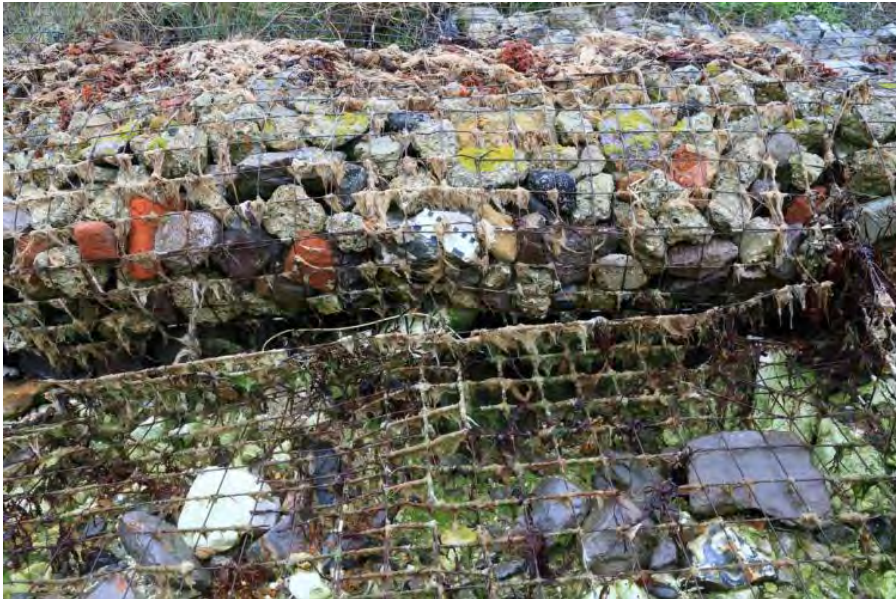
<p>Where the lower baskets have completely corroded through the fill is spilling out onto the tidal flats below where the material has been (and will be) washed away by the tide.</p>

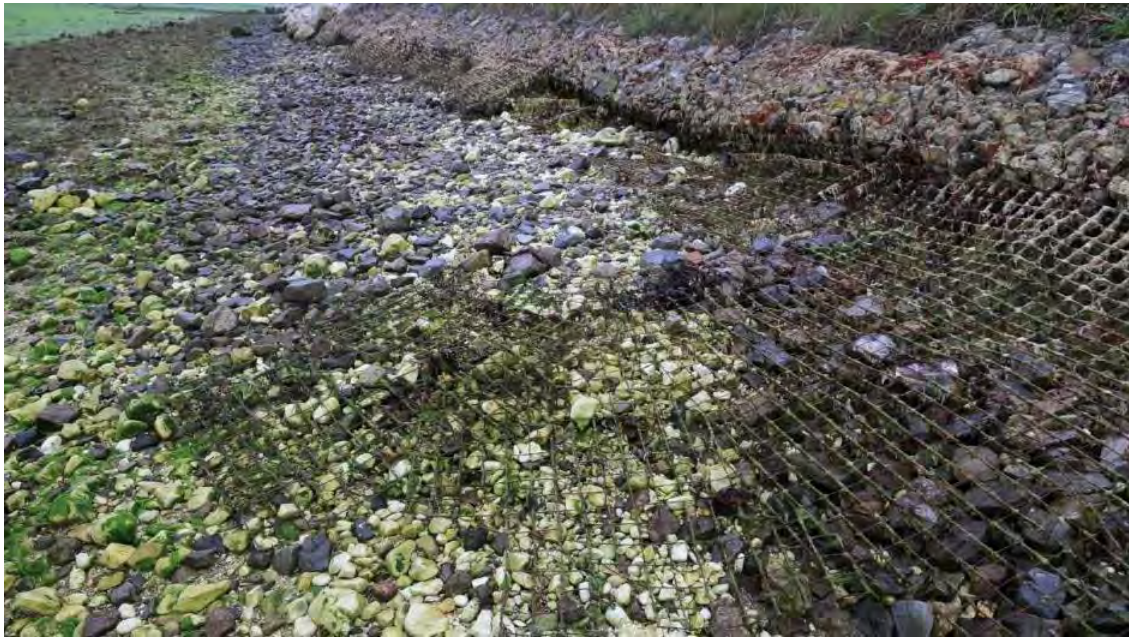
<p>The stability and linkages between adjacent baskets:</p> <p>As the fill has been washed away from the lower baskets this is leaving the upper baskets unsupported. Large gaps at the top of the baskets were evident as the fill has shuffled down slope. This will reduce the support to the coastal footpath above.</p> <p>The baskets appear to be attached to each other with wire wrapped round the joins. This is quite loose in places (top section) and non-existent on some of the lower section.</p>

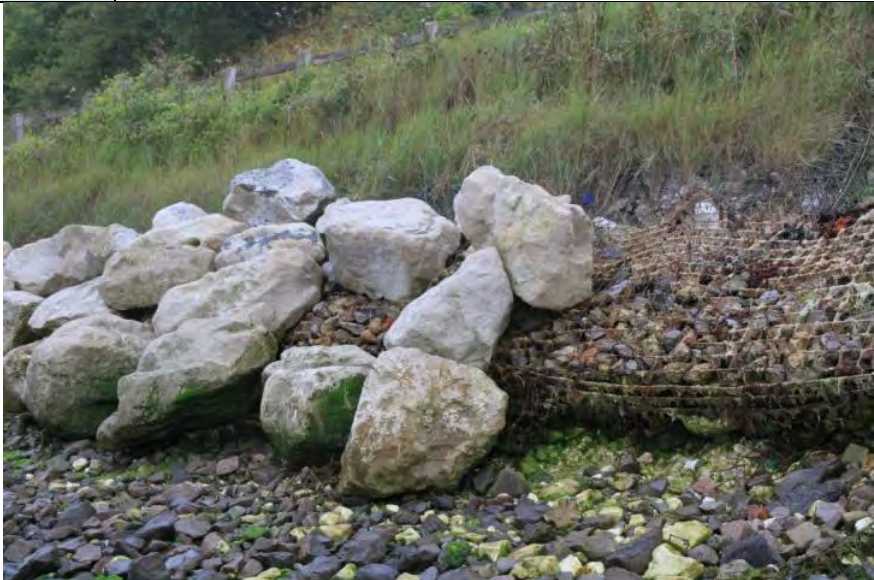
<p>At the end of this stretch of gabion revetments, the mesh is almost completely corroded and washed away. At this location a black geogrid has been placed on top of the mesh with armourstone built up on top.</p>

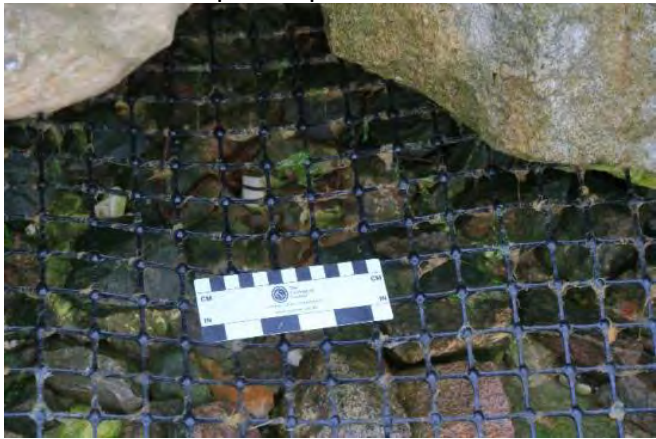
<p>The use of gabions, however the corrosion protection is affected, seems questionable in a marine environment.</p>

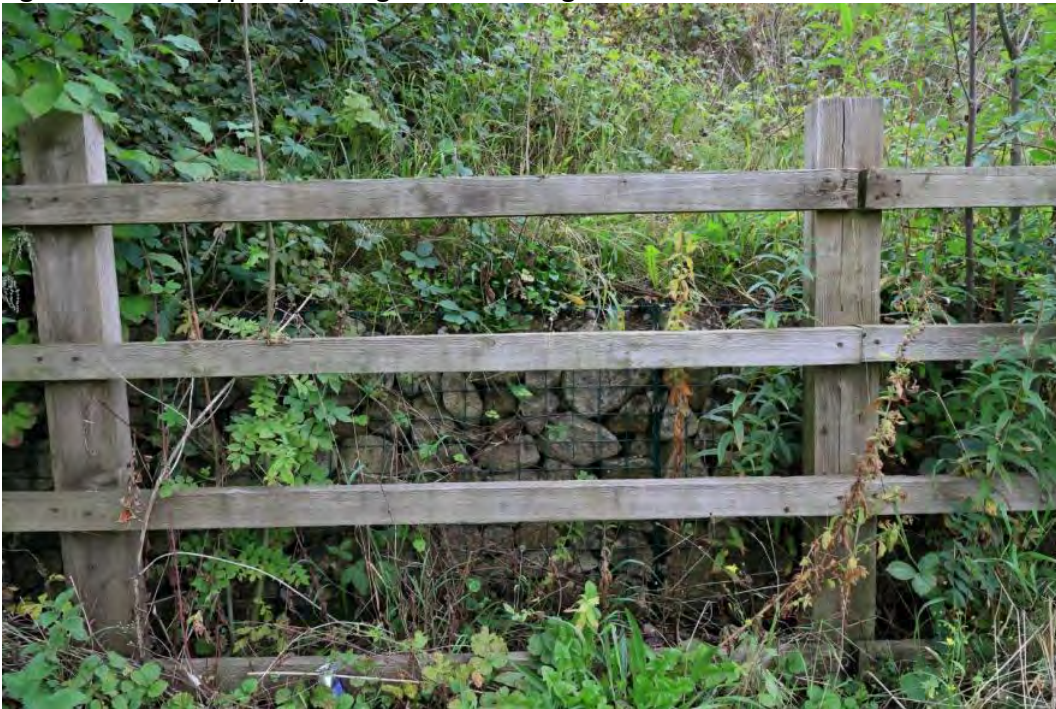
<p>Information pertaining to drainage / watercourses / salt spray: No drainage or watercourses were observed during the inspection. Assumed to be free draining. Possibly could be a toe drain present but heavily vegetated. No water was observed to be coming from the slope.</p>

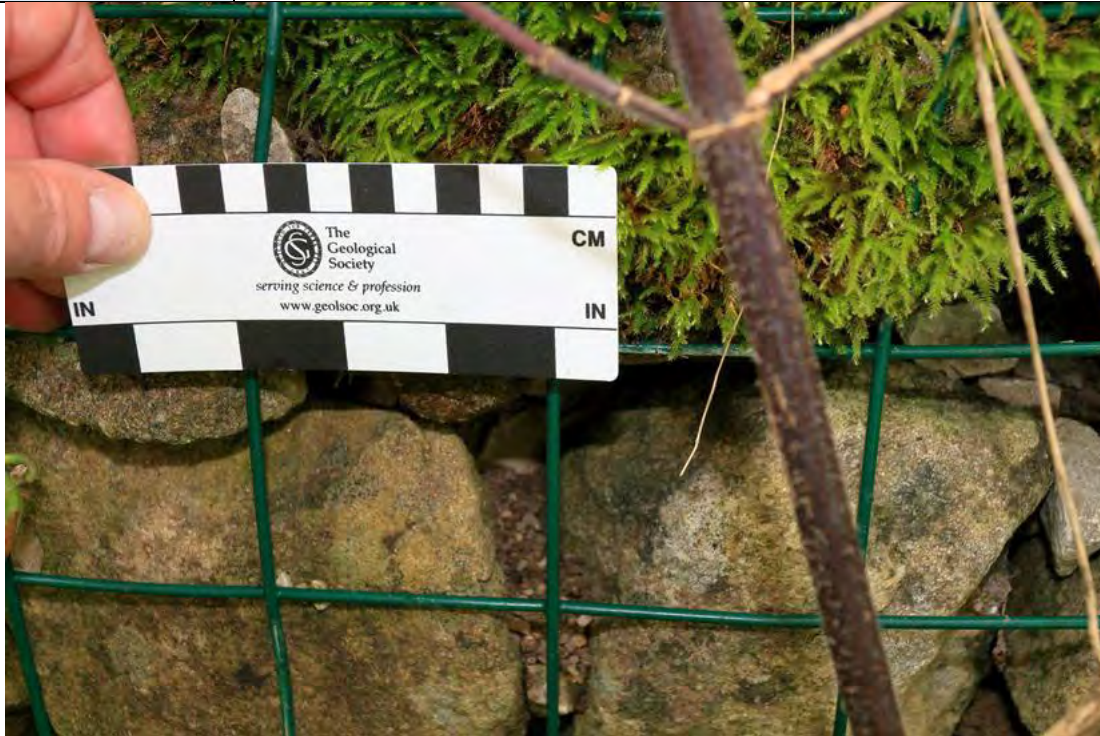
The stability and linkages between adjacent baskets:

The baskets were typically fastened (individually) with metal links along the top and at the sides. Adjacent baskets were tied together with plastic-coated green wire wrapped round the join between the two.

In some locations it was observed that the top of the basket had been tied to the top of the adjacent basket rather than its own side. The reason for this is unknown; however, this has led to voids being left within the fill (80mm to 100mm gaps at the top in some areas with the depth being unknown but clearly in excess of 300 to 400mm).

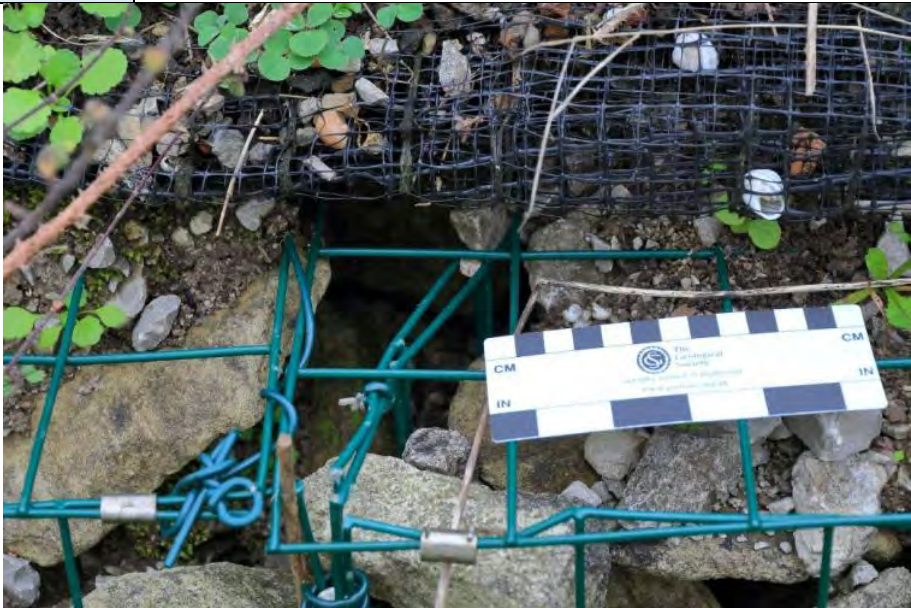
<p>The stability of the individual elements (gabions) e.g. damage and distortion of baskets:</p> <p>The baskets are distorted in localised areas. No breakages of the baskets were observed.</p>	
<p>Additional Comments:</p> <p>Black small aperture geogrid was observed above the gabion wall in localised areas (see previous photo). This appeared to be either a multi-layered geogrid or it was rolled up. It is unknown if this is related to the stability of the slope above from the original construction or if it could have been installed to assist with vegetation regrowth.</p>

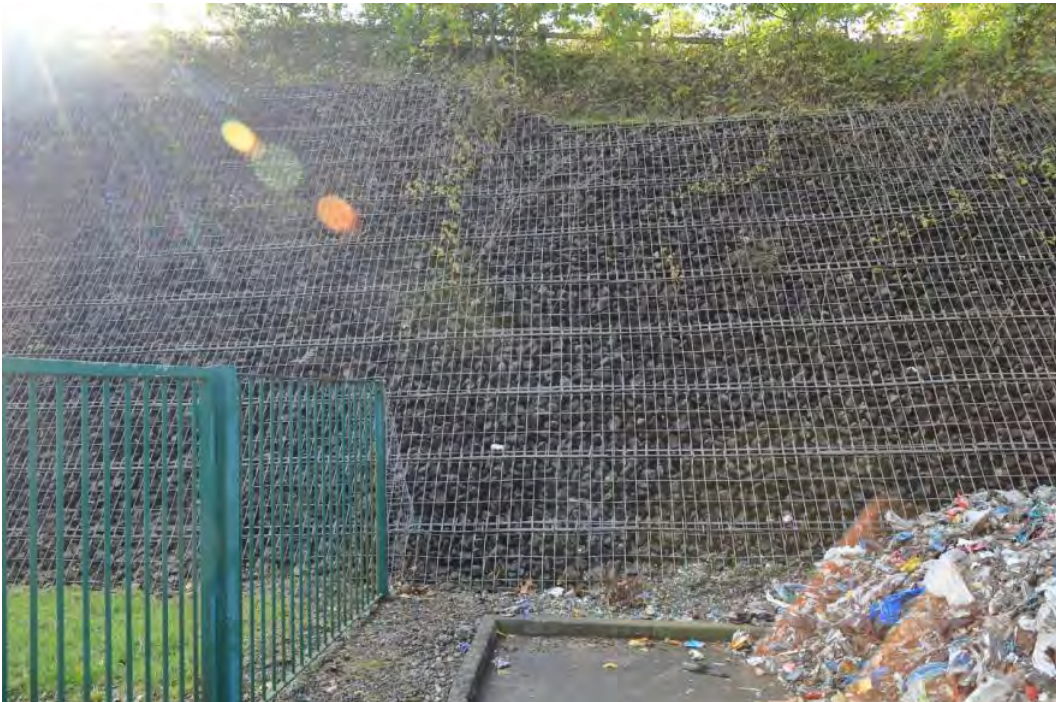
Task 1-1109: SGMs Phase 2	
Gabion Wall Proforma	
Area / SGM ID:	Area 10 / 7066
Location	E 382432, N 390873
SGM Type:	Gabion Wall
Date:	5 th October 2020
Weather:	Dry
Attending site:	Michelle Duffy-Turner (Coffey) & Mike Winter (Winter Associates)
Equipment Used:	Tape measure, distomat, compass clinometer, camera and notebook
Description:	Strengthened slope approximately 4.5m high at 60° comprising rock fill with a mesh facing.
<p>The setting and location of the wall, in particular relative to the carriageway: On the bridge embankment of the Eastbound carriageway of the M60 as it goes over the Princess Parkway at Junction 5. The earthwork can be accessed via the maintenance area off Princess Parkway. This is also the access to a United Utilities site and approximately 50% of the wall was not accessible as it was behind a locked fence in the United Utilities maintenance area. Fly tipping is present in the area. The SGM varies between 3.7m and 4.5m high (the highest section is in the fenced off part) and is at approximately 60°.</p>

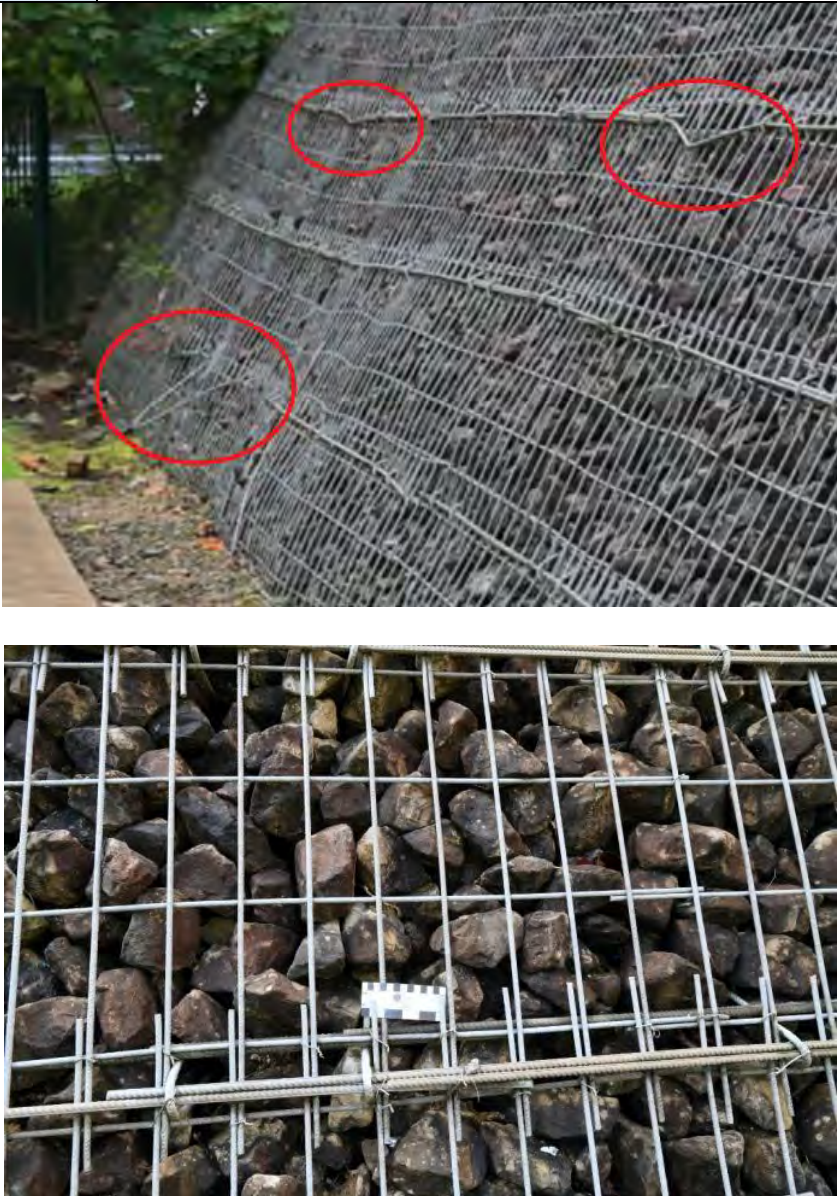
Task 1-1109: SGMs Phase 2	
Gabion Wall Proforma	
Area / SGM ID:	Area 10 / 7066
Location	E 382432, N 390873
SGM Type:	Gabion Wall
Date:	5 th October 2020
Weather:	Dry
Attending site:	Michelle Duffy-Turner (Coffey) & Mike Winter (Winter Associates)
Equipment Used:	Tape measure, distomat, compass clinometer, camera and notebook
Description:	Strengthened slope approximately 4.5m high at 60° comprising rock fill with a mesh facing.
The stability and linkages between adjacent baskets: Not applicable as no baskets; however, linkages between mesh manels appear to be typically satisfactory with the exception of the bent horizontal bars in the United Utilities section of the SGM. There was evidence observed of the slope failing behind the bars which indicates that it may be damage caused by external factors (albeit that close inspection was not possible). This highlights a vulnerability of the system to these accessible components.

The stability of the individual elements (gabions) e.g. damage and distortion of baskets: No obvious distortion of the mesh – the slope appears to be uniform.	
Additional Comments: None

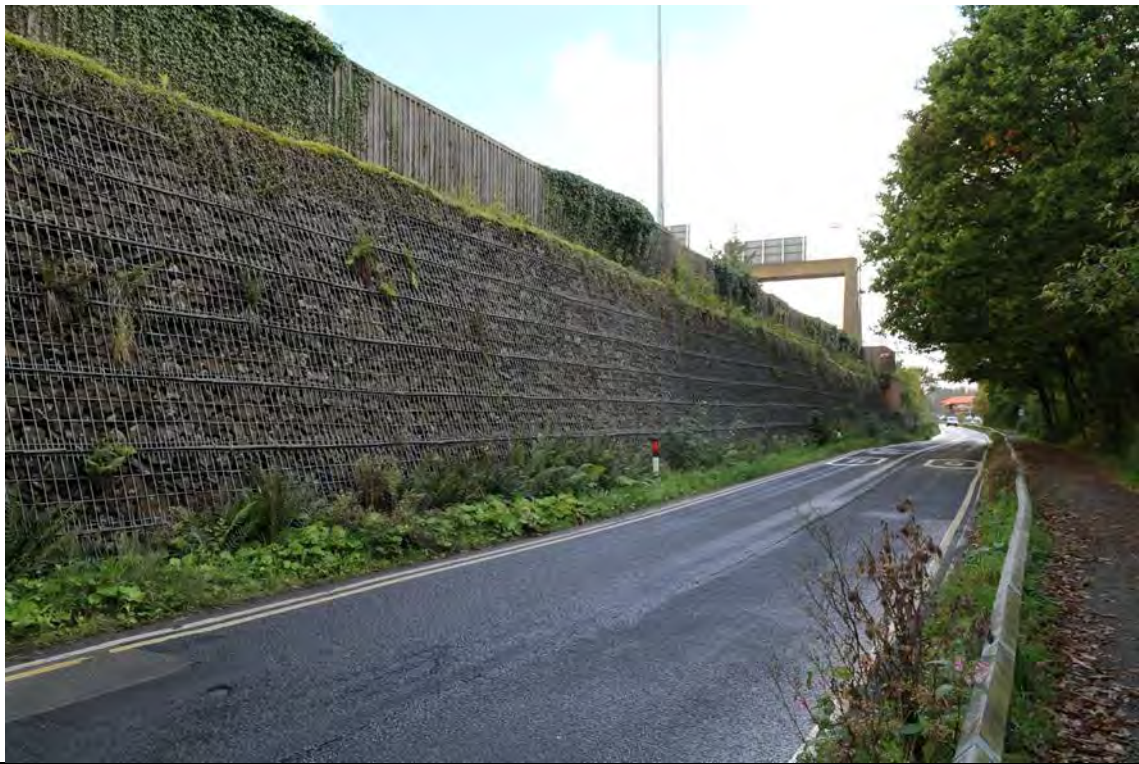
Task 1-1109: SGMs Phase 2	
Gabion Wall Proforma	
Area / SGM ID:	Area 10 / 7038
Location	E 380474, N 392493
SGM Type:	Gabion Wall
Date:	5 th October 2020
Weather:	Dry
Attending site:	Michelle Duffy-Turner (Coffey) & Mike Winter (Winter Associates)
Equipment Used:	Tape measure, distomat, compass clinometer, camera and notebook
Description:	Strengthened slope approximately 5m high at 60° comprising rock fill with a mesh facing.
<p>The setting and location of the wall, in particular relative to the carriageway: On the embankment slope of the M60 Junction 6 off-slip Eastbound. The mesh covers the majority of the embankment with a small (approx. 0.5m high) part of the slope at the crest vegetated.</p> <p>The earthwork can be accessed via the access road to Sale Water Park.</p>

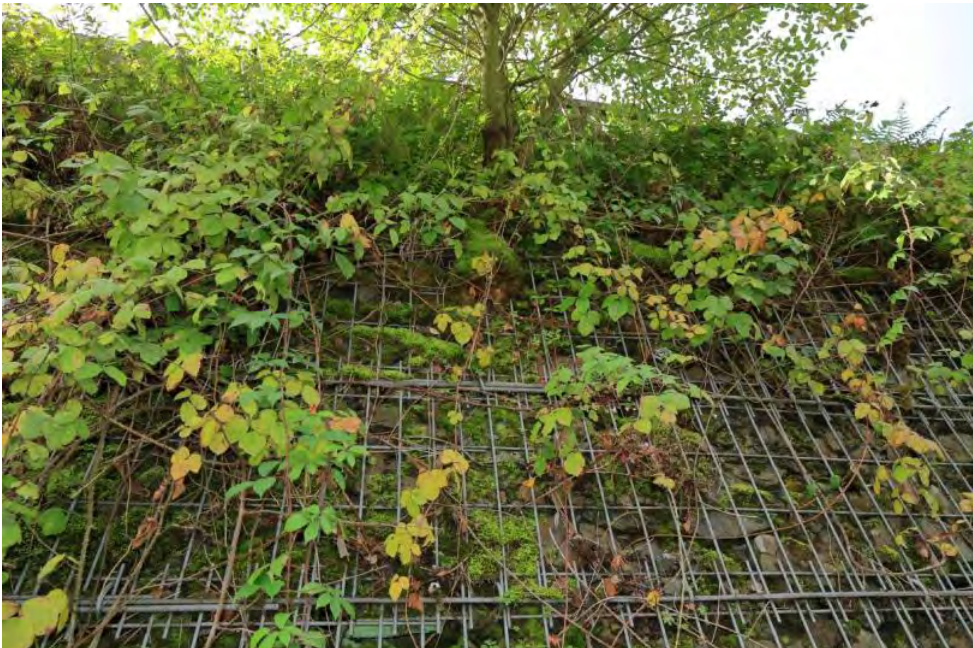
Task 1-1109: SGMs Phase 2	
Gabion Wall Proforma	
Area / SGM ID:	Area 10 / 7038
Location	E 380474, N 392493
SGM Type:	Gabion Wall
Date:	5 th October 2020
Weather:	Dry
Attending site:	Michelle Duffy-Turner (Coffey) & Mike Winter (Winter Associates)
Equipment Used:	Tape measure, distomat, compass clinometer, camera and notebook
Description:	Strengthened slope approximately 5m high at 60° comprising rock fill with a mesh facing.
Salt spray will be limited by the position of the slope below the road and the fence at the crest.	
Condition and type of foundation: Foundations not observed.	
The condition of the retained slope where visible: Retained slope not visible behind the SGM. The top 1m of the mesh was observed to be overhanging (leaning outwards) in localised areas which appears to be typically associated with the growth of tree roots behind it.

Task 1-1109: SGMs Phase 2	
Gabion Wall Proforma	
Area / SGM ID:	Area 10 / 7038
Location	E 380474, N 392493
SGM Type:	Gabion Wall
Date:	5 th October 2020
Weather:	Dry
Attending site:	Michelle Duffy-Turner (Coffey) & Mike Winter (Winter Associates)
Equipment Used:	Tape measure, distomat, compass clinometer, camera and notebook
Description:	Strengthened slope approximately 5m high at 60° comprising rock fill with a mesh facing.
<p>The condition of the elements (gabions), including but not limited to gabion basket wire damage and/or repairs, gabion basket wire corrosion protection (galvanising and/or plastic), gabion fill (including suitability and deterioration):</p> <p>The structure comprises 9mm welded mesh with an aperture of 100mm across and 200mm high. The mesh is reinforced with 12mm horizontal bars and 12mm pins. Pins are irregularly spaced – measurements of spacings taken over a localised section include 450mm, 250, 550, 900, 400, 800, 400, 300, 500 and 1000mm.</p> <p>Mesh, horizontal bars and pins are galvanized and appear to be in good condition with no signs of corrosion. Occasional staining/deformation of the mesh was observed.</p> <p>The fill behind the mesh comprises a shaley material which is badly weathered quite across the length of the SGM. The fill varies in size from 10mm up to 400mm. The mesh comprises 7 to 8 rows (each row 0.7m high) and the degree of weathering of the fill was different in each row. The most weathered area appeared to be the 4th row consistently along the length of the SGM (approximately 2 to 3m above road surface). The best quality fill appeared to be just below this in the 3rd row. This may indicate that the fill was in a weathered state prior to placement.</p> <p>At the top of the mesh there were gaps observed up to 100mm in places. It is assumed this is due to the weathering of the fill below causing settlement within the structure.</p>

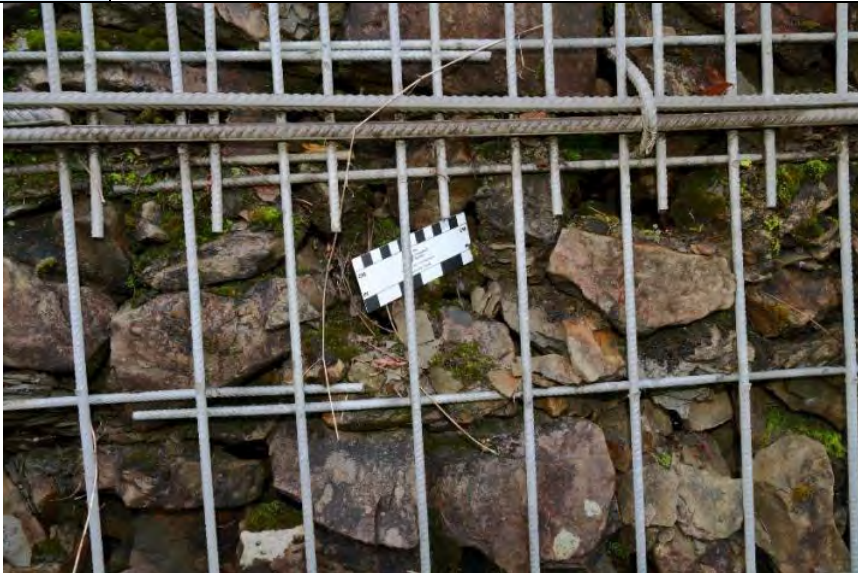
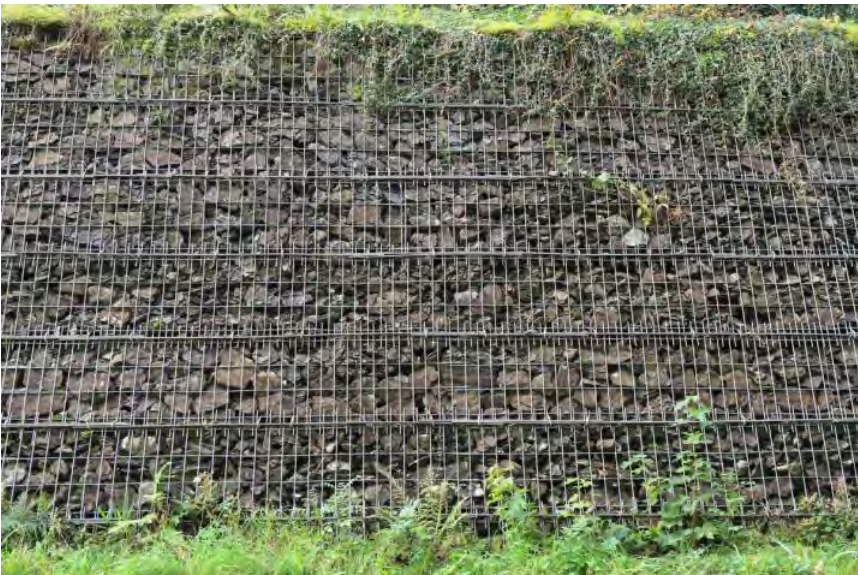
Task 1-1109: SGMs Phase 2	
Gabion Wall Proforma	
Area / SGM ID:	Area 10 / 7038
Location	E 380474, N 392493
SGM Type:	Gabion Wall
Date:	5 th October 2020
Weather:	Dry
Attending site:	Michelle Duffy-Turner (Coffey) & Mike Winter (Winter Associates)
Equipment Used:	Tape measure, distomat, compass clinometer, camera and notebook
Description:	Strengthened slope approximately 5m high at 60° comprising rock fill with a mesh facing.
The stability and linkages between adjacent baskets: Not applicable as no baskets; however, linkages between mesh manels appear to be satisfactory.	
The stability of the individual elements (gabions) e.g. damage and distortion of baskets: The top 1m was observed to be overhanging in places as the mesh was being distorted by tree roots and vegetation growth at the crest. A horizontal sinuosity was observed along the length of the SGM.	
Additional Comments: The SGM is assumed to be free draining due to the coarse fill; however, as more of the fill weathers it may create some impermeable sections which may prevent free draining of any water from the slope. In addition, further internal settlement would be expected as weathering occurs.

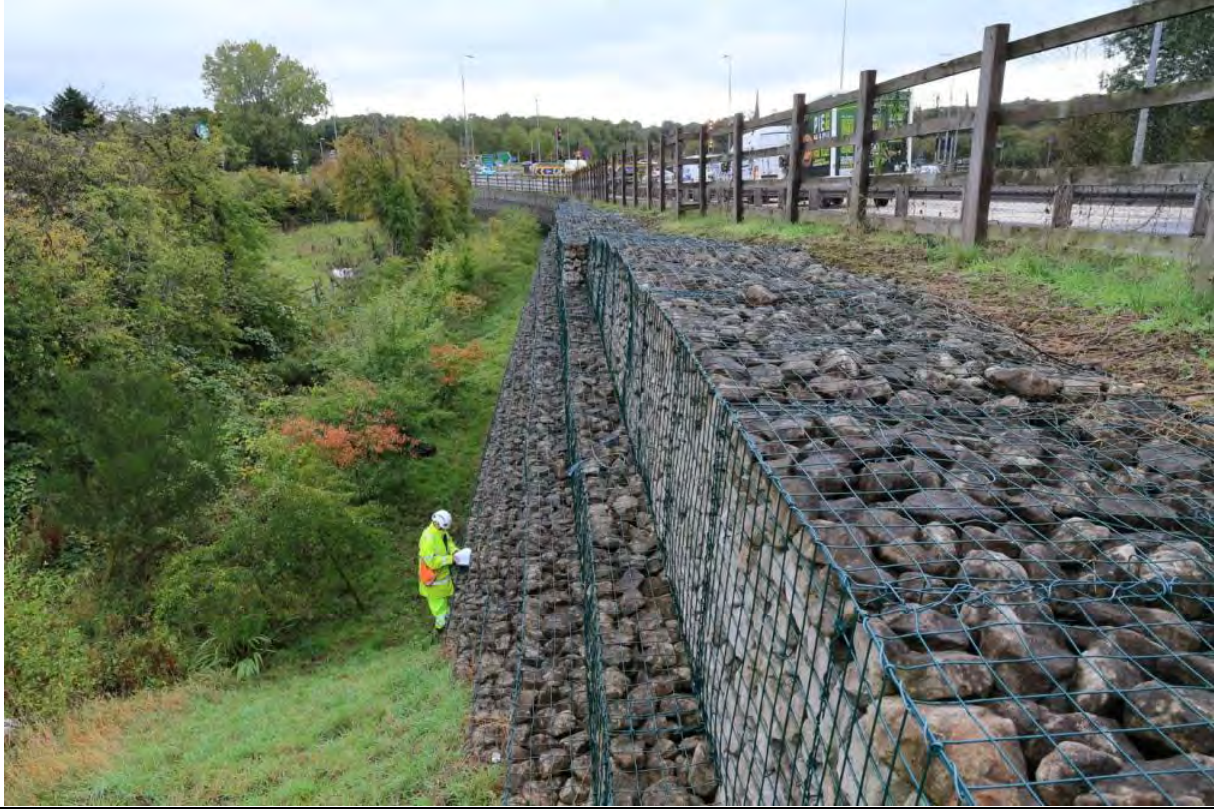
Task 1-1109: SGMs Phase 2	
Gabion Wall Proforma	
Area / SGM ID:	Area 7 / 7630 (structure ID A38/450.1)
Location	E 436275, N 340007
SGM Type:	Gabion Wall
Date:	6 th October 2020
Weather:	Dry
Attending site:	Michelle Duffy-Turner (Coffey) & Mike Winter (Winter Associates)
Equipment Used:	Tape measure, distomat, compass clinometer, camera and notebook
Description:	Gabion wall up to 6m high along the A38.
<p>The setting and location of the wall, in particular relative to the carriageway: The gabion wall is located on the A38 eastbound embankment at the approach to the Little Eaton roundabout. The gabion wall is approximately 2.75m high at the eastern extents and 6m high at the west.</p>

<p>Information pertaining to drainage / watercourses / salt spray: No drainage or watercourses were observed during the inspection. Assumed to be free draining. No water was observed to be coming from the slope; however, the ground at the toe was wet in places.</p>

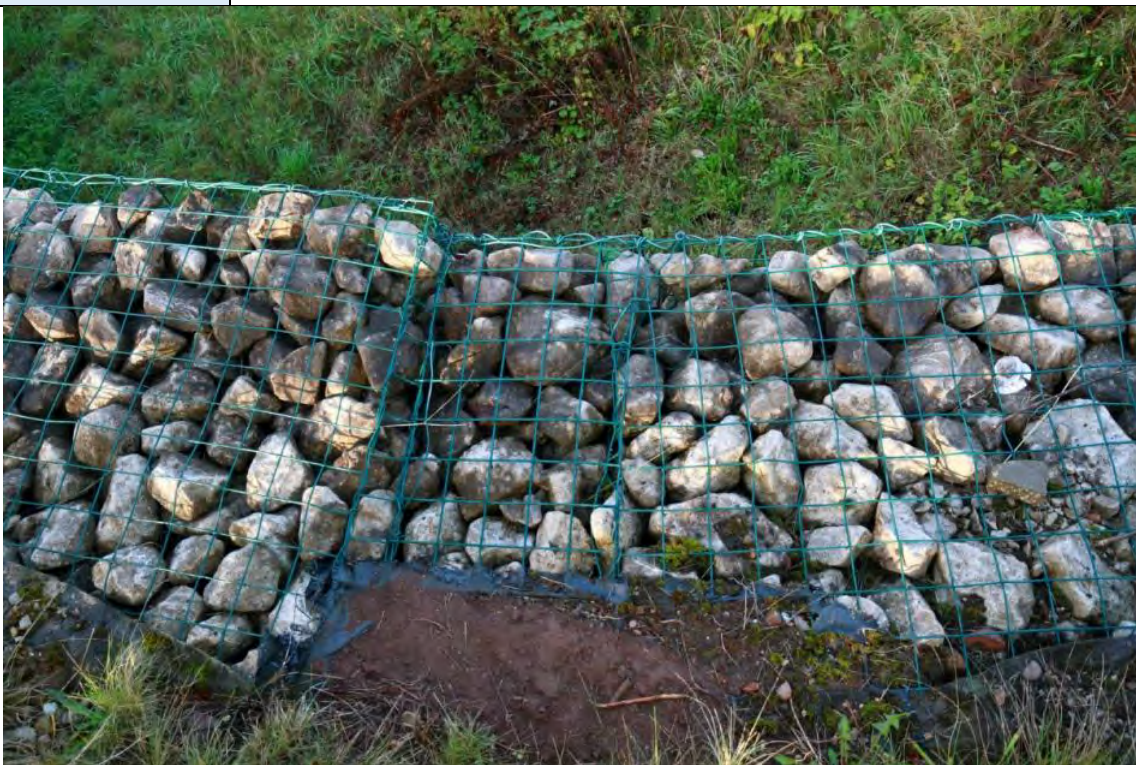
<p>The gabions have been filled very neatly by hand (at least the front face) and the fill comprises a clean, hard limestone which has not undergone any significant weathering.</p> <p>Due to the bespoke nature of the gabions it would be difficult to replace an individual basket. It would require whole sections to be removed and replaced.</p> <p>The stability and linkages between adjacent baskets:</p> <p>The gabions are not baskets as such, and instead have been constructed in situ with overlaps and joints along the horizontal and vertical planes with significant overlaps in places.</p>
