PUBLISHED PROJECT REPORT PPR1032

Forensic Examination of Critical Special Geotechnical Measures

M Duffy-Turner (Coffey Geotechnics Ltd), M G Winter (Winter Associates Limited), I M Nettleton (Coffey Geotechnics Ltd) and G Butler (Coffey Geotechnics Ltd)

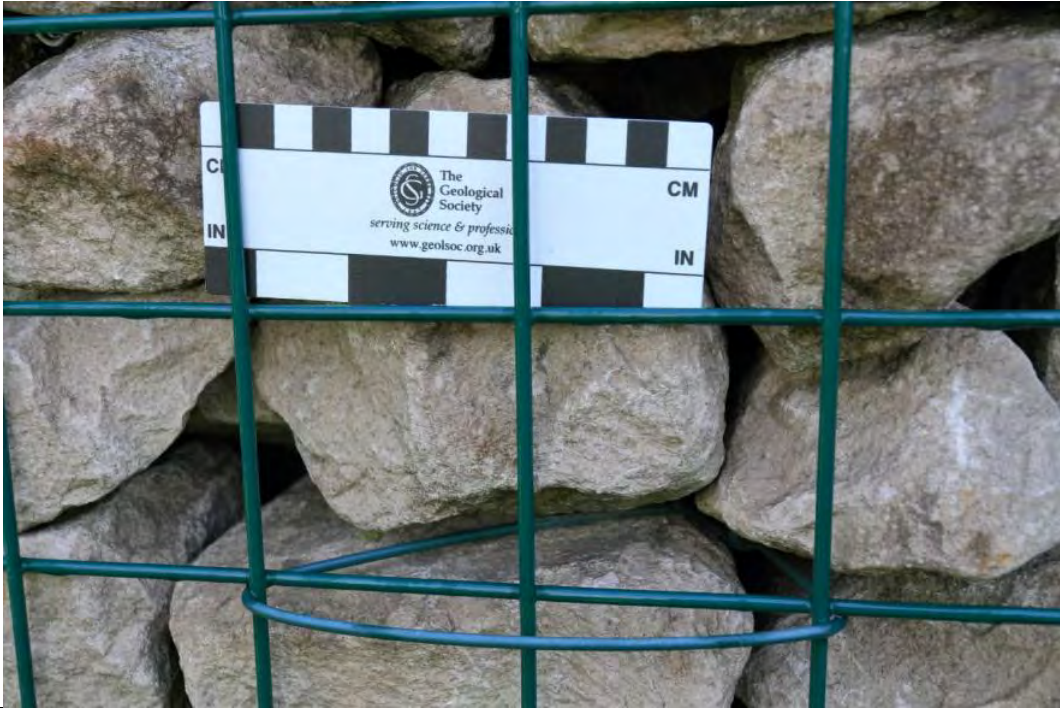
Task 1-1109: SGMs Phase 2	
Gabion Wall Proforma	
Area / SGM ID:	Area 7 / 7630 (structure ID A38/450.1)
Location	E 436275, N 340007
SGM Type:	Gabion Wall
Date:	6 th October 2020
Weather:	Dry
Attending site:	Michelle Duffy-Turner (Coffey) & Mike Winter (Winter Associates)
Equipment Used:	Tape measure, distomat, compass clinometer, camera and notebook
Description:	Gabion wall up to 6m high along the A38.
<p>The adjacent gabion baskets (or insitu mesh) were tied together with plastic-coated green wire wrapped round the join between the two. This is also how the individual baskets themselves are tied together.</p> <p>The rows of the gabions (vertically) are attached with spenax clips every 4th aperture.</p> <p>Additional tie-back reinforcement was visible and is presumed to have been used to limit basket distortion during filling and construction.</p>

<p>The stability of the individual elements (gabions) e.g. damage and distortion of baskets: No distortion of or damage to the baskets or mesh was observed.</p>

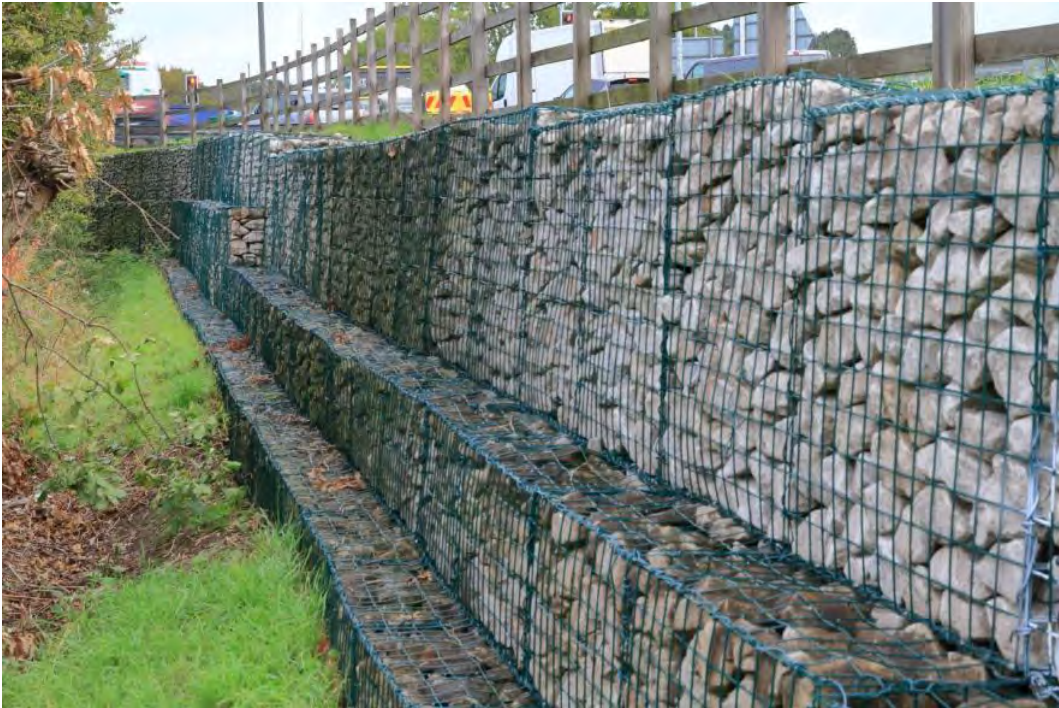
Task 1-1109: SGMs Phase 2	
Gabion Wall Proforma	
Area / SGM ID:	Area 7 / 7761
Location	E 436386, N 339922
SGM Type:	Gabion Wall
Date:	6 th October 2020
Weather:	Dry
Attending site:	Michelle Duffy-Turner (Coffey) & Mike Winter (Winter Associates)
Equipment Used:	Tape measure, distomat, compass clinometer, camera and notebook
Description:	Gabion wall up to 2m high along the A61.
<p>The setting and location of the wall, in particular relative to the carriageway: The gabion wall is located on the A61 northbound embankment at the approach to the Little Eaton roundabout. The gabion wall is approximately 2m high.</p>

<p>Information pertaining to drainage / watercourses / salt spray: No drainage or watercourses were observed during the inspection. Assumed to be free draining. No water was observed to be coming from the slope.</p>	
<p>Condition and type of foundation: The gabion baskets were embedded into the ground, possibly up to 0.5m.</p>

<p>The condition of the retained slope where visible: The gabion wall is the full height of the carriageway. No issues observed.</p>

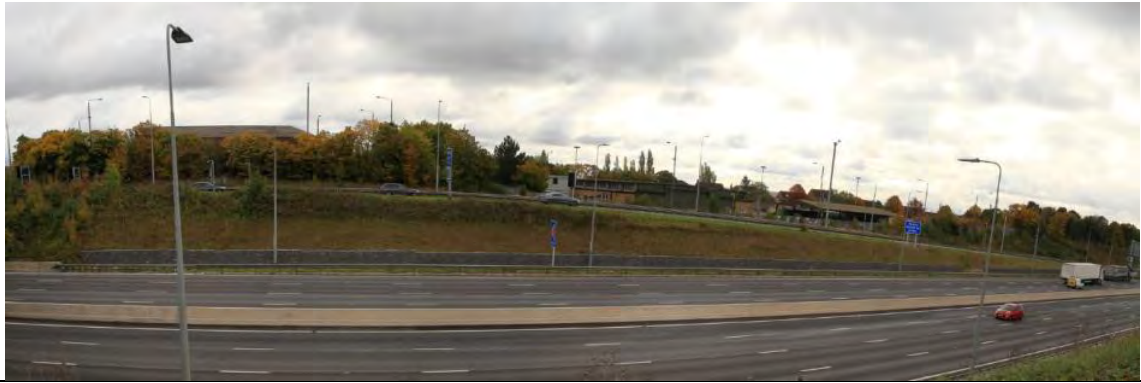
<p>Information pertaining to drainage / watercourses / salt spray: No drainage or watercourses were observed during the inspection. Assumed to be free draining. It is likely that the wall will be subject to lots of vehicle spray as it is adjacent to Lane 1 of the M1 motorway.</p>

<p>Condition and type of foundation: The gabion baskets appear to be embedded into the ground by approx. 0.5m (assuming the bottom row is a 1m high gabion basket).</p>	
<p>The condition of the retained slope where visible: The slope above the gabion wall appears to be satisfactory and is not showing any adverse slope stability issues.</p>

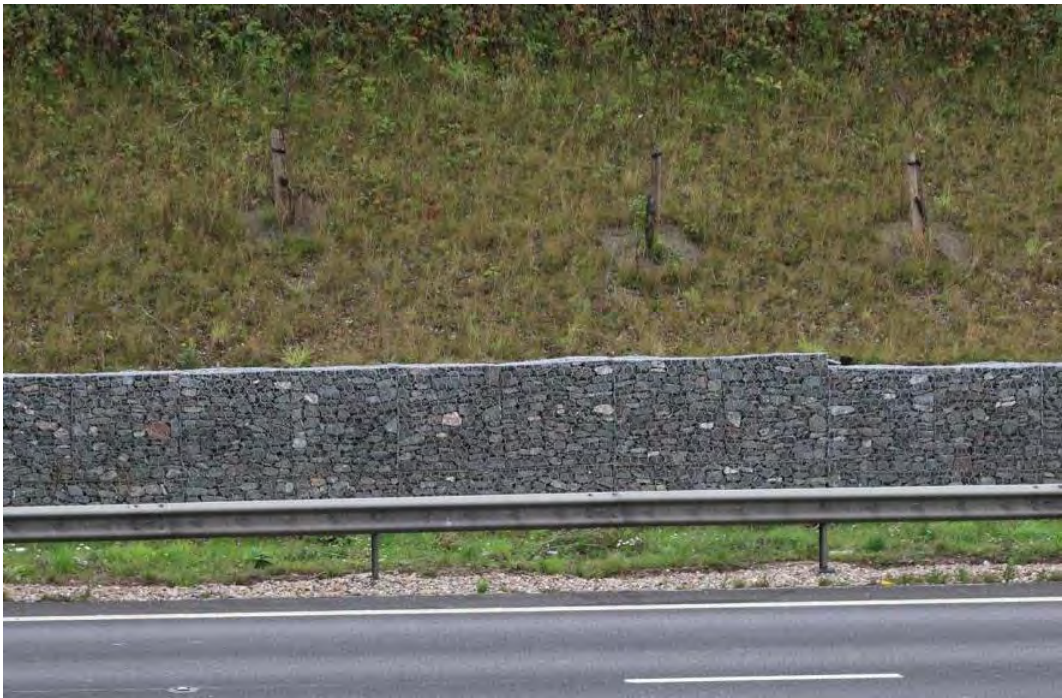
<p>The stability and linkages between adjacent baskets:</p> <p>Linkages unknown. Stability appears satisfactory.</p>	
<p>The stability of the individual elements (gabions) e.g. damage and distortion of baskets:</p> <p>No distortion of the baskets was observed.</p>

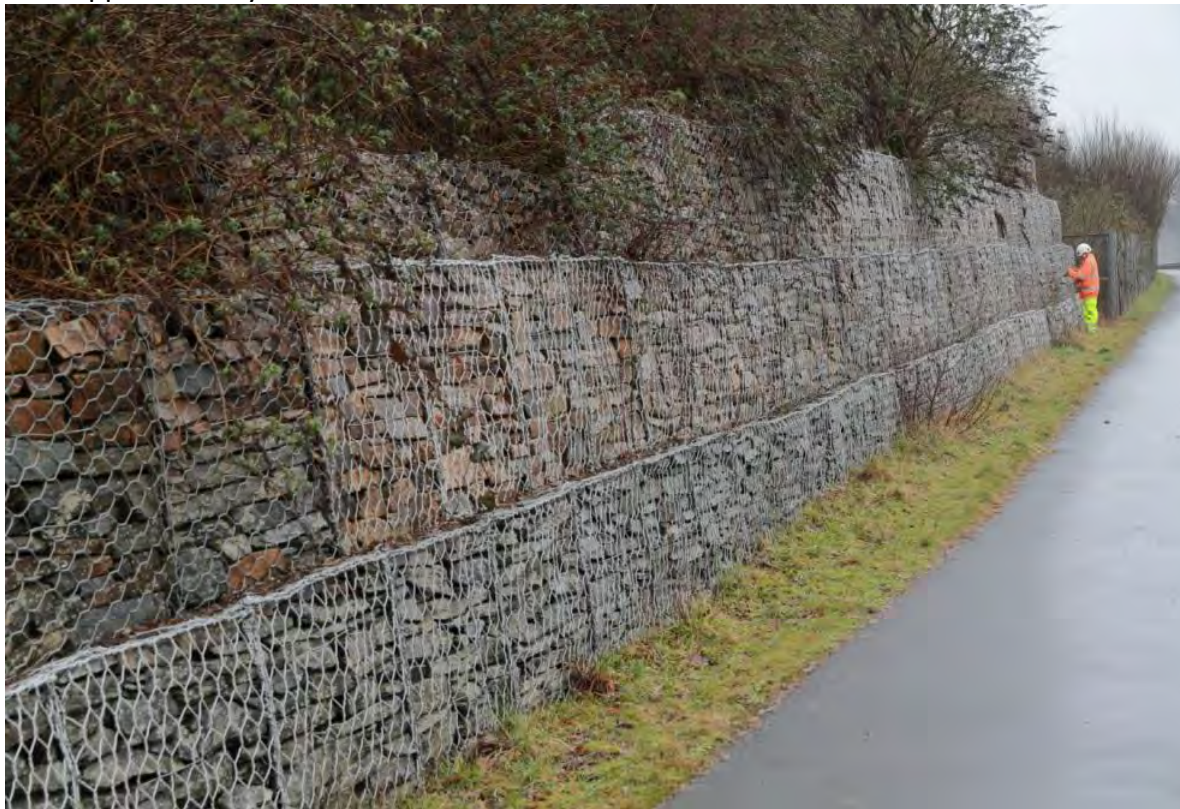
Task 1-1109: SGMs Phase 2	
Gabion Wall Proforma	
Area / SGM ID:	Area SW / 10862
Location	E 223331, N 64669
SGM Type:	Gabion Wall
Date:	27 th January 2021
Weather:	Dry
Attending site:	Michelle Duffy-Turner (Coffey) & Mike Winter (Winter Associates)
Equipment Used:	Tape measure, distomat, compass clinometer, camera and notebook
Description:	Gabion wall up to 3.5m high along the cutting of the A38
<p>The setting and location of the wall, in particular relative to the carriageway: The gabion wall is located in front of a rock cutting along the eastbound carriageway of the A38 to the west of Liskeard. It is approximately 3.5m high (above ground) and likely to be founded 0.5m into the ground. There are 4 rows of gabions with each row steeped back approximately 0.15m.</p>

<p>Information pertaining to drainage / watercourses / salt spray: There was no drainage associated with the gabion wall and it is assumed to be free draining.</p>

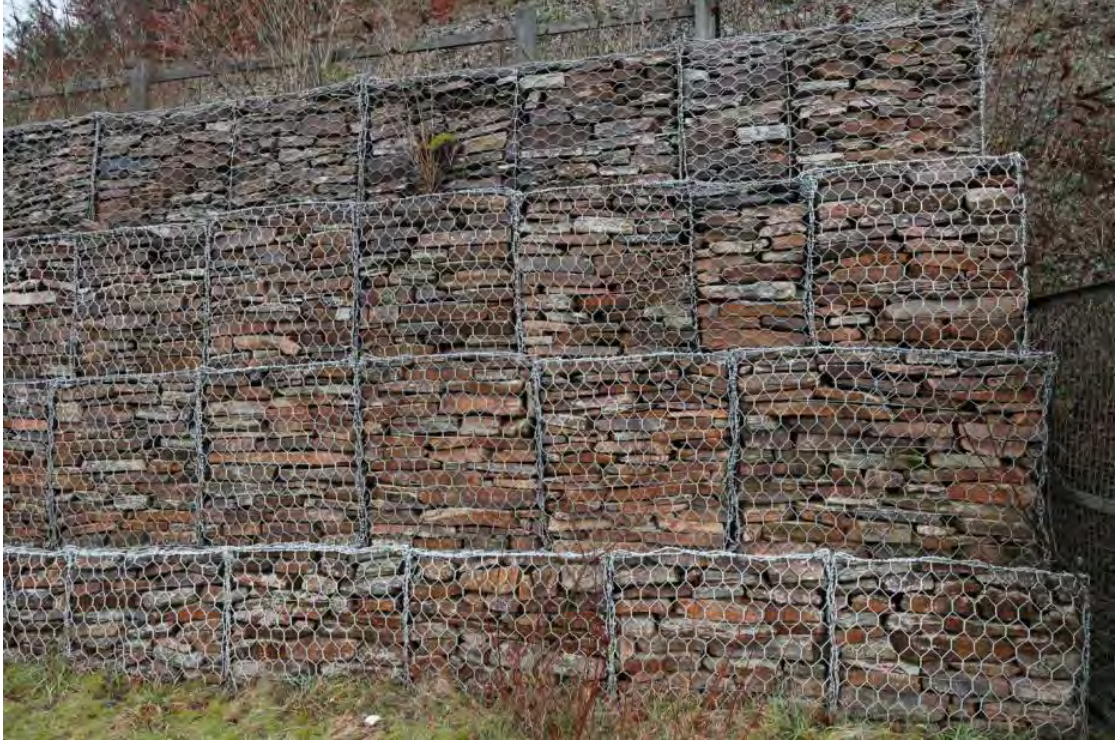
The stability and linkages between adjacent baskets: The finish of the gabion walls is very neat with the baskets joined with either spenax clips or wrapped wire.	
The stability of the individual elements (gabions) e.g. damage and distortion of baskets: No damage or distortion to the gabion baskets were observed. There were tie backs present within the fill to help stabilise the face.	
Additional Comments: None

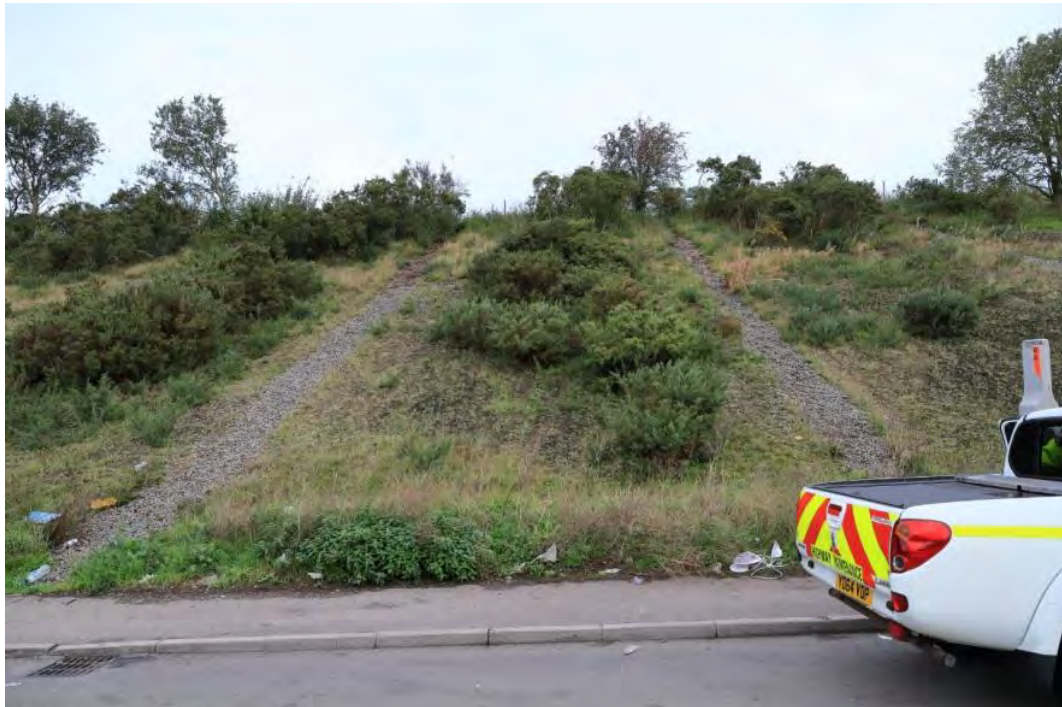
The counterfort drains are located along a cutting on the A14. At the toe of the cutting is a layby which was used to access the SGMs.

The slope is approximately 30m long (crest to toe) and at 25°.

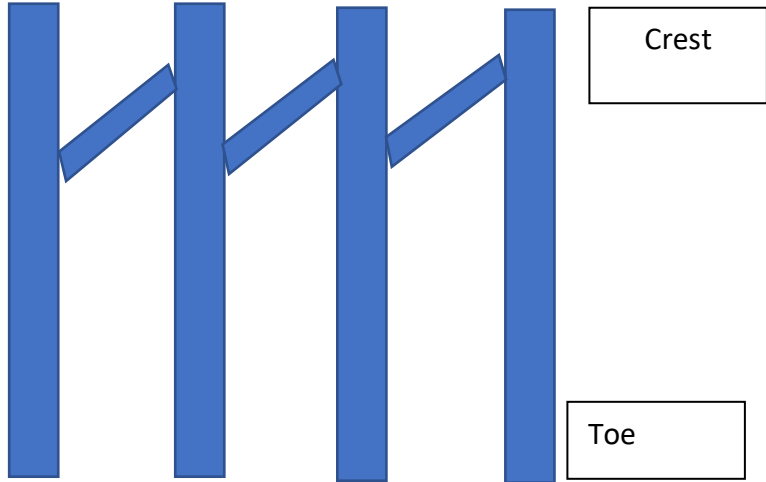
<p>The stone used in the drains (visible at surface) was an angular granite and varied in size between 20mm to 60mm (avg 40mm). A manhole was observed at the crest of one of the counterforts (not observed on any of the others). Adjacent to this same counterfort (just upslope of where the western herringbone joined), a white 100mm diameter PVC pipe was observed protruding through the ground surface. At the toe of this counterfort a manhole approx. 350mm x 800mm was adjacent to the emergency telephone. No other drainage at the toe was observed and it is considered likely that these manholes and pipe are connected to localised drainage from the field at the crest. A hole was opening up adjacent to the manhole at the crest (on the downslope side). It is likely this is from burrowing animals or potentially from water erosion. The field at the crest of the cutting is relatively flat and it appears that the majority of the field has a catchment away from the cutting to the north west.</p>

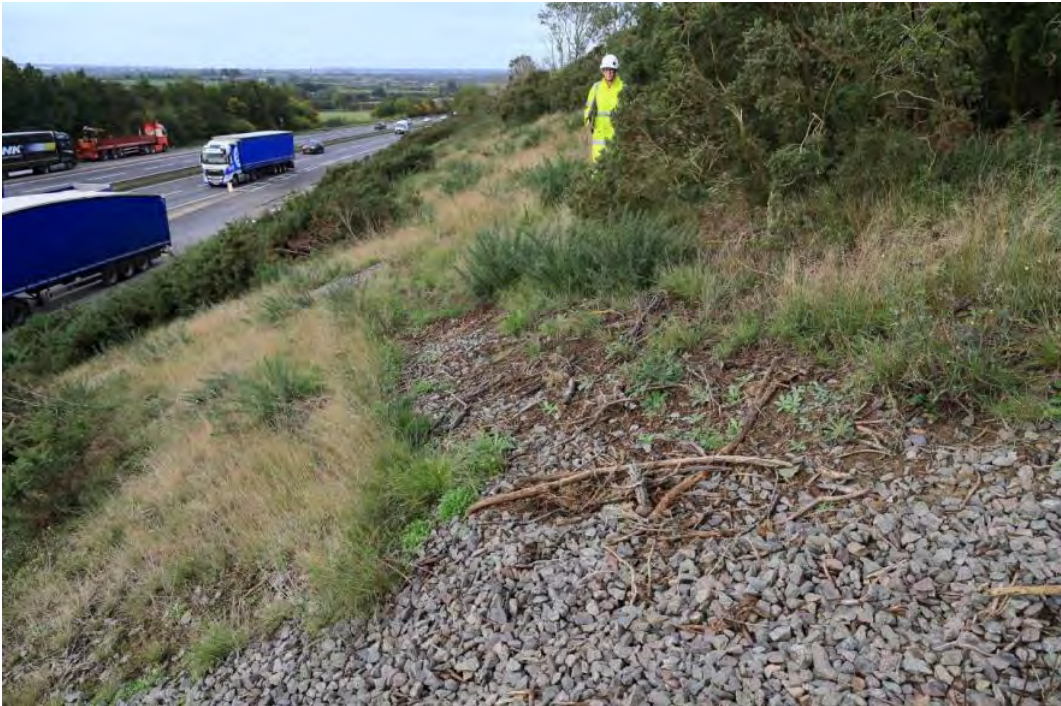
Task 1-1109: SGMs Phase 2	
Counterfort Drain Proforma	
Area / SGM ID:	Area 7 / NA (not recorded as an SGM)
Location / NGR:	E 462408, N 277609
SGM Type:	Counterfort Drains
Date:	7 th October 2020
Weather:	Dry
Attending site:	Michelle Duffy-Turner (Coffey Geotechnics) and Mike Winter (Winter Associates)
Equipment Used:	Tape measure, distomat, compass clinometer, camera and notebook
Description:	Counterfort drains located along A14 cutting.
<p>The surface condition of the drains prior to excavation, including any distortion to the drain line, and the condition of any geosynthetic wrap and stone drainage media (type, deterioration, clogging/presence of fines):</p> <p>Excavation of the counterforts were not undertaken during the inspection.</p> <p>The slopes were typically vegetated with grass and low-lying vegetation with trees present towards the crest of the slope. In some locations it was observed that where the vegetation had been cut previously, the detritus had been left lying on top of the drains, effectively creating a barrier to water infiltration and possibly providing fine material to clog the drains.</p>

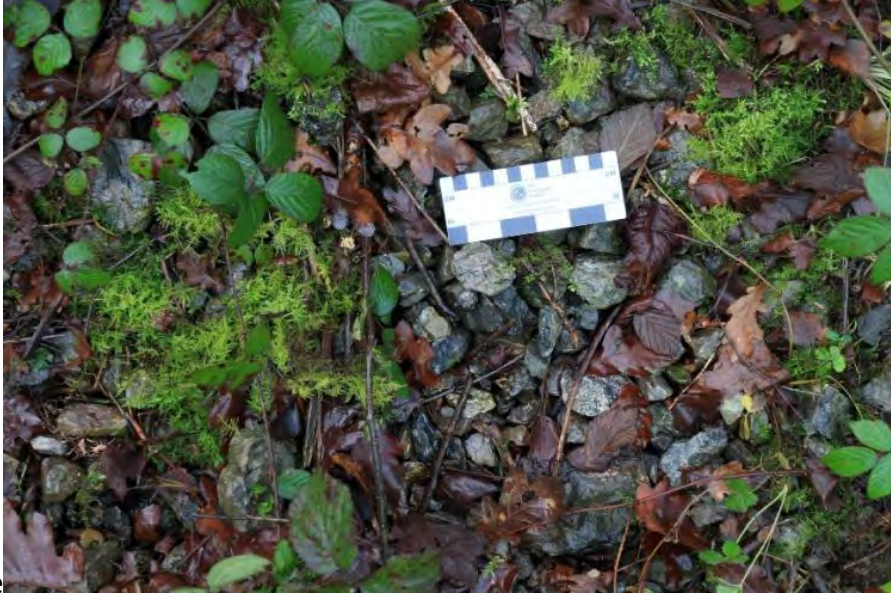
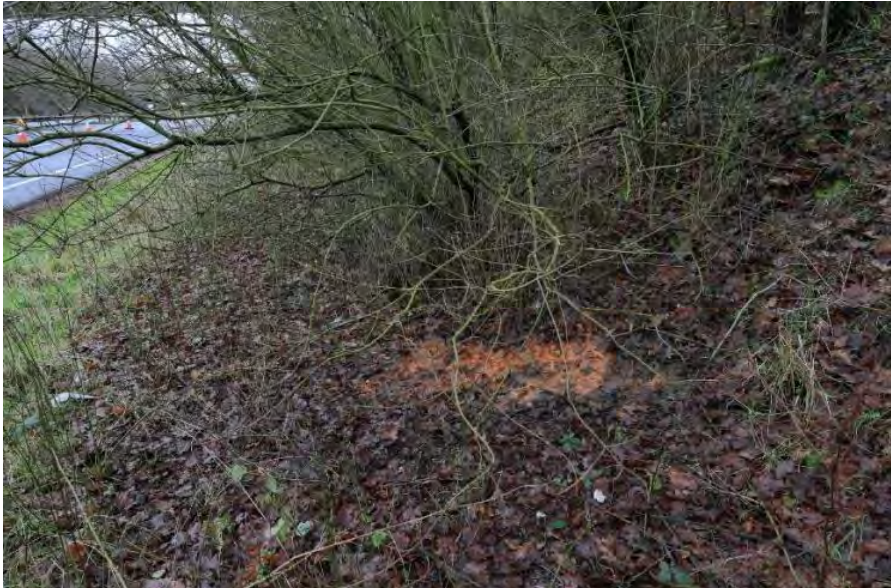
Task 1-1109: SGMs Phase 2	
Counterfort Drain Proforma	
Area / SGM ID:	Area SW / 1924
Location / NGR:	E 284326, N 93113
SGM Type:	Counterfort Drain
Date:	27 th January 2021
Weather:	Light Rain
Attending site:	Michelle Duffy-Turner (Coffey) & Mike Winter (Winter Associates)
Equipment Used:	Tape measure, distomat, compass clinometer, camera and notebook
Description:	Counterfort Drain site located in a cutting along the A30.
<p>The setting and location of the counterfort drains, in particular relative to the carriageway: The counterfort drains are located along the westbound cutting of the A30 to the west of Exeter. The site was accessed via the overbridge off Five Mill Hill Road.</p> <p>The slope is approximately 40m long (crest to toe) in the east of the site (adjacent to a bridge wingwall) and shallows towards the west. The slopes are approximately between 20° and 25° (becoming steeper towards the toe) and are heavily vegetated with trees and brambles making access difficult.</p> <p>Information pertaining to drainage / watercourses / outfalls: Only one counterfort was observed on the site which was located approximately 14m west of the bridge wingwall. This counterfort was 0.7m wide with some overspill to the counterfort edges. The depth of the counterfort is unknown. There were no other counterfort drains within a reasonable distance (we walked 30m+ to the west of the counterfort). Any additional counterforts present on the site would be acting as individual drains rather than a counterfort system.</p> <p>A drain was observed running across the slope approximately 2/3 of the way down the slope length. This was 1m wide by 0.5m high and had clay present in the base. The counterfort observed was located between this drain and the toe of the slope (i.e. not the full length of the slope).</p> <p>The stone used in the drains (visible at surface) was angular and varied in size between 20mm and 70mm (average 40mm to 50mm). The drain was observed to be covered with vegetation, but limited fines were observed (see photo below).</p> <p>A filter drain was present at the toe of the slope.</p> <p>Ponding was present approximately 50m to the west of the bridge wingwall. This was orange in colour indicating ferritic material (see photo below) and a spring at the base of the slope.</p>

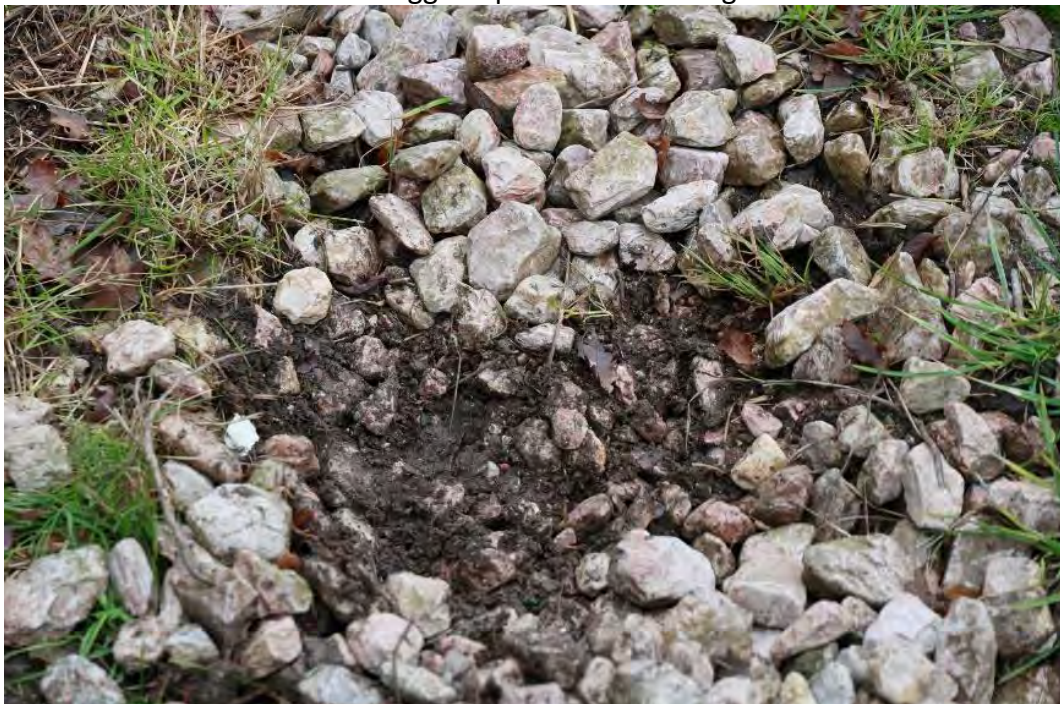
Task 1-1109: SGMs Phase 2	
Counterfort Drain Proforma	
Area / SGM ID:	Area SW / 2053
Location / NGR:	E 285307, N 92785
SGM Type:	Counterfort Drain
Date:	26 th January 2021
Weather:	Drizzly
Attending site:	Michelle Duffy-Turner (Coffey) & Mike Winter (Winter Associates)
Equipment Used:	Tape measure, distomat, compass clinometer, camera and notebook
Description:	Counterfort Drain site located in a cutting along the A30.
<p>The setting and location of the counterfort drains, in particular relative to the carriageway: The counterfort drains are located along the westbound cutting of the A30 to the west of Exeter. There is a layby immediately to the west of the site which was used to access the SGMs. The slope is approximately 30m long (crest to toe) in the east of the site (adjacent to a bridge wingwall) and shallows to ground level towards the layby in the west. The slopes are approximately 22° and are heavily vegetated with trees.</p> <p>Information pertaining to drainage / watercourses / outfalls: The counterforts are 1.2m wide and spaced every 20m. The depth of the counterforts is unknown. The stone used in the drains (visible at surface) was angular and varied in size between 30mm to 90mm (average 50mm to 60mm). Small amounts of flaky material were observed in the stone fill. The drains were observed to be clogged up with soil and vegetation.</p>

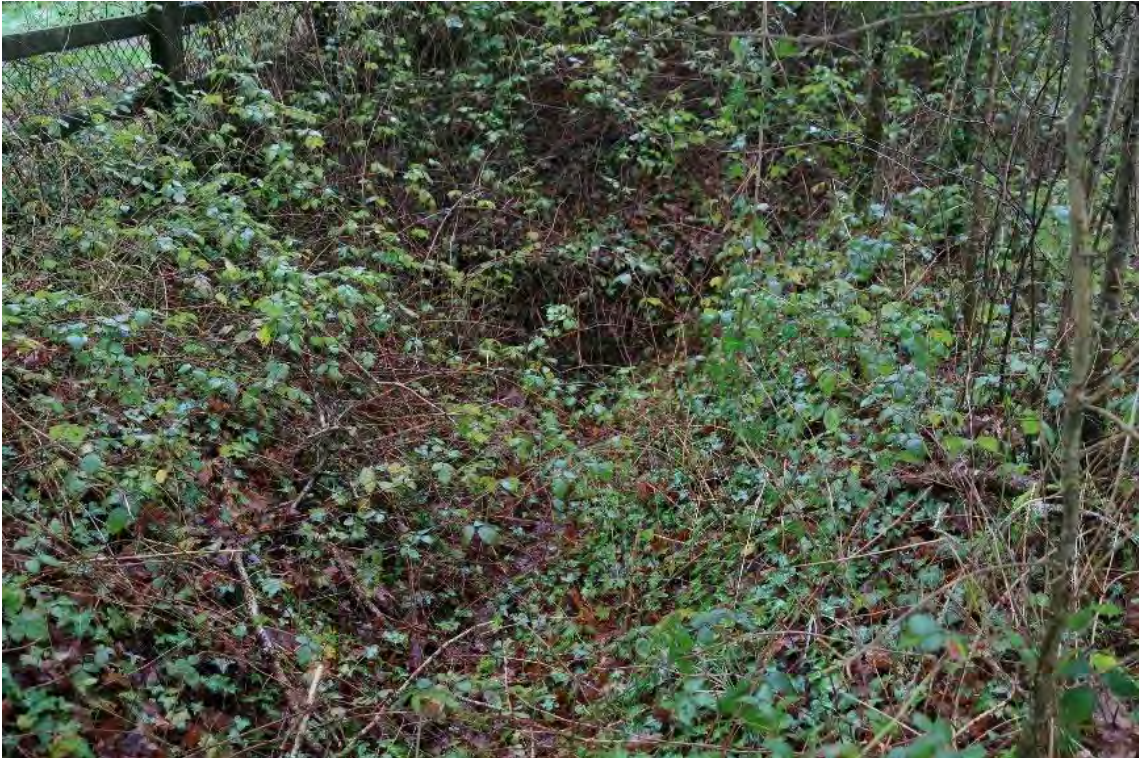
Task 1-1109: SGMs Phase 2	
Counterfort Drain Proforma	
Area / SGM ID:	Area SW / 2053
Location / NGR:	E 285307, N 92785
SGM Type:	Counterfort Drain
Date:	26 th January 2021
Weather:	Drizzly
Attending site:	Michelle Duffy-Turner (Coffey) & Mike Winter (Winter Associates)
Equipment Used:	Tape measure, distomat, compass clinometer, camera and notebook
Description:	Counterfort Drain site located in a cutting along the A30.
<p>Along the top of the slope is a crest drain which follows the line of the slope west towards the road and comes to a stop approximately 2m to 3m above road level. At the downslope edge of the crest drain is a 2m high concrete headwall with a small culvert approx 100mm x 100mm. The ditch is heavily vegetated (see photo below). This crest drain was not present at the top of the slope adjacent to the bridge.</p>

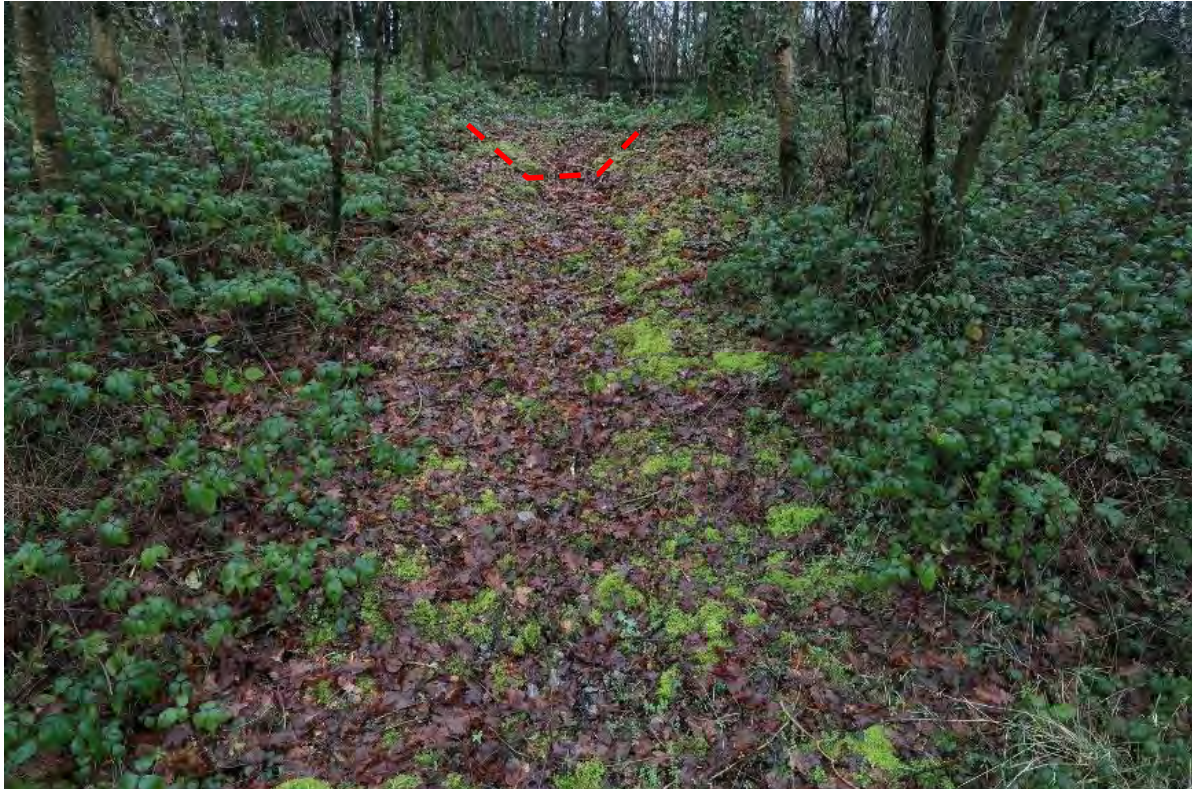
Task 1-1109: SGMs Phase 2	
Counterfort Drain Proforma	
Area / SGM ID:	Area SW / 2053
Location / NGR:	E 285307, N 92785
SGM Type:	Counterfort Drain
Date:	26 th January 2021
Weather:	Drizzly
Attending site:	Michelle Duffy-Turner (Coffey) & Mike Winter (Winter Associates)
Equipment Used:	Tape measure, distomat, compass clinometer, camera and notebook
Description:	Counterfort Drain site located in a cutting along the A30.
<p>The overall stability of the slope in the area of the drains and the surrounding area(s): One of the counterforts had significant settlement located towards the crest. This is possibly caused by a loss of fines below or by loosely placed stone (see photo below). No other distortion to the counterforts or surrounding slopes were observed.</p>

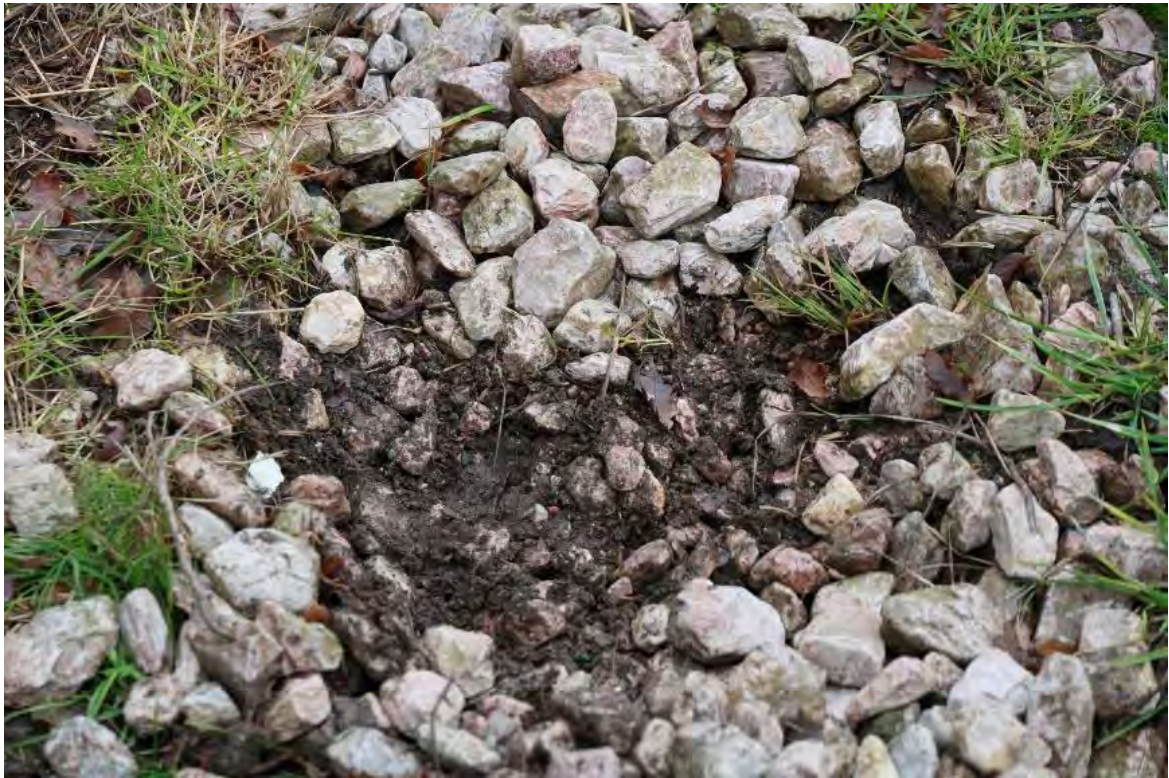
Settlement of the herringbone drain was observed towards the toe of the slope immediately below where the 'V' of the herringbone comes into the central stem (see photo below). This has led to a sunken section of the drain and appeared to be where water has been forced to the surface.

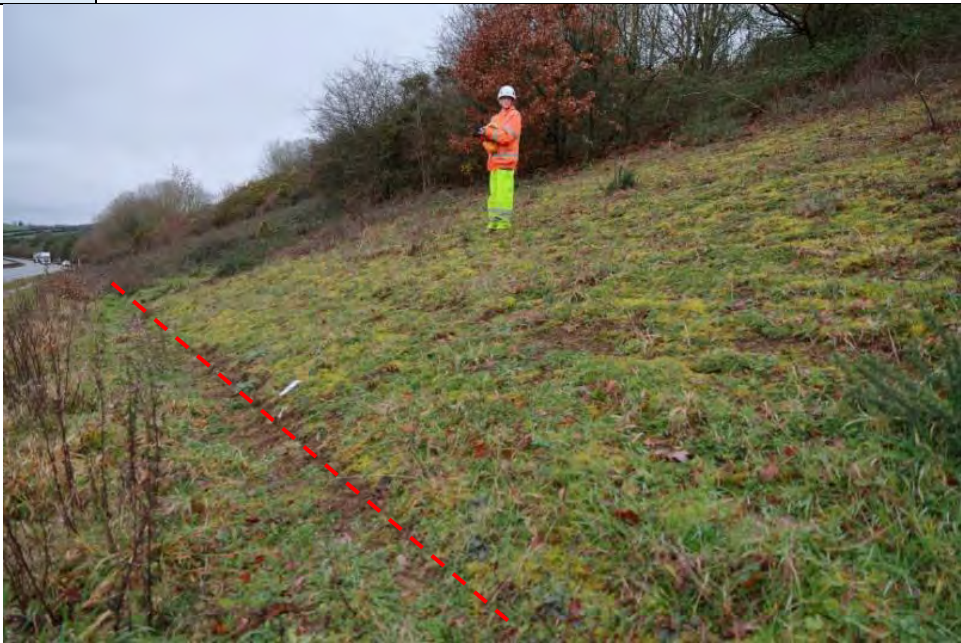
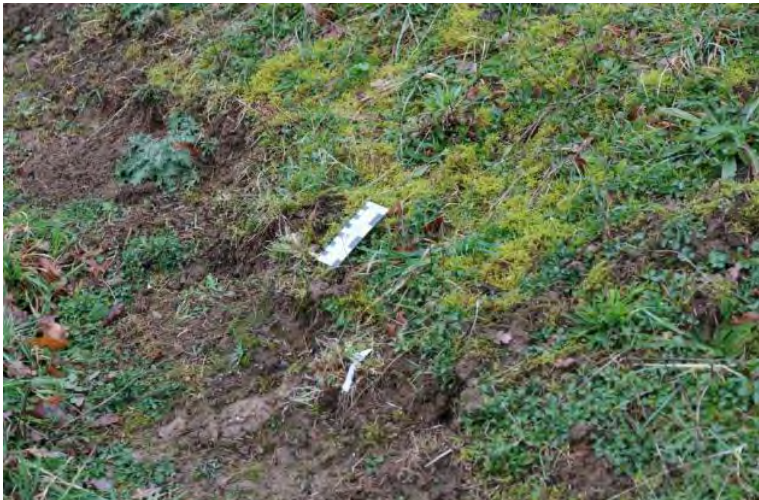
<p>The whole cutting appears to suffer from translations sliding (likely to be shallow). These look similar to solifluction but with longer, more persistent horizontal runs (see photos below).</p>

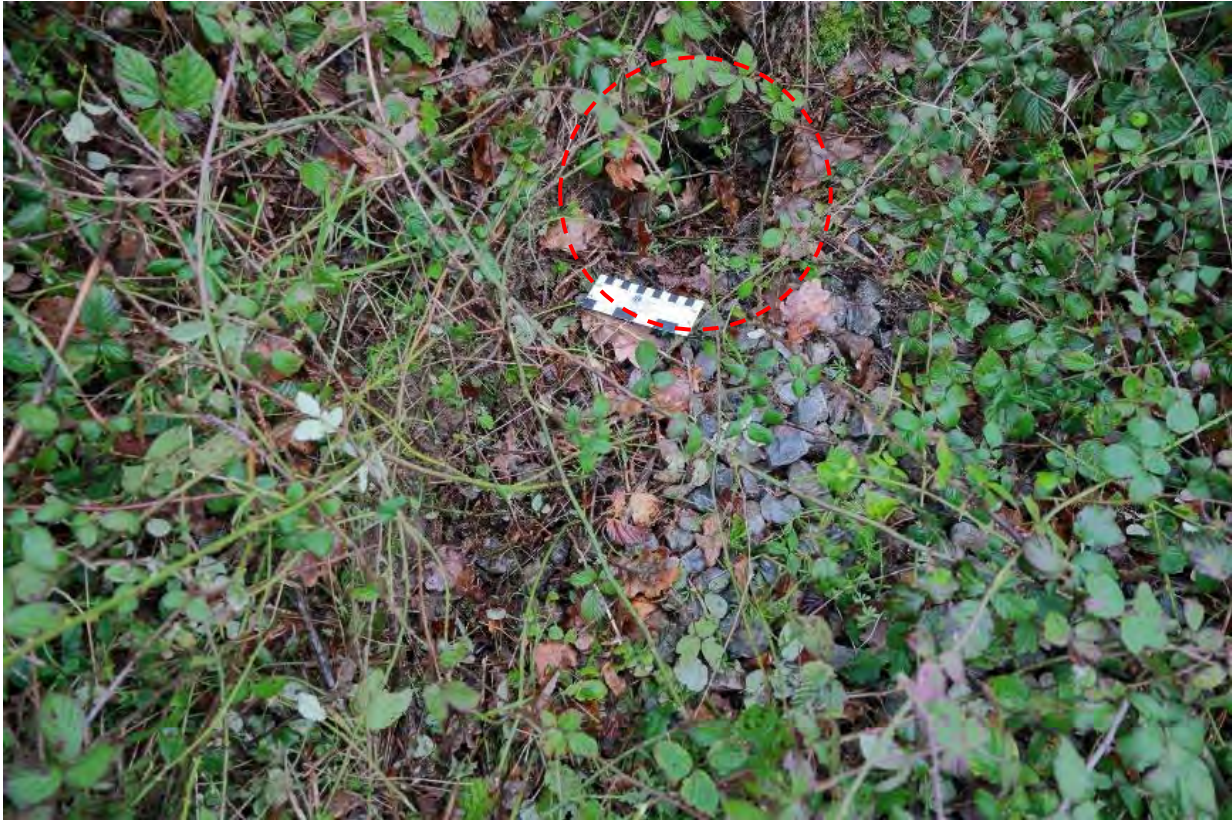
Task 1-1109: SGMs Phase 2	
Counterfort Drain Proforma	
Area / SGM ID:	Area SW / 2065
Location / NGR:	E 287064, N 92536
SGM Type:	Counterfort Drain
Date:	27 th January 2021
Weather:	Drizzly
Attending site:	Michelle Duffy-Turner (Coffey) & Mike Winter (Winter Associates)
Equipment Used:	Tape measure, distomat, compass clinometer, camera and notebook
Description:	Counterfort Drain site located in a cutting along the A30.
<p>The surface condition of the drains prior to excavation, including any distortion to the drain line, and the condition of any geosynthetic wrap and stone drainage media (type, deterioration, clogging/presence of fines):</p> <p>Settlement of the drain towards the toe was observed (see section above). On the upper slope (on the western branch of the 'V') there was an area that had water 'piping' present (i.e. where water had been forced to the surface along with aggregate carried by the water – see photo below). This water appears to have then excavated along the side of the drain causing scour along the drain edge.</p>

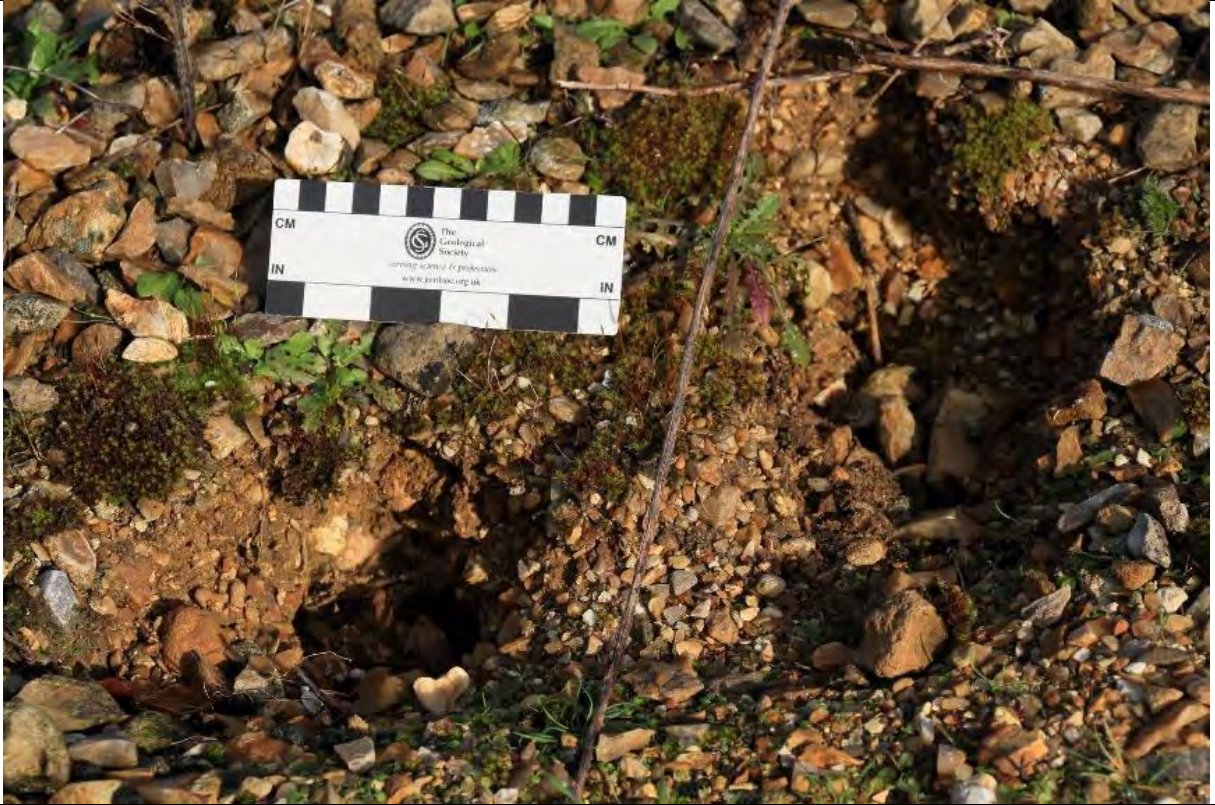
<p>The overall stability of the slope in the area of the drains and the surrounding area(s): Across the whole slope there were numerous instances of piping observed with finer gravel washed out of the slope (see photo below). It is possible that these areas of 'piping' could be related to animal activity; however, the holes did not appear to be very deep and the finer material was typically restricted to immediately downslope (with burrowing the material excavated often ends up around the sides of the hole as well as downslope).</p>

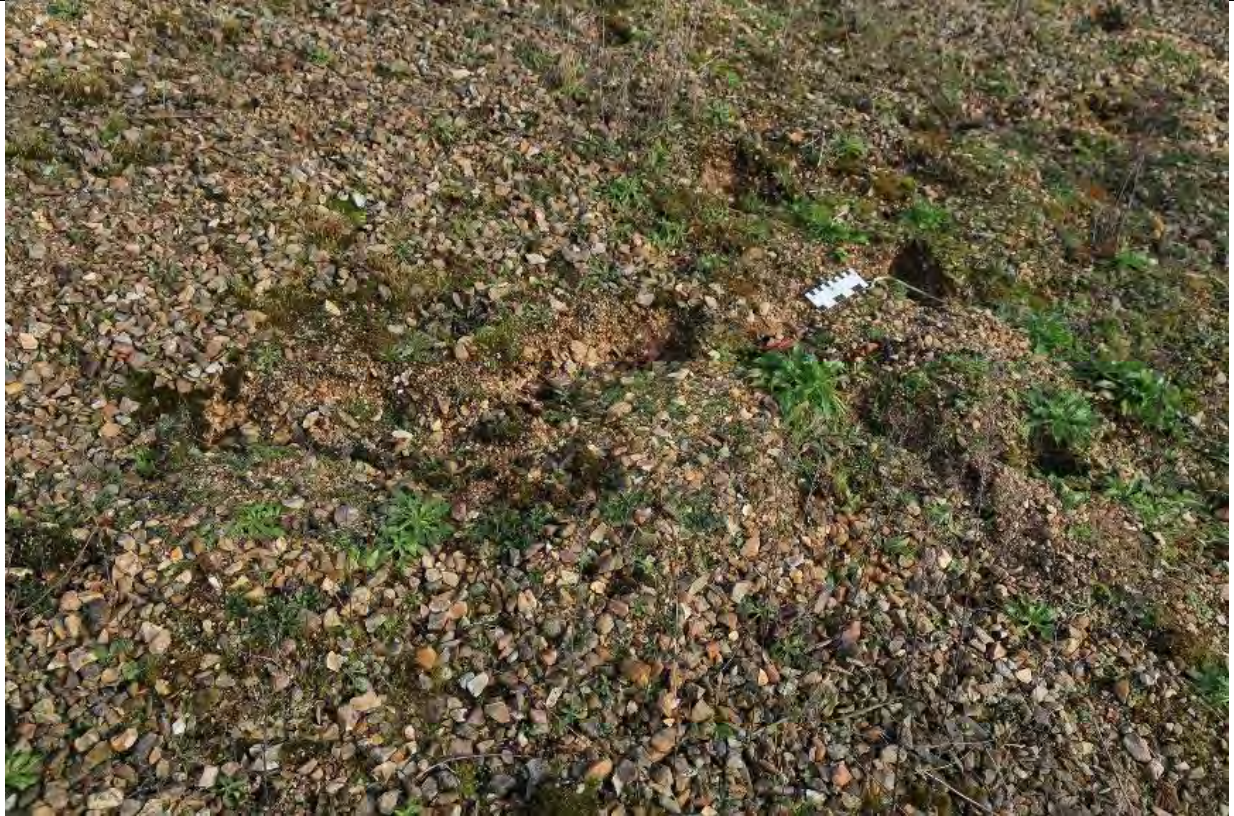
<p>The surface condition of the drains prior to excavation, including any distortion to the drain line, and the condition of any geosynthetic wrap and stone drainage media (type, deterioration, clogging/presence of fines):</p> <p>The material used on the slope was fine to coarse gravel, much smaller than would typically be used in a counterfort drain.</p> <p>The surface was very loose and numerous 'piping failures' or animal burrows across it (see photo below).</p> <p>No geosynthetic was observed on the slopes.</p>

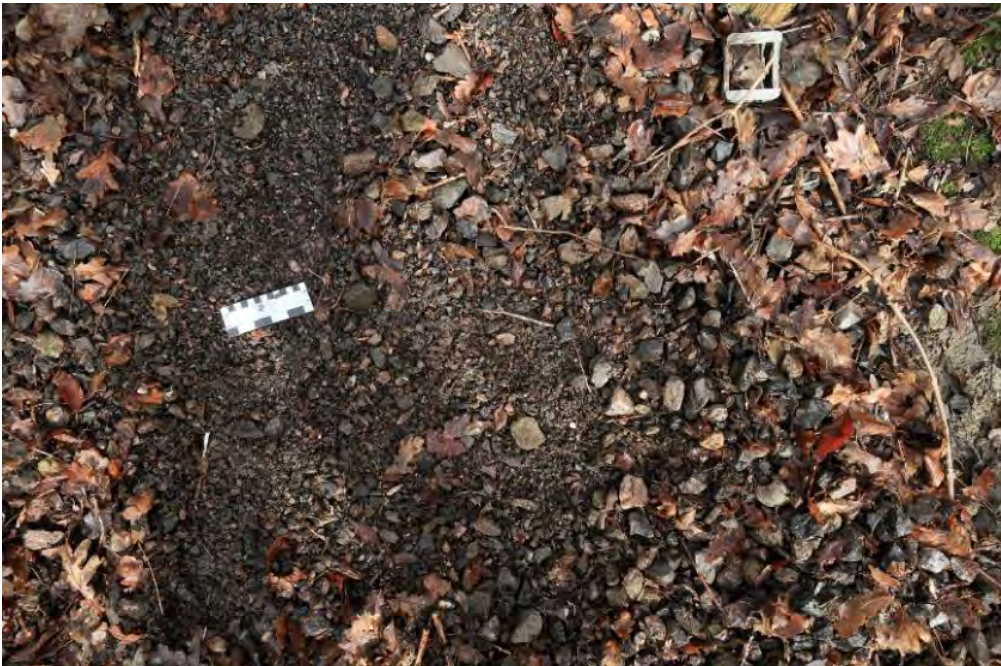
Task 1-1109: SGMs Phase 2	
Counterfort Drain Proforma	
Area / SGM ID:	Area SW / 3329
Location / NGR:	E 332272, N 114244
SGM Type:	Counterfort Drain
Date:	28 th January 2021
Weather:	Dry
Attending site:	Michelle Duffy-Turner (Coffey) & Mike Winter (Winter Associates)
Equipment Used:	Tape measure, distomat, compass clinometer, camera and notebook
Description:	Counterfort Drain site located on embankment of the A303
<p>The setting and location of the counterfort drains, in particular relative to the carriageway: The counterfort drains are located along the westbound embankment of the A303 to the south of Horton. Access to the site was via Whitney Hill road. The slope is located to the east of the Whitney Hill road underpass and is approximately 8m high adjacent to the bridge and shallows to 5m high towards the eastern part of the site. The slopes are approximately 25° (getting steeper towards the bridge).</p> <p>Information pertaining to drainage / watercourses / outfalls: At the eastern end of the site the counterfort drains are 1.2m wide and spaced every 10m. Towards the western end the counterforts are approximately 1.3m wide and spaced every 5m. The counterforts comprise a fine gravel and coarse sand with a layer of coarse gravel (40mm to 50mm) on top (see photos below). At the toe of the slope is a toe drain which comprises coarse angular gravel (nominally 40mm to 50mm).</p>

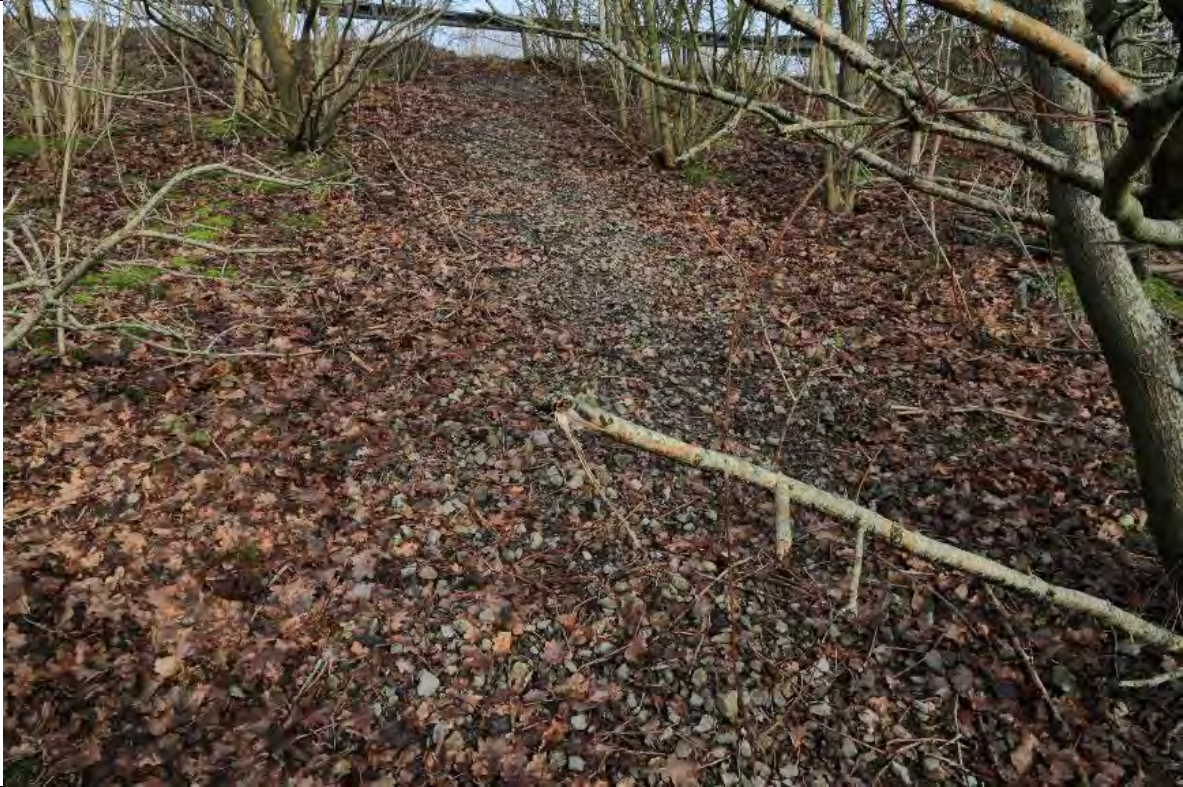
<p>The overall stability of the slope in the area of the drains and the surrounding area(s): There were no signs of instability of the counterfort drains or surrounding slopes observed.</p>	
<p>The surface condition of the drains prior to excavation, including any distortion to the drain line, and the condition of any geosynthetic wrap and stone drainage media (type, deterioration, clogging/presence of fines): The material used in the counterfort drains was coarse sand to fine gravel, much smaller than would typically be used in a counterfort drain. From a review of the pre-existing design information it was clear these counterforts were installed to increase the phi angle of the surface material rather than allow drainage of the slopes.</p>

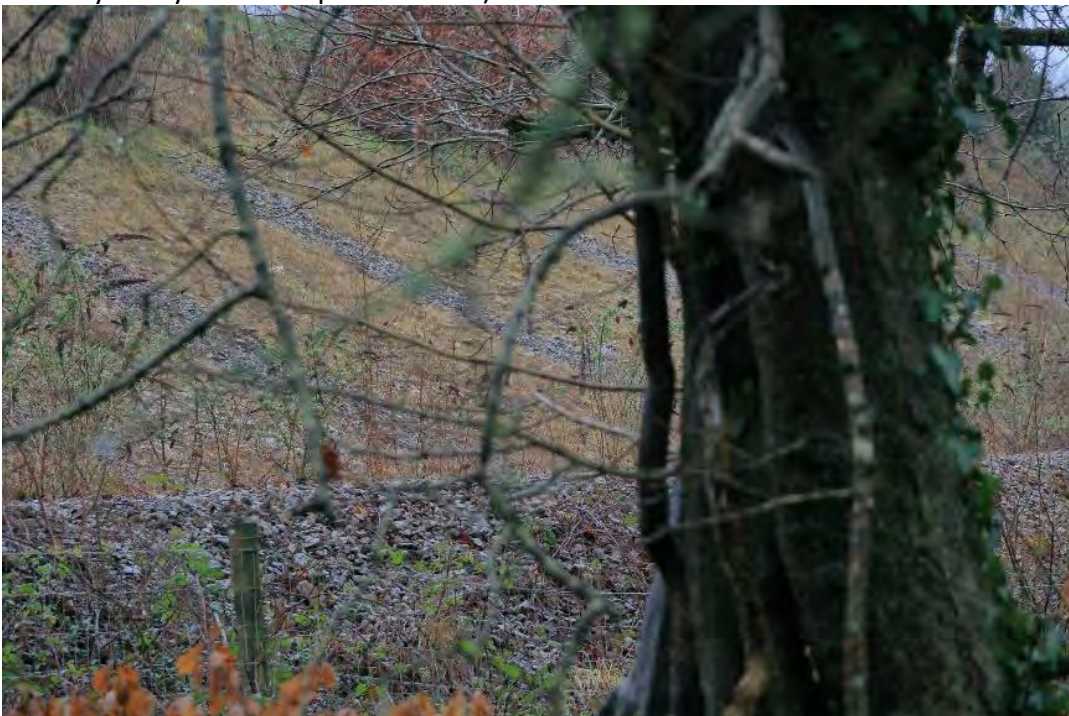
Task 1-1109: SGMs Phase 2	
Counterfort Drain Proforma	
Area / SGM ID:	Area SW / No SGM ID
Location / NGR:	E 287064, N 92536
SGM Type:	Counterfort Drain
Date:	27 th January 2021
Weather:	Drizzly
Attending site:	Michelle Duffy-Turner (Coffey) & Mike Winter (Winter Associates)
Equipment Used:	Tape measure, distomat, compass clinometer, camera and notebook
Description:	Counterfort Drain site located on embankment of the A38.
<p>The setting and location of the counterfort drains, in particular relative to the carriageway: The counterfort drains are located along the eastbound embankment of the A38 to the west of Liskeard. Access was to the east of the site; however, vegetation, fencing and a watercourse prevented access to the main site area so this was viewed from a distance. The slope is approximately 9m to 11m long and the counterforts stop 2m to 3m below the crest of the embankment.</p> <p>Information pertaining to drainage / watercourses / outfalls: The counterforts were not examined up close so no observation on the stone fill was possible. The counterfort drains appeared to be approximately 1.2m wide and closely spaced (approximately every 3m – see photo below).</p>
