PUBLISHED PROJECT REPORT PPR1032

Forensic Examination of Critical Special Geotechnical Measures

M Duffy-Turner (Coffey Geotechnics Ltd), M G Winter (Winter Associates Limited), I M Nettleton (Coffey Geotechnics Ltd) and G Butler (Coffey Geotechnics Ltd)

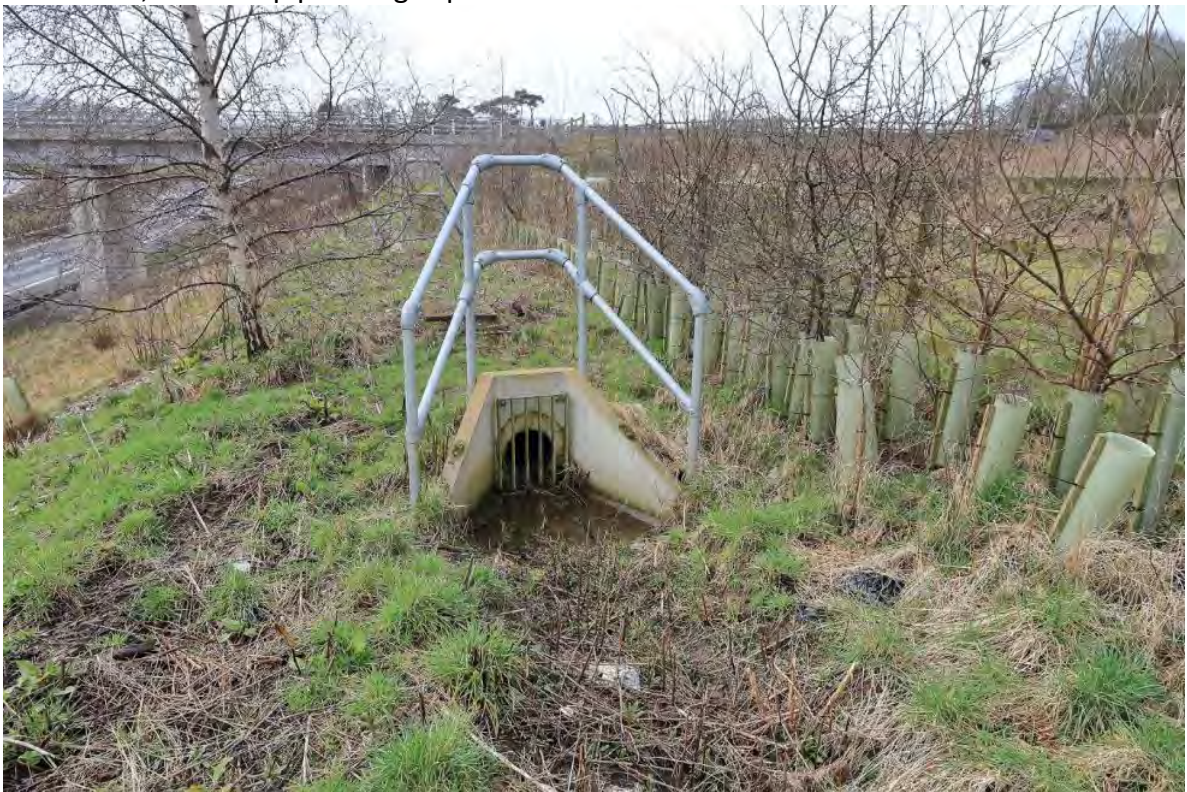
Task 1-1109: SGMs Phase 2	
Counterfort Drain Proforma	
Area / SGM ID:	Area NW / No SGM ID – located at M6 Jct 34
Location / NGR:	E 349701, N 465325
SGM Type:	Counterfort Drain
Date:	11 th March 2021
Weather:	Dry
Attending site:	Michelle Duffy-Turner and Ian Nettleton (Coffey) & Mike Winter (Winter Associates)
Equipment Used:	Tape measure, distomat, compass clinometer, camera and notebook
Description:	Counterfort Drain site located in a cutting along the M6.
<p>two inlet headwalls had been installed within the crest drain with the intention assumed to be picking up water from the ditch from the north and south. A manhole was located between the two headwalls where a pipe was observed going downslope. The ditch had been shallowed on either side of the headwalls and the invert of the pipes (225mm polypipes) was approximately 100mm above the base of the ditch. The pipes were not bedded in sufficiently, especially on the southern side, with the pipe being exposed behind the headwall.</p>

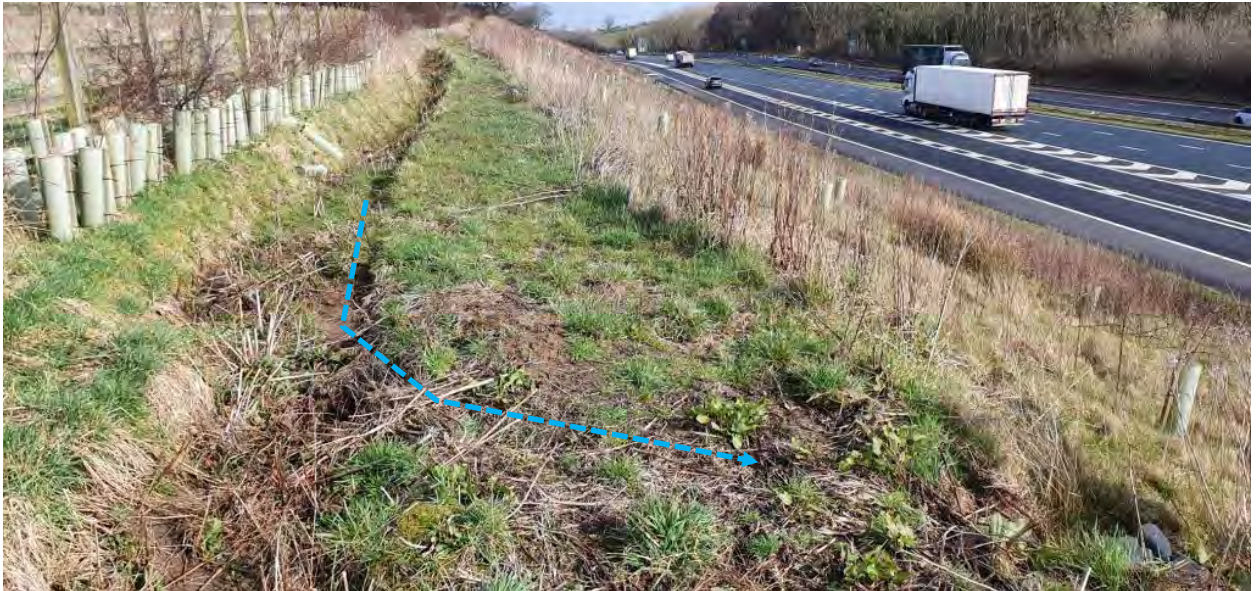
Task 1-1109: SGMs Phase 2	
Counterfort Drain Proforma	
Area / SGM ID:	Area NW / No SGM ID – located at M6 Jct 34
Location / NGR:	E 349701, N 465325
SGM Type:	Counterfort Drain
Date:	11 th March 2021
Weather:	Dry
Attending site:	Michelle Duffy-Turner and Ian Nettleton (Coffey) & Mike Winter (Winter Associates)
Equipment Used:	Tape measure, distomat, compass clinometer, camera and notebook
Description:	Counterfort Drain site located in a cutting along the M6.
<p>In some places on the run up to the inlets the sides of the ditch were shallower than the pipe invert meaning that water could overtop of the ditch before making it into the pipe. This had occurred immediately adjacent to the northern inlet where a well-defined area of run-off was observed with flattened grass indicating flow path. Below this section is an area of slope repair where a 1.5m wide rockfill repair had been installed. The rock fill was angular and between 150mm and 300mm (avg 200mm).</p>

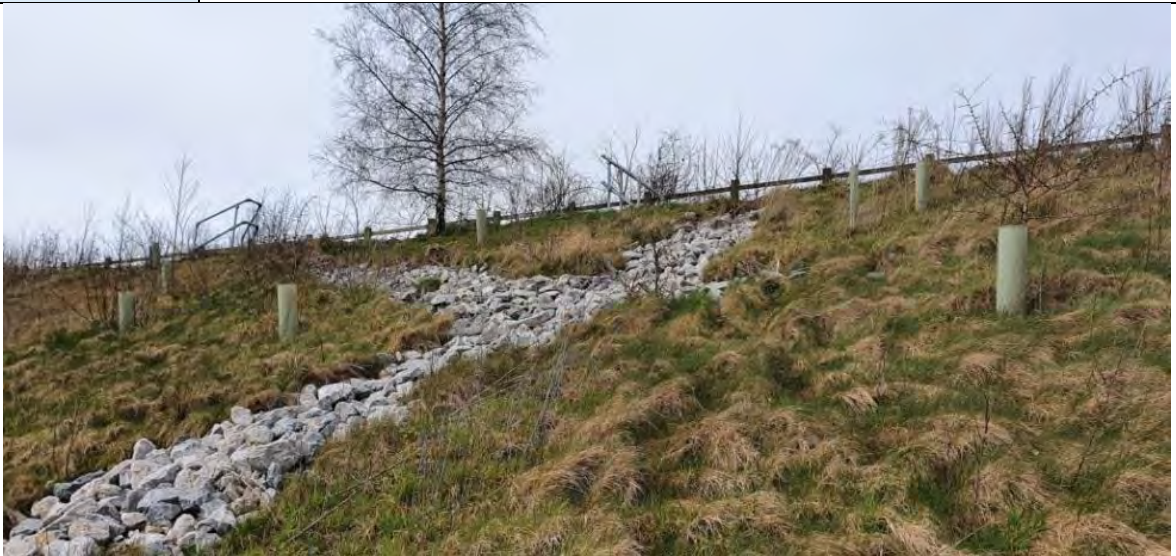
<p>Further east at another low spot along the crest drain (also where a stream from the adjacent fields flowed down to the cutting), a headwall inlet was present with a 225mm polypipe to take water downslope. Like above the ditch was shallowed on the run up to the headwall from both sides and three 300mm diameter sections of pipe had been left in the base of the ditch. Downslope of this headwall there was no sign of a manhole to connect the pipe into the toe drain. It is unclear where this water is taken to.</p> <p>A number of land drains (typically 75mm VE clay pipes) were observed in the slope with water issuing from them. The slopes surrounding these were typically wet and covered in hydrophilic vegetation. A land drain was also observed in the base of the ditch where water was flowing into and presumably into the adjacent counterfort downslope (assumed due to no water issuing from the slope downslope at this location).</p>

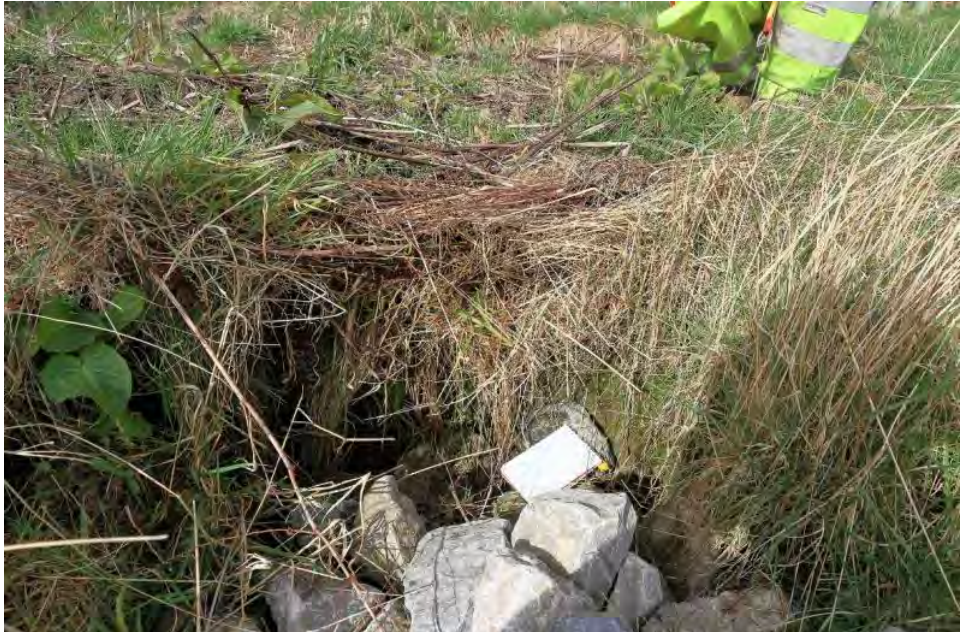
Task 1-1109: SGMs Phase 2	
Counterfort Drain Proforma	
Area / SGM ID:	Area NW / No SGM ID – located at M6 Jct 34
Location / NGR:	E 349701, N 465325
SGM Type:	Counterfort Drain
Date:	11 th March 2021
Weather:	Dry
Attending site:	Michelle Duffy-Turner and Ian Nettleton (Coffey) & Mike Winter (Winter Associates)
Equipment Used:	Tape measure, distomat, compass clinometer, camera and notebook
Description:	Counterfort Drain site located in a cutting along the M6.
<p>The overall stability of the slope in the area of the drains and the surrounding area(s): There were a number of places on the cutting where instability was observed. Immediately to the north of the overbridge a tension crack and bowl feature approximately 8m wide was observed. This was located below one of the land drains and the area was extremely boggy. The filter drain at the toe of the slope in this area was covered by the slipped deposits.</p> <p>As described in the section above an area of rockfill repair has been undertaken on the slope (presumably replacing an existing herringbone). It was observed that water is still flowing over the top of the ditch and into the head of this repaired area. This is further cutting into the slope and at present there is a 0.6m high scarp which appears to be regressing upslope. It is expected that this will continue unless the ditch is reinstated above. The soil type in this area was observed to be a sandy, silty clay.</p>

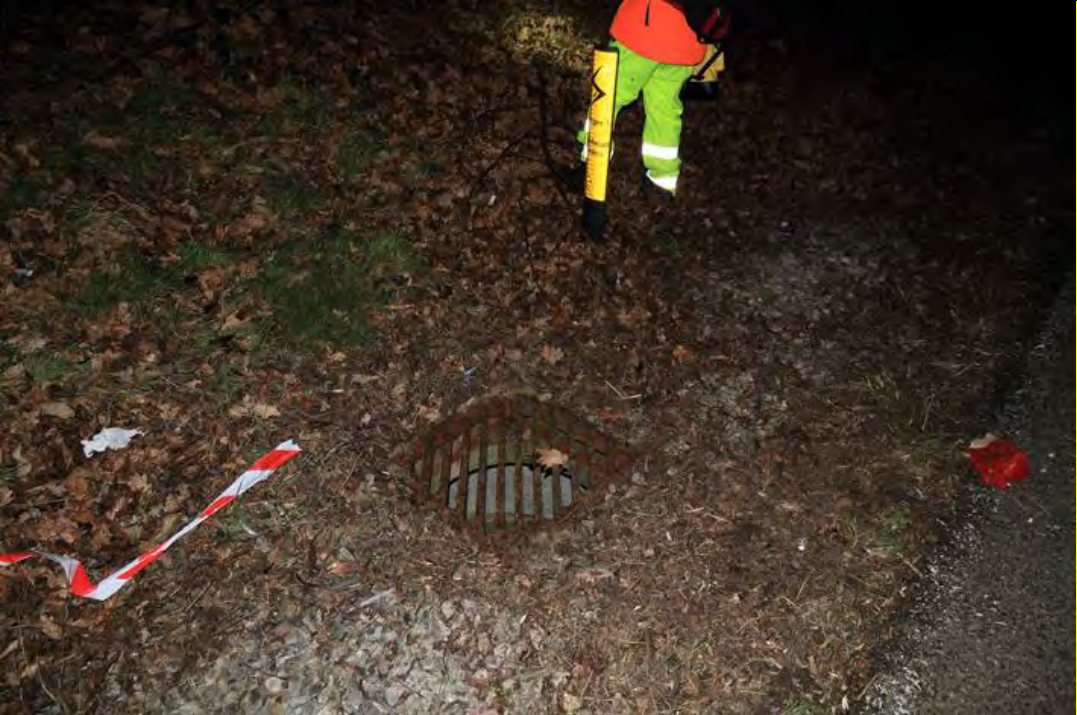
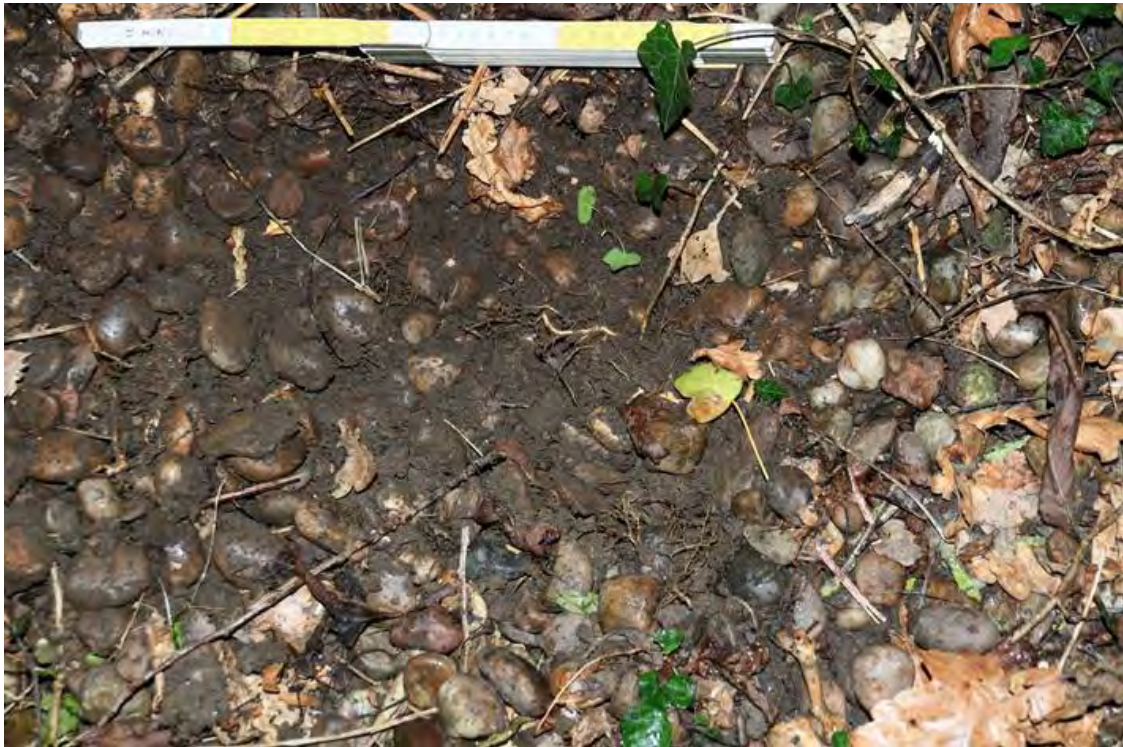
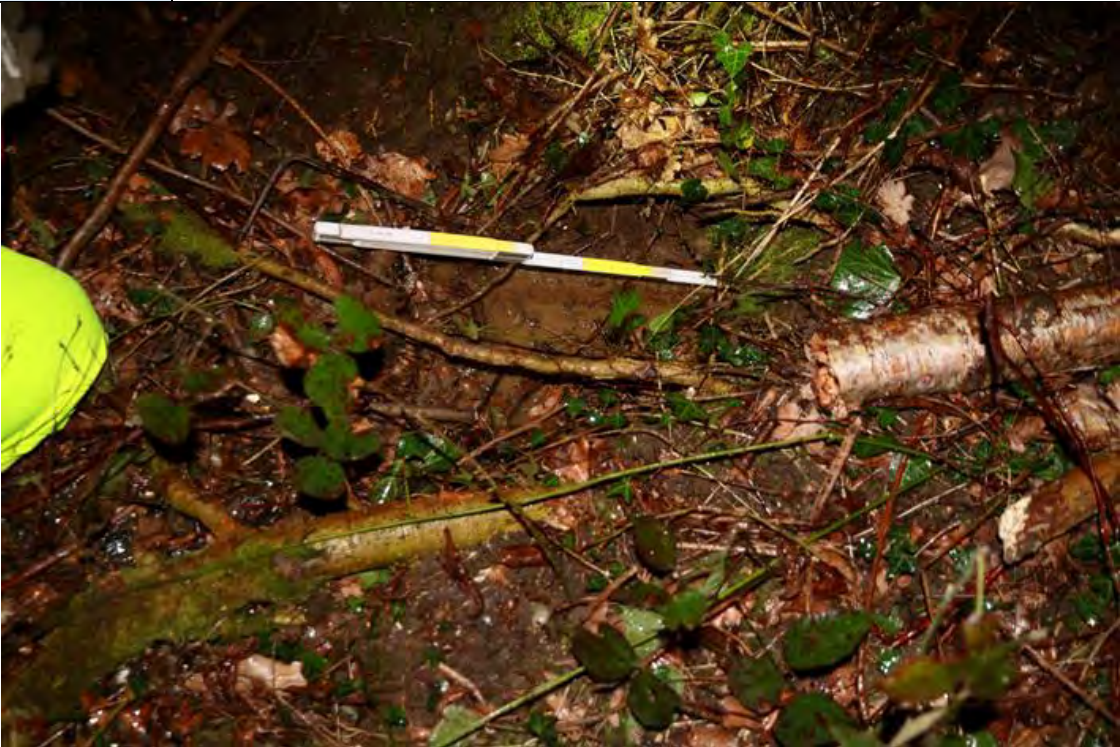
<p>The overall stability of the slope in the area of the drains and the surrounding area(s): No instability of the slope was observed; however, the visit was undertaken at night so visibility was poor.</p>	
<p>The surface condition of the drains prior to excavation, including any distortion to the drain line, and the condition of any geosynthetic wrap and stone drainage media (type, deterioration, clogging/presence of fines): Surface clogging due to a build up of leaf litter and humous and washing in of fines were all observed. This clogging was worsened where trees were found to be growing on top of drain and also where roots had actively followed and invaded the course of drains (see photos below). No geosynthetic or other form of filter was encountered.</p>

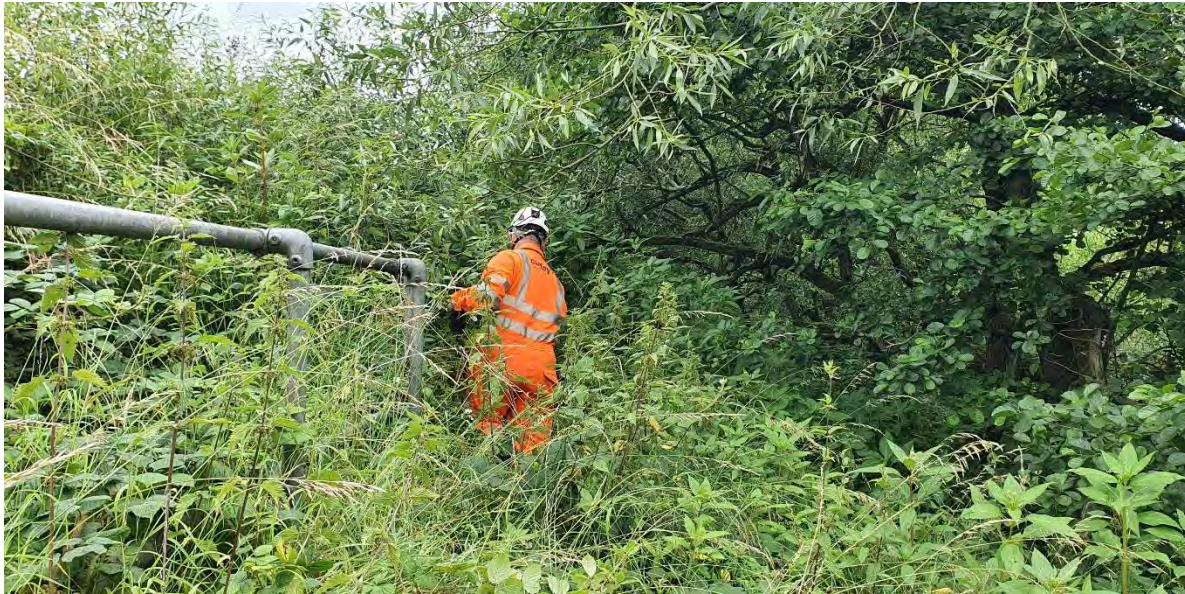
Task-0077: SGMs Phase 3	
Soil Nail Proforma	
Area / SGM ID:	Area 10 / 2456
Location	M56 J7 Westbound – E 375655, N 384655
SGM Type:	Soil Nails
Date:	15/07/2021
Weather:	Dry and warm
Attending site:	Ian Nettleton and Michelle Duffy-Turner (Coffey)
Equipment Used:	Tape measure, distomat, compass clinometer, camera and notebook
Description:	Soil nail embankment along M56 slip road
<p>The setting and location of the soil nail slope, in particular relative to the carriageway: The soil nail slope is located along the westbound off slip at Junction 7 of the M56. The site was accessed via the M56 J6 to J8 work site hosted by Galliford Try.</p> <p>The slope was heavily vegetated with nettles and brambles during the inspection and the soil nails could not be identified.</p>

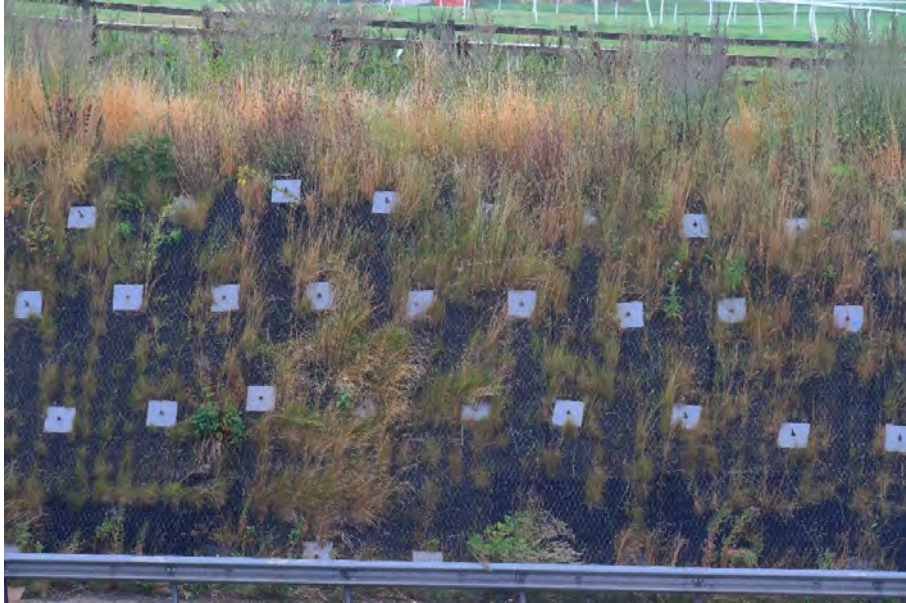
Task-0077: SGMs Phase 3	
Soil Nail Proforma	
Area / SGM ID:	Area 14 / No ID
Location	A1(M) – E 422513, N 499012
SGM Type:	Soil Nails
Date:	26/08/2021
Weather:	Wet
Attending site:	Mike Winter (Winter Associates)
Condition and type of foundation: Foundation not visible	
The condition of the retained slope where visible: Slope not visible below the facing; however, no obvious signs of instability were observed. Two of the soil nail cuttings (SNS1 and SNS2) were faced with a rigid stone filled mattress and the other cutting (SNS3) was faced with a double twist mesh with a black finer geogrid underneath. Slope SNS3 has vegetation growing on it (see photo below).

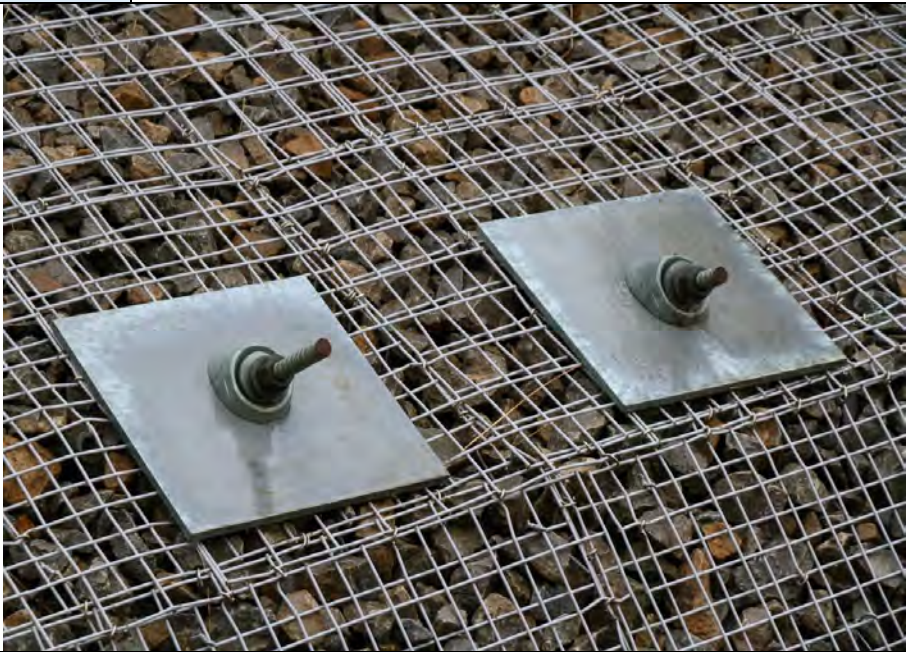
The condition of the nails prior to excavation (as far as they can be observed): e.g. can the nails be moved by applying force to the nail head: The soil nail slopes were observed from a distance so no tactile inspection undertaken. The head plates appeared to be secure to the face and no obvious signs of nay issues with the nails.

The condition of the nail heads (corrosion, mechanical integrity) prior to excavation: The nail heads appeared to be in good condition with slight corrosion observed on the nail ends. The nails are a solid bar so no grout was observed.

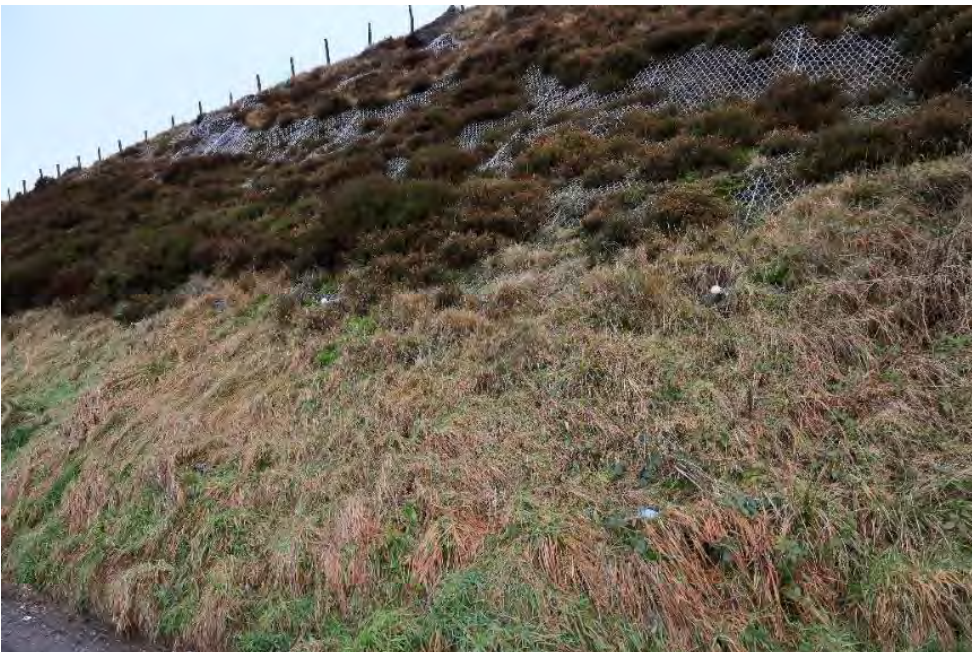
The condition of the nails prior to excavation (as far as they can be observed): e.g. can the nails be moved by applying force to the nail head: The majority of the lower row had faceplates that were loose and could be moved by hand; however, the soil nails were secure and could not be moved. Occasional soil nails were observed to be misaligned to the face plate.

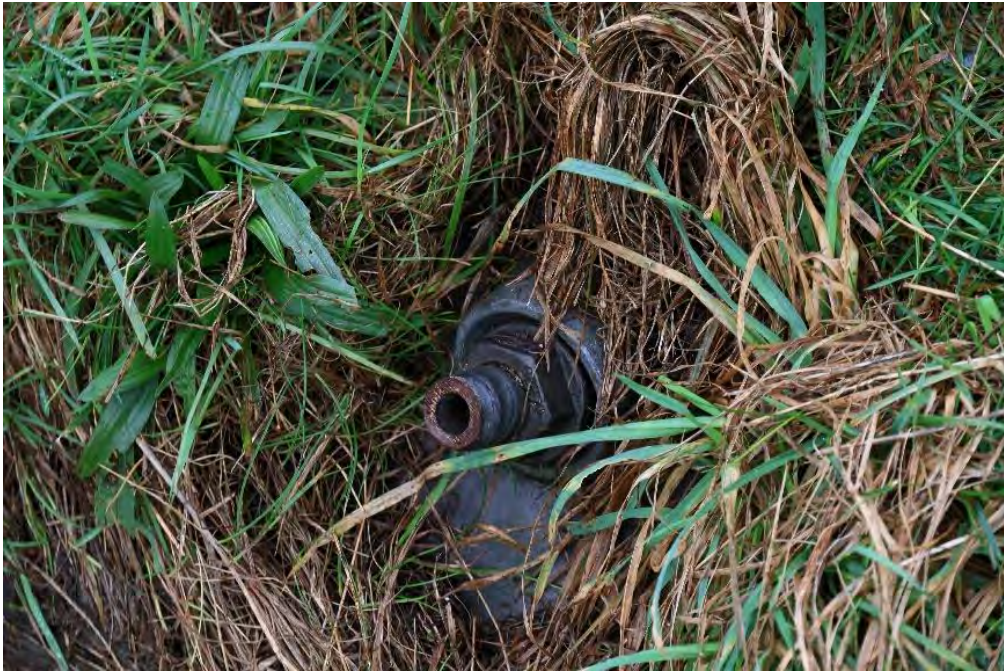
Task T-0077: SGMs Phase 3	
Soil Nail Proforma	
Area / SGM ID:	Area 12 / 6312
Location	A628 - E 411812, N 399609
SGM Type:	Soil Nails
Date:	11 th January 2022
Weather:	Dry
Attending site:	Mike Winter (Winter Associates Ltd) and Michelle Duffy-Turner (Coffey Geotechnics Ltd)
<p>The condition of the nail heads (corrosion, mechanical integrity) prior to excavation: Grout loss was visible in the annulus of some of the soil nails (hollow bar) and surface rust was visible at the bar end (see image below); however, no signs of pitting were observed.</p>

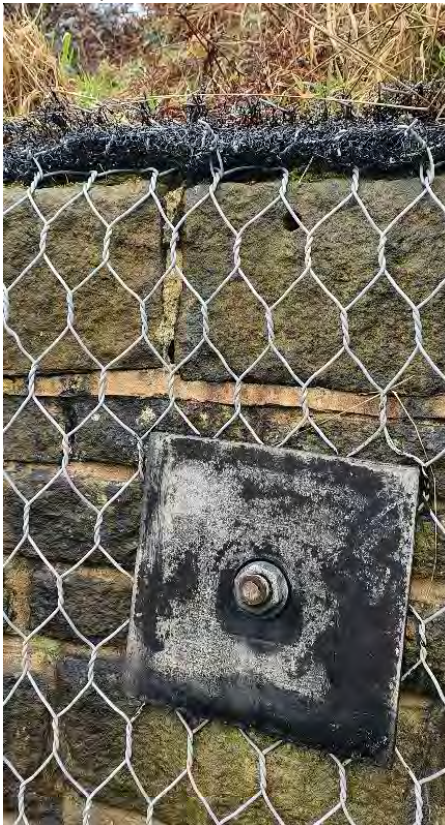
Task T-0077: SGMs Phase 3	
Soil Nail Proforma	
Area / SGM ID:	Area 12 / 9062
Location	A628 - E 408193, N 399658
SGM Type:	Soil Nails
Date:	11 th January 2022
Weather:	Dry
Attending site:	Mike Winter (Winter Associates Ltd) and Michelle Duffy-Turner (Coffey Geotechnics Ltd)
<p>retention of fines and topsoil. This is comprised of a plastic type mesh (polypropylene monofilaments is given in the project GDR).</p> <p>The lower two rows of head plates are 300mm by 300mm and have been painted in bitumen which is wearing off (see image below).</p>

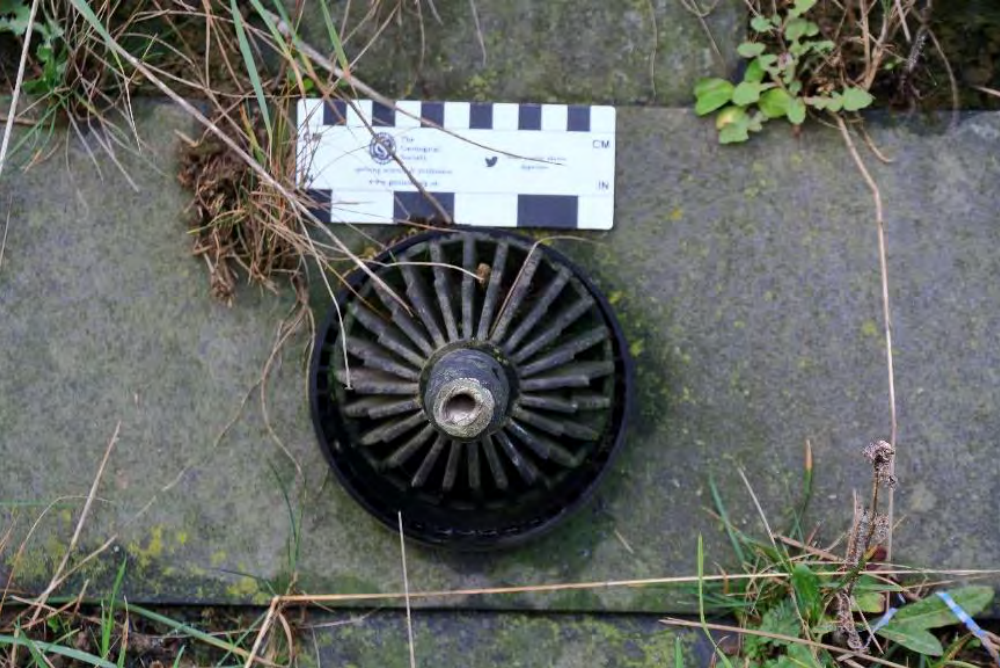
e	
<p>The condition of the nail heads (corrosion, mechanical integrity) prior to excavation: The nails showed loss of grout from the annulus and pitting corrosion on the nail ends (see image below).</p>

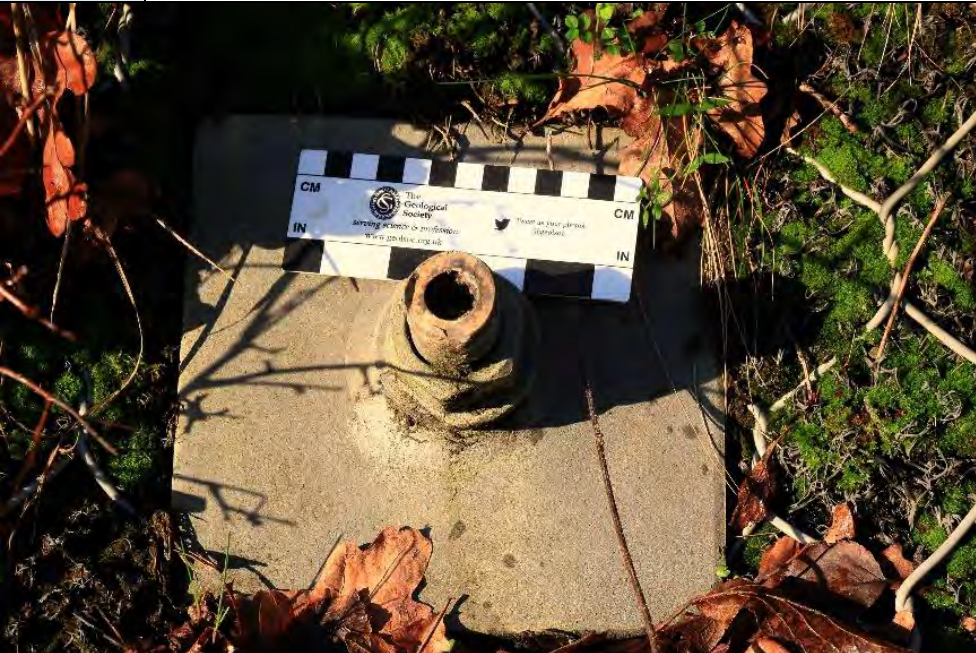
<p>The condition of the retained slope where visible:</p> <p>The soil nail slope was observed to have bulging between the nails and typically the deformation was midslope and seemed to be more evident in the far north and far south of the soil nail slope.</p> <p>Some of the faceplates appeared to be rebated into the slope suggesting that the slope is moving outwards around them. These were approximately between 50mm and 70mm behind the plane of the slope face.</p>	
<p>The condition of the nails prior to excavation (as far as they can be observed): e.g. can the nails be moved by applying force to the nail head:</p> <p>The nail heads and face plates were all secure and tight to the face.</p>	
<p>The condition of the nail heads (corrosion, mechanical integrity) prior to excavation:</p> <p>Grout loss was visible in the annulus of some of the soil nails (grout loss observed between full loss, half loss and no loss). Most of the nail heads had corrosion visible at the bar ends (see image below).</p>

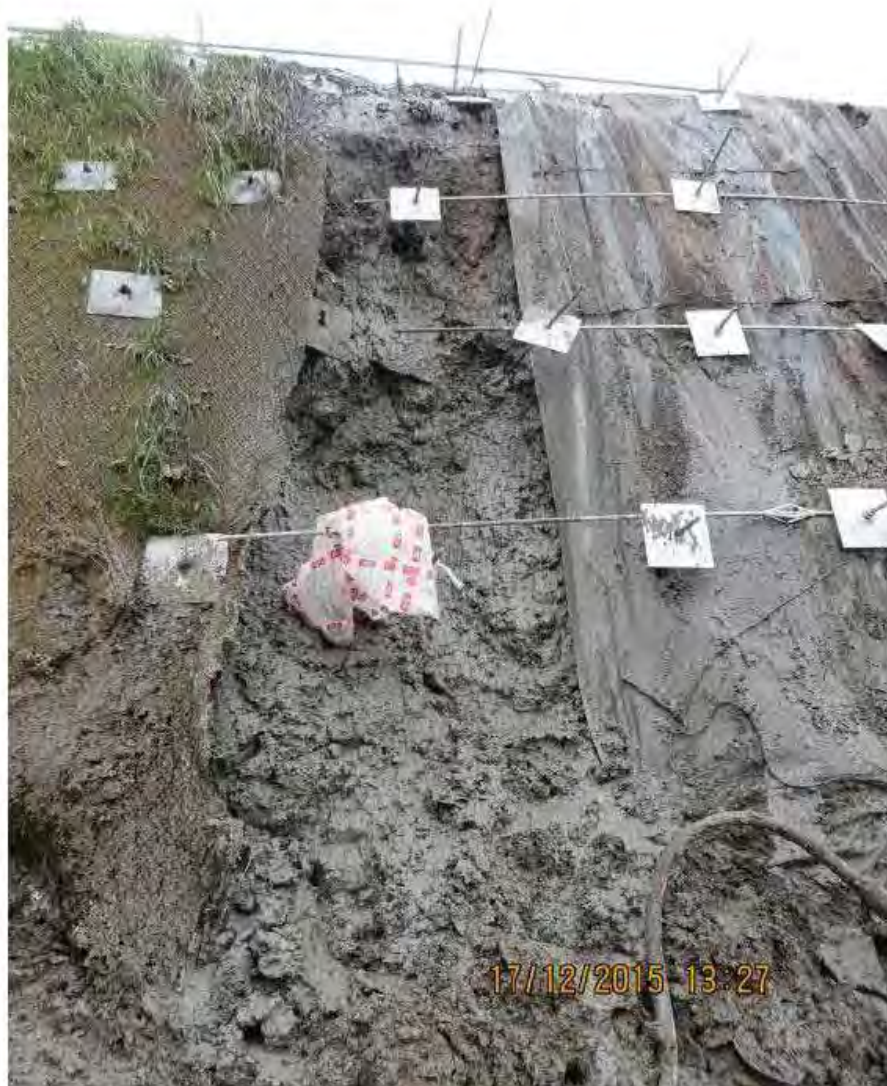
Summary of Failure Between early October 2015 and April 2016 a number of failures occurred during the construction of the northbound soil nail slopes, soil nail slopes 1 and 2. The failures were characterised by a series of conventional slip and slumping failures. From July 2016 to February 2017 progressive deformation of the soft faced sections of soil nail slope 2 took place, culminating in intervention from the HA Geotechnical Advisor, effectively condemning the original nailing and facing installed on the soil nail slopes. This deformation presented as ‘slumping’ of the mid and lower half of the slope, with localised slope crest regression where material had mobilised below. Soil nail slope 1 also showed – to a lesser extent – evidence of deformation at the slope toe.	
Observations Made on Site: The failures were characterised by a series of conventional slip and slumping failures.

Figure 1: Extract of construction phase pre-nailing/facing failure, Soil Nail Slope 1 Plate 27 (image) taken from A1L2B Geotechnical Feedback Report.

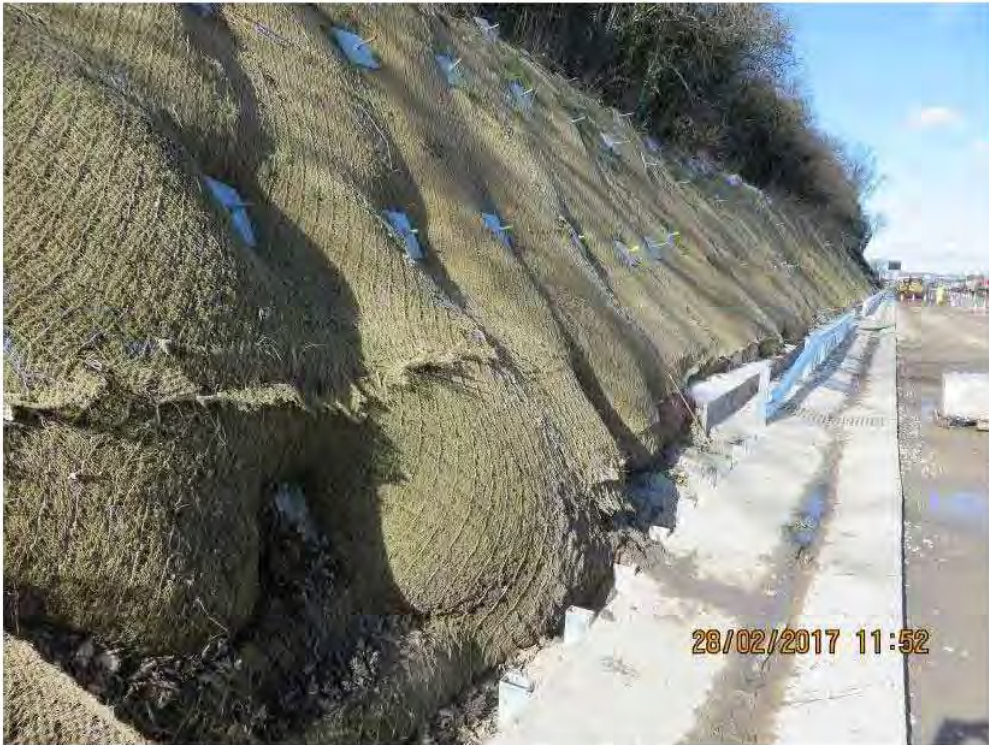
<p>Figure 2: Extract of post construction phase post-nailing/facing softening and flow failures (slumping at the toe), Soil Nail Slope 2 Plate 30 (image) taken from A1L2B Geotechnical Feedback Report</p>	
<p>Failure Mechanisms:</p> <p>The cause of these failures was probably a result of a number of factors including:</p> <ul style="list-style-type: none"> • Excavation in inclement weather, including working over 2015/16 winter period. • Slopes left unsupported (un-nailed/faced) for significant periods of time, particularly on SNS1 with slope left over Christmas 2015 break partly nailed and faced. • Full height excavation and nailing/facing of slopes, rather than benched excavation with top-down nailing/facing. • A general lack of tension in a number of elements in the facing system, allowing progressive deformation of the slope face to take place until tension was finally mobilised. This included:

Task-0077: SGMs Phase 3	
Soil Nail Case Study	
Area / SGM ID:	Area 14 / SGM: No SGM recorded
Location	A1(M) / Cataractonium Cutting
SGM Type:	Soil Nails
Scheme Name:	A1 Dishforth to Barton Improvement
Year of Installation:	2015 to 2018
<ul style="list-style-type: none"> ○ Lack of tension in facing mesh when applied to slope. Mesh not applied taut' and locally observed to be loose, with slack available. ○ Loose head plate nuts. Numerous nuts observed to be loose and not fully engaged throughout works. ○ Lack of crest and toe facing mesh tie-in for significant periods of time. ○ Mesh not anchored at crest and toe due to delays in installing the SNS1 and SNS2 crest anchor selvedge cable and SNS3 anchor trench, and due to disruption caused by retrospective road box cutting and drainage installation works adjacent to the toe of the slope. ○ Regular damage to mesh at toe of slope, requiring splicing repairs, and a temporary but often significant prolonged loss of tension in the facing system. ● Low volume water flow/seepage through slope face which softened exposed materials. This was considerably more prevalent on SNS2 where an often persistent seepage of groundwater was observed, emanating through and over the upper slope and discharging both over the crest and from within the face. Flows were more prevalent at the locations of historic coarse stone drainage grips encountered during the original slope excavation. It is thought that these water flows emanated from a perched water body generated at a sharp permeability contrast between the relatively high permeability Made Ground Archaeology deposits and the underlying relatively low permeability Glacial Till, with incised ditches and channels present at the base of the archaeology allowing water to flow onto the fresh exposed soil on the 55° slope face. ● For the construction phase failures some seepages were observed at lower levels, appearing to use the soil nail bores as flow conduits. <p>Severing of original stone filled counterfort trenches allowing water to flow over newly cut exposed soil and progressively soften its surface.</p>

Task-0077: SGMs Phase 3	
Soil Nail Case Study	
Area / SGM ID:	Area 14 / SGM: No SGM recorded
Location	A1(M) / Cataractonium Cutting
SGM Type:	Soil Nails
Scheme Name:	A1 Dishforth to Barton Improvement
Year of Installation:	2015 to 2018
<p>The results of this investigation resulted in the condemnation of the original nails installed on the soil nail slopes. Between September and October 2017, in light of the results of the additional testing and extraction investigation, nail layouts were re-designed for SNS1 and SNS2. New nails were offset from the original nails.</p> <p><i>Facing – SNS1 and SNS2</i></p> <p>The facing deformation concerns outlined above culminated in a series of site visits by the Client's Geotechnical Advisor and Client's Agent, effectively condemning the original facing system installed on the soil nail slopes. Between February and July 2017 a period of optioneering took place, followed by re-design of the facing system for SNS1 and SNS2.</p> <p>Between August 2017 and February 2018 re-nailing and re-facing works were carried out across SNS1 and SNS2. Broadly the works comprised the following sequence:</p> <ol style="list-style-type: none"> 1. Removal of original facing product and head plates (Geobrugg Greenax steel wire mesh). 2. 500mm slope trim back (around original nails) to competent ground, including overdig at original wide counterfort drains (SNS2 only), where soft ground was observed on site and where temporary shotcrete repair was to be removed. 3. Placement of geocomposite drainage strips and separator fabric. 4. Placement of impermeable crest membrane (SNS2 only). 5. Excavation to existing slope toe drain, inspection and replacement of drain filter media surround (SNS2 only). 6. Placement of double layer of A393 structural mesh and temporary placement of geotextile layer for protection during subsequent re-nailing works. 7. Installation of full set of new nails across slopes (layout offset from original nails). 8. Construction of concrete toe plinth, and 9. Construction of stone-filled mattress facing.

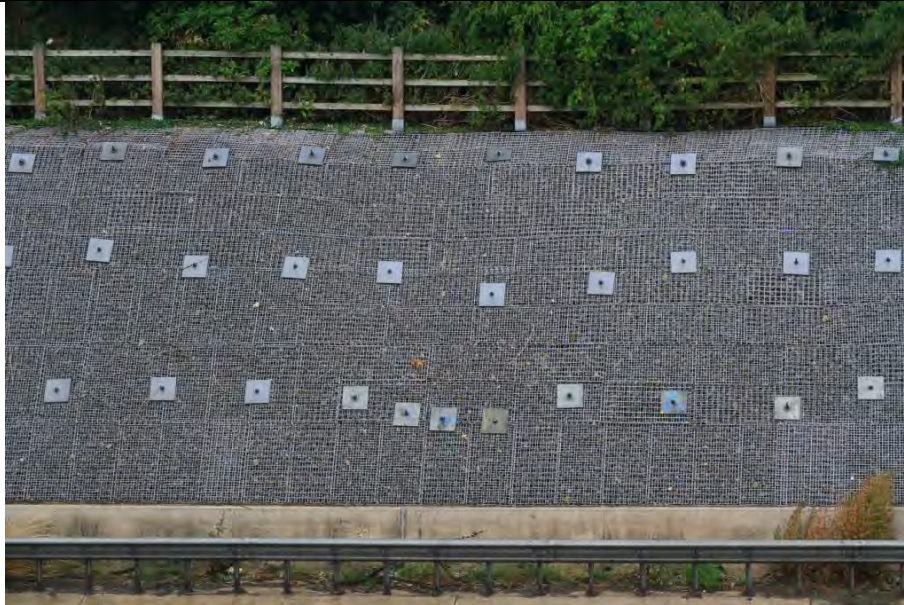
Figure 3: Photograph of SNS2 showing nail placement (old and replacement)

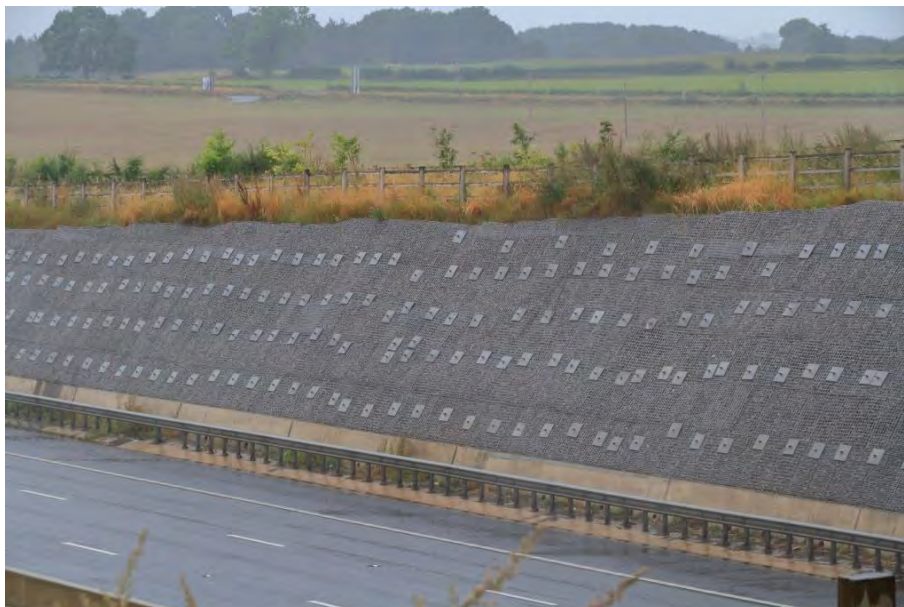
Figure 4: Photograph of SNS1 showing nail placement (old and replacement)

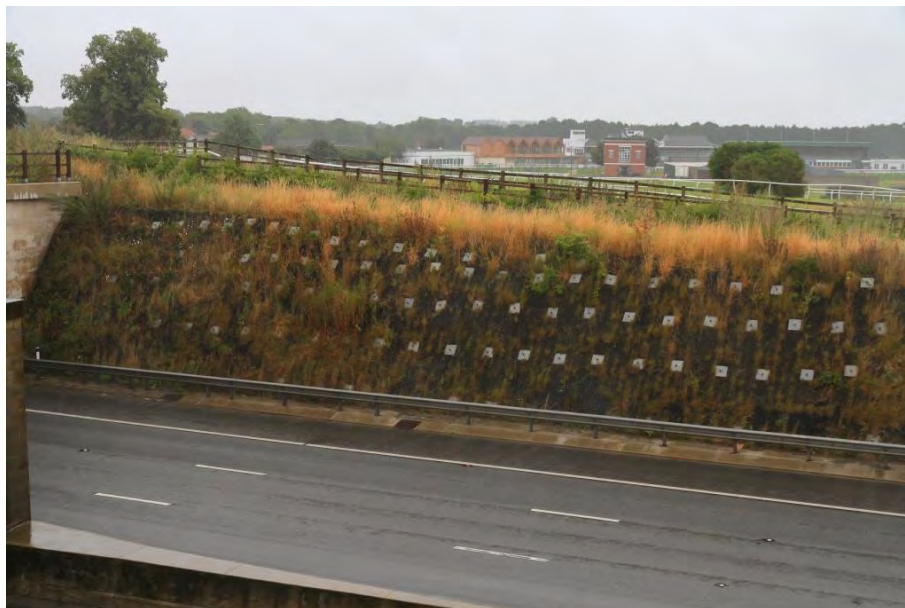
In April 2017 concerns were raised – post-Geotechnical Report certification – by the Client's Geotechnical Advisor with respect to the durability and suitability of the original facing product (Geobrugg Greenax). Concerns centred on a difference of opinion between the designer and the HA Geotechnical Advisor with respect to the corrosion environment at the location of the soil nail slopes.

Figure 5: Photograph of SNS3 showing replacement facing product

Following review by the design team, and considering the limited time which was available to implement repairs, a new facing product (Maccaferri MacMat-R) was installed. The original product was left derelict, insitu, behind the new product.

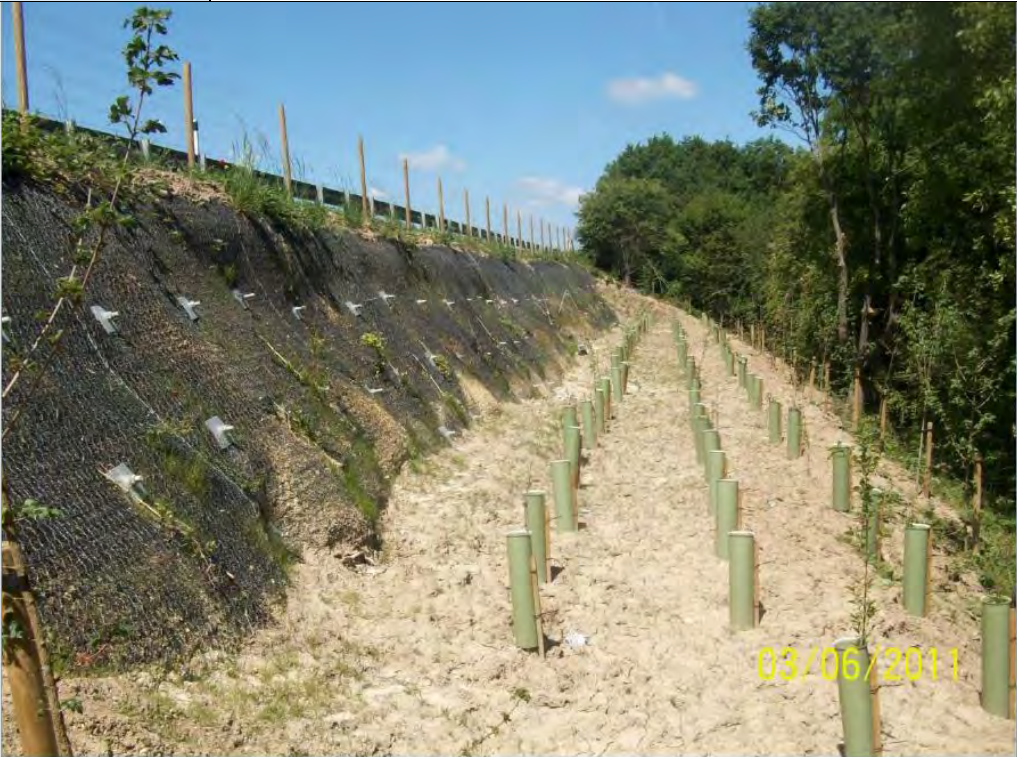
Summary of Failure <p>Following completion of works, slumping was identified over and between the soil nails, beneath the reinforced geogrid (see Figure 1). Out of four other sites soil nailed on the A21 in the same way, the Lower Haysden site was the only one affected by this problem.</p>

<p>Figure 1: Extract of Completed works, six months on. Image taken from BBMM 2011 Report showing the slumping between the nails.</p>	
<p>Observations Made on Site: Following re-inspection of the site 6 months after completion of these works, slumping was identified over and between the soil nails, beneath the reinforcing geogrid.</p>	
<p>Failure Mechanisms: It was determined that the failure was due to the embankment fill having a lower sand content than at the other sites on the A21 and failure occurred because:</p> <ul style="list-style-type: none"> The lower sand content allowed the soil nails to be spaced further apart due to higher soil shear strength. However, this then made shallow slumping between the nails more likely.

Task-0077: SGMs Phase 3	
Soil Nail Case Study	
Area / SGM ID:	Area 4 / 4940
Location	A21 Lower Haysden
SGM Type:	Soil Nails
Scheme Name:	A21 Lower Haysden
Year of Installation:	2011
<ul style="list-style-type: none"> The geogrid facing was designed to prevent the shallow slumping. However, this requires the facing to have an intimate contact with the soil. In reality this was not possible as the higher granular content of the soil made the final trimmed surface more irregular than at the other A21 sites. <p>One of these issues alone would not have been a problem, but both together meant the slumping was able to occur.</p>	
<p>Remediation:</p> <p>The slumping was rectified by unpinning the geogrid facing and excavating the slope to a depth of 1.2m from the crest of the earthwork in 400mm deep benches (phase two). The excavation was lined with geogrid and backfilled with Class 6I well graded granular material, voids above the upper most row of nails were filled with ST2 concrete. The slope facing geogrid was then reinstated following the works.</p>

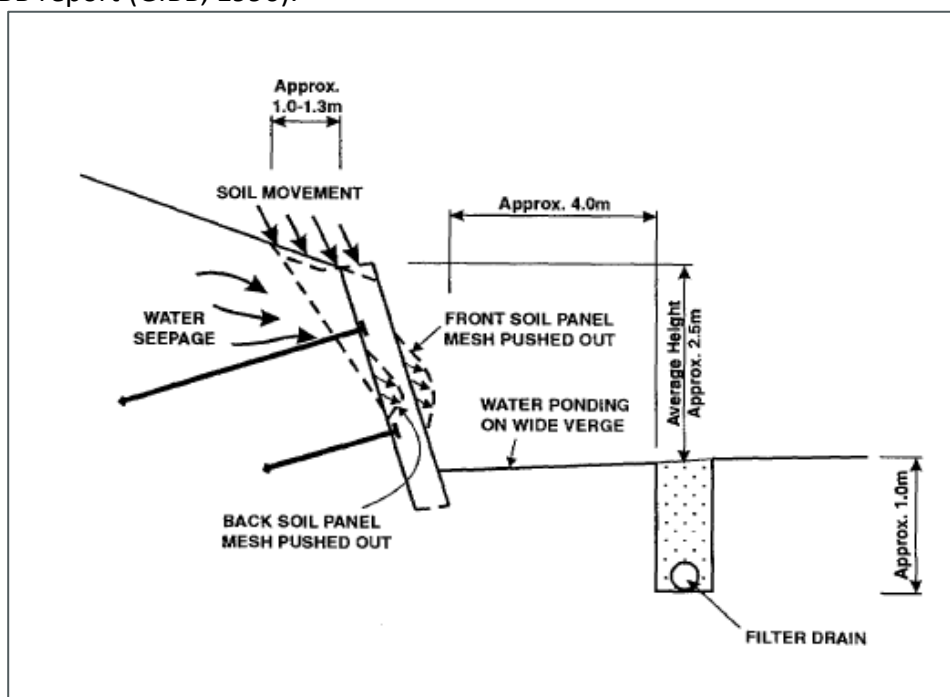
Topsoil, placed between two layers of mesh for the facing, became saturated and in a fluid suspension and was unable to transfer any shear which was required to make the facing work. It acted as a dense fluid and increased pressure on the mesh. The two layers of facing mesh used for the design work separately taking loads by tension only and act as diaphragms, i.e. before they are able to carry any load they need to deform. However, the mesh was not continuous but consisted of panels connected together by clips, which were not capable of providing sufficient connection when significant deformation occurred. Figure 1 below provides an extract of the soil panel failure from the GIBB report (GIBB, 1996).

Figure 1: Extract of Soil Panel Failure Mechanism taken from GIBB 1996a Report.

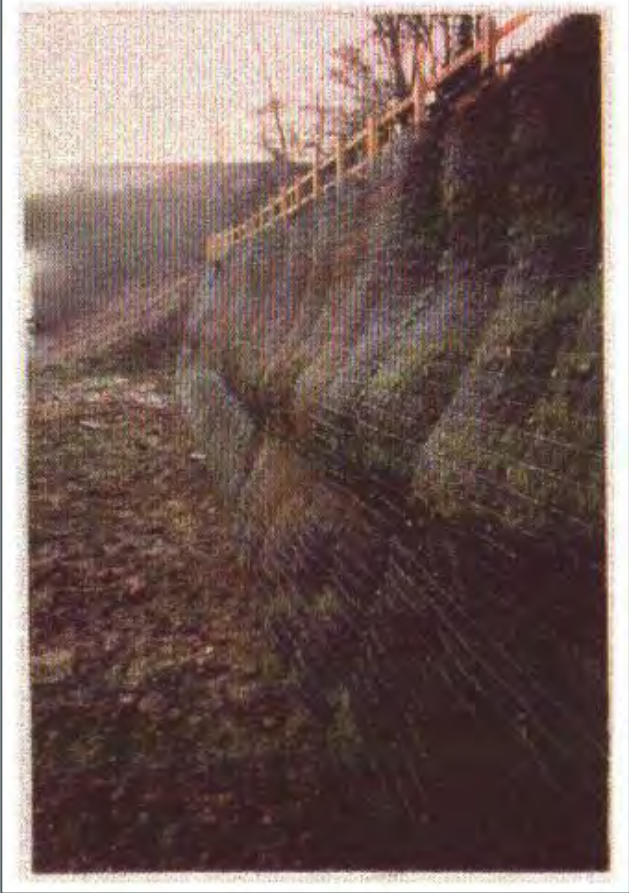
<p>Figure 2: Extract of Soil Panel Failure Plate 1 (image) taken from GIBB 1996a Report.</p>	
<p>Remediation: Remedial action was undertaken including excavating the slipped material, refixing the galvanised steel plates to the slipped plane, excavating the verge and backfilling with a layer of 400mm thick type B filter material connected to the drainage system and backfilling in front of the slope with class 1C rockfill.</p>	
<p>Any Further Information: None</p>

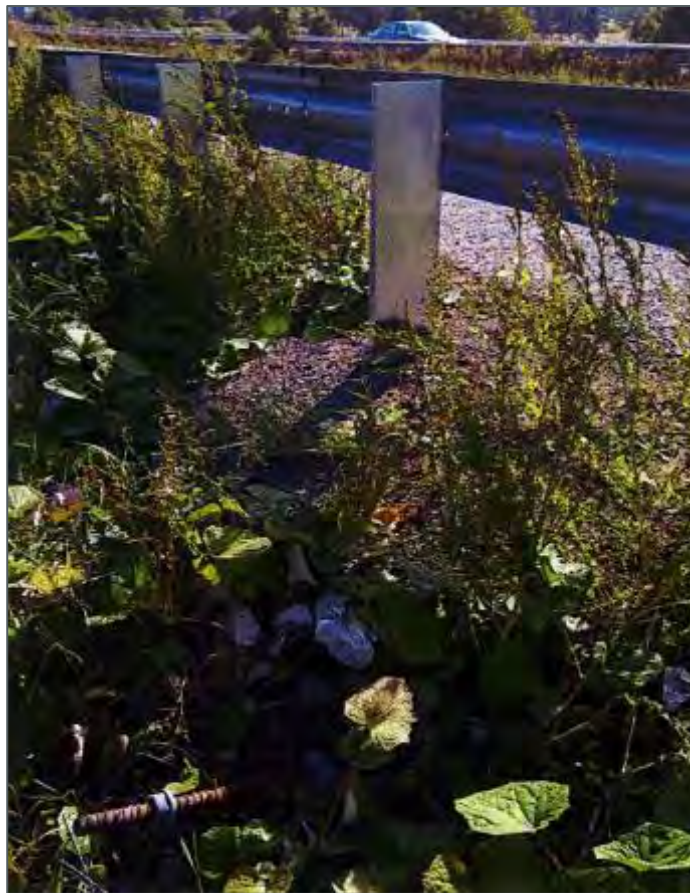
Summary of Failure BBMM were advised by Amey that during a site visit in June 2011, they observed some of the soil nails on the northern side of M23 Gatwick Spur embankment to have been damaged. The site was located on the M23 Gatwick Spur between junctions 9 and 9a where two areas of soil nails had been installed by Atkins in 2003.	
Observations Made on Site: On 15 th September BBMM visited site and two nails were found to be damaged, one was completely missing and one nail was intact but required the nut to be retightened (Figure 1). In addition to the damage to the soil nails, the galvanised steel mesh placed on the slope had been disturbed. During the visit it was also observed that the top row of nails had been installed around 300mm from the crest rather than the 1.35m shown on the design drawings.

Figure 1. Extract of Damaged Soil Nail Photograph 1 (image) taken from BBMM 2011 Report.

No failure mechanism was given; however, discussions with the Area 4 Managing Agents indicated that the nails may have been damaged by a contractor installing the safety barrier at the crest of the embankment.

The upper three rows of soil nails were cut flush with the existing ground level. Replacement nails were installed on a like for like basis at a 0.5m off set to the existing (upper three rows only). A protective coating of galvafrond was used to cover any exposed parts of the nails. 250mm x 250mm x 8mm galvanised mild steel head plates were used to cap the soil nails. The existing mesh covering the slope remained in place.
