PUBLISHED PROJECT REPORT PPR662

Package Order 001/4/45/12 - Traffic Officer Vehicle Conspicuity

Prepared for: Highways Agency,
Project Ref: Package Order 001/4/45/12

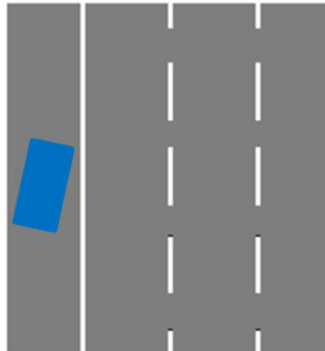
The TOV is parked in 'fend off' when the nose of the vehicle is directed towards the live lane (Figure 1).

Figure 1: TOV parked 'fend off' within the hard shoulder

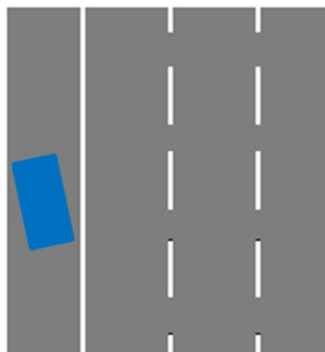
The TOV is parked in 'fend in' when the nose of the vehicle is directed away from the live lane (Figure 2).

Figure 2: TOV parked 'fend in' within the hard shoulder

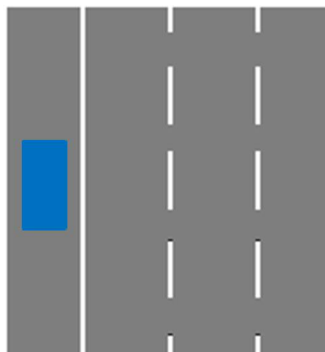
Figure 3 shows the TOV parked 'parallel' within the hard shoulder: the vehicle is positioned such that it is parallel to approaching traffic.

Figure 3: TOV parked 'parallel' within the hard shoulder

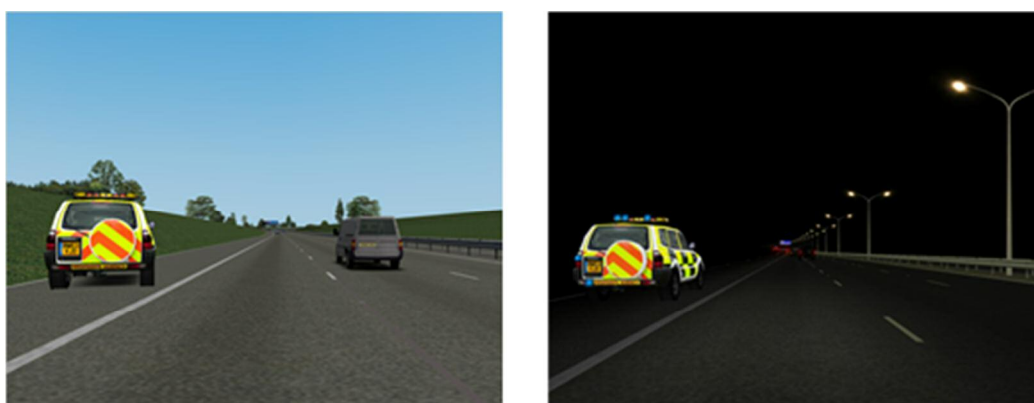
Figure 4: Screenshot from the simulator database, showing the TOV parked fend in (left), and parallel parked, displaying blue flashing lights (right)

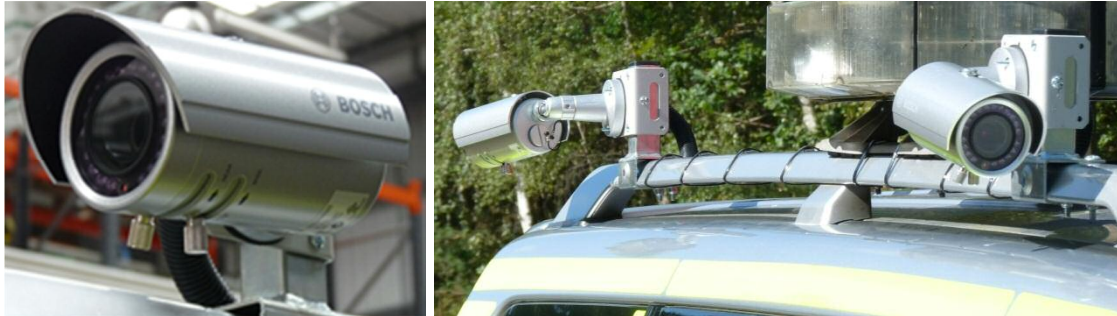
Several suitable manufacturers were provided with the specification; subsequently CSS Group was awarded the task of design, manufacture and fitting of the measurement and logging system. Fitting was undertaken within TRL's vehicle workshops. Figure 5 shows the roof-mounted video cameras; Figure 6 shows the laser distance sensor, mounted on the TOV's spare wheel cover, directed horizontally to the right side of the vehicle at a level where it was expected to measure the widest selection of passing vehicles.

Figure 5: Roof-mounted video cameras

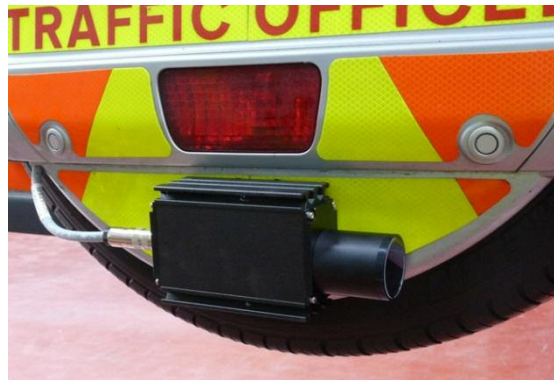
Figure 6: Laser distance measurement sensor, fitted to spare wheel cover on rear of TOV

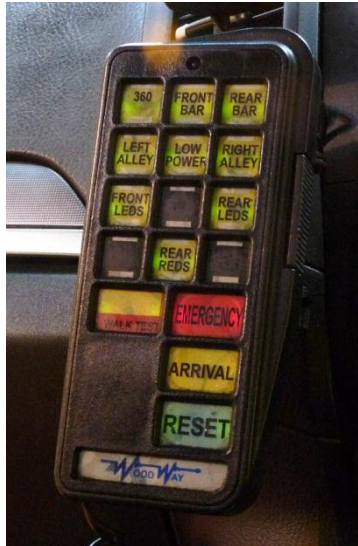
The system was powered from the vehicle's 12V system, and operated via the main lighting control switching system already installed in the TOV. When the TOV was arriving at an incident scene one of the crew would select the 'Arrival' button (while the vehicle was still travelling in a live lane), which operated both amber and red beacons. Connections made within the roof-mounted light bar were used to identify which beacons were in use.

Figure 7: Lighting control panel

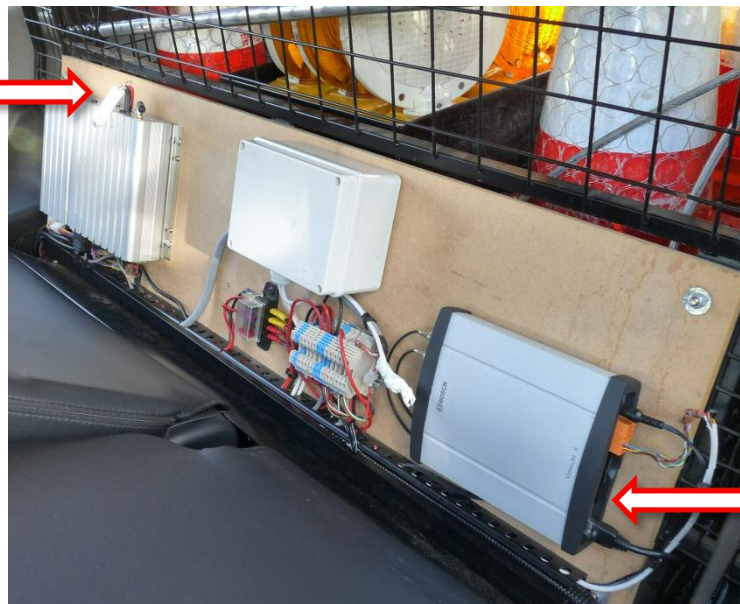
The mobile PC and video recorder were mounted in the TOV's passenger compartment, behind the rear seat back (see Figure 8). Video was recorded onto a CompactFlash card; distance measurements and beacon trigger information were recorded onto USB memory.

Figure 8: Mobile PC (left) and video logger (right) installed into TOV

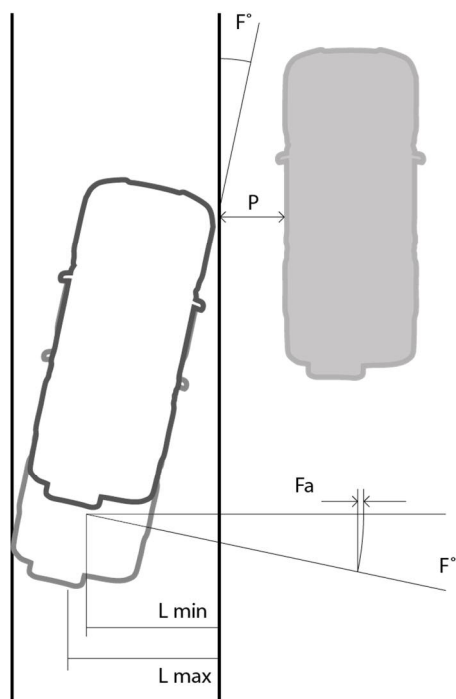
In order to allow for those two inaccuracies, it was necessary to first identify the fend angle at which the TOV was parked and its lateral offset, then adjust the data recorded and supplied for analysis. The variables of fend angle and lateral offset are shown in Figure 9.

Figure 9: Adjustment variables for distances recorded

Lmin and Lmax show the range of lateral offsets possible when the vehicle is parked within the hard shoulder, measured from the laser lens to the edge of the lane marking. The two extreme conditions used during test track calibration when determining the likely ranges of lateral offsets were:

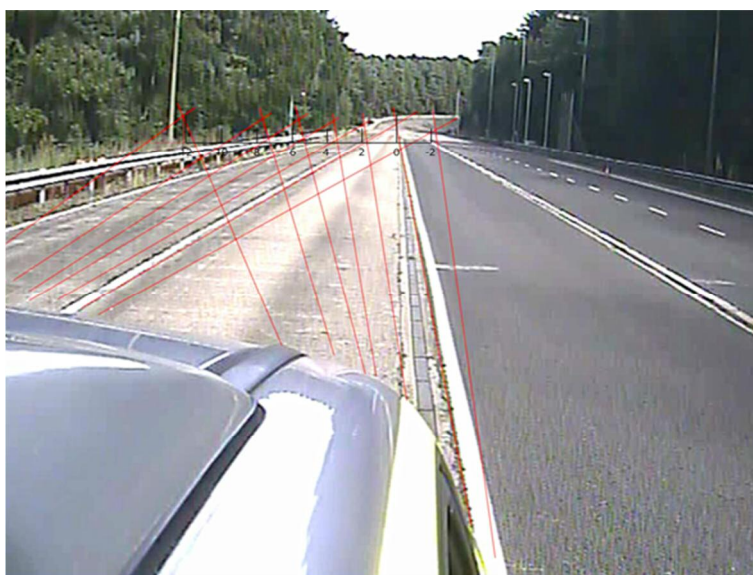
Figure 10 shows a screen image from video taken during calibration on the TRL test track. The horizontal (red) scale was used to identify the angle in degrees (from straight ahead) at which the vehicle was parked. The lines drawn along the carriageway identify, from the white line markings along the track, the 'vanishing point'; a vertical line from that vanishing point to the horizontal scale shows the fend angle (in this example, 0° , i.e. straight ahead).

Figure 10: On-track calibration for fend parking angle

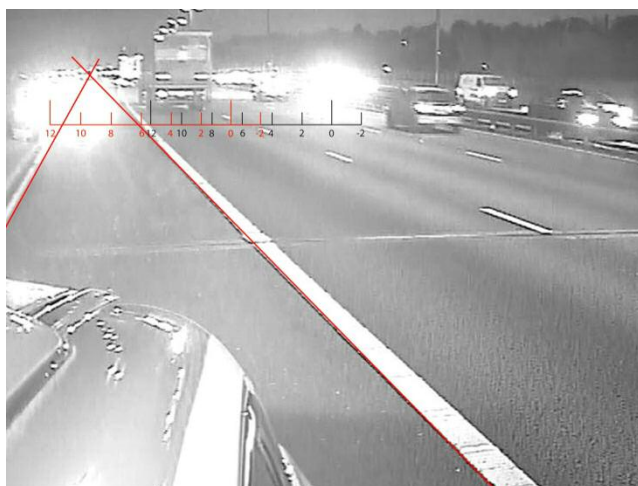
Figure 11 demonstrates how a screen grab from the TOV's forward-facing video can be used to identify the vehicle's fend angle while attending an incident.

Figure 11: Identifying fender angle from incident video

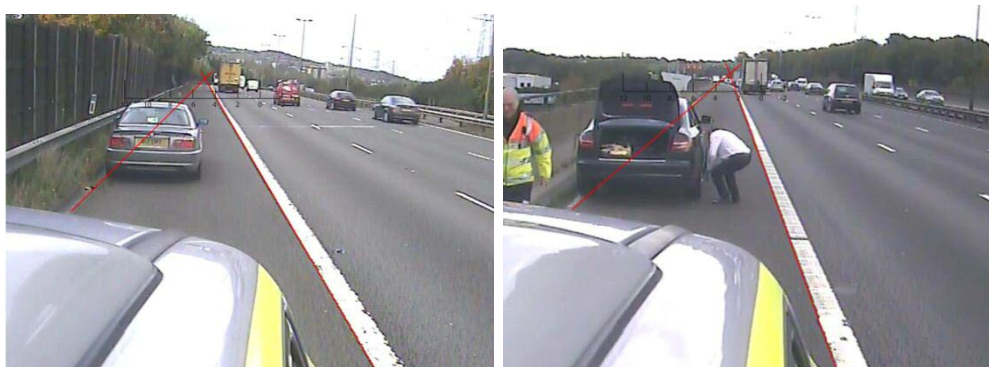
Figure 12 shows how the white line adjacent to the right side of the vehicle appears further away from the TOV in the left image, showing that the TOV is further left within the hard shoulder. It is likely that the TOV is further towards the right of the hard shoulder in the right hand image so that the driver performing the wheel change is afforded some protection from passing traffic.

Figure 12: Determination of fender angle and lateral offset

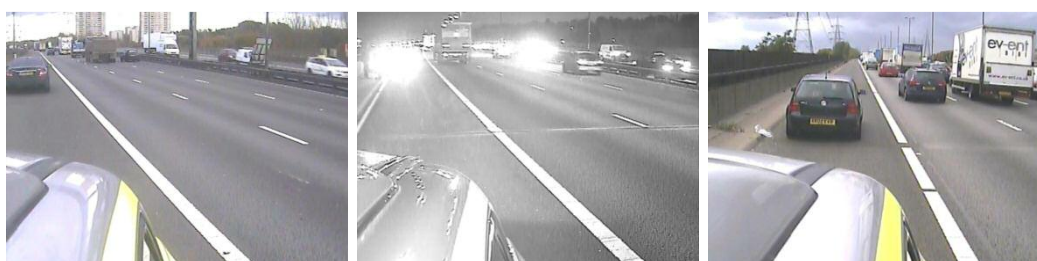
Figure 13 gives further examples of TOV attendance at incidents, showing a variety of fender angles and range of lateral positions within the hard shoulder.

Figure 13: Examples of incidents attended, showing the variety of fender angles and range of lateral positions used

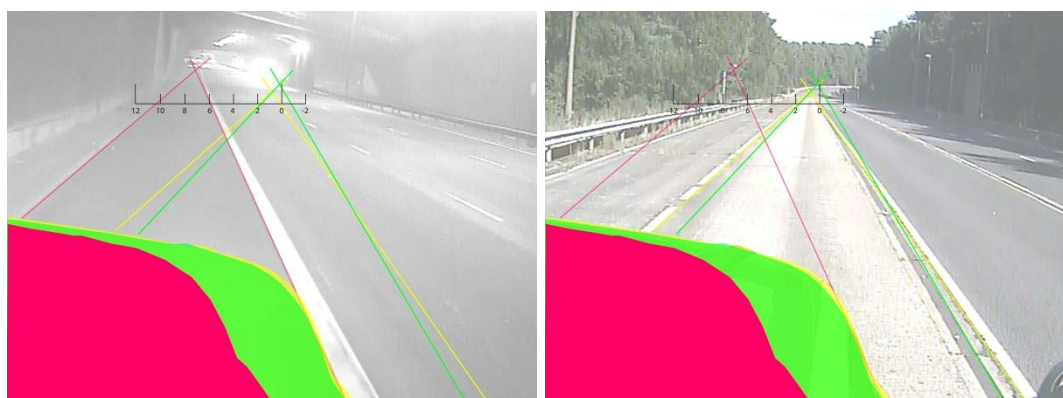
It was found during analysis that, on two occasions between incidents during the on-road trial, the position of the camera had changed, invalidating the pre-calibrated scale. In Figure 14 the bodywork of the TOV, as visible in the camera view, is shown in colour. The green lines and vehicle outline show the original camera view as at system installation; the yellow and red lines and outline show the camera view after the first and second time on which the camera position had changed.

Figure 14: Camera movement. Green (right image) shows original calibration

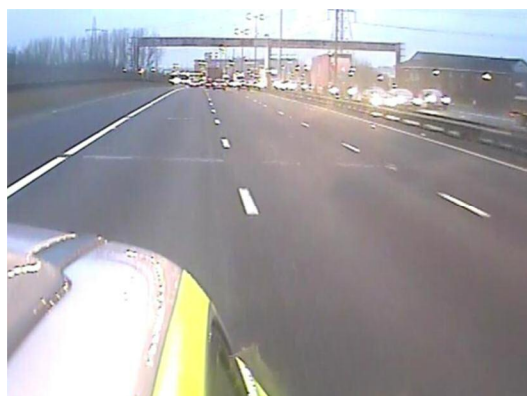
It was possible to re-orientate the 'straight ahead' (i.e. 0° parking orientation) from the video obtained whilst the vehicle was being driven forwards (Figure 15), though this approach did mean that the pre-calibrated scale was not as accurate as it had been previously for angles other than 0° . It was intended that a visit would be undertaken to re-measure and re-calibrate the scale in full, but the collision involving the TOV led to it being written off and so this was not possible. Therefore, accurate measurements could not be obtained from the laser measurement system, and the distances and angles used are therefore approximations only.

Figure 15: Live lane with TOV travelling forward; image as used to reorient the fender angle scale after camera movement

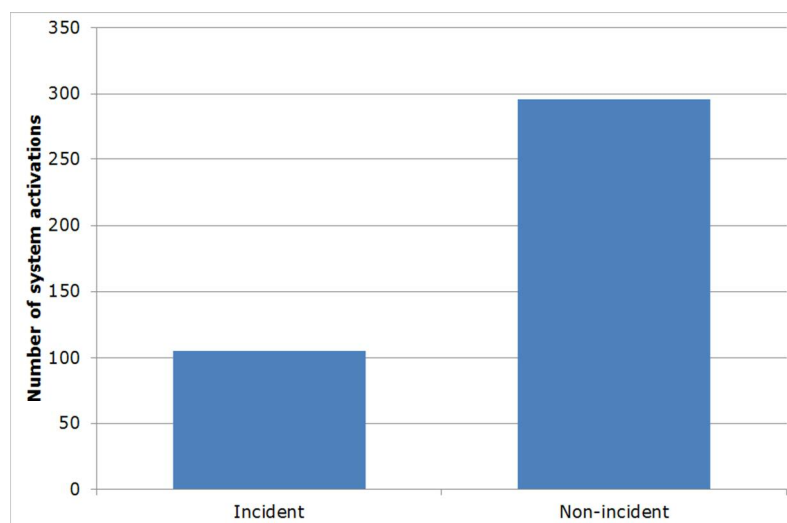
Using the available camera footage, the location of the TOV during each incident was identified. Figure 16 shows the number of system activations recorded split by type.

Figure 16: Number of system activations by type

The majority of the non-incidents occurred when the vehicle was undergoing daily checks (so the beacons were activated) or travelling on link roads accessed via the hard shoulder, hence these were not of interest. There were 105 incidents; of these, incidents were excluded where:

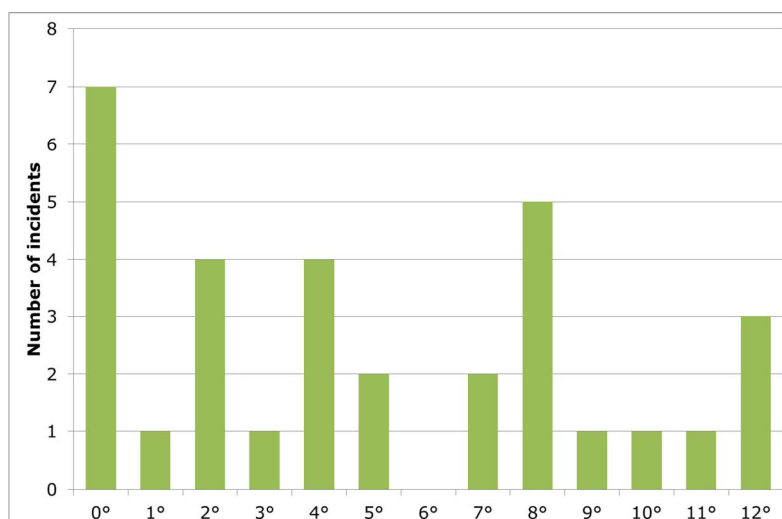
It was possible to analyse estimated fend angles used, although the data available represent only a small sample of the incidents attended by TOVs. Figure 17 provides an indication of the range of fend angles used by TOs when attending an incident. The methods used by TOs to place the vehicle into fend when attending incidents is considered in section 5.1.

Figure 17: Variety of fend angles (degrees) identified (not to scale), and quantities of each orientation recorded

This range shows that 12° is the maximum angle at which the TOVs were parked. Certain road conditions such as an adjacent lane closure, however, may allow the TOV to be parked at greater angles and not encroach on the lane containing passing traffic.

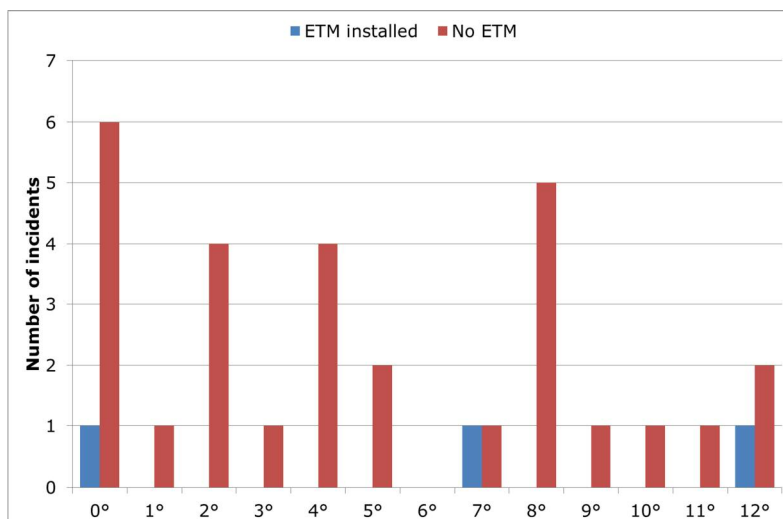
Figure 18: Fend angle selected according to ETM use: ETM deployed (left), no ETM (right)

Given the wide range of fend angles identified, comparisons were made to determine whether these choices were related to factors concerning the incident, such as the vehicles involved or time of day. These comparisons are shown below in Figure 18 to Figure 20.

Figure 18 to Figure 20 suggests that selection of fend angle does not seem to be related to any aspect of the incidents attended.

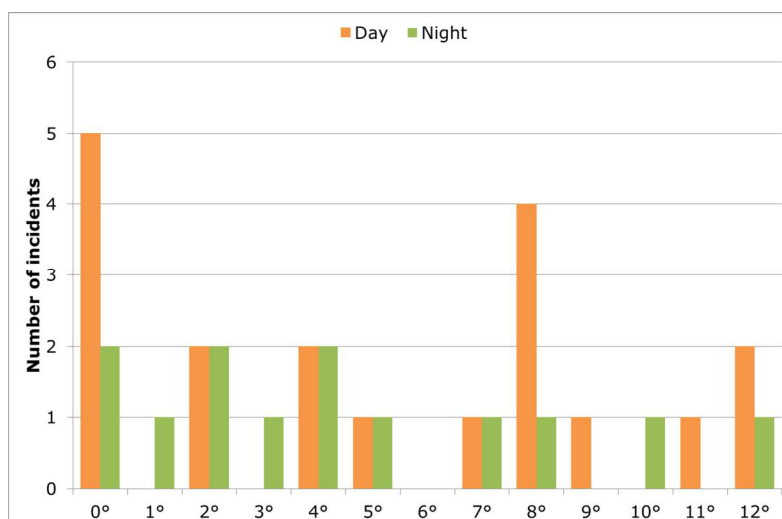
Figure 19: Fend angle selected according to time of day: daytime (left), night time (right)

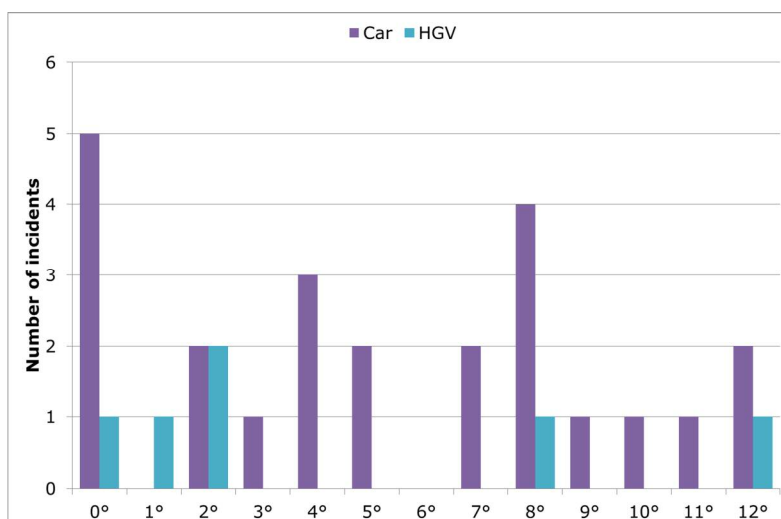
Figure 20: Fend angle selected according to incident vehicle: car (left), HGV (right)

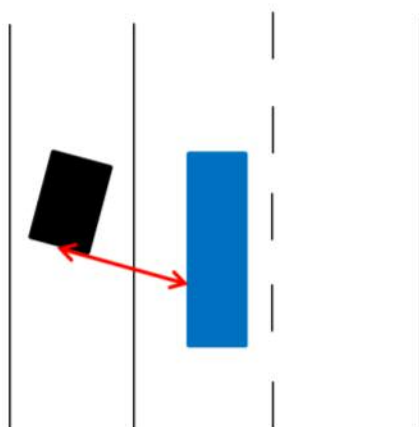
When the vehicle was parked fend off, the distances measured by the laser were as shown in Figure 21.

Figure 21: Laser measurement when parked at fend

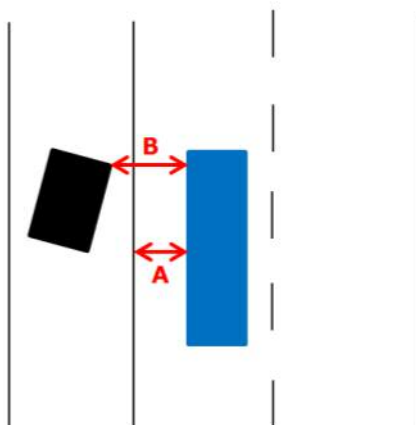
Using trigonometry, the measurements recorded by the laser in each of these incidents were therefore converted into the two measurements shown in Figure 22.

Figure 22: Converted measurements

Distance A is the distance from the rib line to the passing vehicle. Distance B is the distance from the nearest point of the TOV to passing traffic.

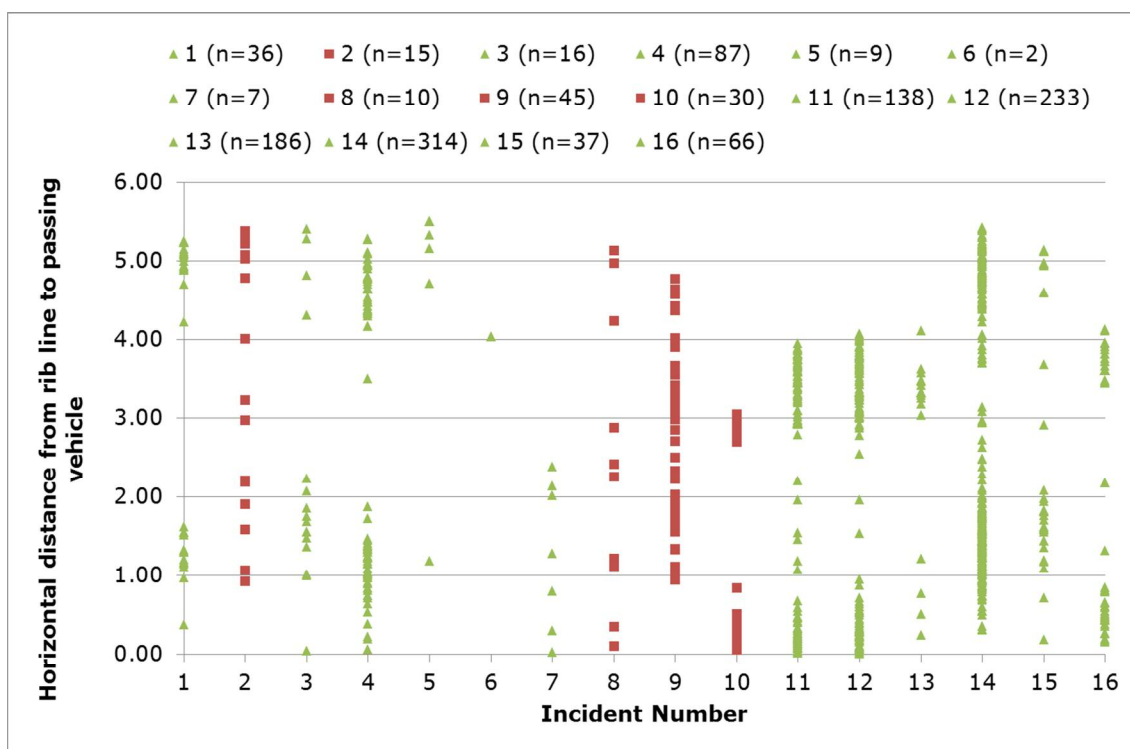
Figure 23 shows the range of distances from the 'rib' line (the line between the hard shoulder and lane 1) to passing vehicles recorded in each incident (distance A). Figure 24 shows the range of distances from the TOV to the passing vehicle (distance B). The legend shows the number of passing vehicles (n) for which measurements were obtained in each incident.

Figure 23: Distance A - horizontal distance from rib line to passing vehicle
[parallel = green, fender = red]

A number of the incidents show two distinct groups of distances; these represent the vehicles in the closest two lanes to the TOV.

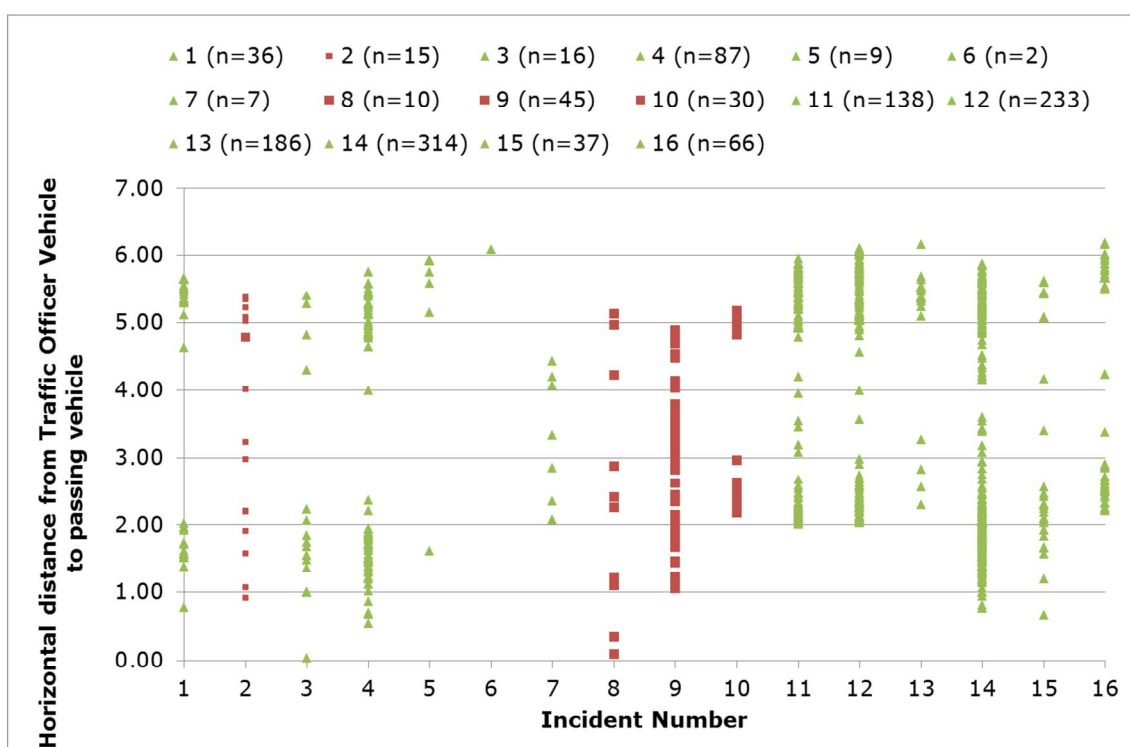
Figure 24: Distance B - horizontal distance from TOV to passing vehicle
[parallel = green, fender = red]

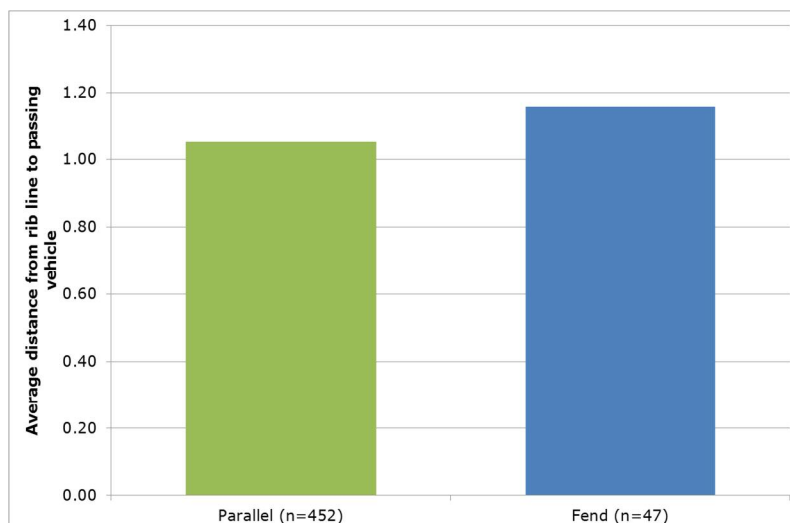
Given that lane widths are typically 3.6m, it was possible to identify those vehicles which were travelling in the lane 1 to the TOV and examine their average distance from the TOV for each of the two fend types. Figure 25 displays the average distance from the rib line to the vehicle passing in lane 1 by fend type. Figure 26 displays the average distance from the TOV to the vehicle passing in the lane 1 by fend type.

Figure 25: Average distance from the rib line to the vehicle passing in the lane 1 by fend type (average distance A)

Figure 25 shows that when the TOV is parked in fend, vehicles in lane 1 were on average further from the rib line separating the TOV from the passing vehicle. Figure 26 demonstrates that when the additional distance to the nearest point of the TOV was incorporated, the average distance was very similar when the TOV was in fend and when it was in parallel. However, given the small sample size, these data are not suitable for statistical analysis.

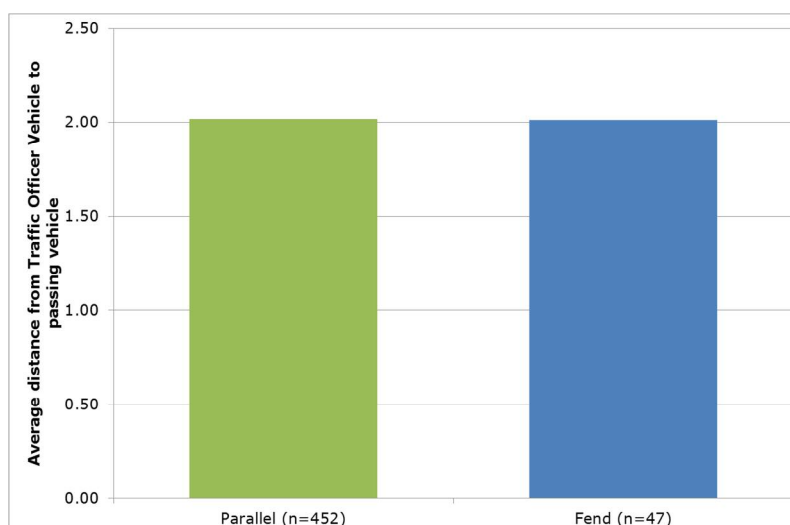
Figure 26: Average distance from the TOV to the vehicle passing in the lane 1 by fend type (average distance B)

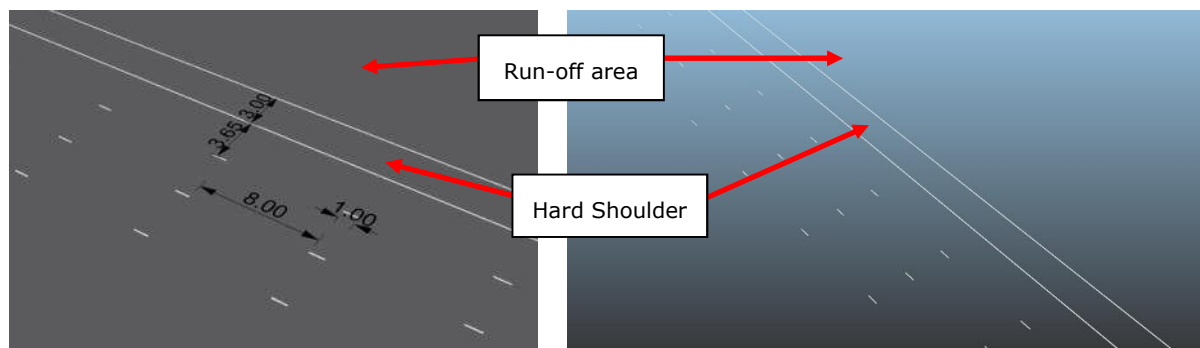
The environment model for this project was created to represent a typical three-lane motorway with a hard shoulder. The model was created within the Rhinoceros 3D modelling software. Lanes 1-3 of the motorway were created with widths of 3.65m and the hard shoulder was 3.00m wide. Dashed white lines were used to separate the 'live' traffic lanes. The line lengths were 1.0 metres and the separation was 8.0 metres. Between the hard shoulder and lane 1 a solid white line was used, with a similar solid white line used to highlight the extents of the hard shoulder (Figure 27).

Figure 27: The three-lane motorway with hard shoulder and flat run-off area environment model

The motorway environment was simulated to be flat and therefore did not include any provision for camber or cross fall as may occur on some sections of highway. The area to

the nearside of the hard shoulder was created as a flat 'run-off' area. Whilst this area may not necessarily be representative of the environment in the real-world due to the inclusion of concrete barriers, grass embankments etc., it provided an opportunity to investigate the interaction between a striking vehicle and the TOV parked on the highway, as well as the potential route the vehicles would follow post-collision.

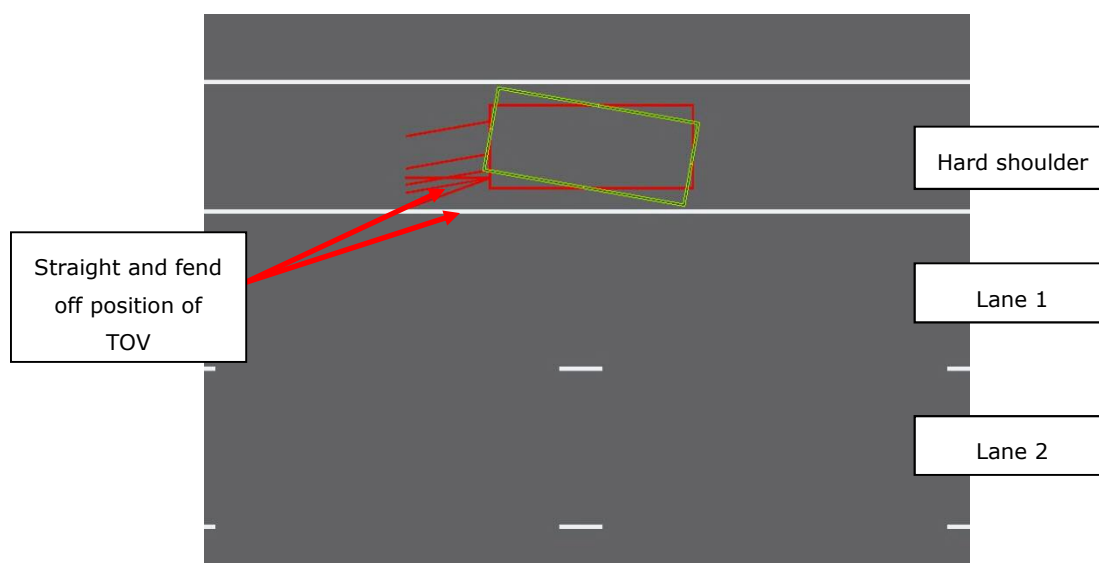
To help with the alignment of the vehicle models within the HVE environment, lines were added to the surface model to show the orientation and position of the impacting vehicle and the position and orientation of the TOV (see Figure 28). The angle of impact, overlap and angle of the TOV on the hard shoulder will be discussed later.

Figure 28: Lines laid onto the surface of the hard shoulder to show the position of the stationary TOV

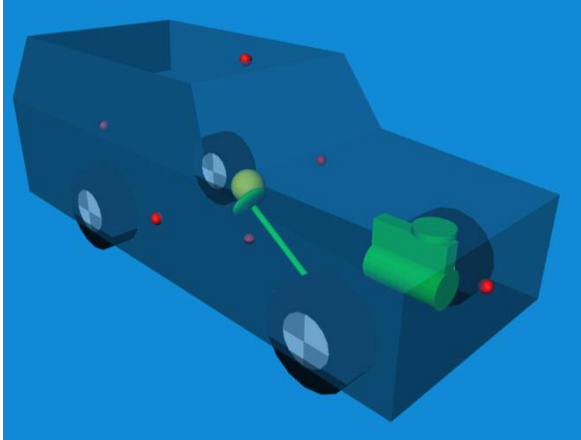
Table 7: Summary of the HA Traffic Officer Vehicle specification in HVE

Actual Vehicle Specification		HVE Vehicle
Ground Clearance	220mm

Wheelbase	2780mm	
Front Overhang	750mm	
Rear Overhang	1175mm (bumper)	
	1305mm (wheel carrier)	
Wheels and Tyres	265/60 R18 (265/70 R16 used in HVE)	
Kerb Weight	2265kg	
Loaded Vehicle Weight	2630kg

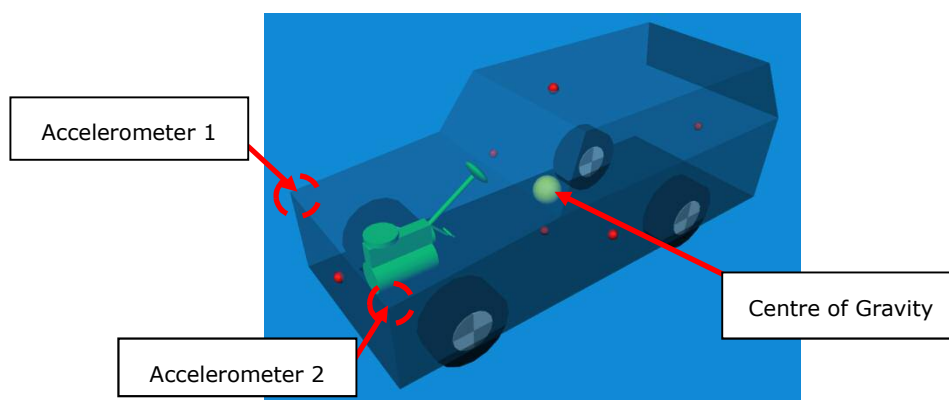
The deflection and the route of the TOV after the collision formed part of the analysis. To provide a 'map' of the deflection, it was necessary to identify the location of specific points of the vehicle and be able to track these. The X, Y and Z position of the centre of gravity and two further points are required to enable not only the location but the specific orientation of the vehicle to be known. Within HVE it is possible to 'place' virtual accelerometers at specific coordinate locations on the vehicle. Due to the vehicle being impacted at the rear and thus the rear of the vehicle sustaining deformation the accelerometers are placed on the front nearside and offside corners (Figure 29). From these accelerometers it is possible to obtain their location at a specific instant in time.

**Figure 29: Location of the accelerometers on the TOV model to determine the displacement and orientation of the vehicle post-collision**

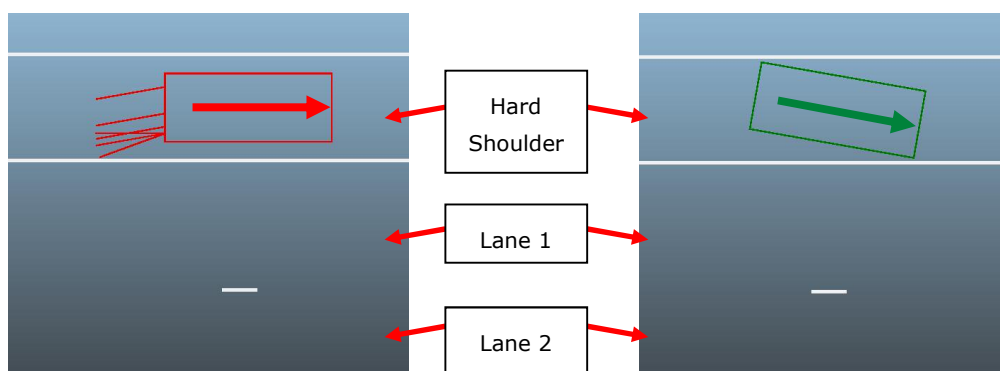
The first orientation of the TOV was such that it was straight within the hard shoulder lane (i.e. parallel to the line of the road) and central (laterally) within its lane. The second orientation was such that the vehicle was angled at 10 degrees to the straight ahead direction in a fend off position (Figure 30). The wheels of the TOV were straight (in the line of the vehicle) with zero steering angle in both vehicle orientations.

Figure 30: The orientation of the TOV in the straight and fend off position within the hard shoulder

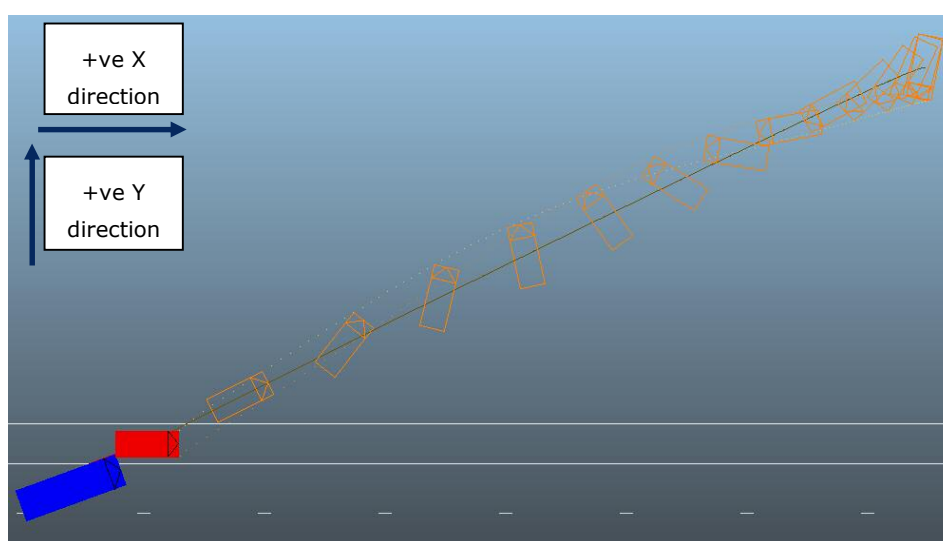
An example of the output from the simulation is shown in Figure 31. This shows Run 3, where the TOV was positioned straight in the hard shoulder lane, the collision overlap was 10% and the lorry approach angle was 20 degrees. The centre of gravity point of the TOV in Run 3 was displaced approximately 58 metres in the X direction (longitudinal movement along the road) and 28 metres in the Y direction (lateral movement, perpendicular to the road). The total (vector) distance travelled by the centre of gravity of the TOV in Run 3 was approximately 64 metres.

Figure 31: The displacement and track of the TOV following the impact from the lorry when the TOV was straight and the lorry was overlapping by 10% and approaching at an angle of 20 degrees (Run 3)

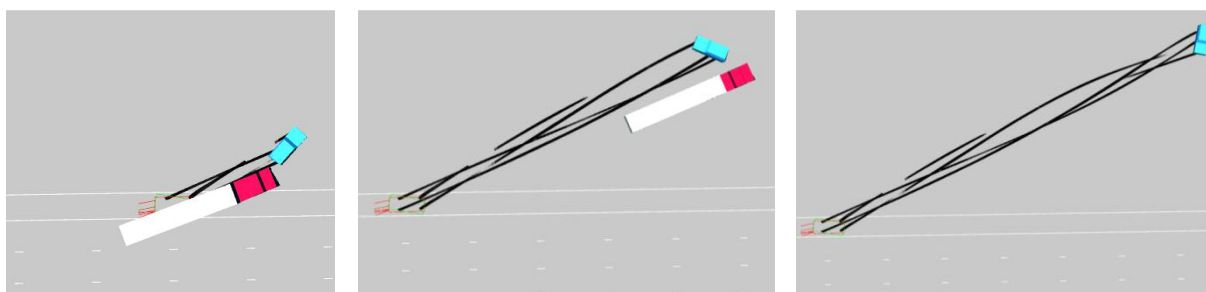
Figure 32 shows the position of the vehicle at various stages of the Run 3 simulation, taken from the HVE software. These can be compared with the vehicle position analysis shown above.

Figure 32: Images of Run 3 from the HVE software, the TOV was stationary and straight in the hard shoulder pre impact

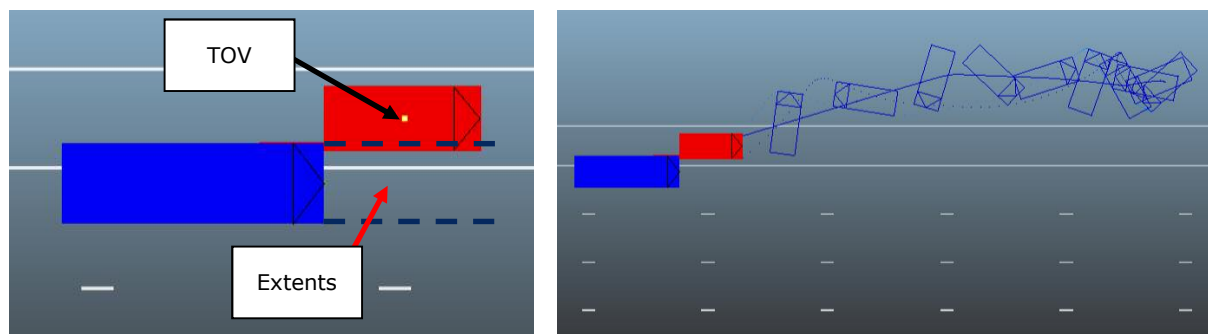
The point of impact on the TOV with respect to its centre of gravity position determines how the vehicle will rotate or displace after the collision. For example if the point of collision is such that the extents of the front of the lorry (thus the direction of force) are not aligned with the centre of gravity of the TOV then it will cause the vehicle to rotate (Figure 33).

Figure 33: Run 1 simulation configuration showing the alignment of the extents of the lorry and the TOV centre of gravity position

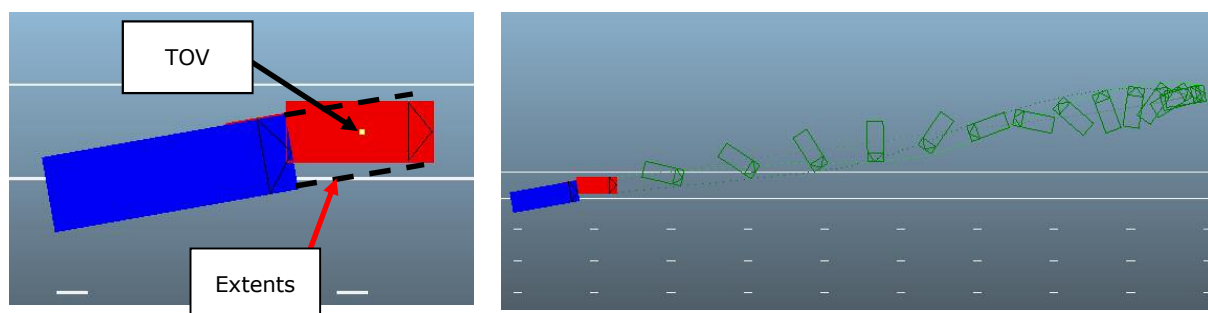
If, however the centre of gravity of the TOV lies within the width of the lorry at impact then the TOV will effectively be 'pushed' in the direction of the lorry (Figure 34). The reason for this is due to how the principle direction of force acts about the centre of gravity of the TOV. When the percentage overlap is low (i.e. Run 1), the exchange of momentum is lower and a larger proportion of the energy from the collision that is transferred to the TOV is then dissipated in its rotation and thus the displacement of the vehicle is lower. Vice versa, when the interaction overlap is larger (i.e. Run 6) a lower proportion of the energy from the collision will be dissipated through rotation, thus the displacement of the TOV will be larger.

Figure 34: Run 6 simulation configuration showing the alignment of the extents of the lorry and the TOV centre of gravity position

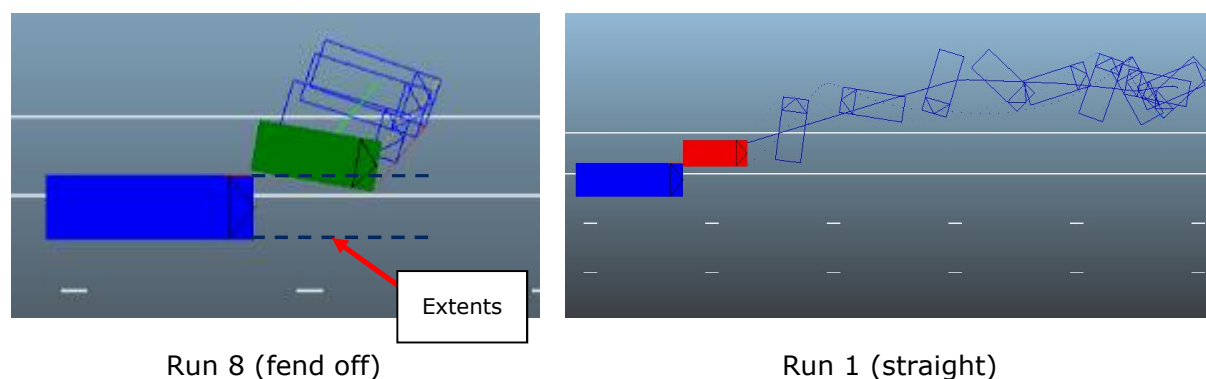
With regard to the simulations when the TOV was parked on the hard shoulder in a fend off position the displacement of the vehicle was found to alter. This was predominantly due to the effect of the point of impact changing. For example Run 1 (straight) and Run 8 (fend off) consisted of the same approach angle and overlap, however, due to the orientation of the TOV the point of impact on the vehicle changed and thus it changed how the TOV was displaced (Figure 35).

Figure 35: The displacement route of the TOV following the collision with the lorry in Run 8 (fend off) and Run 1 (straight) showing the difference due to the differing impact points

In Run 8, it is effectively a glancing contact between the lorry and the TOV, hence the reason for the vehicle appearing to travel sideways post impact. The two dimensional plan of the track and rotation of the fend off TOV post impact are shown in Appendix B. Table 12 shows a summary of the displacement of the centre of gravity of the TOV when it was parked in a fend off position in the hard shoulder for each of the simulation runs.

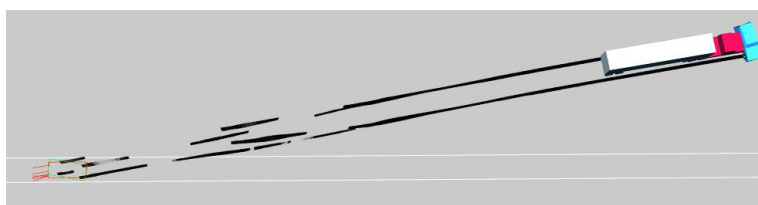
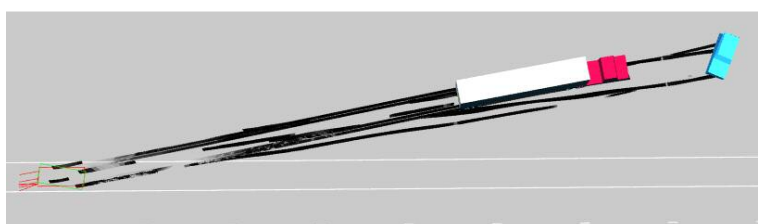
Run 13 was the impact configuration where it was found that the unbraked impacting lorry continued to push the TOV after the collision. Whilst this is possible, it is more likely that the driver of the impacting vehicle would react to the collision and apply the brakes or at minimum remove any application to the throttle. Consequently, Run 13 was re-run with the brakes of the tractor unit being applied immediately after the collision to remove the secondary contact and the pushing of the TOV by the lorry. This simulation has been termed Run 13A (Figure 36).

Run 13 (Lorry unbraked)

Run 13A (Lorry braked)

Figure 36: Comparison of Run 13 where the lorry is unbraked and braked

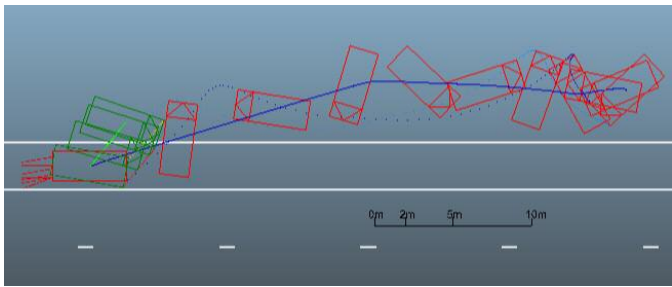
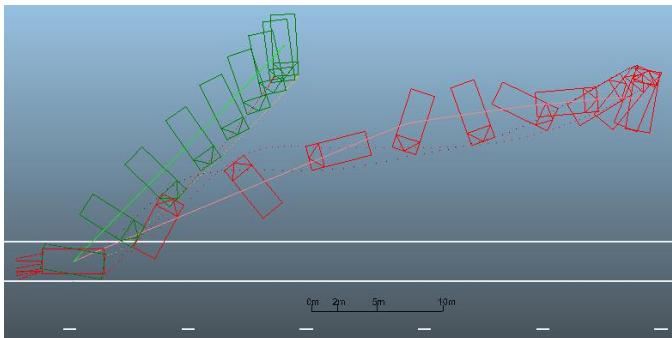
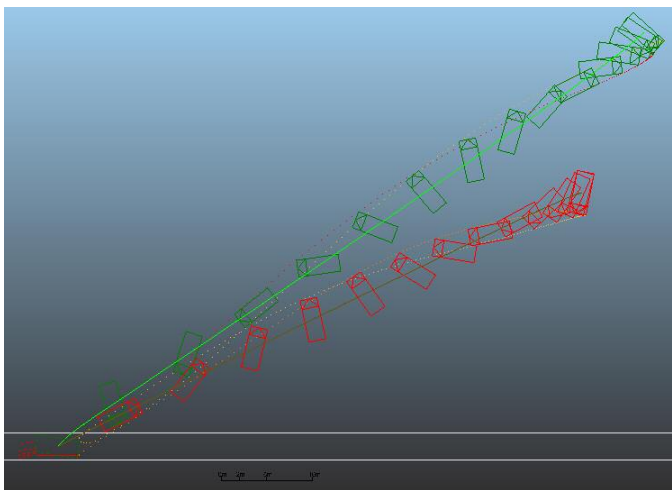
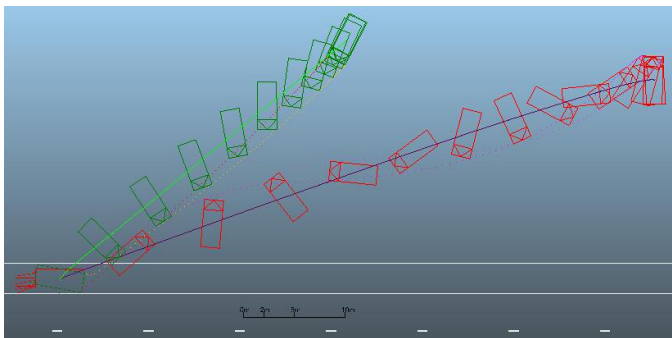
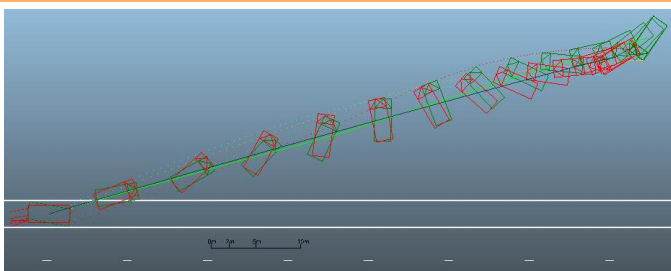
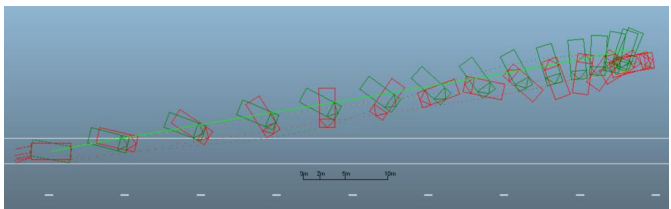
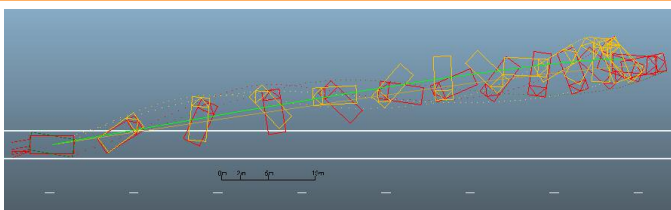
Table 13: A comparison of the effect of the two orientations of the stationary TOV on its trajectory when impacted by the lorry in the HVE simulation.

Table 13 demonstrates the effect on the TOV trajectory due to the two different orientations of the vehicle when stationary. It is seen from the above that the collision configurations where the overlap is greater and thus the extent of the impacting vehicle encompasses more of the TOV and its centre of gravity, the more similar the post-collision trajectory of the vehicle. When the alignment causes a glancing style collision or where it causes the TOV to undertake significant rotation about its centre of gravity, the trajectories are noted to differ. In certain configurations the straight TOV orientation rotated in an opposite direction to that of the fend off orientation and this is mainly due to the point of impact on the vehicle and the influence that has upon how the energy of the collision acts around the centre of mass of the vehicle. However, due to the TOV currently being permitted to park in either of these configurations on the hard shoulder, all of the simulations and the consequent trajectories of the TOV should be considered.

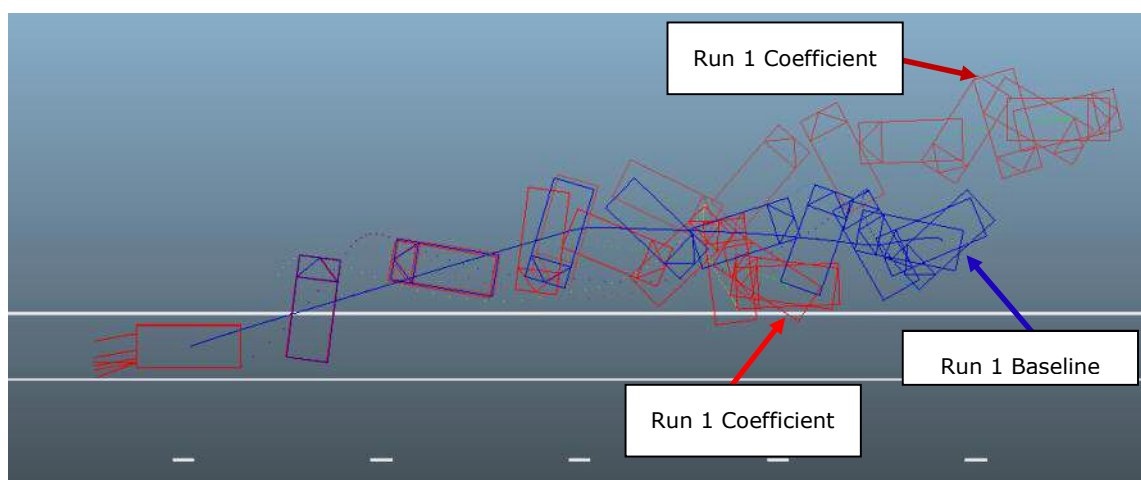
The effect of the friction was such that, if the coefficient of friction between the tyres and road surface was increased (i.e. higher level of 'grip') then the TOV would not be displaced as far due to the increased resistance to the locked tyres travelling over the surface. With the coefficient of friction between the tyres and road surface reduced (i.e. lower level of 'grip') then the resistance to the tyres sliding across the road surface is lower and the TOV travels further post-collision (Figure 37). As mentioned earlier in the report a road surface does not have a particular coefficient of friction, as it is a function of the interaction between the vehicle tyres and the road surface. In addition the environmental conditions at the time of the collision are also likely to affect the coefficient of friction between the vehicle tyres and the road surface. If the road surface is dry, wet or icy it will affect the coefficient and thus potentially affect the displacement of the vehicle.

Figure 37: The track and displacement of the TOV in the HVE Simulation in Run 1 showing the effect of a change in coefficient of friction between the tyres and the road surface

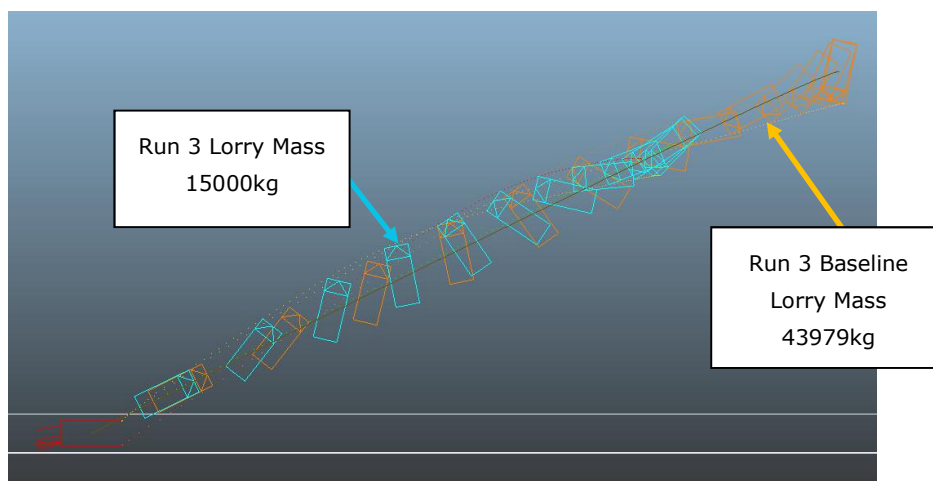
The HVE sensitivity analysis simulations showed that when the TOV was stationary on the hard shoulder, reducing the mass of the impacting vehicle resulted in the overall displacement being reduced. This is due to the energy involved in the collision. For example for the baseline tests, the kinetic energy of the lorry immediately prior to the point of collision (approximately 44,000kg and 96km/h) was approximately 15,644kJ. Comparing this with the kinetic energy of the lorry when its mass has been reduced by approximately two thirds to 15,000kg (at 96km/h) the energy of the collision reduces to approximately 5,333kJ. Therefore due to the law of conservation of energy (energy cannot be created nor destroyed, only transferred one form to another), the higher mass lorry has a greater impact energy to impart upon and transfer to the TOV during the collision and thus the TOV will travel further post-collision (Figure 38).

Figure 38: The track and displacement of the TOV in the HVE Simulation in Run 3 showing the effect of a change in mass of the impacting vehicle
