PUBLISHED PROJECT REPORT PPR662

Package Order 001/4/45/12 - Traffic Officer Vehicle Conspicuity

Prepared for: Highways Agency,
Project Ref: Package Order 001/4/45/12

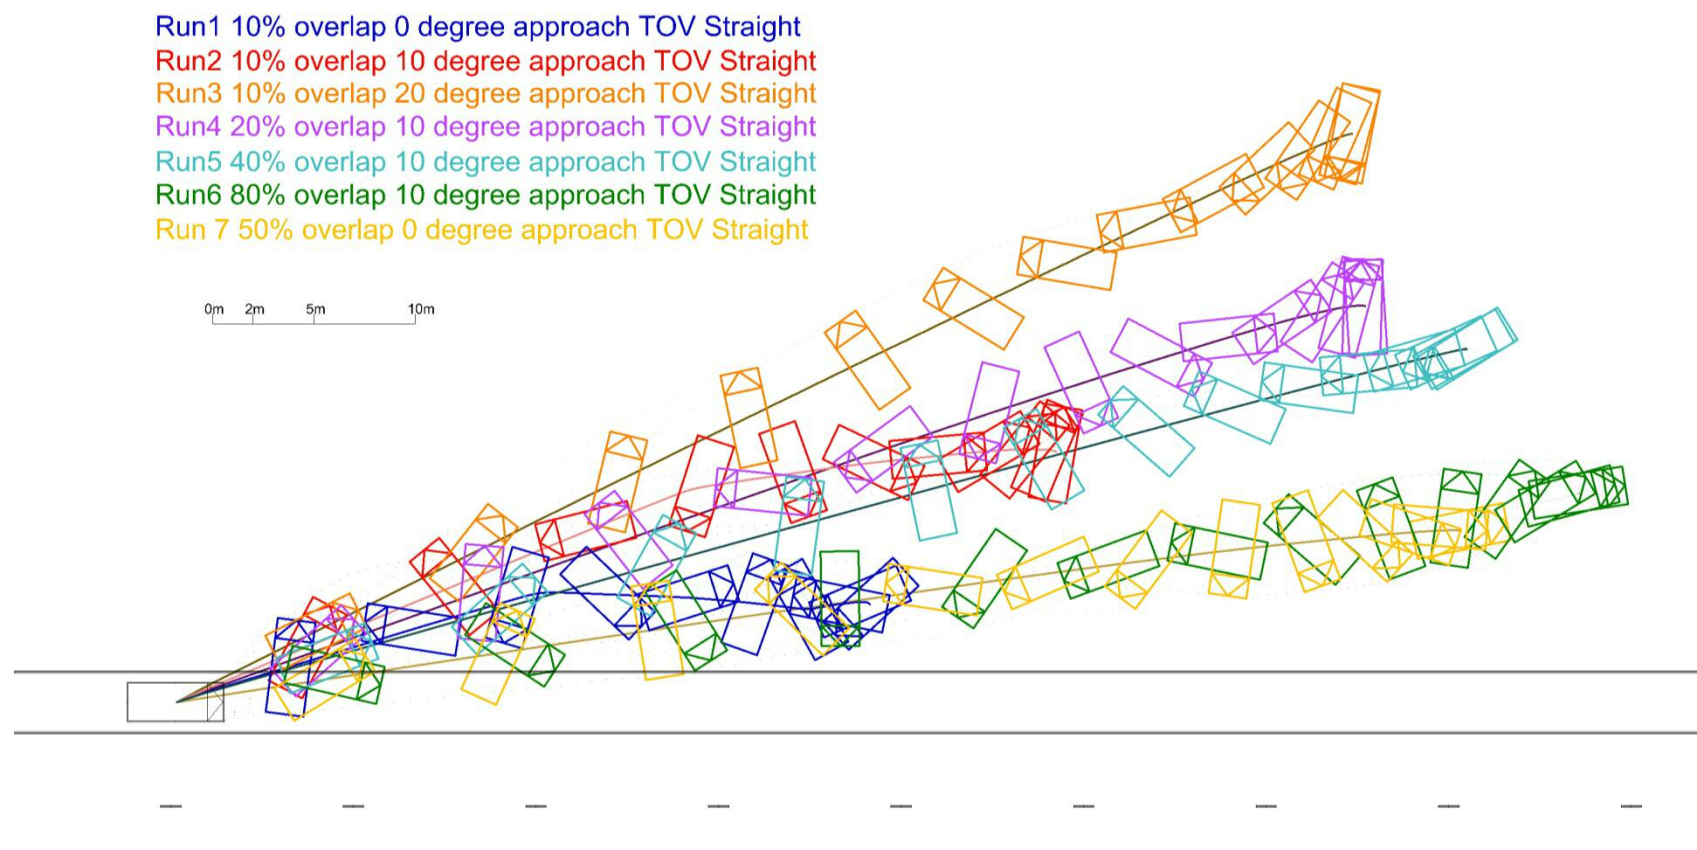
Figure 40 below shows the seven baseline simulation runs performed when the TOV was initially stationary and aligned straight in the hard shoulder. In the HVE simulations in the X direction (i.e. along the carriageway) the maximum displacement of the TOV is approximately 70 metres measured from the front offside corner of the HA vehicle in its pre-impact position to the furthest extent of the vehicle in Run 6. The largest displacement in the HVE simulation of the TOV in the Y direction is approximately 32

Figure 40: Overlay of the displacements of the TOV in the HVE simulations when the TOV is initially stationary and straight within the hard shoulder

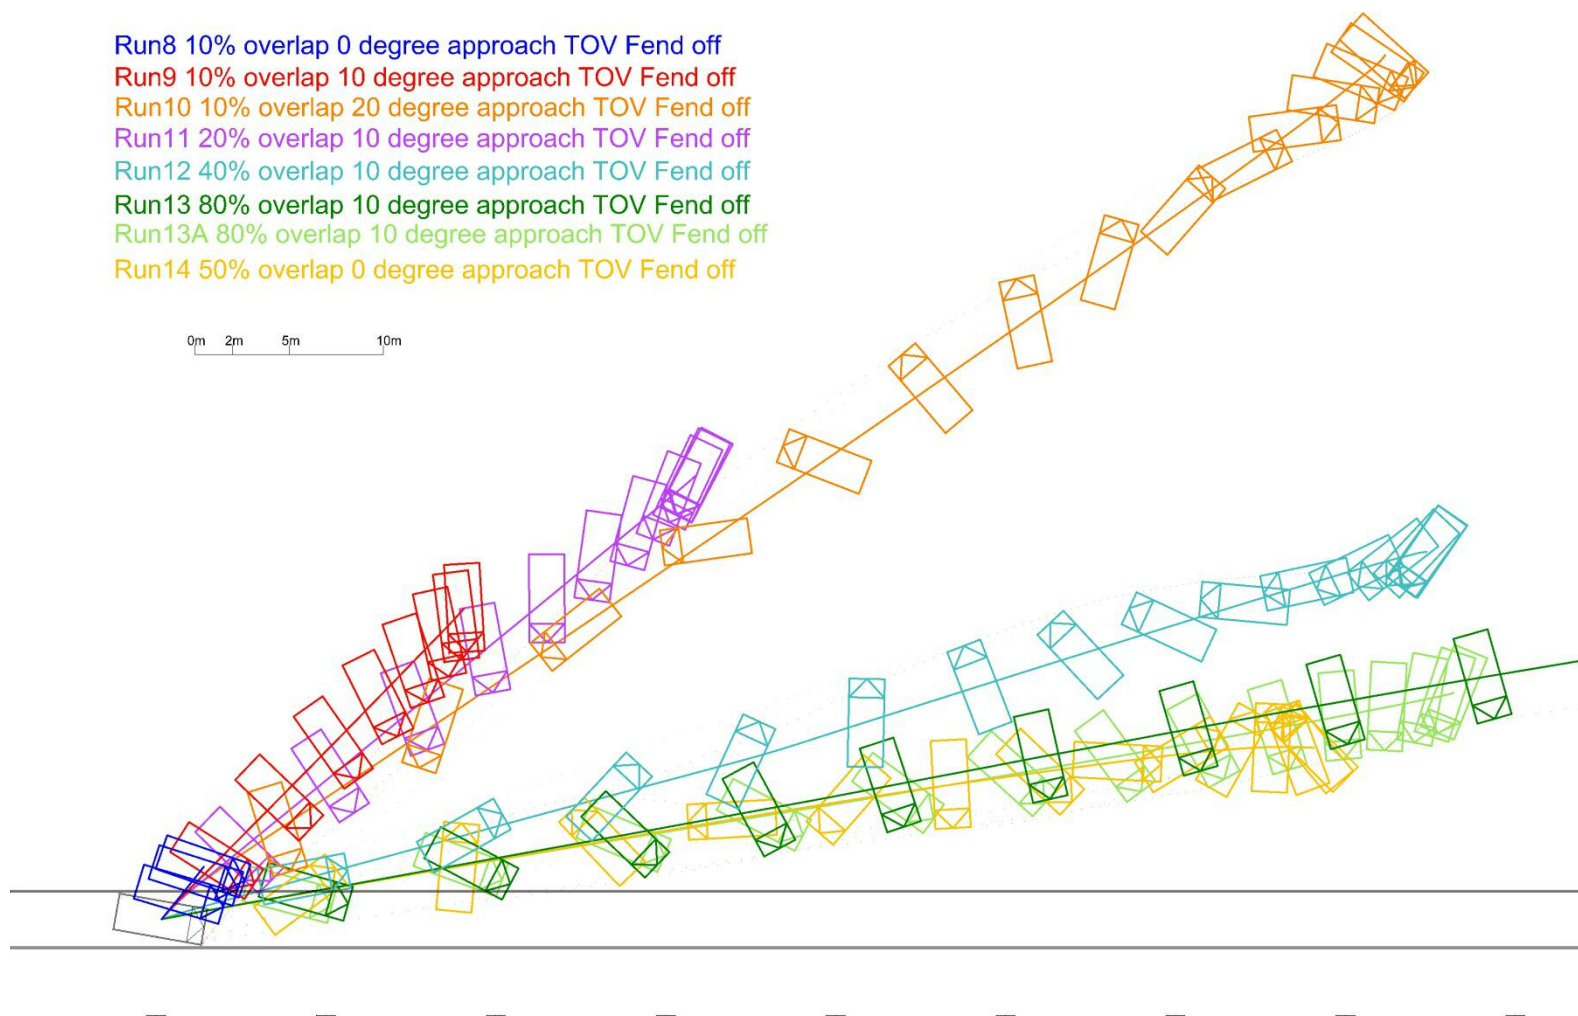
Figure 41: Overlay of the displacements of the TOV in the HVE simulations when the TOV is initially stationary and in a fend off position within the hard shoulder

Figure 41 shows the eight baseline simulation runs performed when the TOV was initially stationary and in the fend off position. The additional run (Run 13A) is included and shows the displacement of the TOV when the lorry is braked and does not have a secondary impact as is the case in Run 13. In the HVE simulation the maximum deflection in the X direction when the TOV is initially in the fend off position was approximately 70 metres (not including the Run 13 where the TOV was 'pushed' by the unbraked lorry) measured from the front offside corner of the HA vehicle in its pre-impact position to the furthest extent of the vehicle in Run 13A. The largest displacement based upon the results from the HVE simulation of the TOV in the Y direction was approximately 50 metres measured from the front offside corner of the TOV in its pre-impact position to the furthest extent of the vehicle in Run 10.

Due to the point of impact on the TOV when it is in the fend off position and the approach angle of the lorry, it is possible in some of the configurations that the lorry impacts the side of the TOV. This can cause the vehicle to be displaced sideways. It is noted that this does not occur when the TOV is straight within the hard shoulder. Consequently, if the TOV is to be positioned in a fend off orientation the TOs should be aware that standing by the side of the vehicle may cause them to be struck by the TOV if it is impacted.

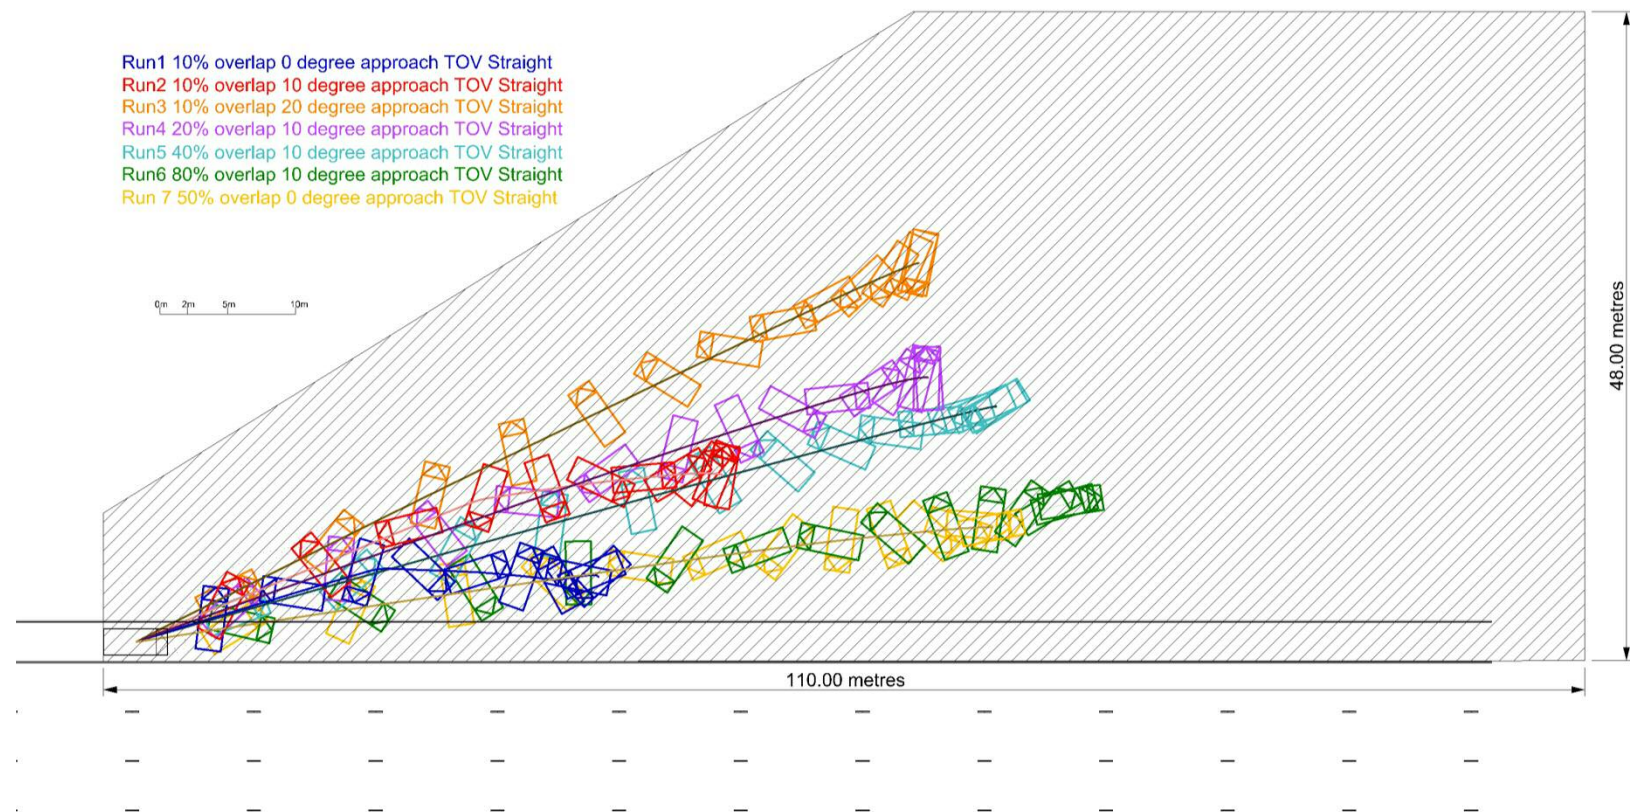
Figure 42: The area including a margin of safety believed from the simulation analysis to be unsafe for a person to stand within when the TOV is stationary in a straight orientation.

Due to the sensitivity analysis finding that changes to variables such as the coefficient of friction can affect the overall displacement of the vehicle, it is important to add a margin onto the maximum displacement in the baseline results to account for this. Whilst the absolute maximum value that the TOV could be displaced is unknown (due to the possibility that the vehicle could be left without the four wheel drive engaged or the handbrake applied for example), assuming these precautions are taken it is prudent to consider a safety margin of the order of 50%. Therefore, this would increase the zone of possible displacement with regard to the straight TOV simulations to 105 metres in the X direction and 48 metres in the Y direction. For the vehicle being stationary in the fend off position the zone of displacement would increase to 105 metres in the X direction and 75 metres in the Y direction (both measured from the front nearside of the vehicle). The figure calculated for the X direction possible displacement zone is similar to that calculated by the Dutch Forensic Institute (The Netherlands Traffic Management Centre, 2005). The calculations do not take into consideration a vehicle being deflected from an embankment or road side restraint into the live lanes.

As mentioned previously, in the simulations with the TOV in the fend off position if the collision configuration is such that the impact is glancing (i.e. Run 8) then the TOV is displaced in a sideways direction. Consequently it is not recommended that any person stand forwards of the rear of the vehicle, irrespective of how the TOV is orientated. Therefore, any zones believed to be unsafe for a person to stand within should also include the length of the vehicle. This increases the X direction of the zone to approximately 110 metres (Figure 42 and Figure 43).

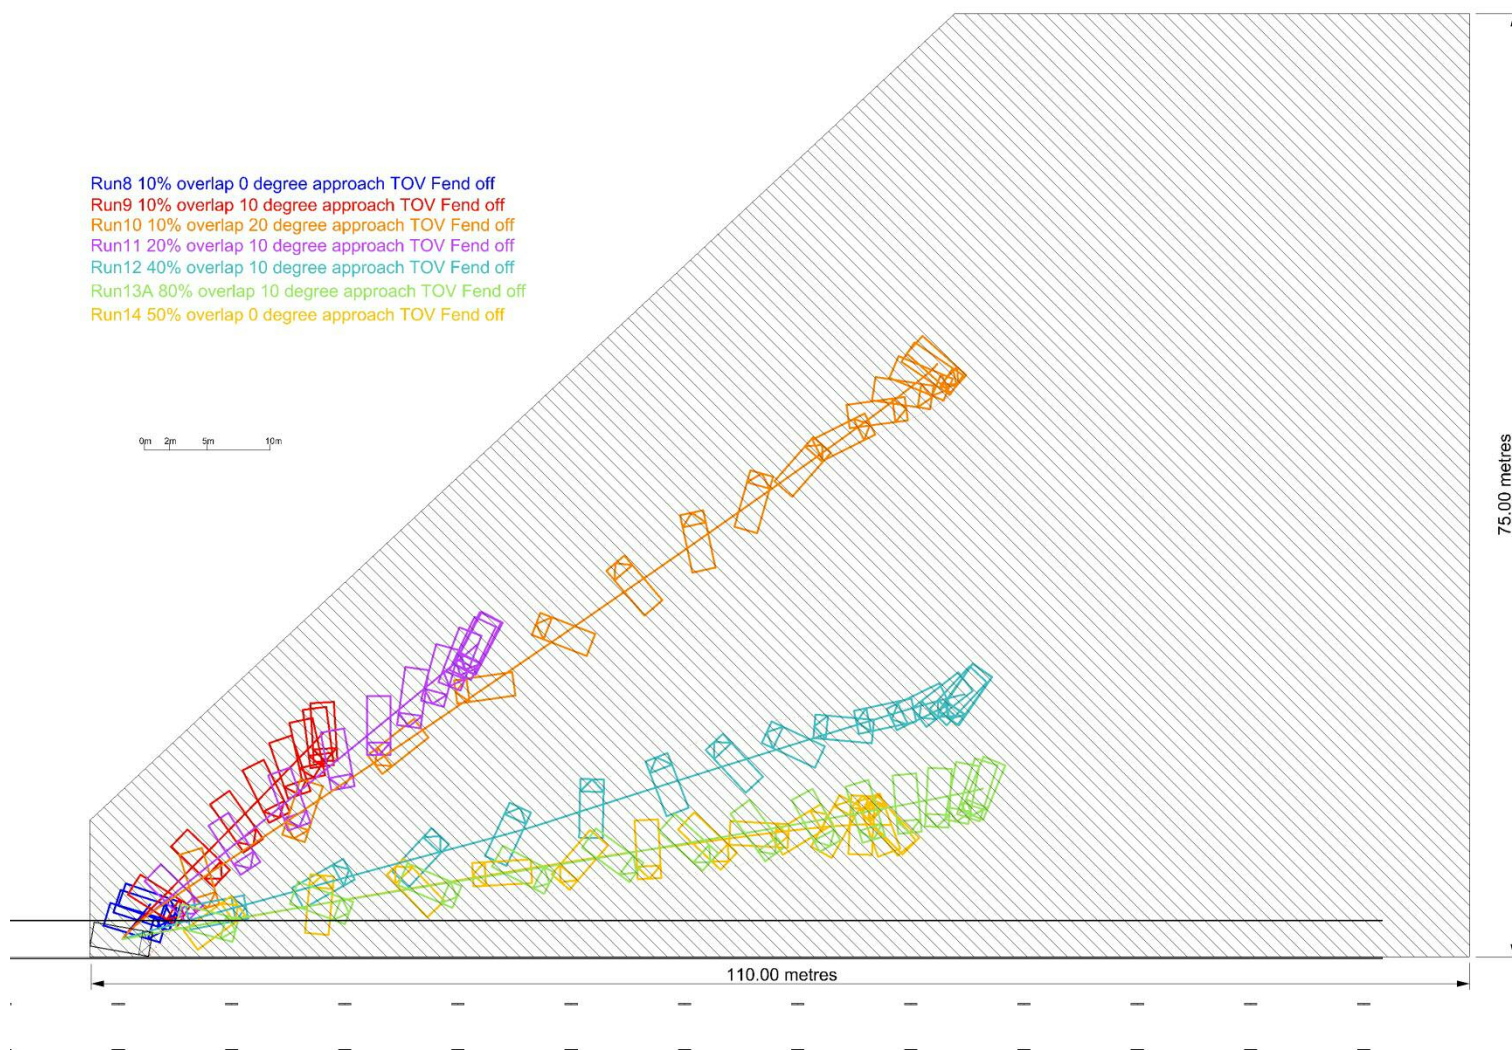
Figure 43: The area including a margin of safety believed from the simulation analysis to be unsafe for a person to stand within when the TOV is stationary in the fend off position.

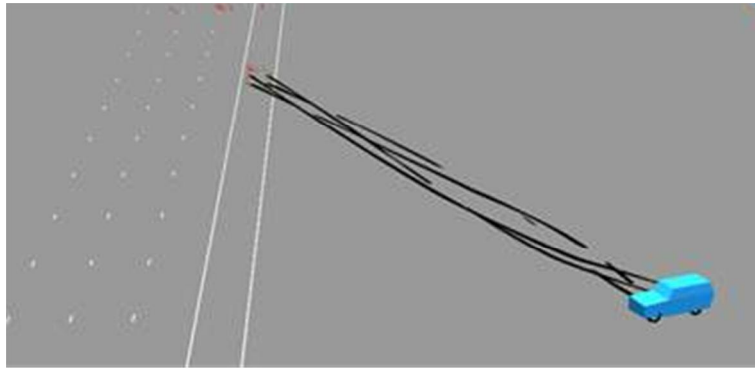
Figure 44: Steered wheels angled towards the live lanes (offside of the vehicle)

It is known that when parked it is possible for the steered wheels of the TOV to be at angles other than straight ahead (i.e. steering wheel angle not zero). As part of the HVE modelling, Run 3 (where the TOV was straight in the hard shoulder) was re-run with both a positive and negative steering angle on the front axle of the TOV. The angle of the front wheels was changed so that it represented a wheel angle of approximately 16 degrees which, in the 3D model, represented approximately 280 degrees of steering wheel angle. The images below show the trajectory and travel path of the TOV with and without the steering angles applied.

It was found that, at the simulated collision speed of approximately 60mph and where it was impacted with a model of a 44t lorry, the effect of the steered wheels made little difference to the overall travel distance of the vehicle and was within the range of the values previously shown in the sensitivity analysis.

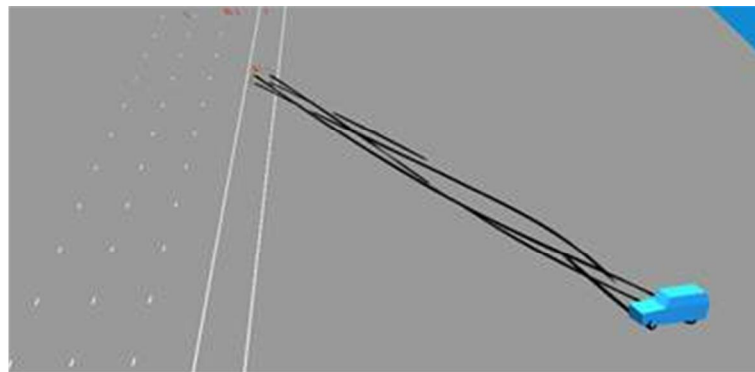
Figure 45: Steered wheels angled towards the nearside of the vehicle

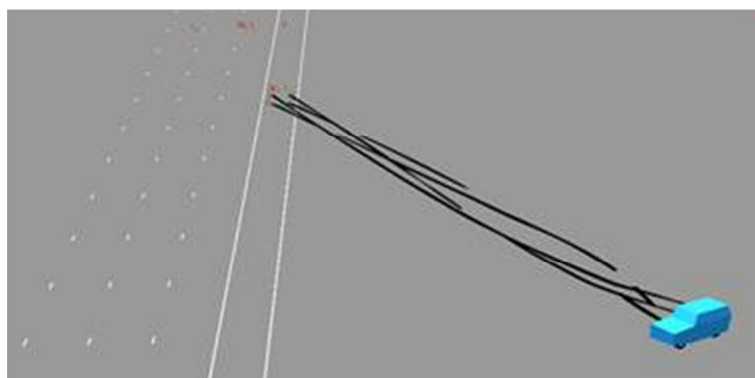
Figure 46: Zero steering applied (i.e. steered wheels in-line with the vehicle)

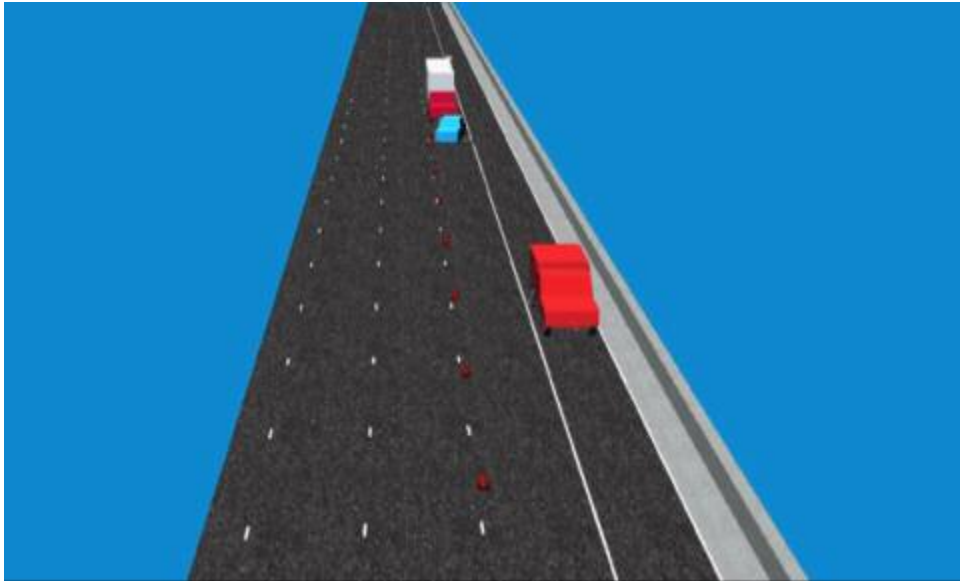
Figure 49: Simulation 1; HGV continues straight ahead, 1s braking prior to impact

Both of these simulations graphically demonstrate how far both the errant (impacting) and impacted (TOV and recovery) vehicles might travel along the carriageway as a result of the collision, with implications for any pedestrians present at the scene.

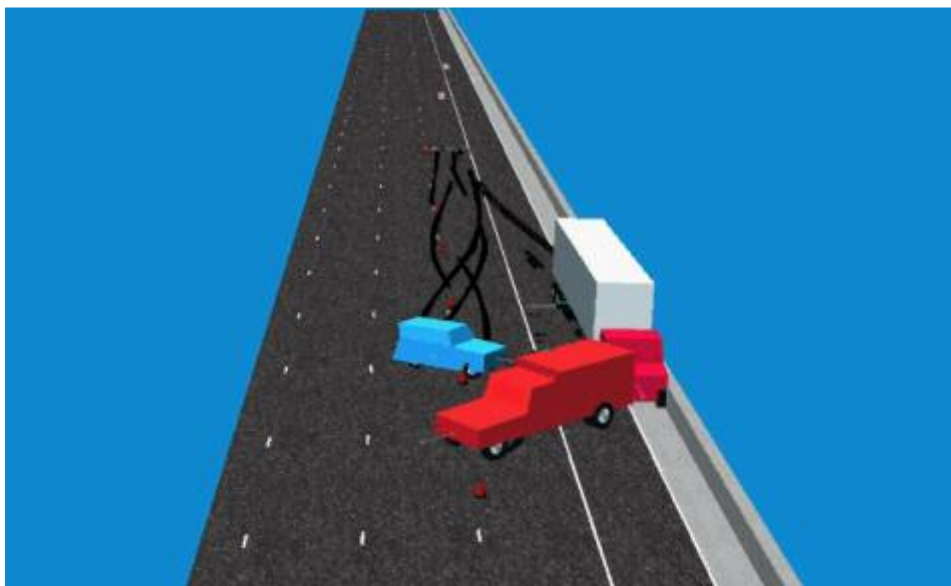
Figure 50: Simulation 1; final positions of vehicles

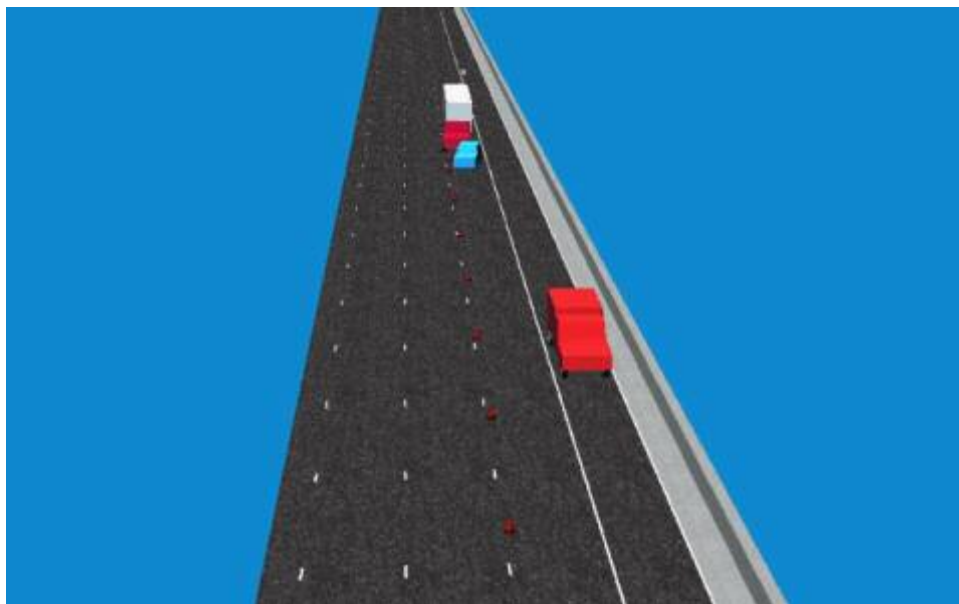
Figure 51: Simulation 2; no braking, HGV swerves

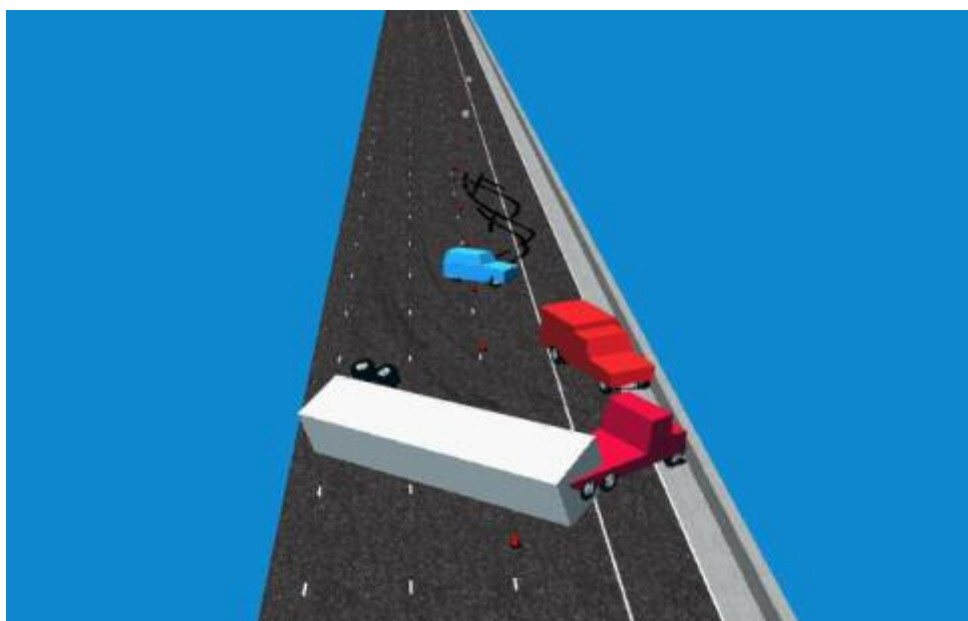
Figure 52: Simulation 2; final positions of vehicles

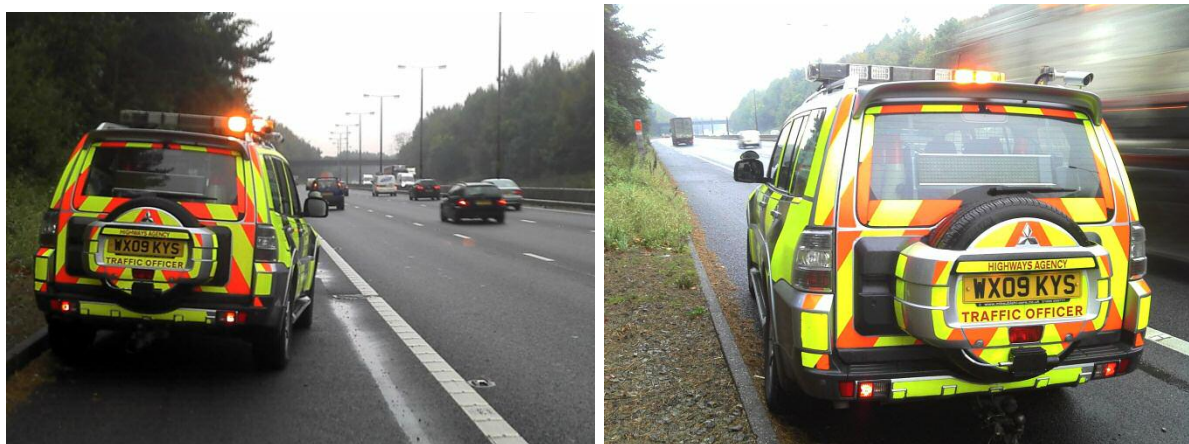
Figure 54: TOV parked in fend off orientation; note proximity of front offside wing to live lane and front wheels steered to left (TOV was reversed into fend)

In both these cases, the limited space available within the hard shoulder restricts the driver's ability to return the TOV's front wheels to be in line with the vehicle unless this is done with the vehicle stationary, potentially damaging the vehicle or roadway. Also, if those wheels are placed in line with the vehicle, unless they are steered back toward the hard shoulder then the vehicle will have to leave the hard shoulder directly into the live lane.

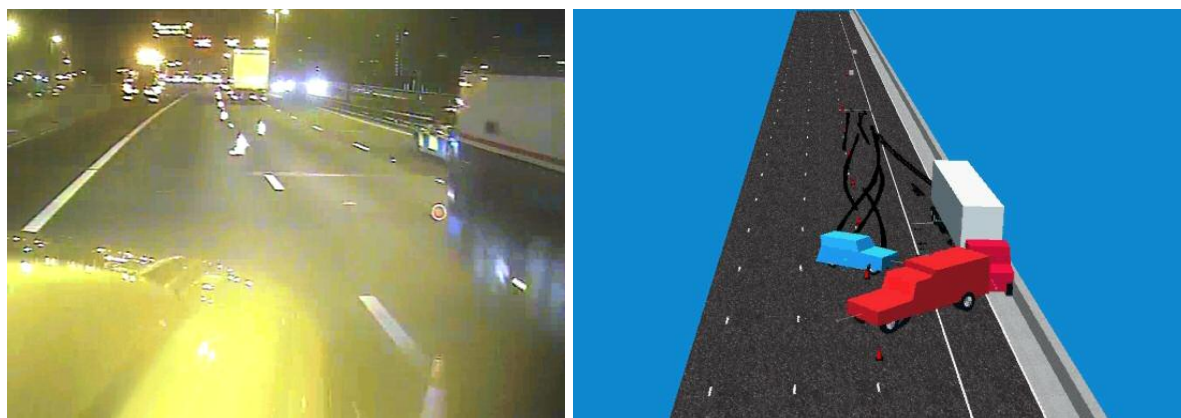
Figure 55: Left: M6 near miss incident ETM, with 50m safety zone; right: simulation 1 post-impact vehicle locations

Workstream 2 has identified that a TOV positioned in conformance with TOS procedures 50m upstream of an incident may, if subjected to a high-energy impact, be propelled through the current 50m 'safe' zone and into the incident and working space.

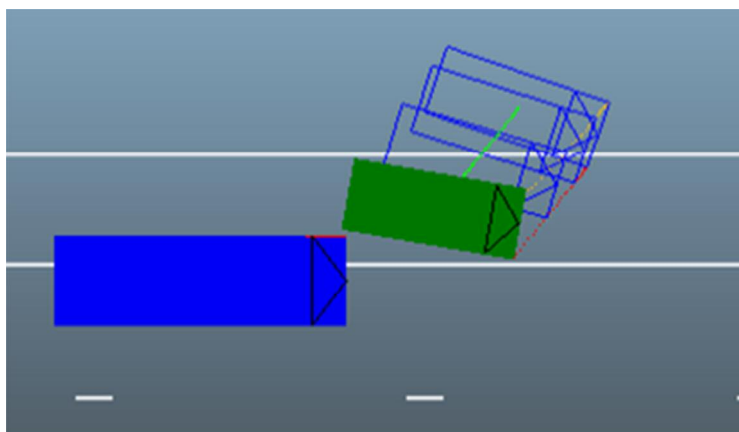
Figure 56: Simulation Run 8 (fend off), displacement route of the TOV following the collision

The displacement diagrams generated from the impact simulations clearly show the areas in which pedestrians are at risk of being hit by a displaced TOV. Perhaps unexpectedly, these areas extend back alongside the parked TOV (it is known that the TOs attending the M6 incident were both stood adjacent to their TOV).

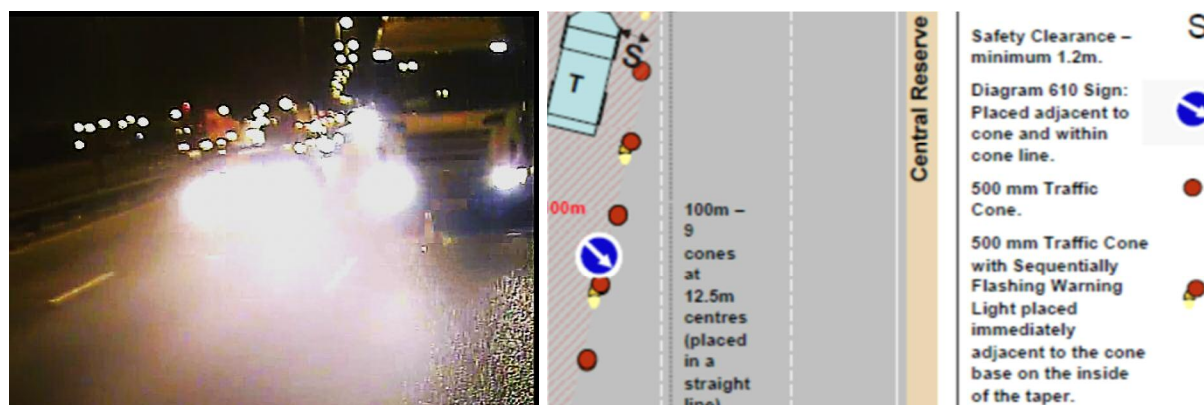
**Figure 58: Left: near miss video screenshot, - ETM cone impact
Right: extract from TOS procedures for ETM layouts, - 1.2m safety clearance**

For live lane parking fend parking, there may be distinct advantages beyond those described in the previous interim report (Palmer et al., 2012). This is shown from careful examination of the near miss incident video, which shows how close the HGV approached the TOV. As can be seen in the image below, the ETM cone is impacted over half way across the HGV's width. These cones are placed in a straight line to pass 1.2m from the parked TOV (the full ETM layout diagram is given in Appendix B). In this incident, the use of the fend off orientation may have provided just enough additional clearance to allow the HGV to pass without impacting the parked TOV.

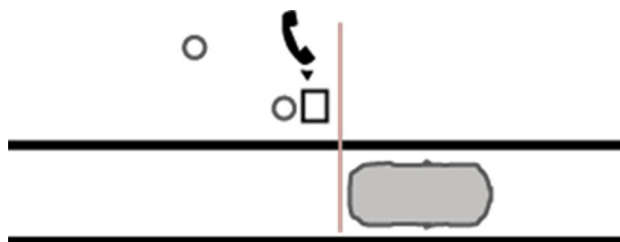
Figure 61: Parking relative to emergency telephones and safer pedestrian locations when stopped on the hard shoulder or in a live lane

This project, particularly from the extensive impact simulations, has identified that substantial revisions of the TOS procedures may be required, and that the same simple advice ("stand in a place where you are off the carriageway and can see the rear of your vehicle") is equally applicable to all people, whether professionals such as the TOS, road workers, etc. who are on the roadside as part of their work, or road users who find themselves on the hard shoulder with their broken-down vehicle.

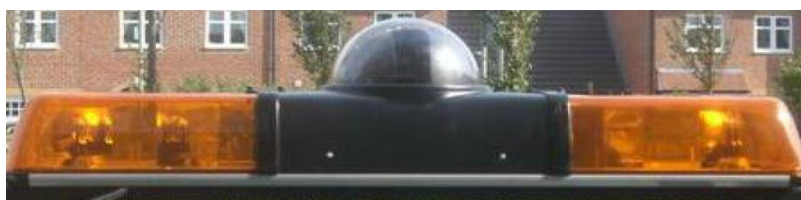
Figure 62: CCTV camera 'dome' integrated into Premier Hazard light bar

Premier Hazard supply a range of in-vehicle CCTV systems, including the option of a remotely-controlled camera integrated into the vehicle’s roof-mounted lighting bar (Figure 62). Their multi-camera systems are able to provide live streaming of video, whilst within the vehicle a hard disk recorder and mirror recording to SD cards provide data security.

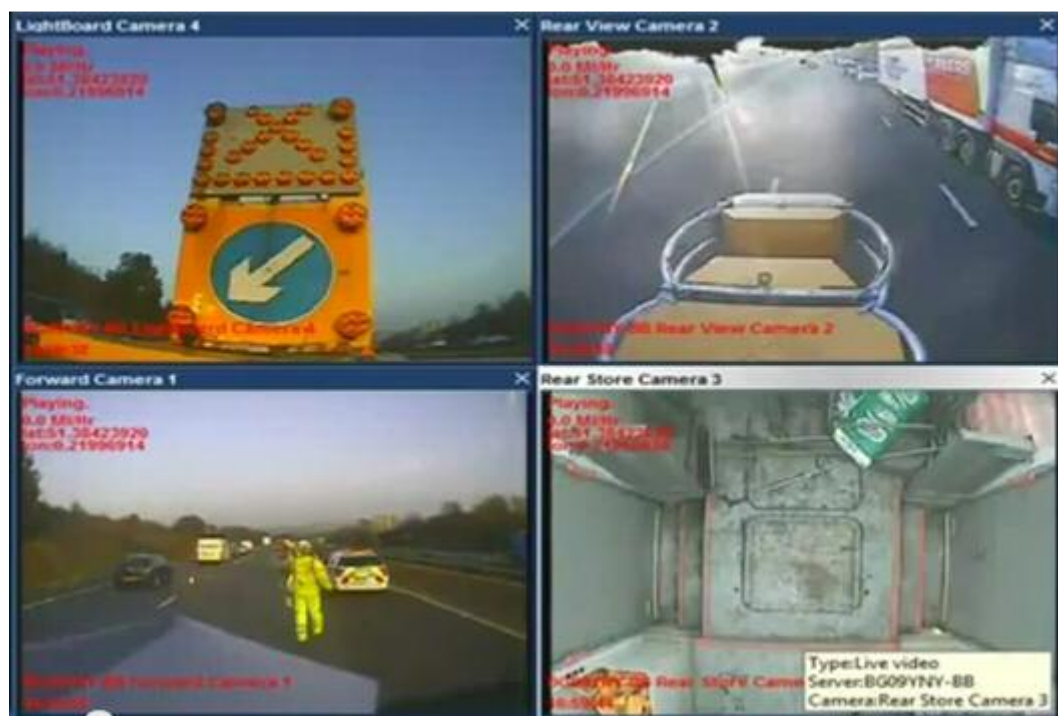
Figure 63: Montage of multi-camera system images

Figure 63 shows a montage from a multi-camera system with live streaming capability, one of several ConnectPlus/BalfourBeatty traffic management vehicles fitted with

systems. These systems also included front and rear G-sensors, allowing instant reporting of impacts.

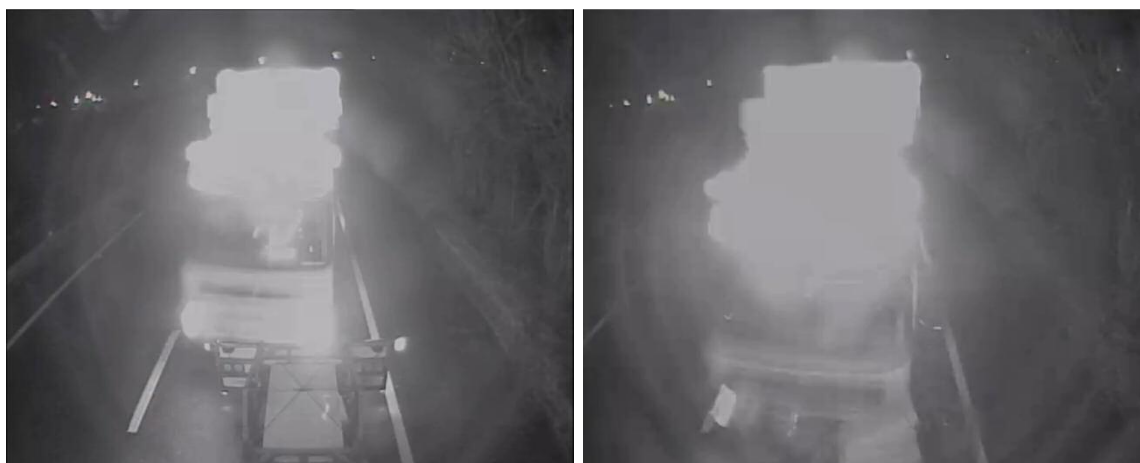
Figure 66: Rear view from a camera installed above the crash cushion, views immediately prior to and after impact

Colas is involved with the traffic management industry and wished to increase the safety of their crews while they are engaged in deployment and retrieval of traffic management signs etc. They have been involved with the development of a multi-camera system with live streaming ability, but with the recent enhancement of a two-stage warning system which utilises Bosch video analysis software to identify vehicles encroaching into predetermined 'at risk' zones behind the Traffic Management Impact Protection Vehicle (TMIPV). If the system identifies approaching vehicles within those zones, additional warning beacons are displayed to the rear and the TM crew are given warnings of imminent impact. An early version of this camera system, prior to the development of the driver and crew warning element, captured several video sequences documenting a high-speed impact from an HGV while the TMIPV was stationary in a live lane during the retrieval of road works advanced warning signs (see Figure 65 and Figure 66).

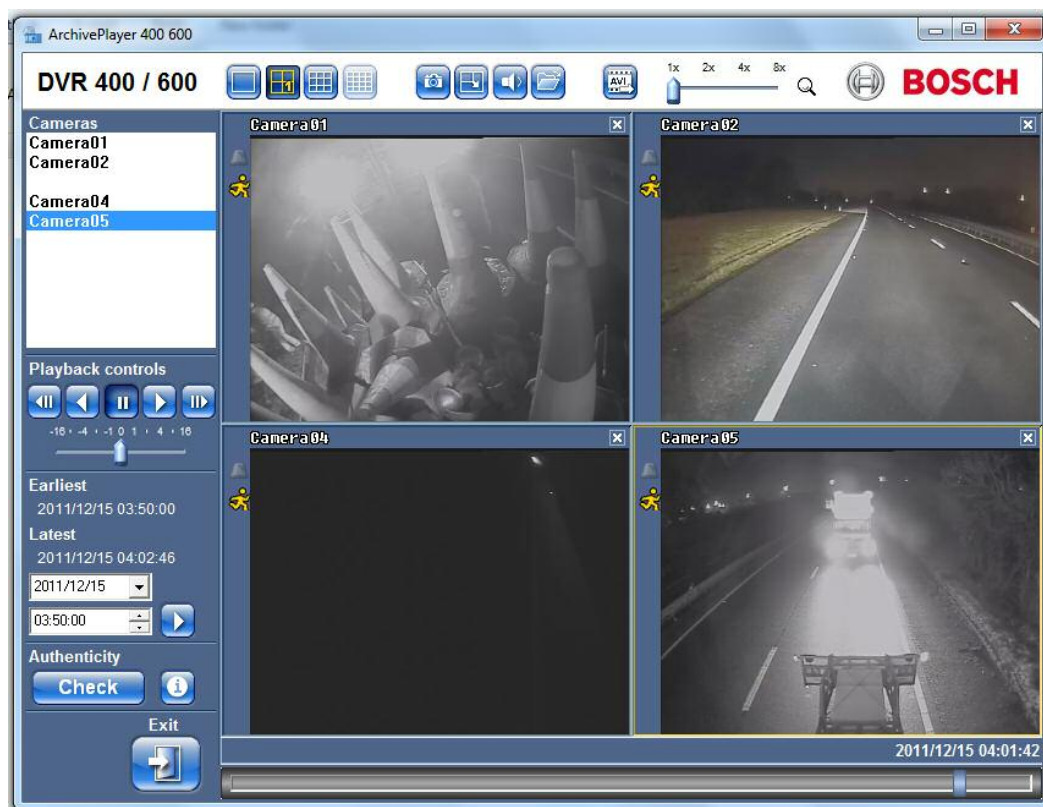
Figure 67: Bosch Archive Player screenshot, immediately prior to impact

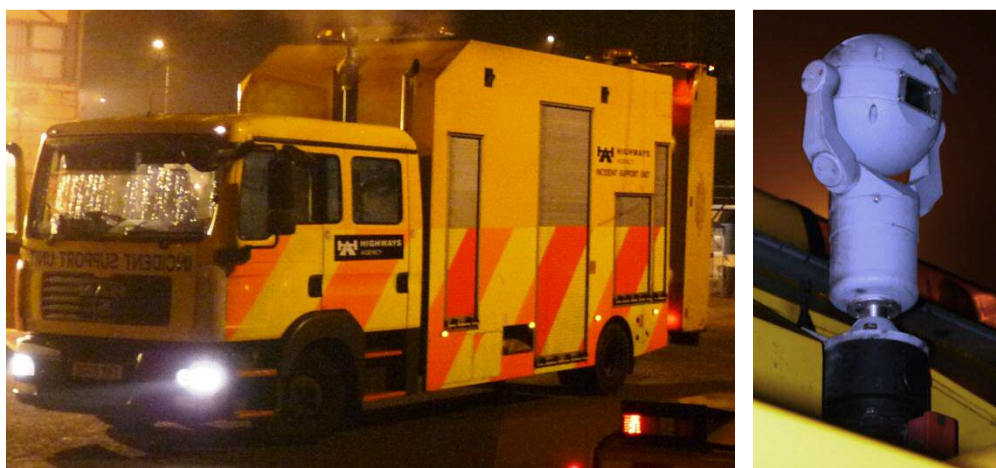
The HA has installed CCTV on a number of Incident Support Units (ISUs), but it is not known whether this equipment has been used at incidents.

Figure 68: Incident Support Unit, with CCTV camera mast installed behind the cab

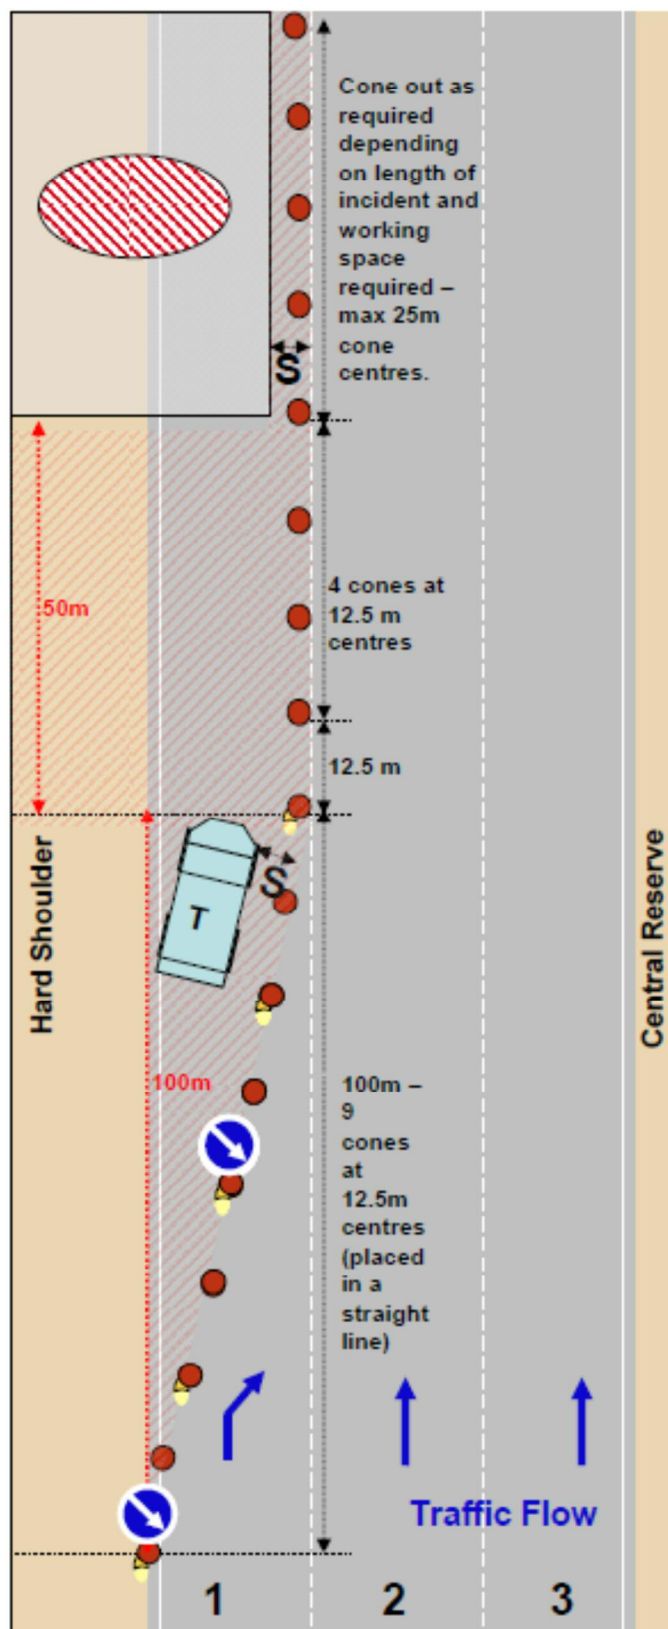
Appendix B Traffic Officer Manual Version 3.2. Extract: ETM Diagram 2 (V10) Lane 1 Closure
