PUBLISHED PROJECT REPORT PPR890

Innovative Geotechnical Repair Techniques Effectiveness of Electrokinetic Geosynthetics

HAGDMS No. 30665

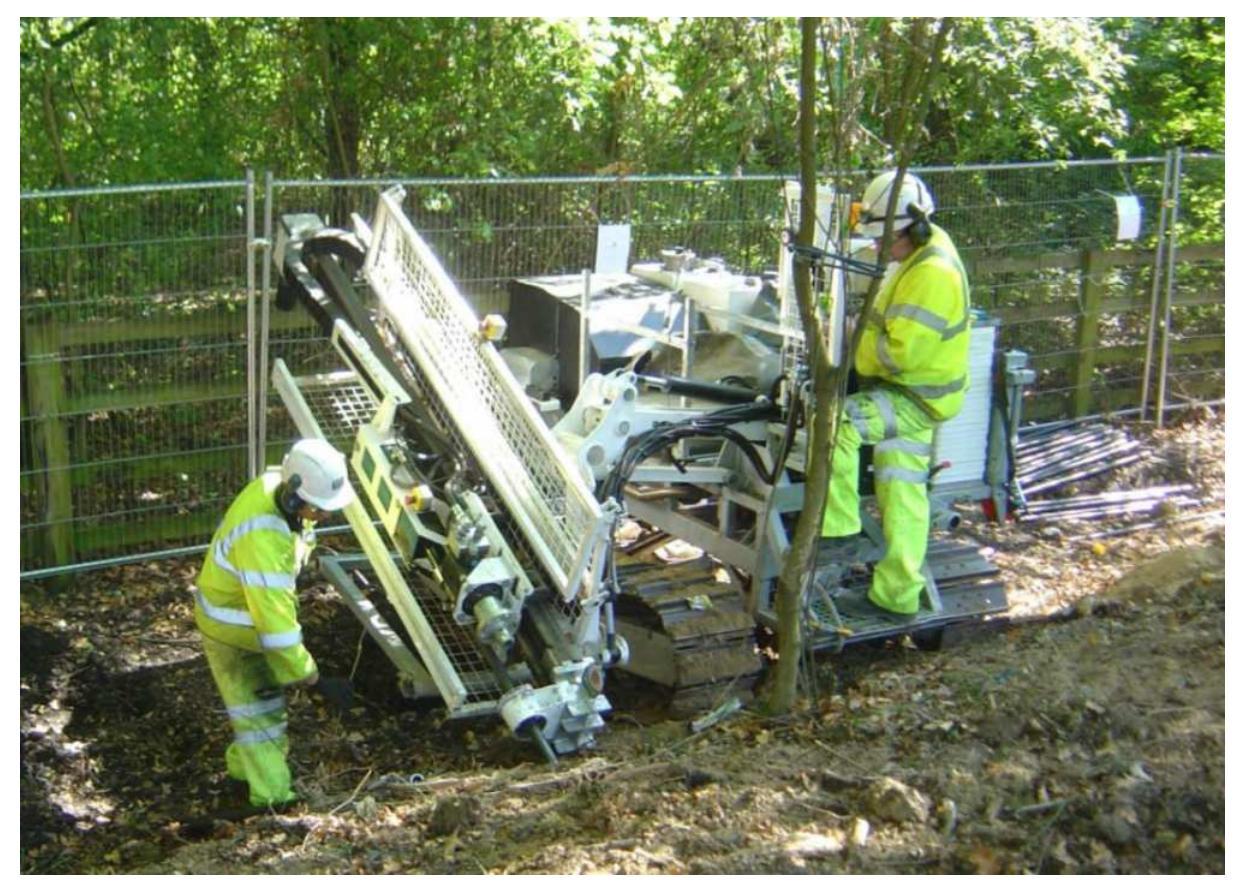
Figure 1: P45K slope climbing drill rig on the A21 Stocks Green scheme (BBMM 2014)

The EKG anodes and cathodes were installed using Geotechnical Engineering Ltd's P45K slope climbing drill rig (Figure 1). The cathodes were installed in augured boreholes and the majority of the anodes were installed by driving. However, during the initial driving of anodes there were failures of some of the treaded couplings and modifications had to be made to the remaining anodes (BBMM 2014). This involved cutting off the threaded coupler sections and welding on a collar.

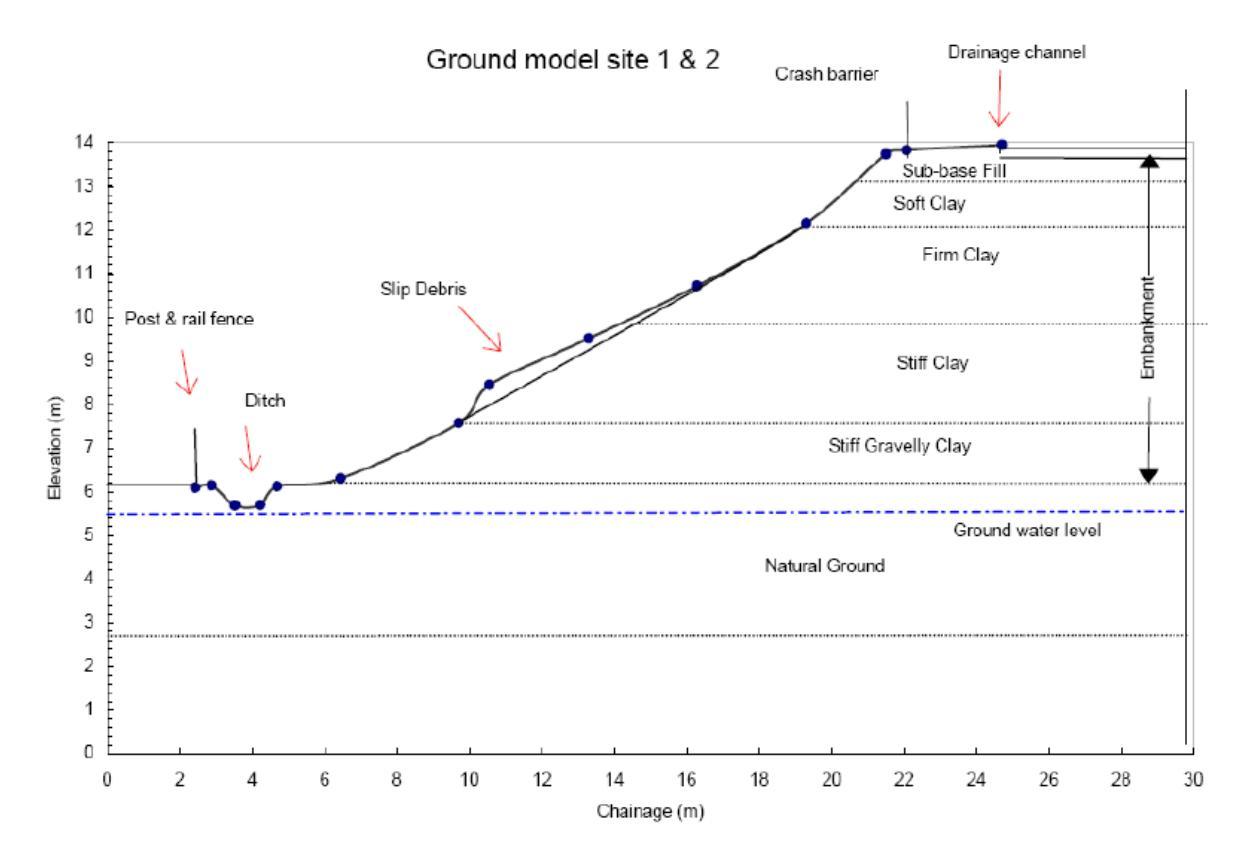
Figure 3: Generalised ground model for A21 Stocks Green (InterRoute 2009)

Investigations by InterRoute (2009) identified soil bulges, dislocated trees and the presence of hydrophilic vegetation. The ground investigation found the ground conditions to be as indicated in Figure 3.

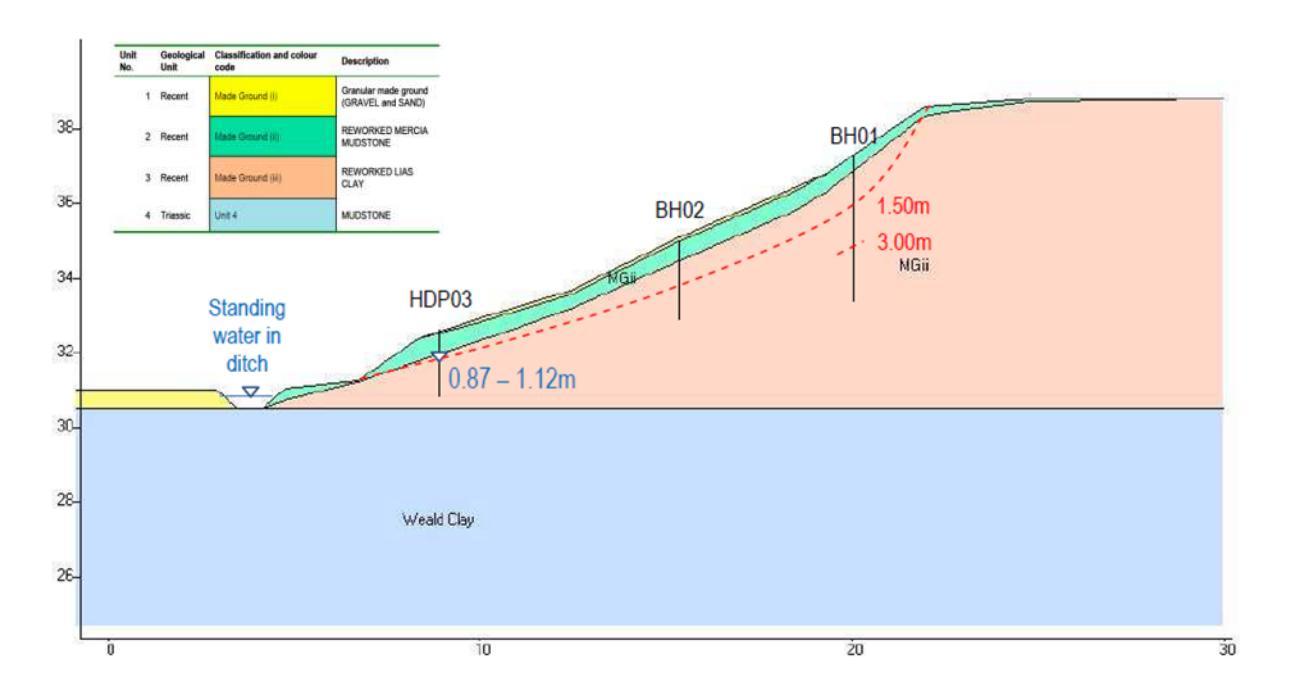
Figure 4: Generalised ground model for A21 Stocks Green showing slip planes at 1.5m and 3.0m depth (Electrokinetic Ltd 2011a)

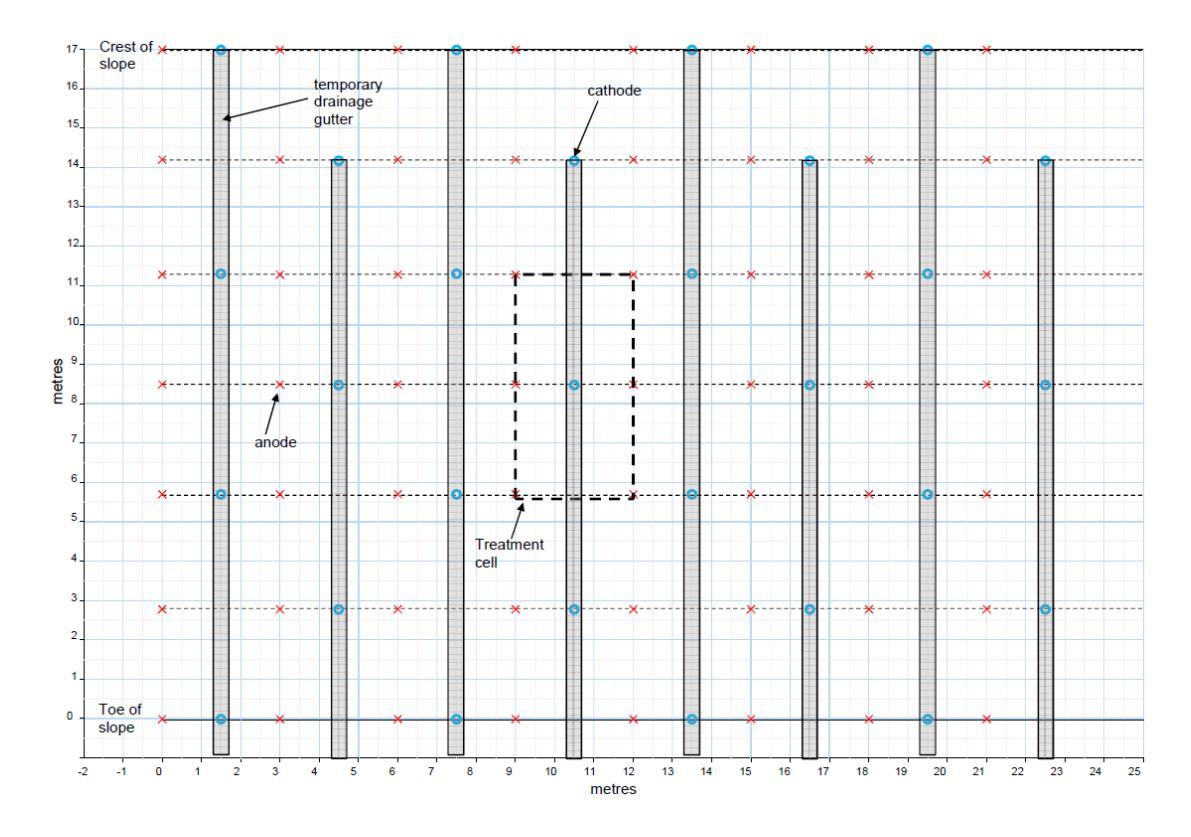
Figure 5: Schematic slope elevation showing the general arrangement of the EKG trial (Electrokinetic Ltd 2011a)

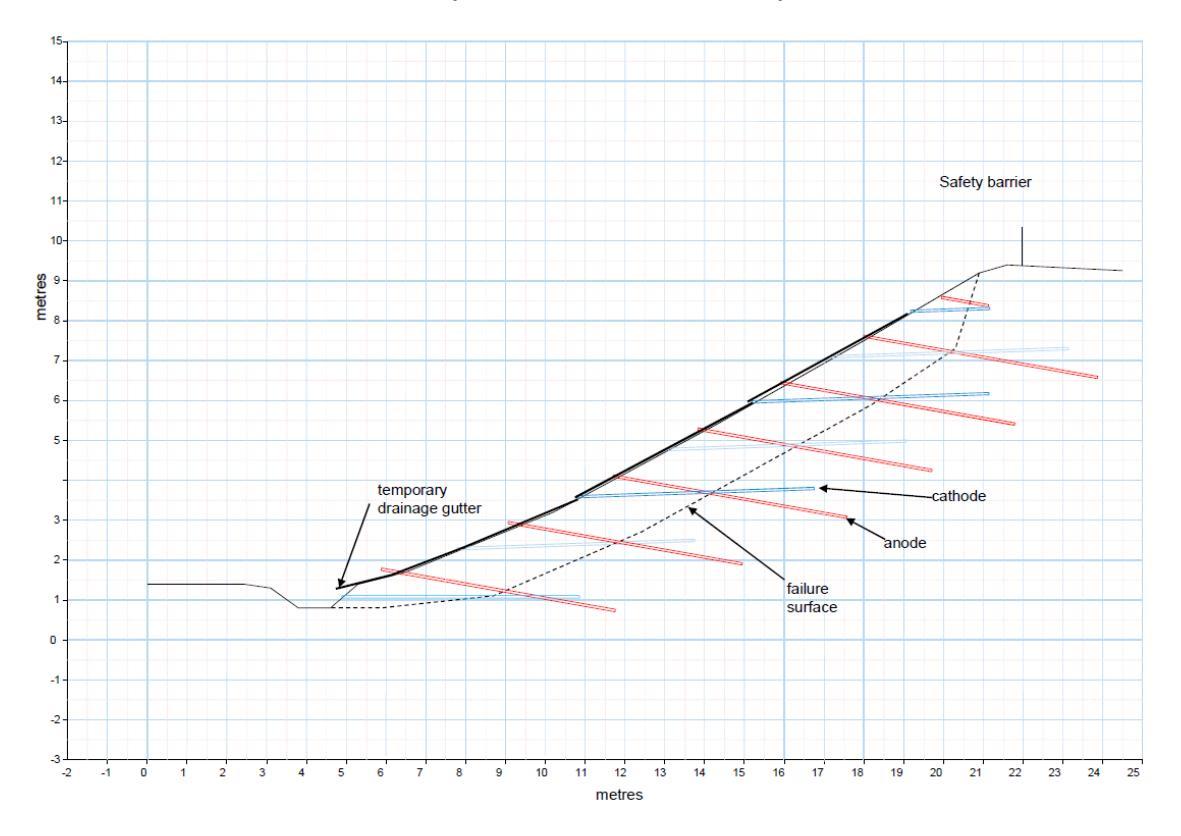
Figure 6: Schematic slope cross section showing the general arrangement of the EKG trial (Electrokinetic Ltd 2011a)

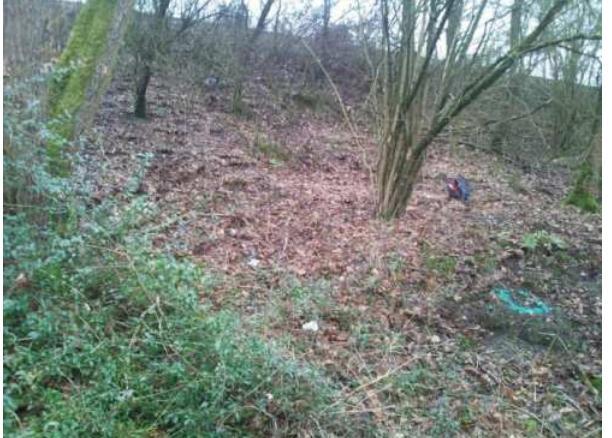
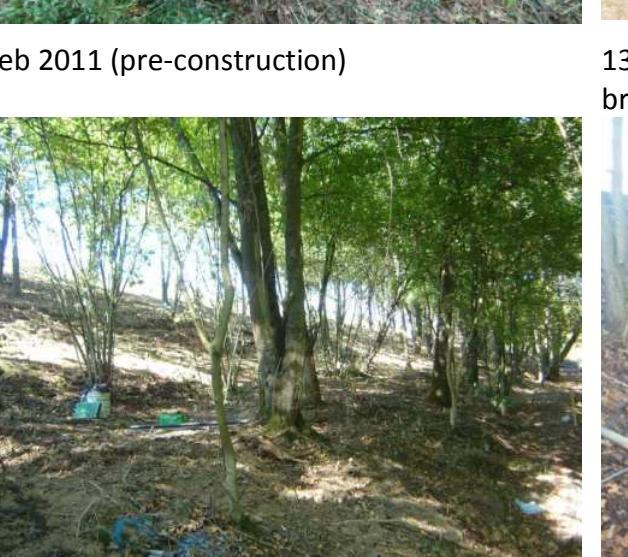
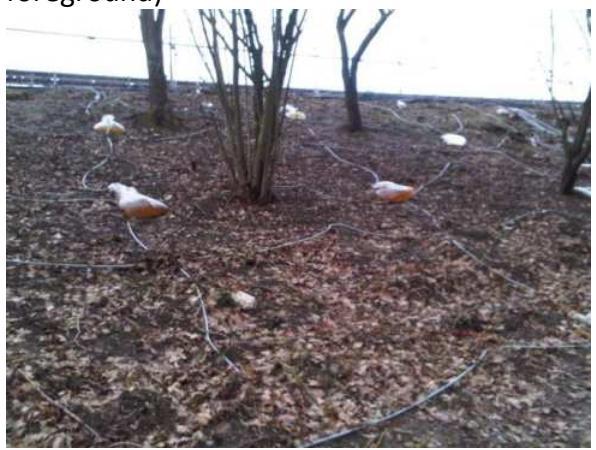
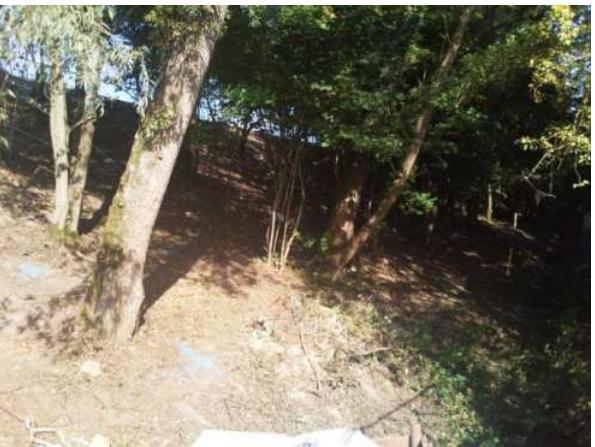
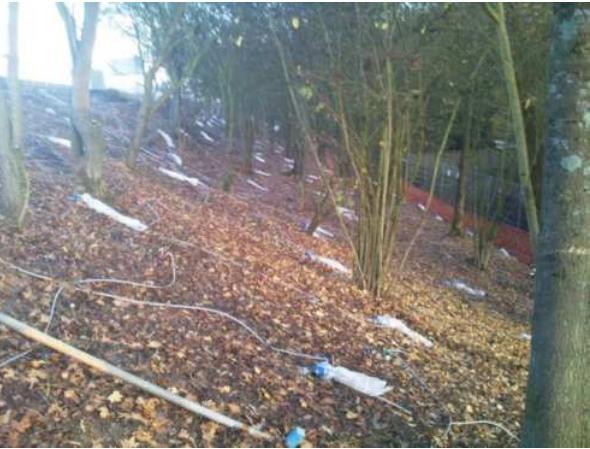
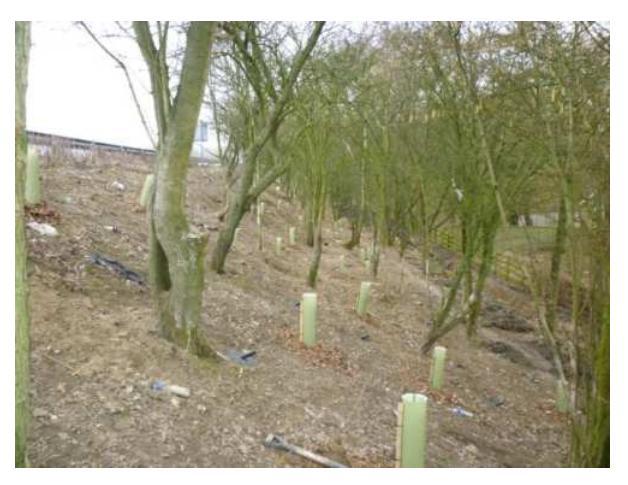
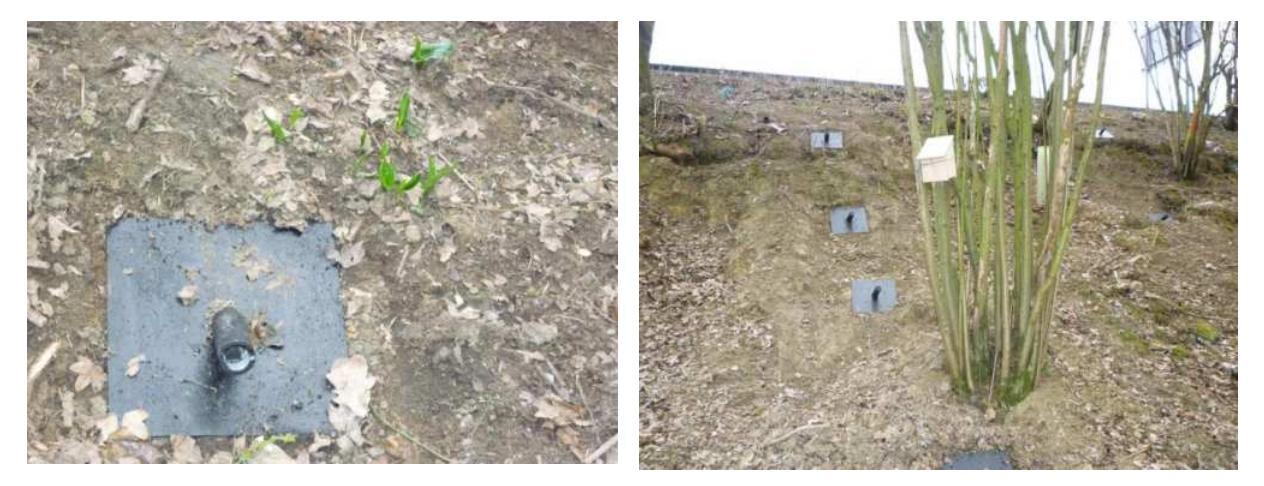
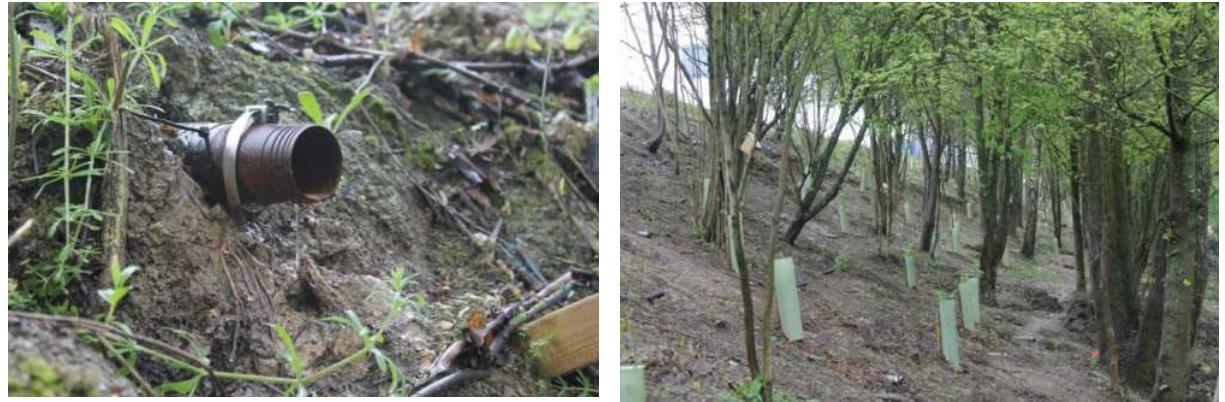
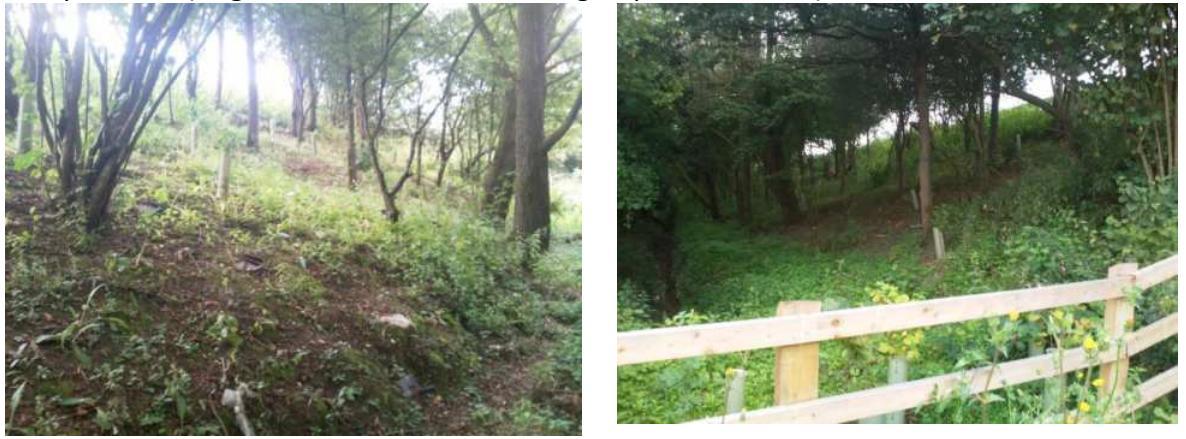
Feb 2011 (pre-construction)

29 September 2011 (start of electrode installation, anode and cathode in foreground)

9 January 2012 (treatment)

13 September 2011 (initial clearance of bramble and dogwood undergrowth)

18 November 2012 (mid treatment)

18 February 2012 (cables removed and anodes converted to reinforcement)

28 February 2012 (some regrowth, boxes for dormice re-established)

26 April 2012 (regrowth and cathodes acting as passive drains)

03 August 2012 (less than a year after mobilisation)

Figure 7 shows photographs taken before, during and after the works and highlights some of the environmental benefits of the scheme and in particular the rapid recovery of the vegetation cover. The approach to repair at this site was driven by the preservation of topsoil and vegetation, particularly trees, and dormouse habitat; the dormice particularly favour coppiced trees and in Figure 7 a dormouse nesting box is visible. Added bonuses were the lack of a need for traffic management and thus the creation of delays on the network and improved worker safety.

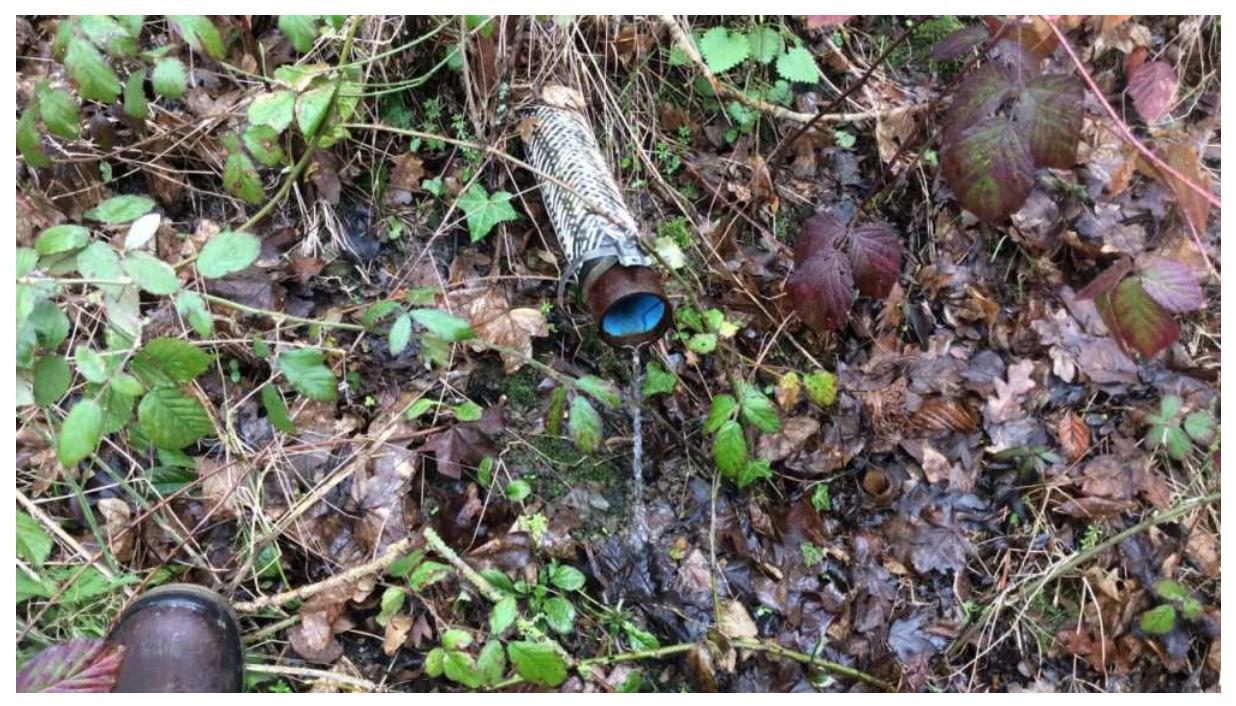
Figure 8: Cathode at A21 Stocks Green. Water flowing from cathode (passive flow)

Anodes and cathodes were easily identifiable on the slope and, as expected, the spacing between them was variable. The majority of the anodes appeared to have been coated in bitumen and those anodes not coated were corroded. The cathodes were also partially corroded and the majority of them were dry. However, towards the southern end, water was seen flowing from a number of the cathodes indicating that they continued to work as drains. (Figure 8). Corrosion of the anodes/soil nails is an issue that needs further consideration and investigation if large scale EKG repairs are to be taken forward on the HE network in future.

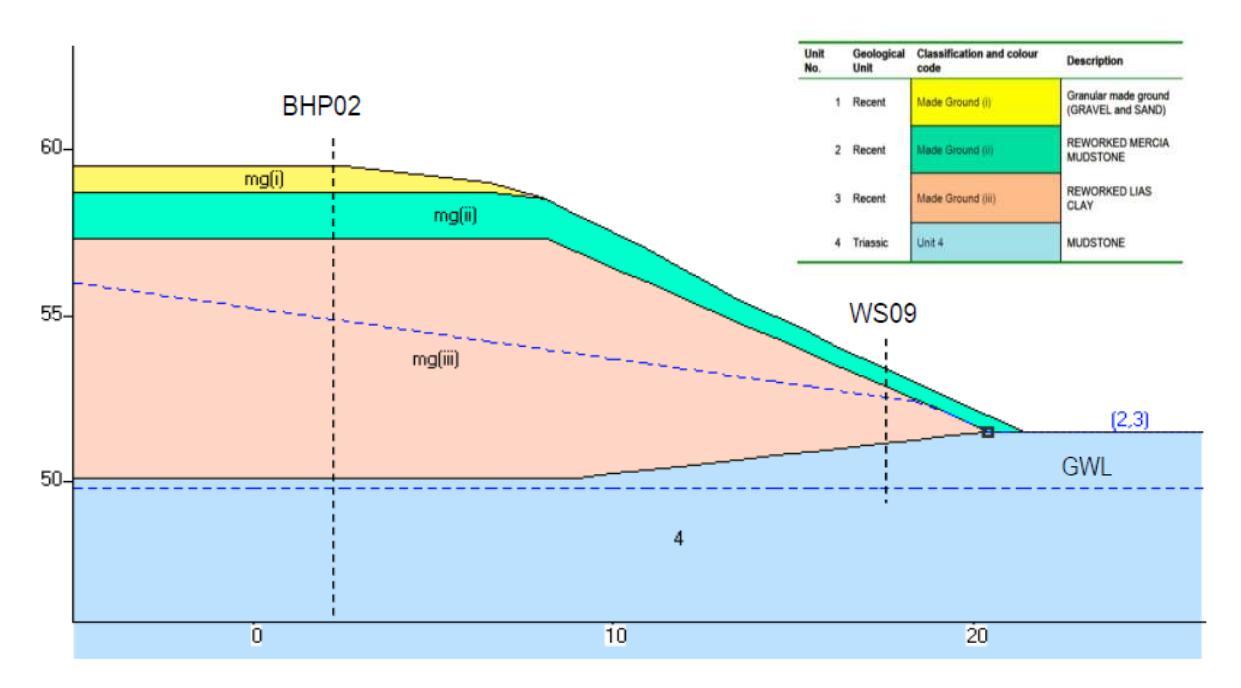
Figure 10: Generalised ground model for M5 Junction 7 based on cross section 2 (Electrokinetic Ltd 2011b)

A ground investigation was undertaken in 2010 by Geotechnical Engineering limited and reported in a GIR in 2011 (Amey 2011). This found the ground conditions to be as indicated in Figure 10.

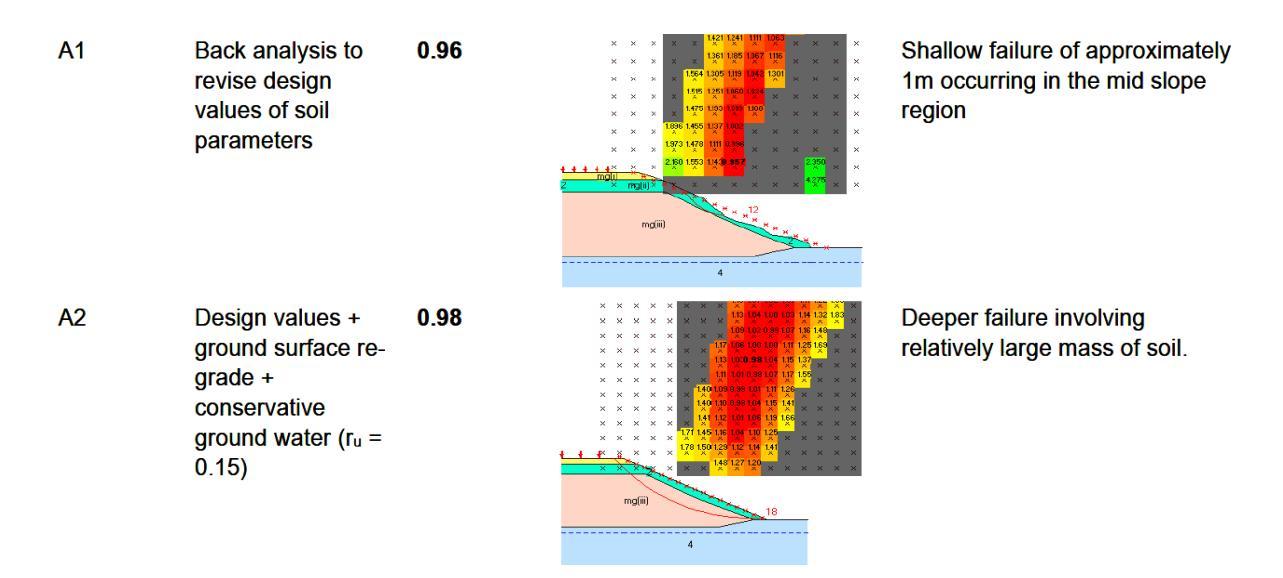
Figure 11: Results of Elecrokinetic (2011b) stability analysis showing postulated failure modes

As part of the EKG design, Electrokinetic undertook a detailed series of slope stability analyses to back analyse the slope failures and to develop the design of an EKG installation. The analyses and resulting EKG trial design are shown in Figures 11 to 13.

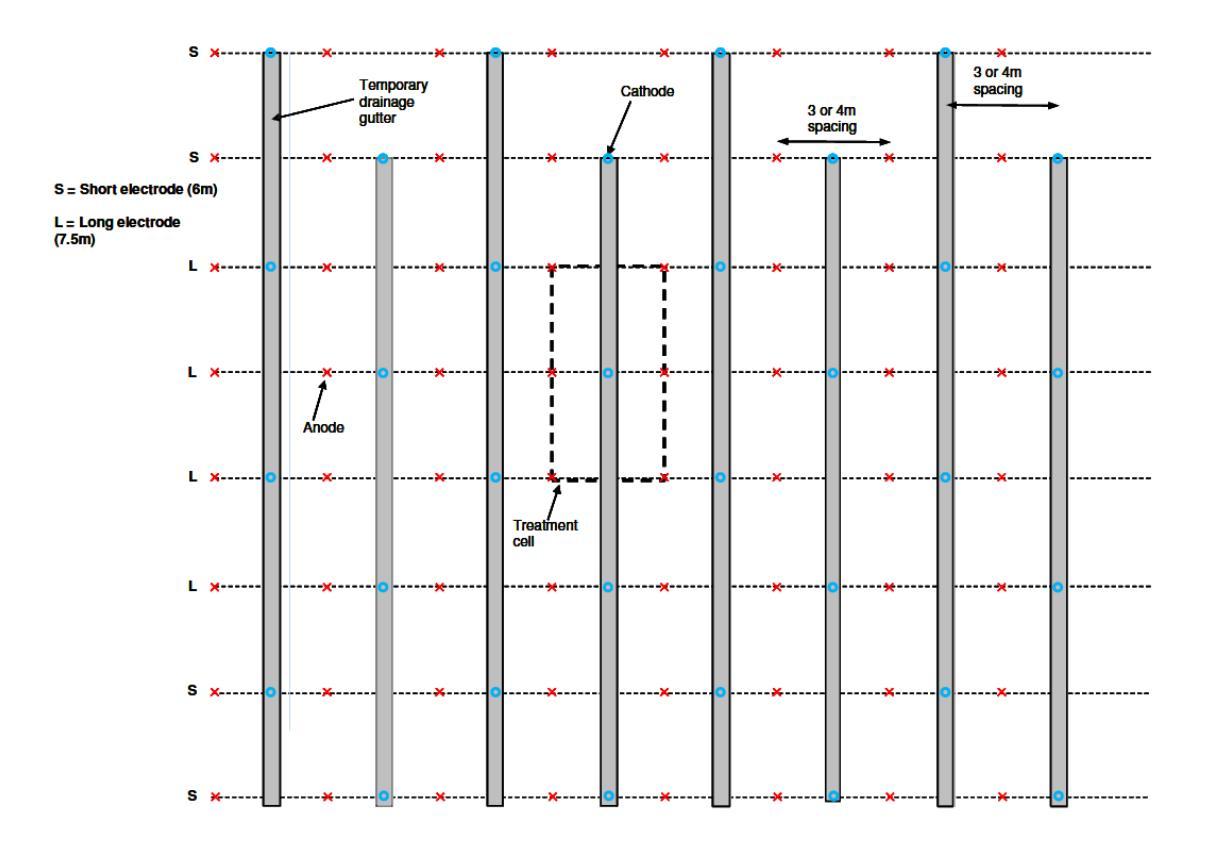
Figure 12: Schematic slope elevation showing the general arrangement of the EKG trial (Electrokinetic Ltd 2011b)

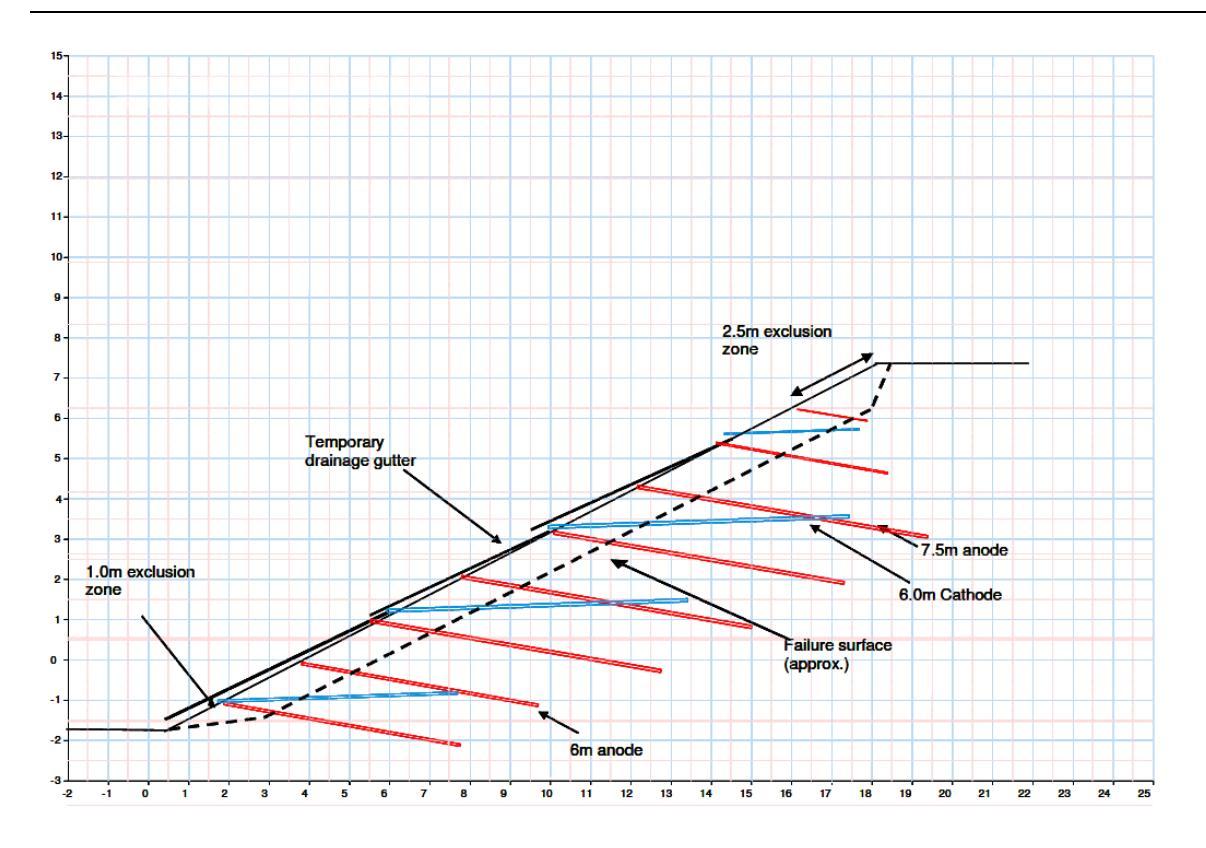
Figure 13: Schematic slope cross section showing the general arrangement of the EKG trial (Electrokinetic Ltd 2011b)

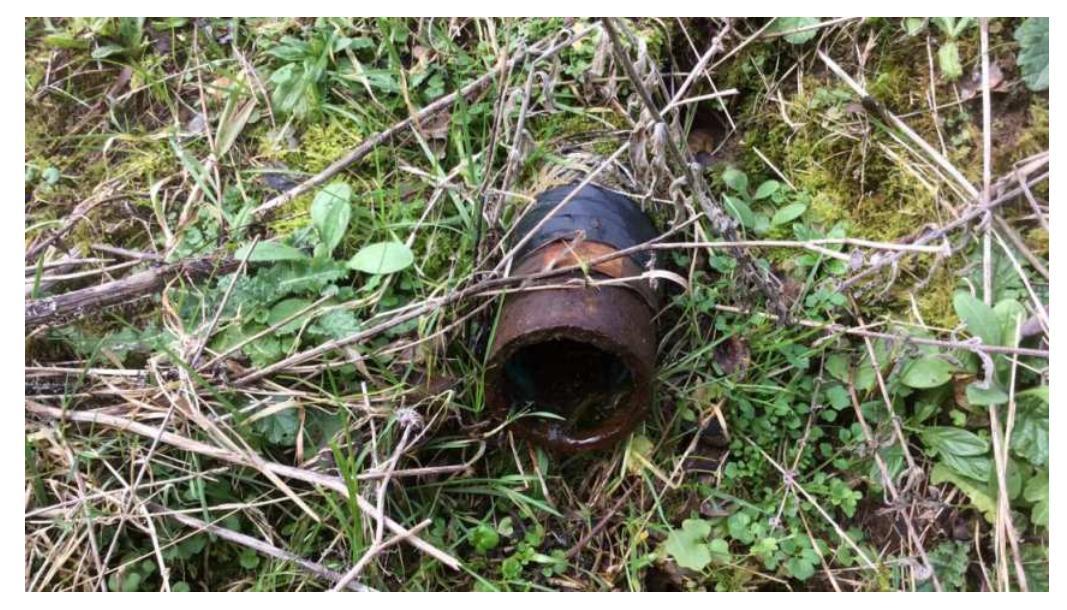
Figure 14: Cathode at M5 Junction 7 Southbound Off-slip. Cathode has water seepage and is significantly corroded

Anodes and cathodes were easily identifiable on the slope. The majority of the anodes had galvanised steel face plates which were in reasonable condition. The 16mm steel tendons within the anodes were significantly corroded considering the time since installation. The cathodes tended to display a similar degree of corrosion. Water was noted to be seeping from some of the cathodes indicating that they continued to work as drains. (Figure 14)

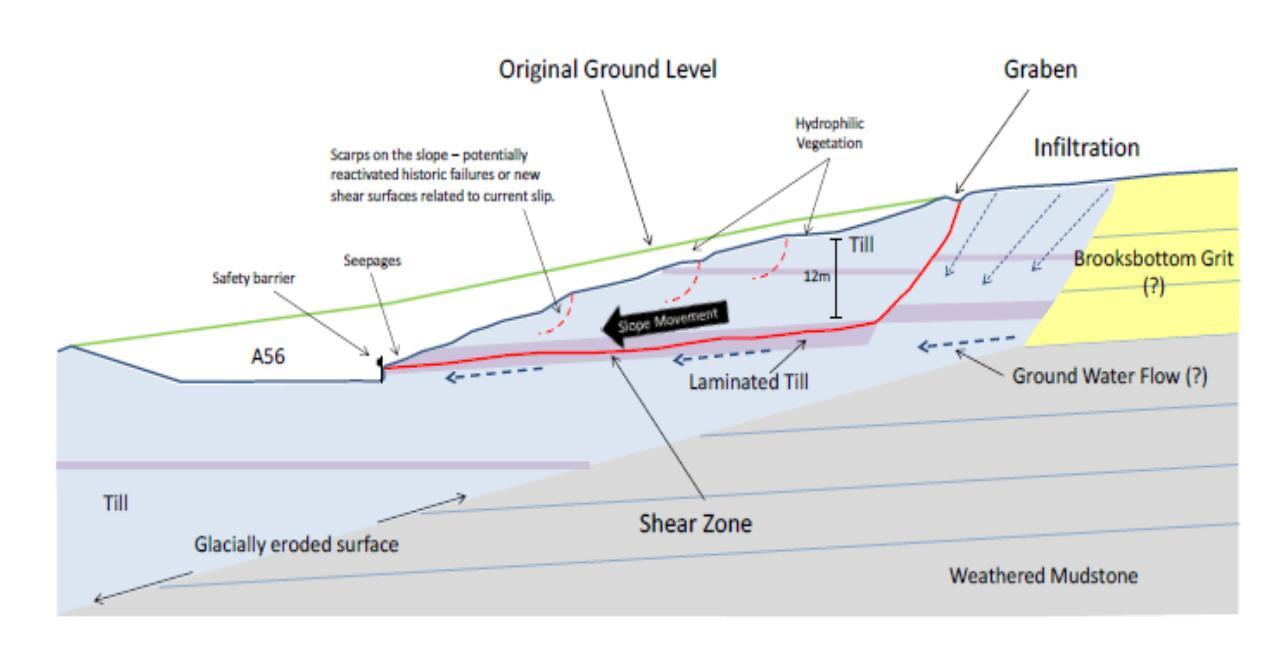
Figure 16; Generalised ground model for A56 Woodcliffe EKG trial (Mott MacDonald 2016a; 2016b).

The west facing slope of the A56 Woodcliffe Cutting began to fail by landsliding shortly after construction in 1969 (Mott MacDonald 2016a; 2016b). A 100m length of cutting in a natural slope has been affected by deep landslides (Mott MacDonald 2016a and 2016b) which extend some 75m upslope of the highway at an overall slope angle of around 20° (Figure 16).

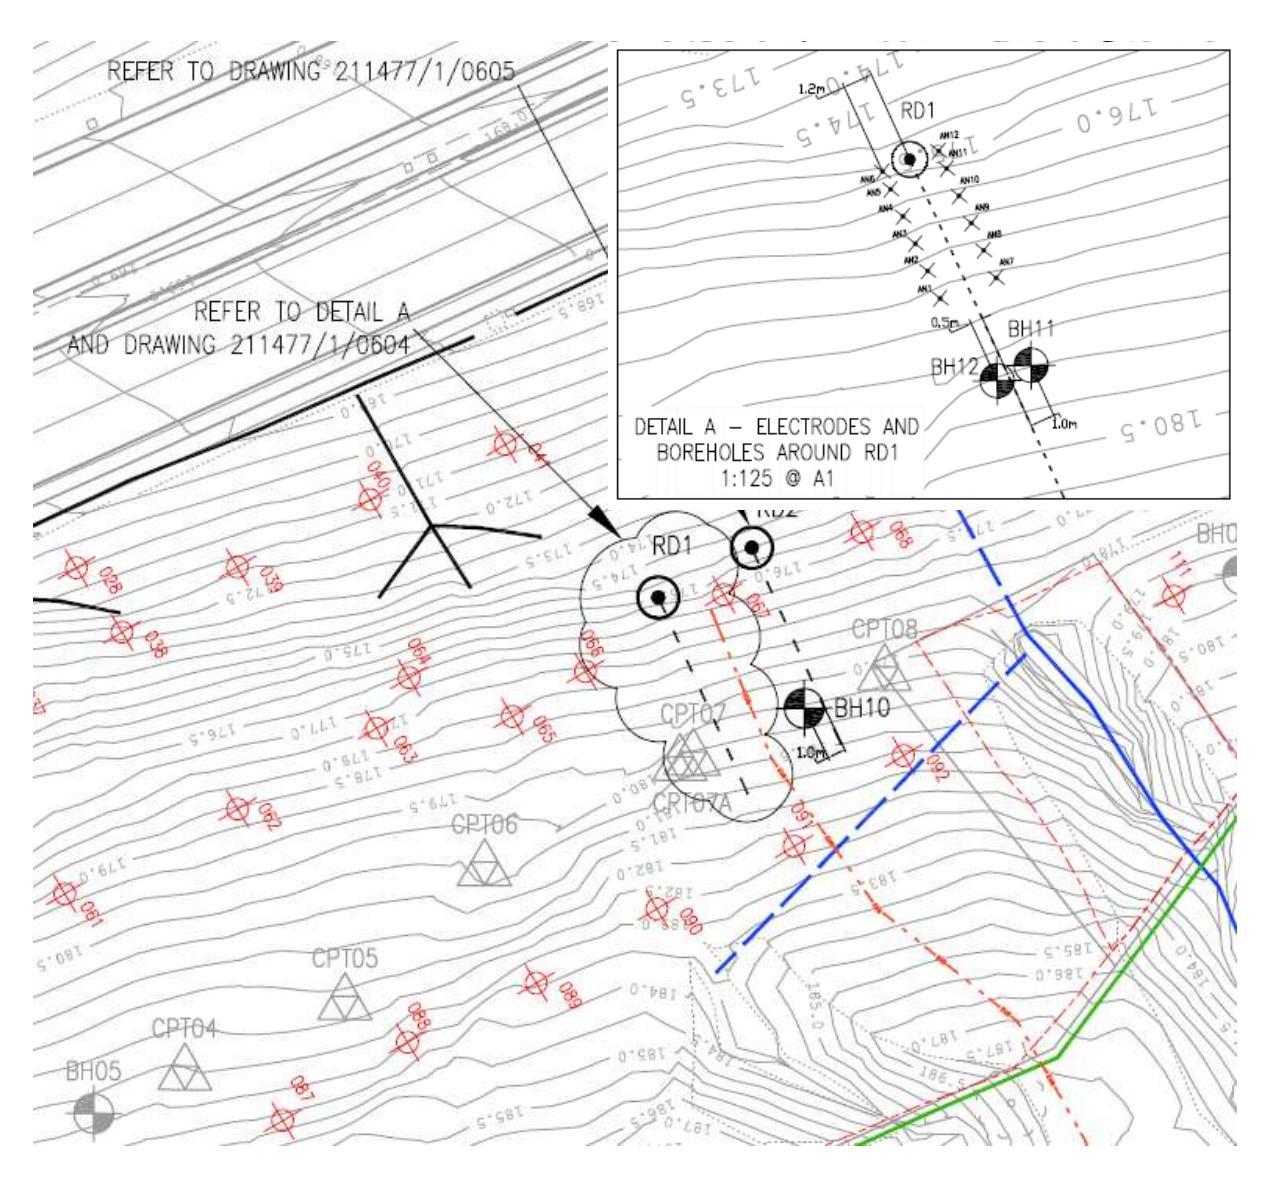
Figure 17: Plan showing the general anode and cathode (RD1 and RD2) arrangement of the A56 Woodcliffe EKG trial (Electrokinetic Ltd 2013)

- Anodes: 3.0m to 7.0m long at 20° below horizontal, horizontal spacing of 3.0m and down slope spacing of 1.2m.
- Cathodes: 15.0m long at 3° above horizontal, horizontal spacing of 3.0m with only one cathode per slope treatment section.

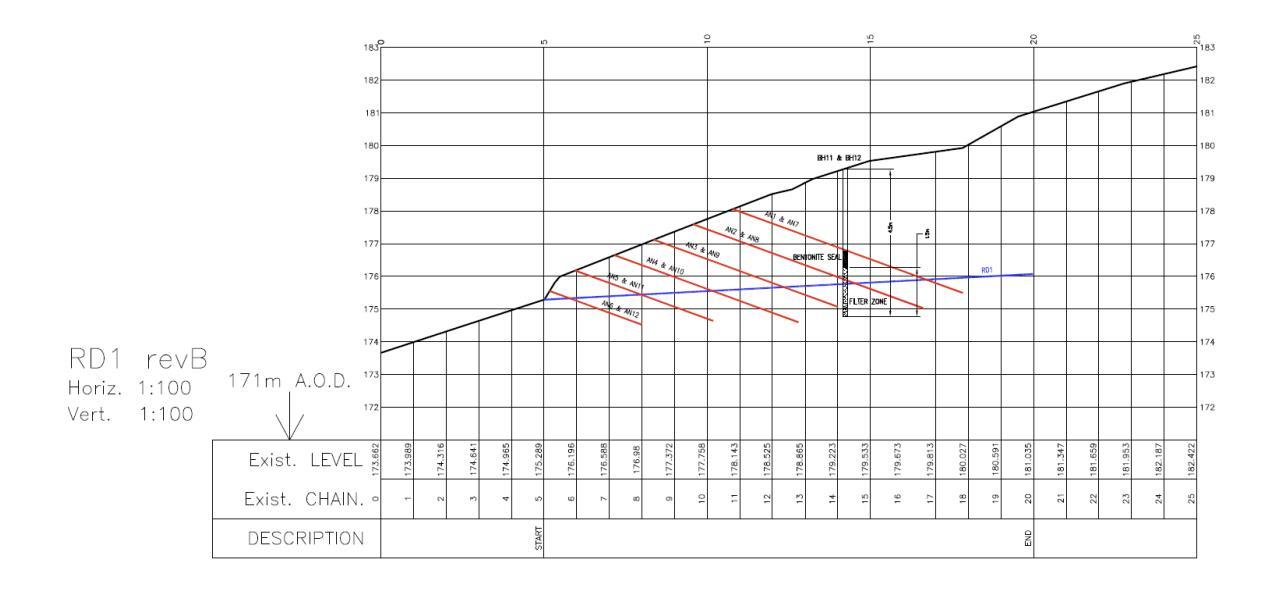
Figure 18: Schematic slope cross section showing the general arrangement of the A56 Woodcliffe EKG trial (Electrokinetic Ltd 2013)

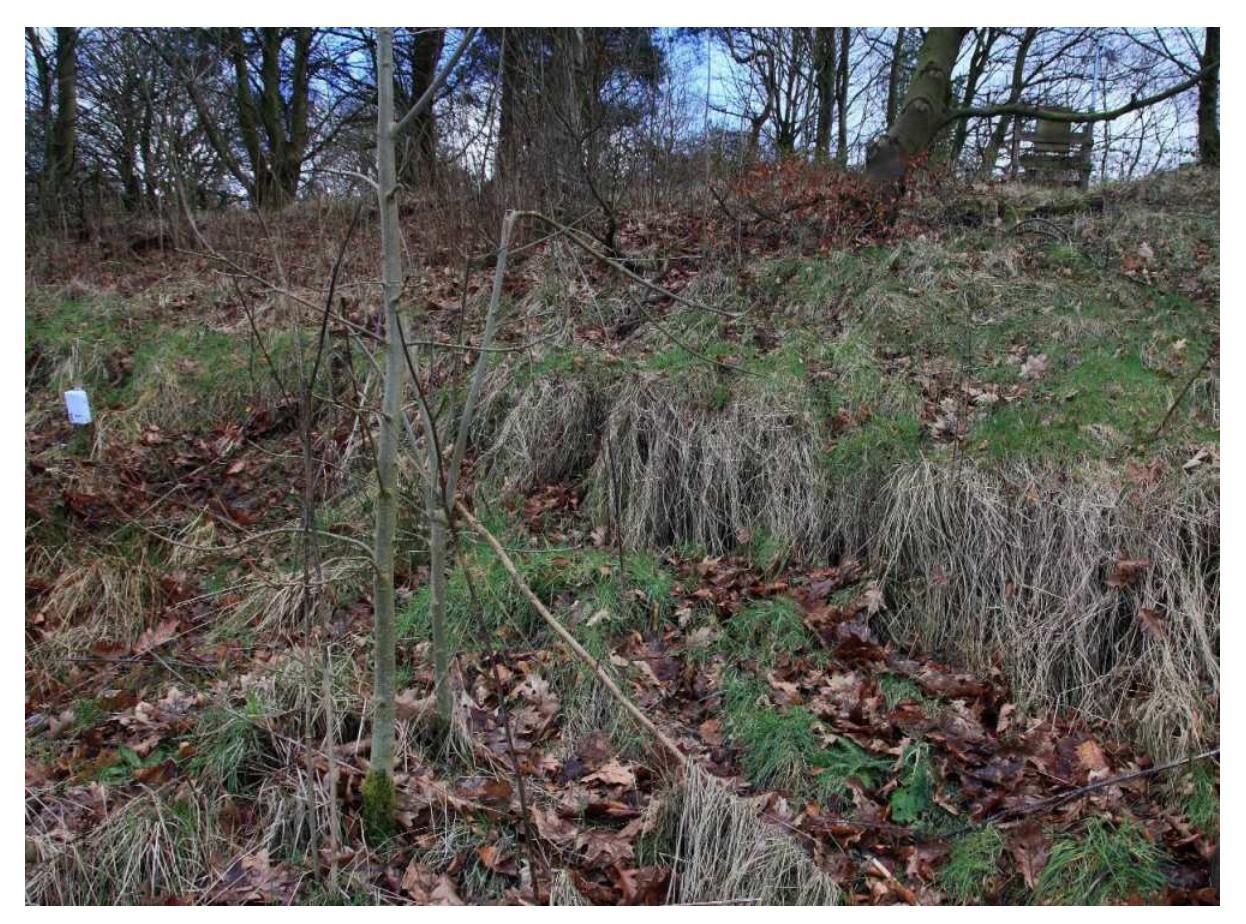
Figure 19: A56 Woodcliffe cutting in vicinity of the EKG trial (Site Photograph 7DW_4145)

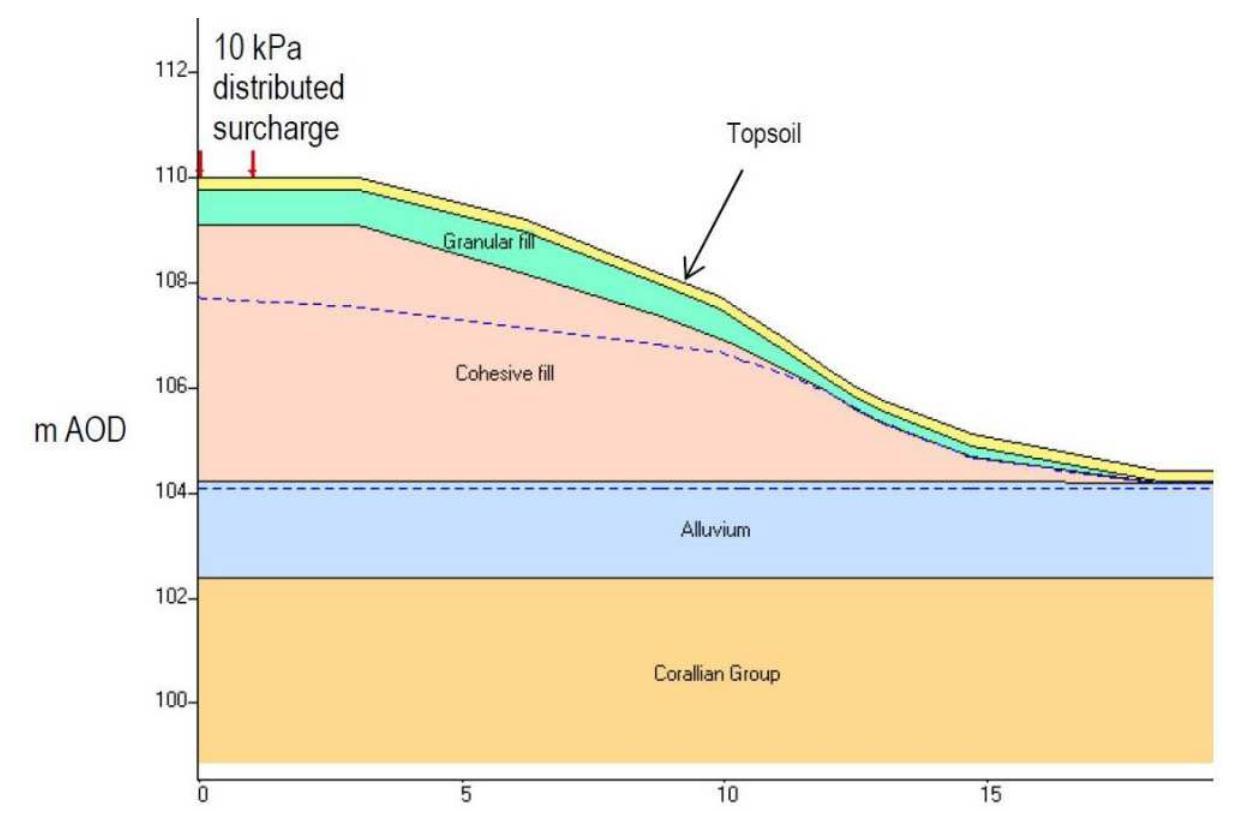
Figure 21: Generalised ground model for the A419 (Electrokinetic Ltd 2015a)

A ground investigation was undertaken by WSP in 2011 (WSP 2012) and this revealed the road embankment was constructed upon very soft alluvium overlying interbedded stiff to very stiff sandy clays and stiff silts of the Jurassic Age Corallian Group strata. The investigation indicated that the embankment was constructed of cohesive fill (reworked clay) overlain by varying thickness of granular fill (Type 1 sub- base material). The ground conditions are shown in Figure 21.

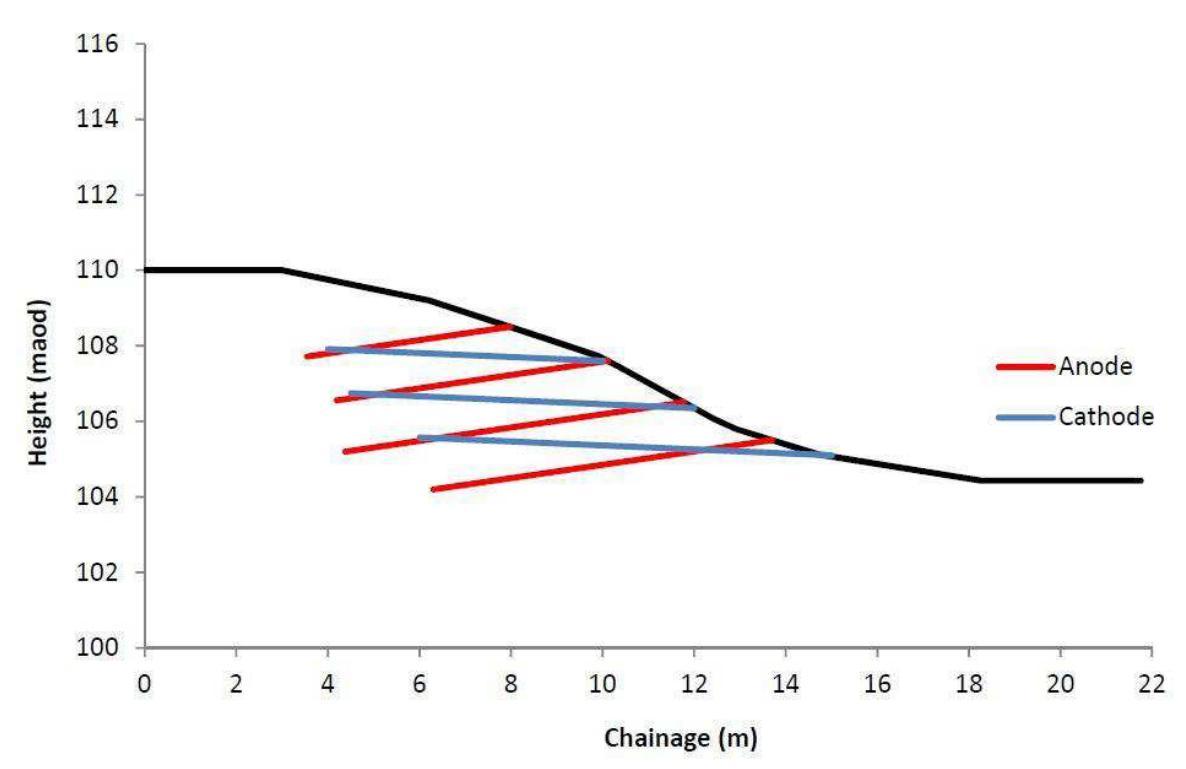
Figure 24: Schematic slope cross section showing the general arrangement of the EKG trial (Electrokinetic Ltd 2015a)

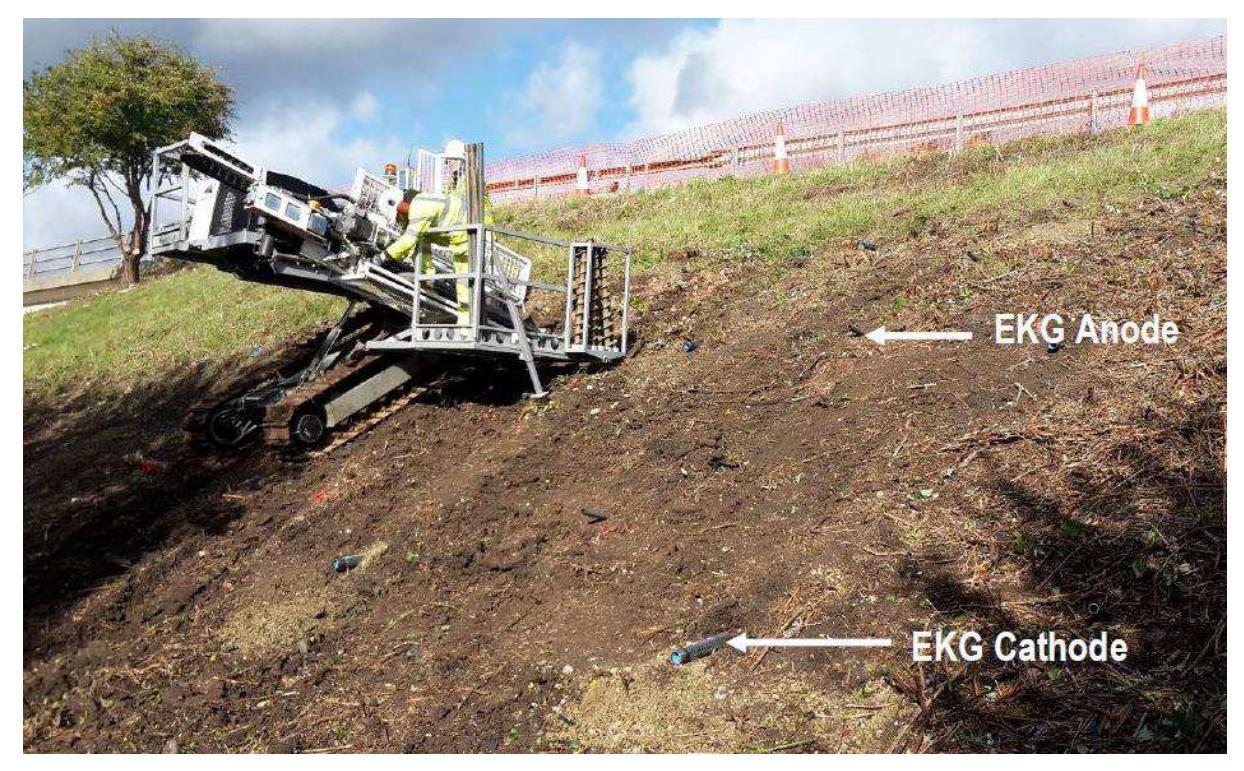
Figure 25: The P45 Slope climbing drill rig installing electrodes (Electrokinetic Ltd 2015b)
