PUBLISHED PROJECT REPORT PPR890

Innovative Geotechnical Repair Techniques Effectiveness of Electrokinetic Geosynthetics

HAGDMS No. 30665

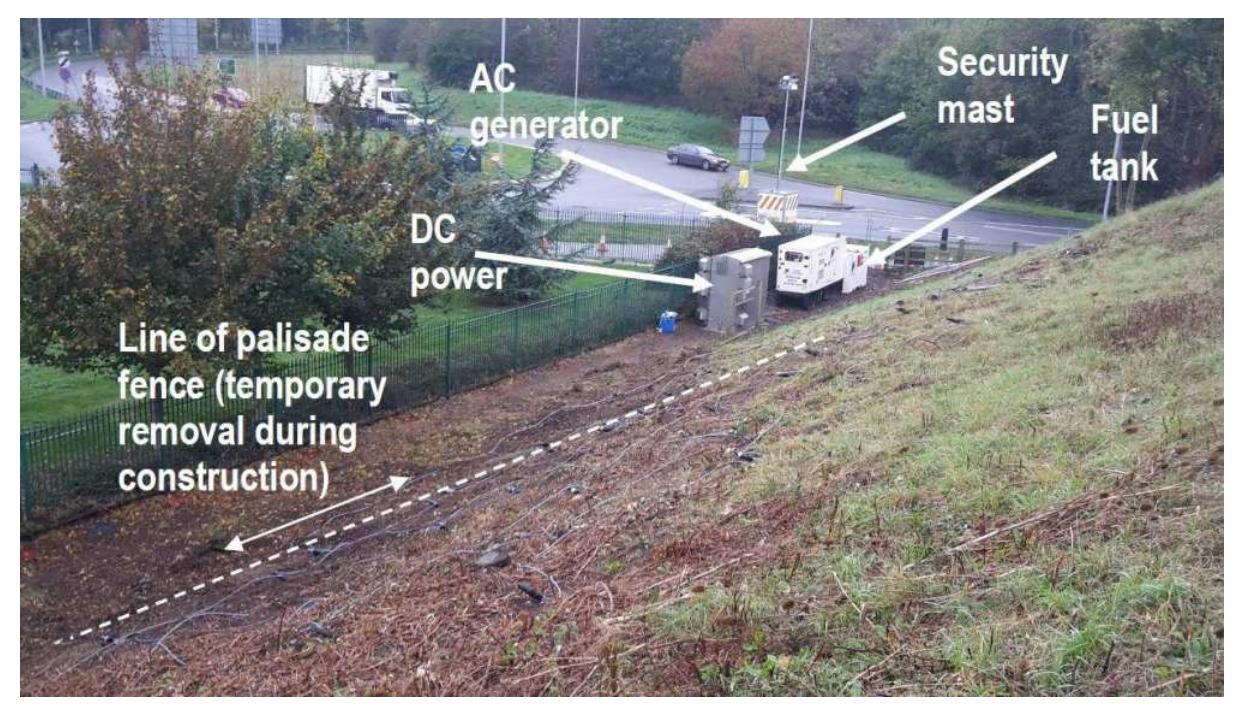
Figure 26: AC generator, fuel tank, DC power supply, electrode connections and security mast for the EKG treatment (Electrokinetic Ltd 2015b)

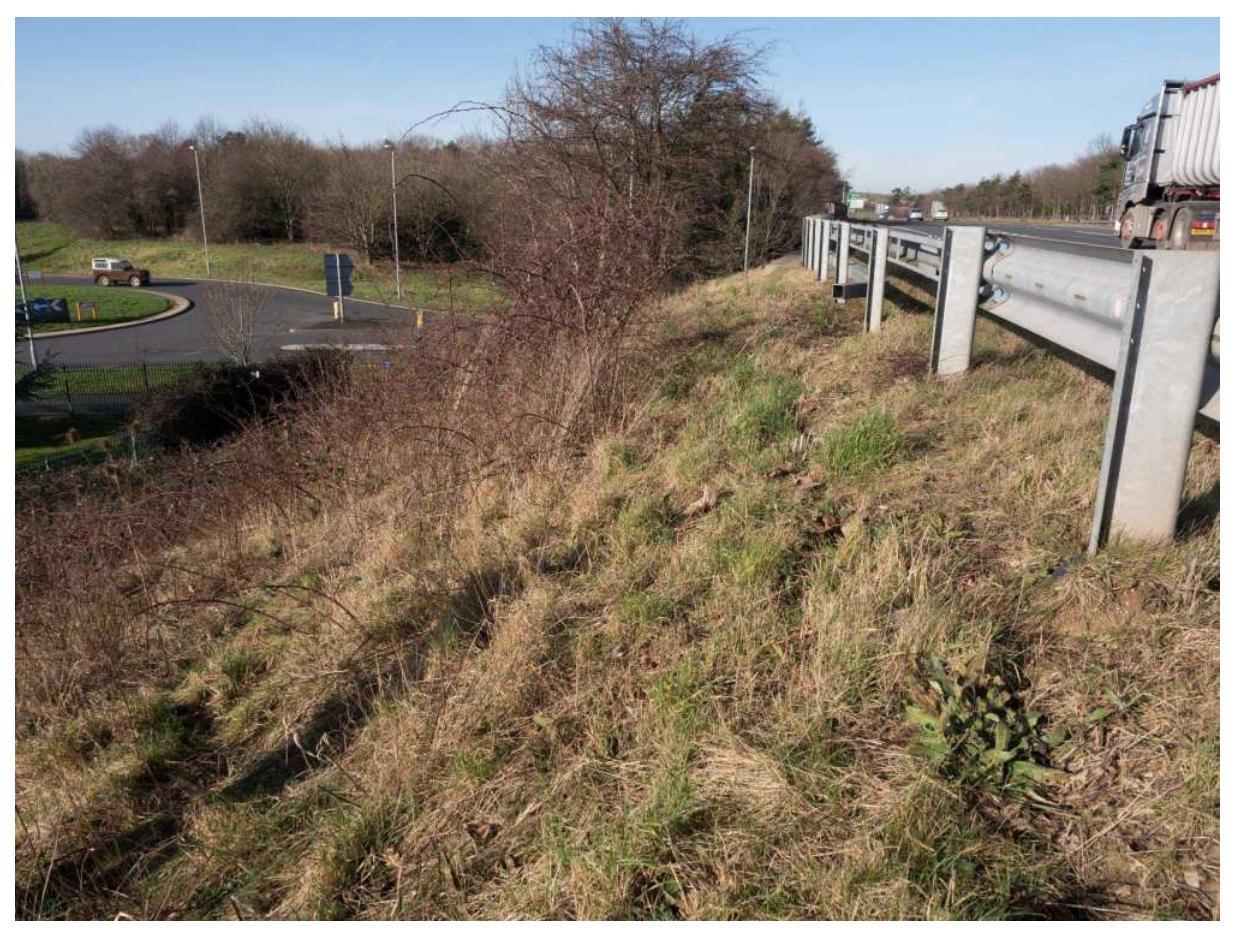
Figure 27: Separation crack between the slope materials and concrete barrier-post foundations (January 2018)

The inspection carried out by the project team in January 2018 revealed both a break in slope, approximately 2m above the toe, in the area immediately to the south-east and a separation between the concrete barrier-post foundations and the embankment materials above the remediation (Figure 27). This separation was approximately 50mm to 100mm wide and was able to be probed with a rule to a maximum of 500mm and 800mm. This separation extended approximately 4m or more from the abutment wing wall. It is not clear whether this separation was evident prior to the EKG remediation, and is thus the scarp that was referred to in the ground investigation, or whether it has developed since the remediation was carried out; in the latter case this could be due to the drying out of the treated material, for example.

The interpretation of the existence of a shallow slide seems to be questionable. This is not only due to the existence of the observed separation described above but also due to other factors. The break in slope observed in January 2018 to the south-east of the remediation is coincident with the reported pre-remediation 'exit plane' and strongly resembles a construction artefact. In addition, despite being specifically intended to locate the hypothesised slip plane this was not observed in the trial pits opened during the ground investigation. Similarly, no evidence of a slip plane was found from the window sampling undertaken.

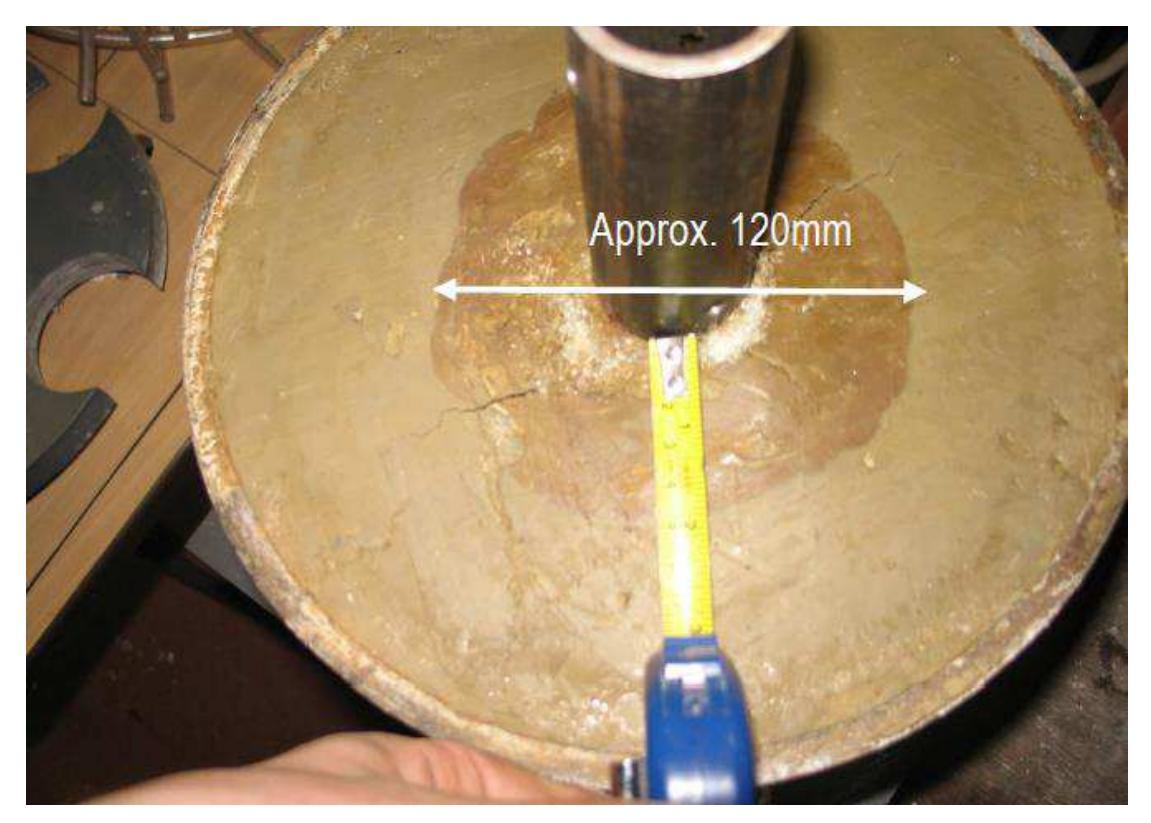
Figure 28: Development of a zone of increased adhesion immediately around the anode in the large cell laboratory test (Electrokinetic Ltd 2013)

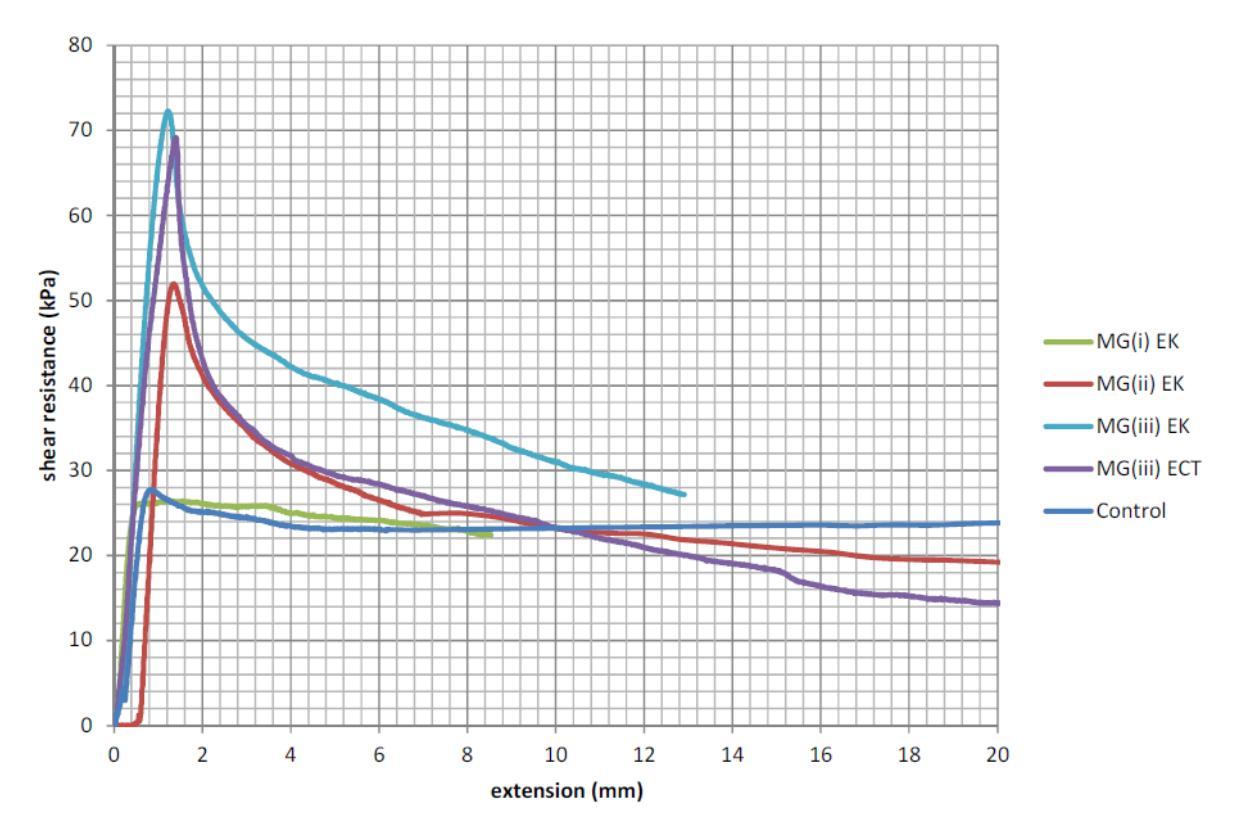
Figure 29: Plot of interface shear resistance against extension for the large cell anode pullout tests (Electrokinetic Ltd 2013)

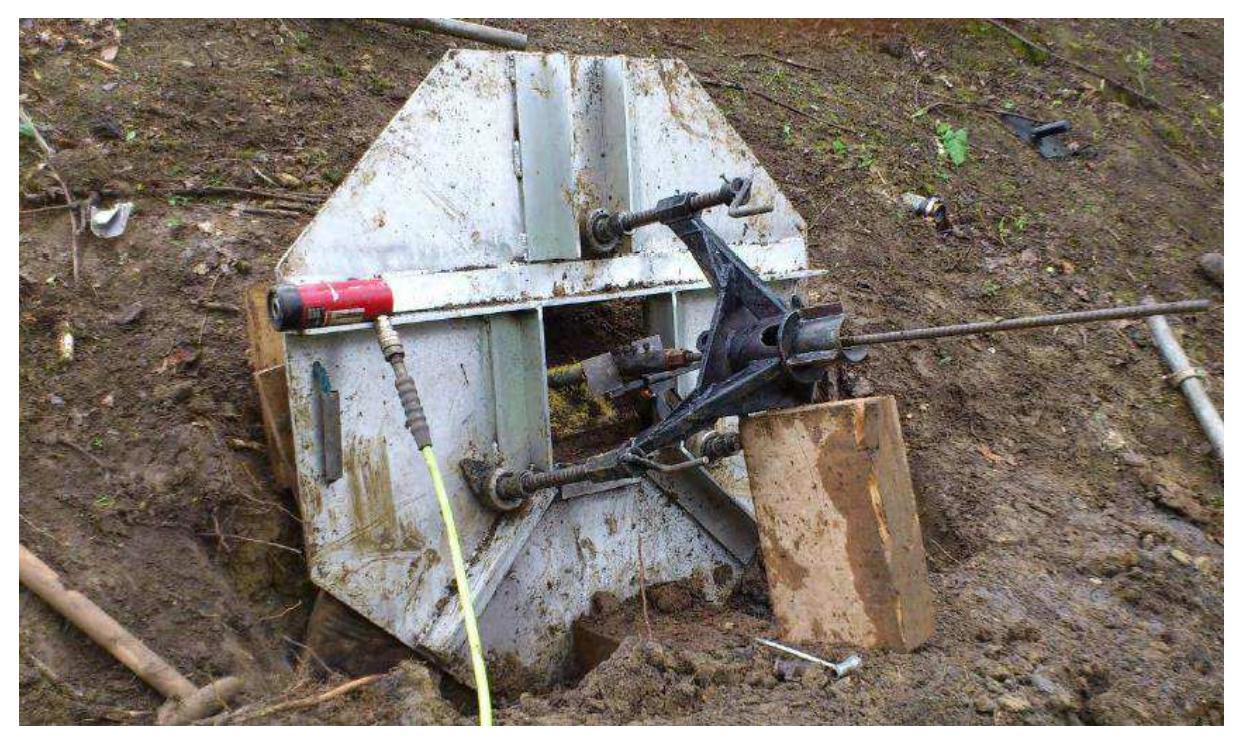
Figure 30: Soil nail testing equipment and set up (after Electrokinetic Ltd 2013)

Six anode soil nails were selected for pull-out testing to confirm that the soil nails met the required design verification load of either 33kN or 50kN (in practice all soil nails were tested to 50kN). Figure 30 shows the testing equipment and set up. BBMM (2014) recommended that for future trials more sacrificial EKG soil nails and conventional control soil nails are installed.

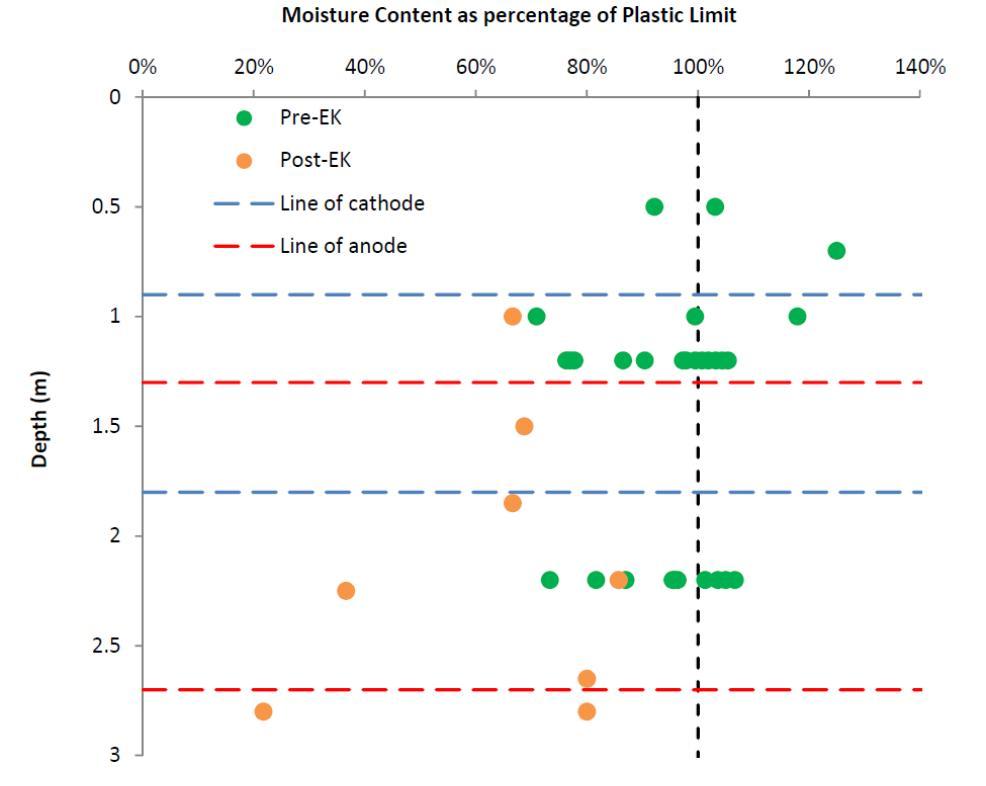
Figure 32: Plot of moisture content in relation to plastic limit before and after EKG treatment (after Electrokinetic Ltd 2014)

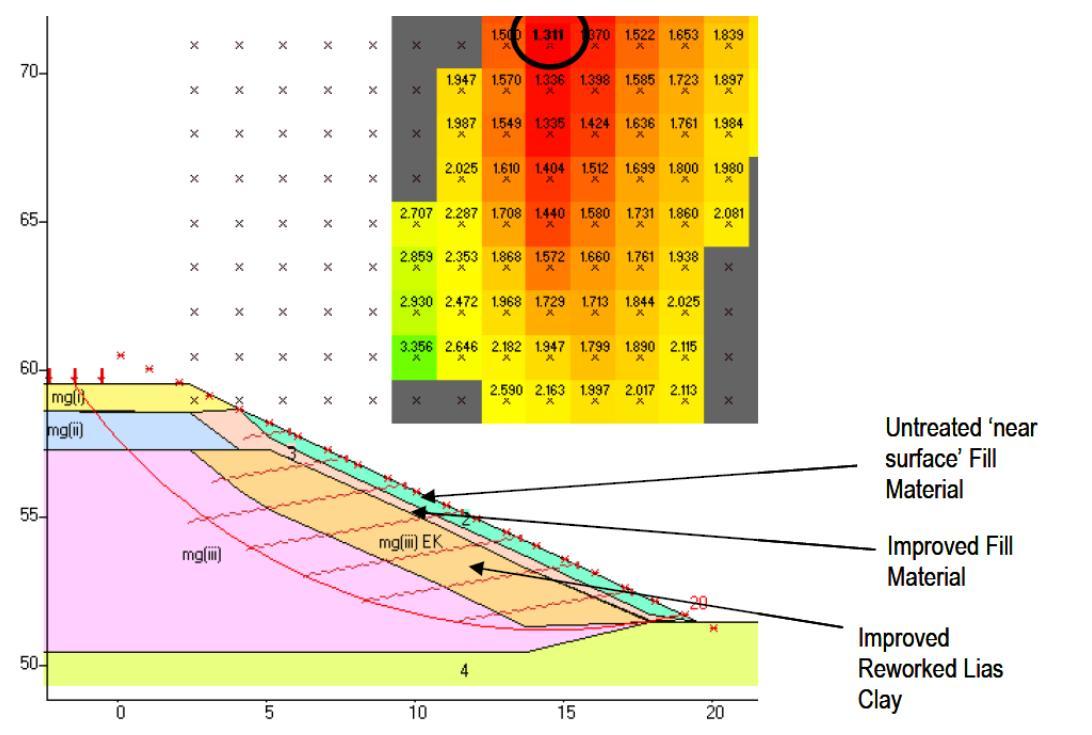
Figure 33: Slope stability analysis following EKG treatment showing failure surface driven deeper and having a satisfactory factor of safety (>1.3) (after Electrokinetic Ltd 2014)

analysis indicated that the failure surfaces been pushed back deeper into the slope and had a satisfactory factor of safety of greater than 1.3 (Figure 33)

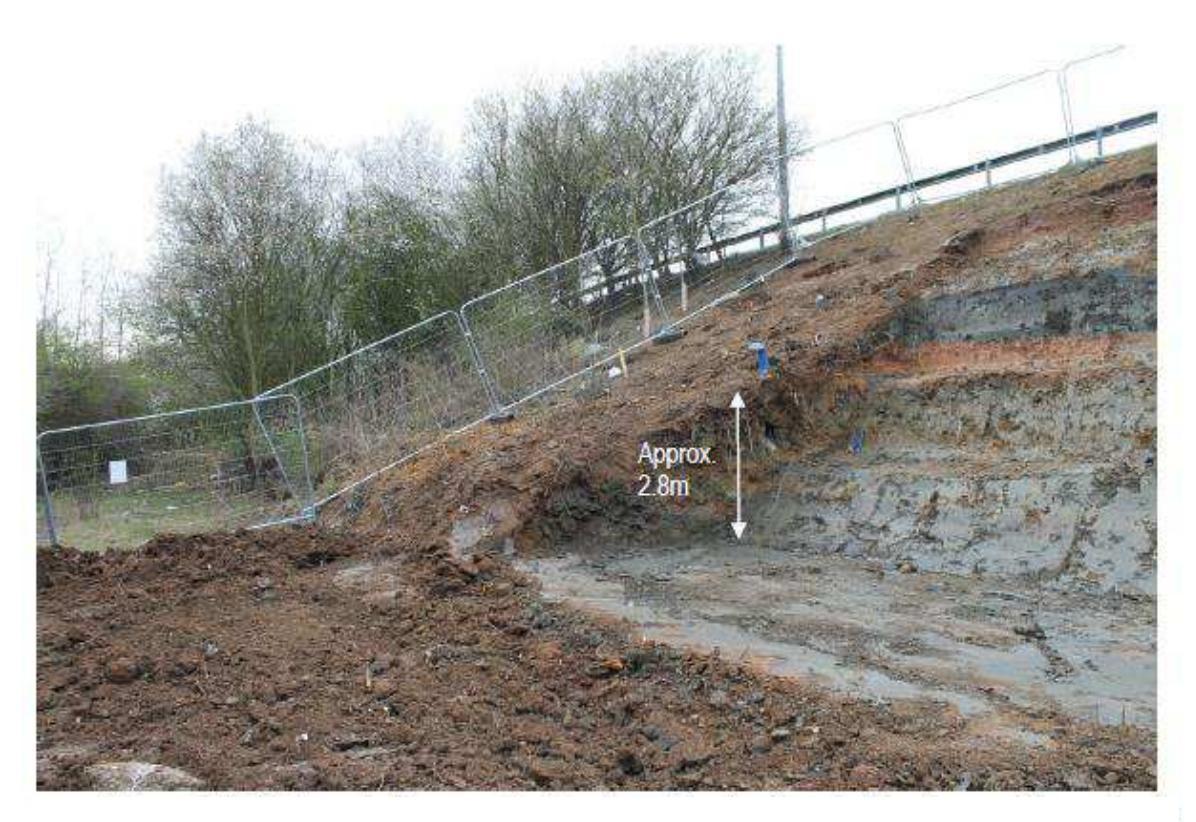
Figure 34: Figure from the Amey (2014) GFR showing the depth of the slope reprofiling

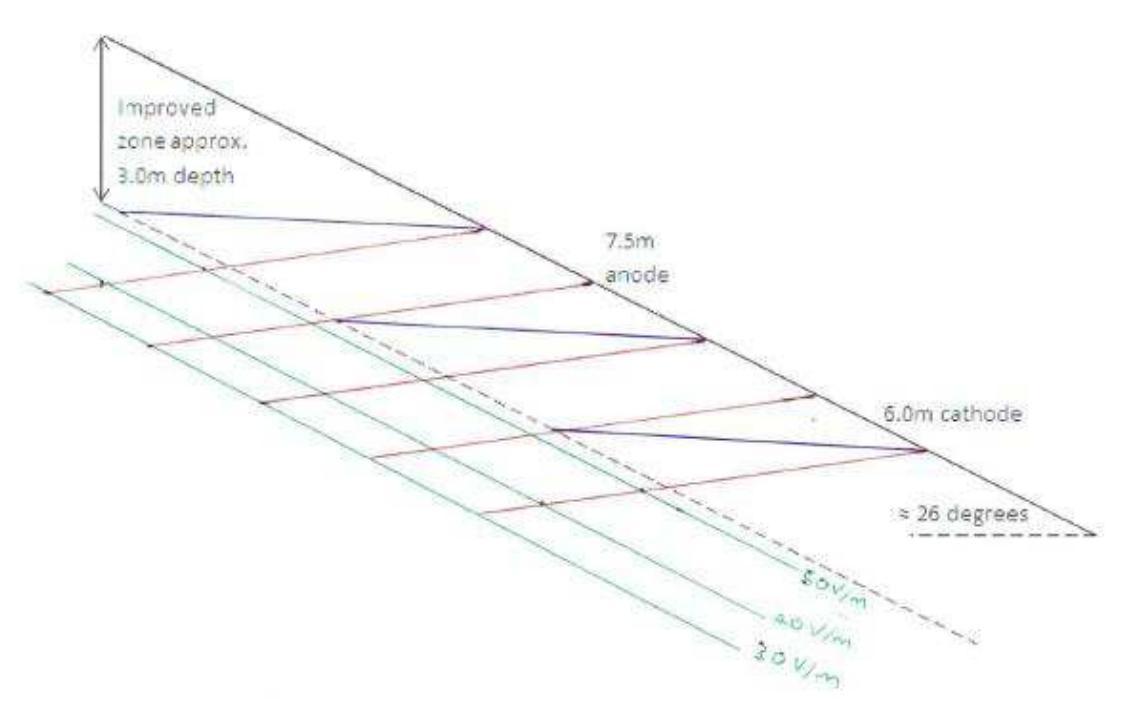
Figure 35: Figure from the Amey (2014) GFR showing the effective depth of EKG treatment

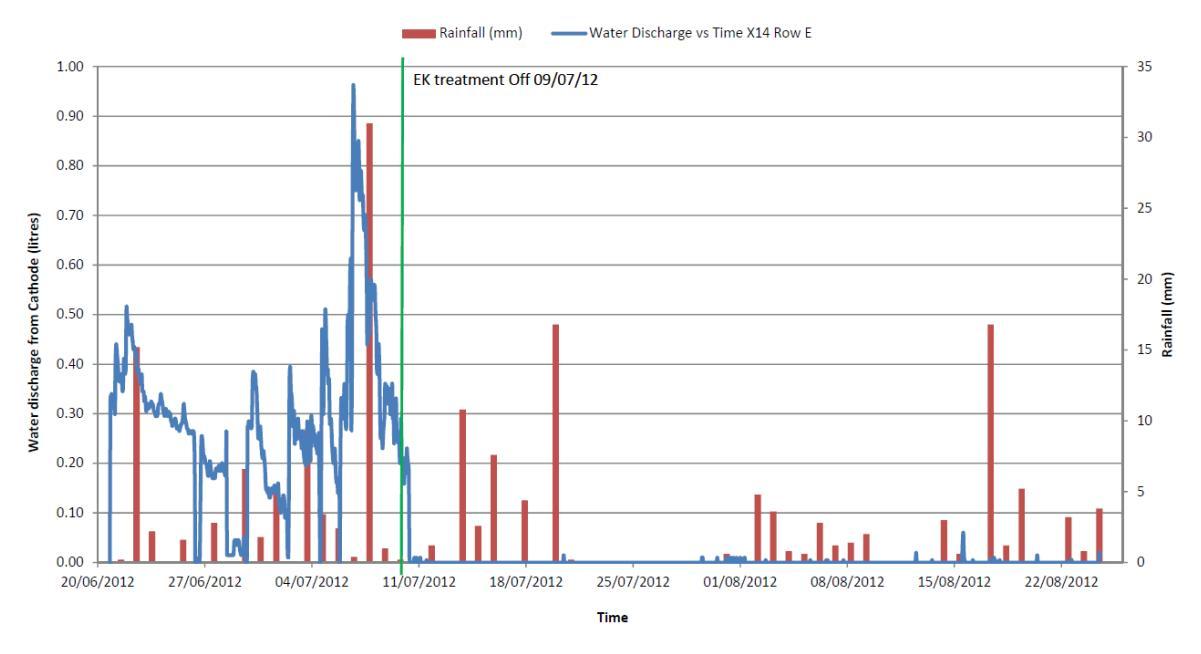
Figure 36: Plot of water discharge from cathode and rainfall against time for Row E cathode during and post-EKG treatment (after Electrokinetic Ltd 2014)

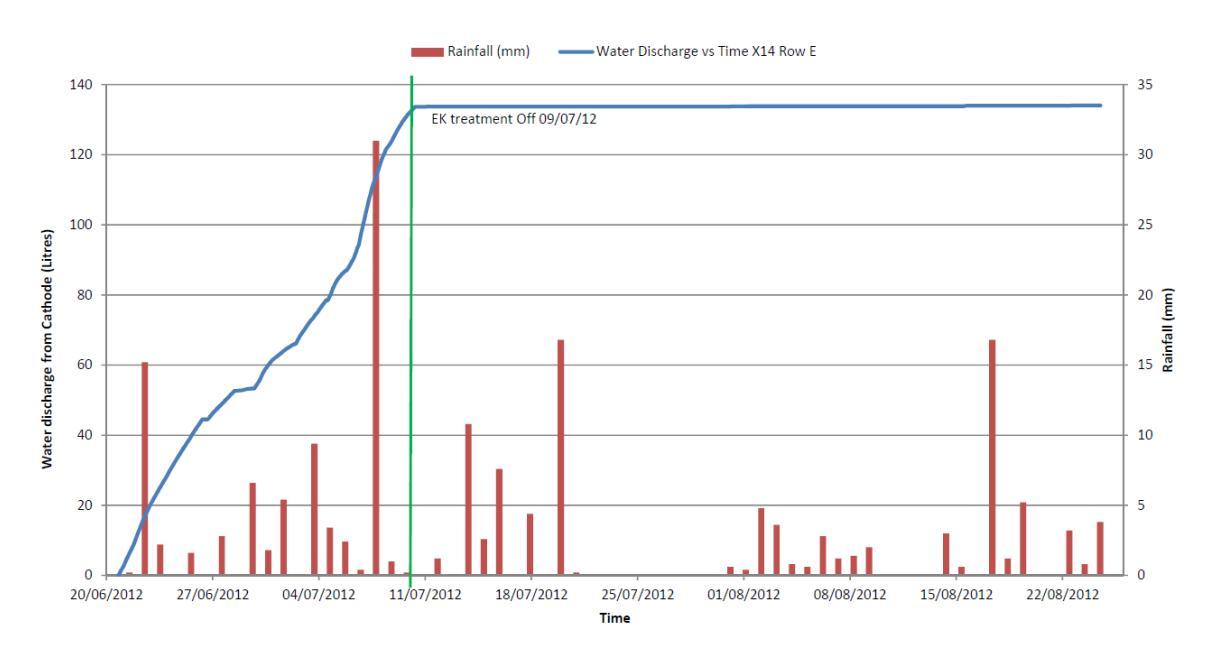
Figure 37: Plot of cumulative water discharge from cathode and rainfall against time for Row E cathode during and post-EKG treatment (after Electrokinetic Ltd 2014)

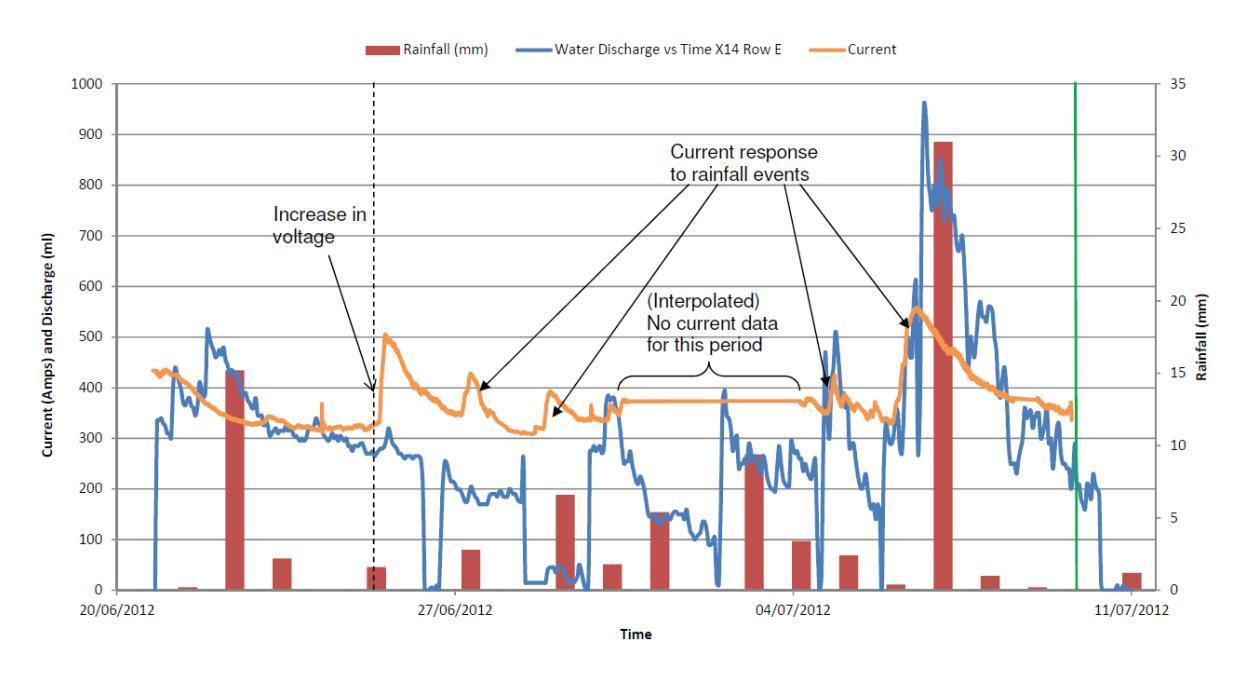
Figure 38: Plot of water discharge from cathode, current draw and rainfall against time for Row E cathode during and post-EKG treatment (after Electrokinetic Ltd 2014)

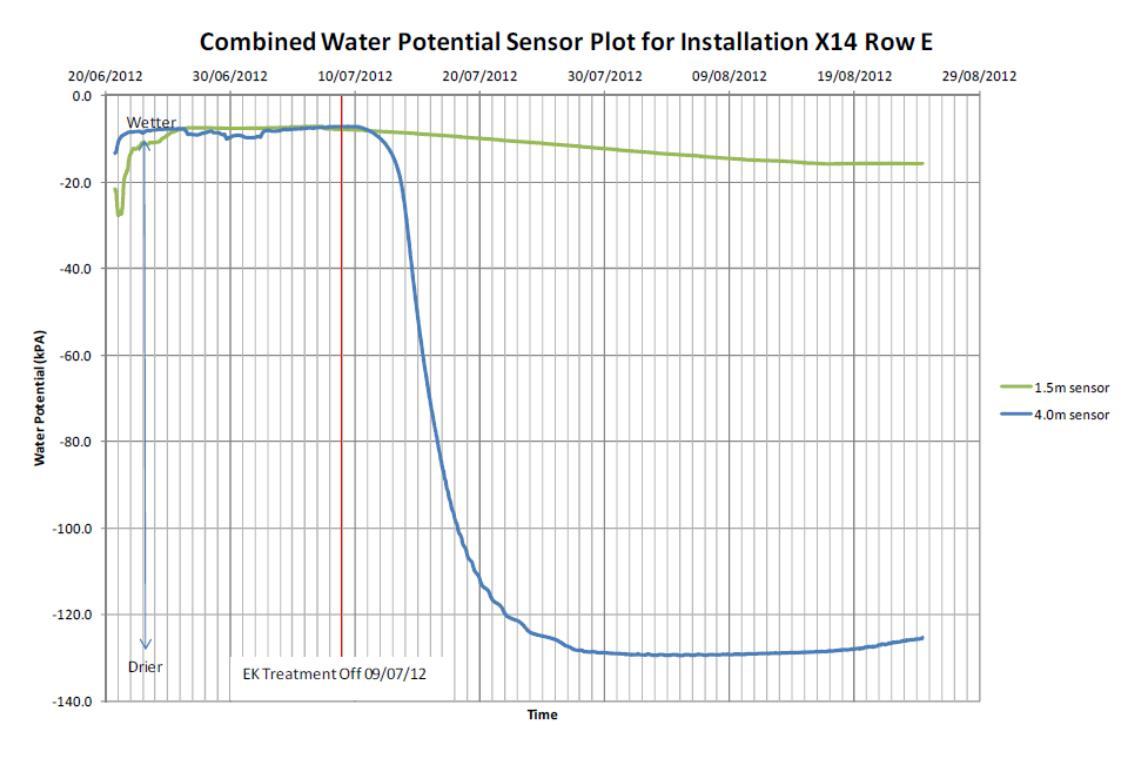
Figure 39: Plot of water potential against time for Row E cathode (after Electrokinetic Ltd 2014)

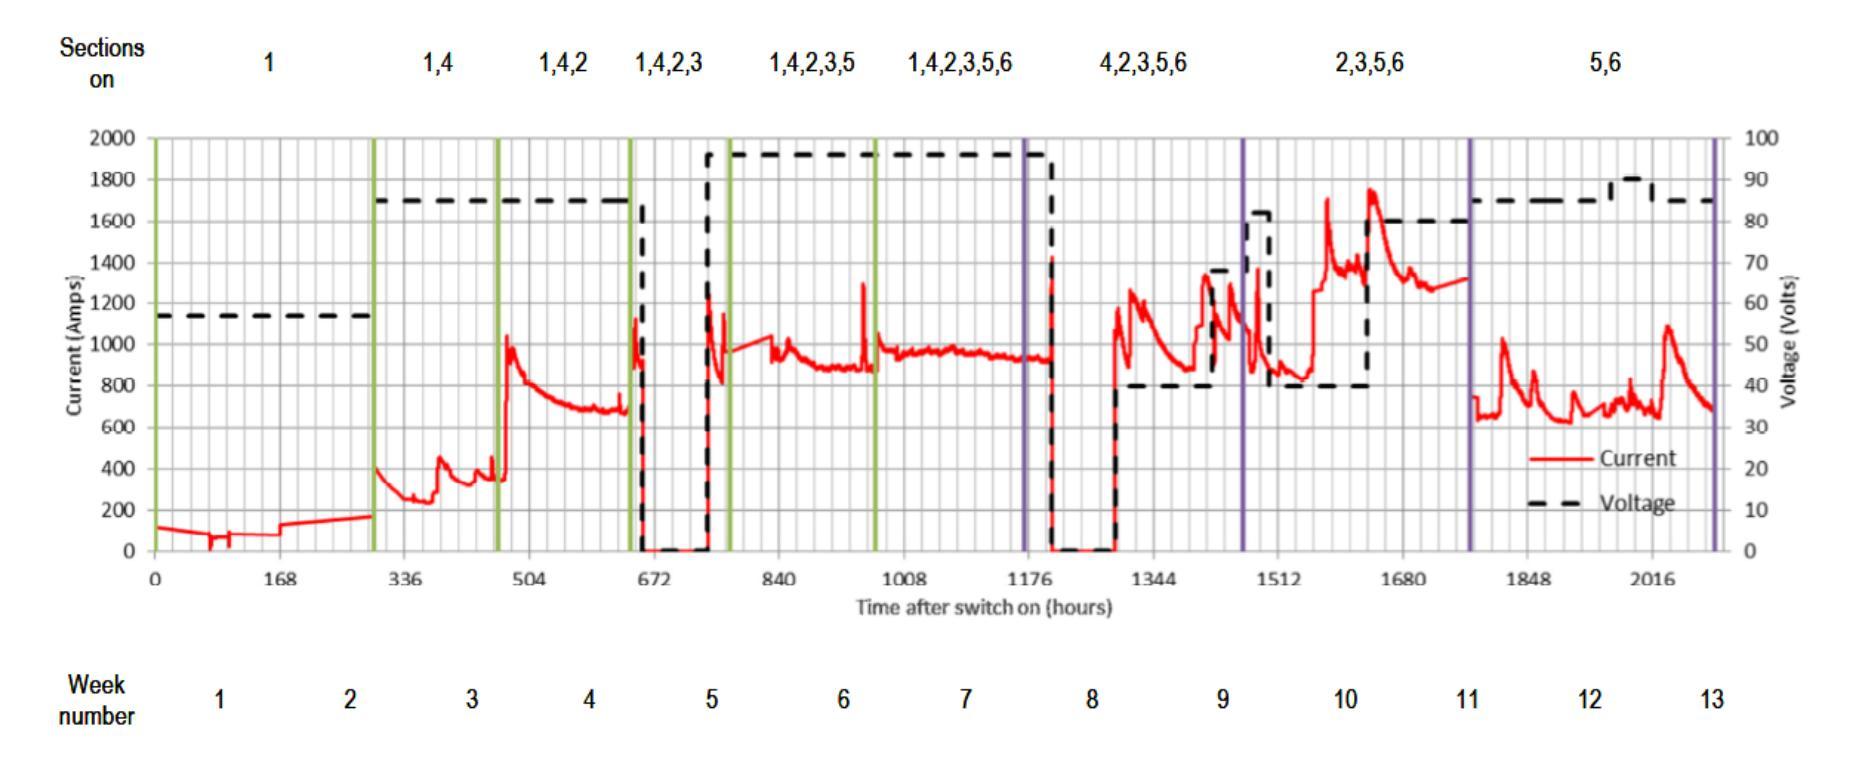
Figure 40: Current and voltage variation for treatment duration (after Electrokinetic Ltd 2014)

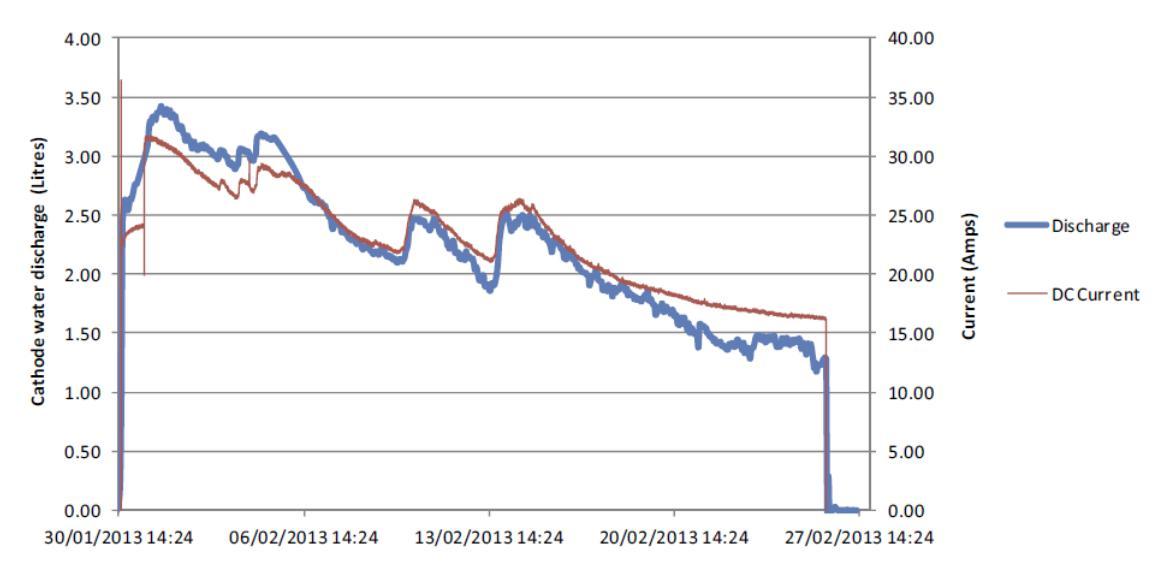
Figure 41: Plot showing EKG current draw against water discharge from the cathode during the 4 week trial (after Electrokinetic Ltd 2013)

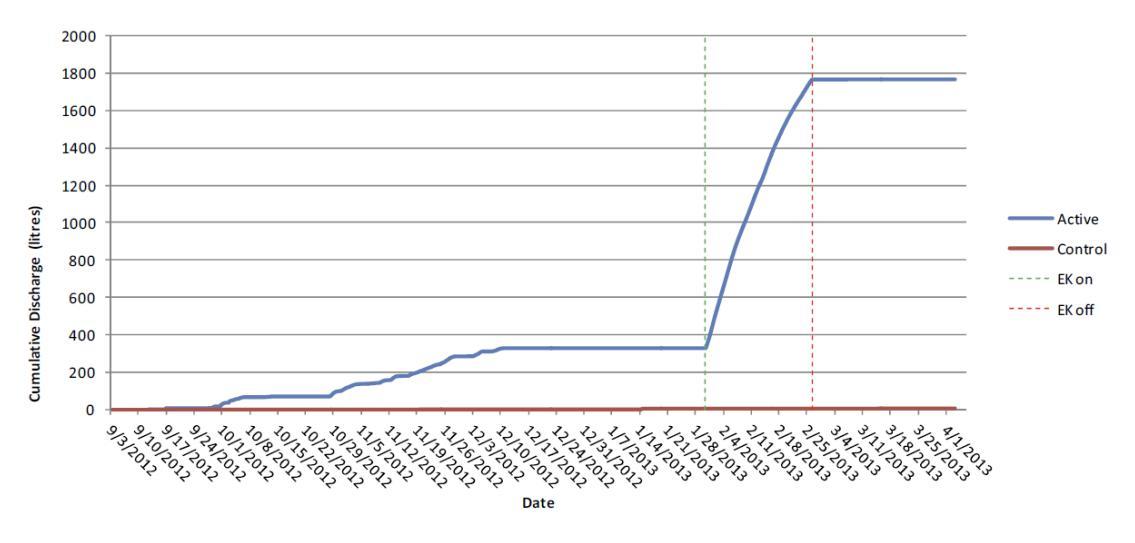
Figure 42: Plot showing the discharge from the cathode during the initial passive phase, during EKG treatment and following treatment (after Electrokinetic Ltd 2013)

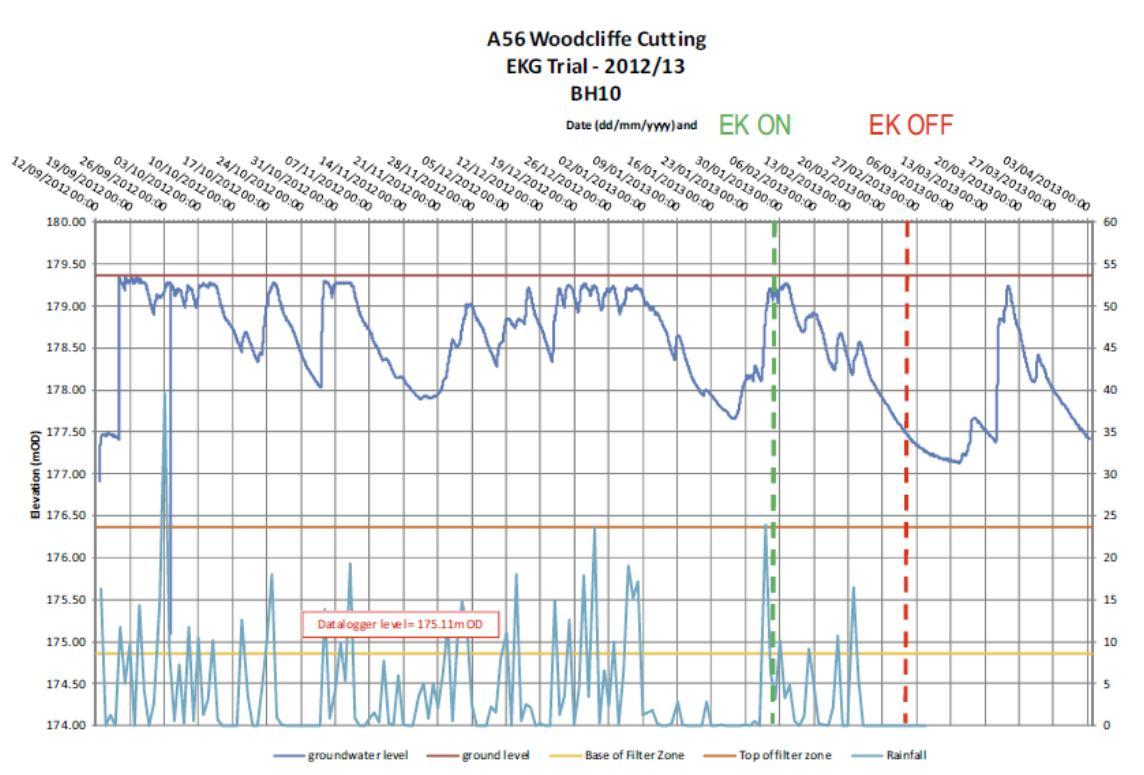
Figure 44: Plot of BH10 groundwater level against date and time (after Electrokinetic Ltd 2013)

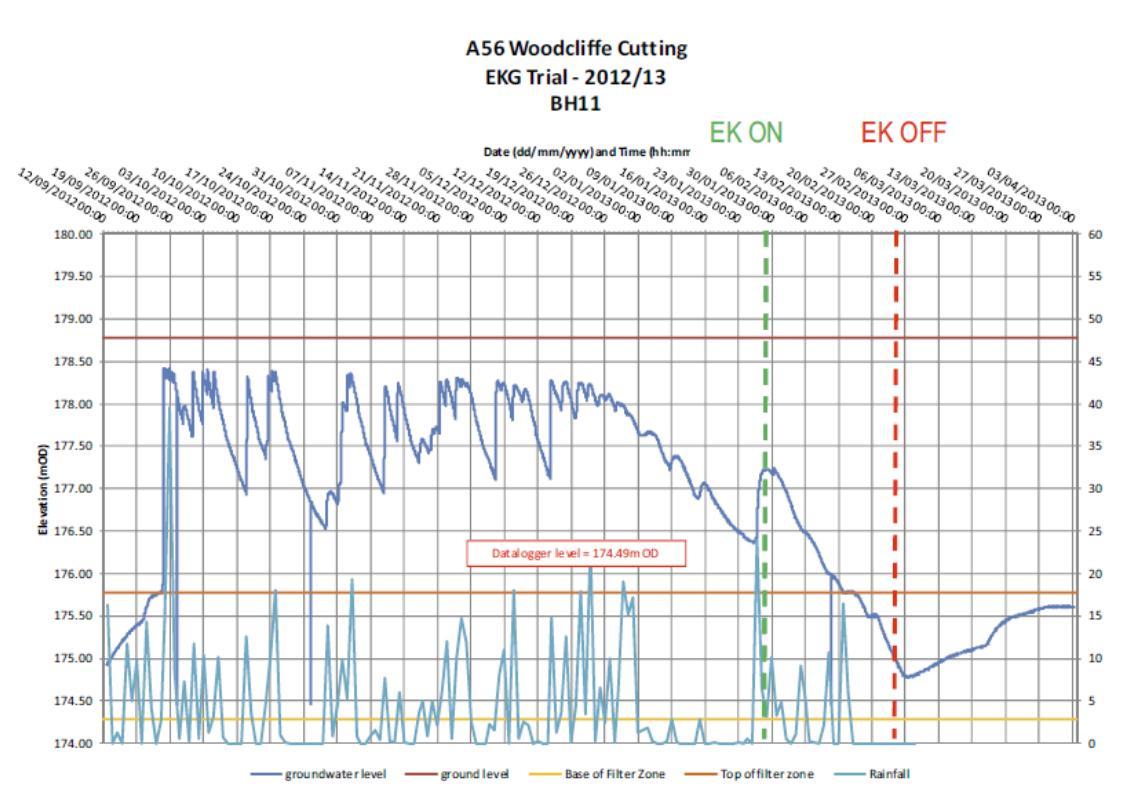
Figure 45: Plot of BH11 groundwater level against date and time (after Electrokinetic Ltd 2013)

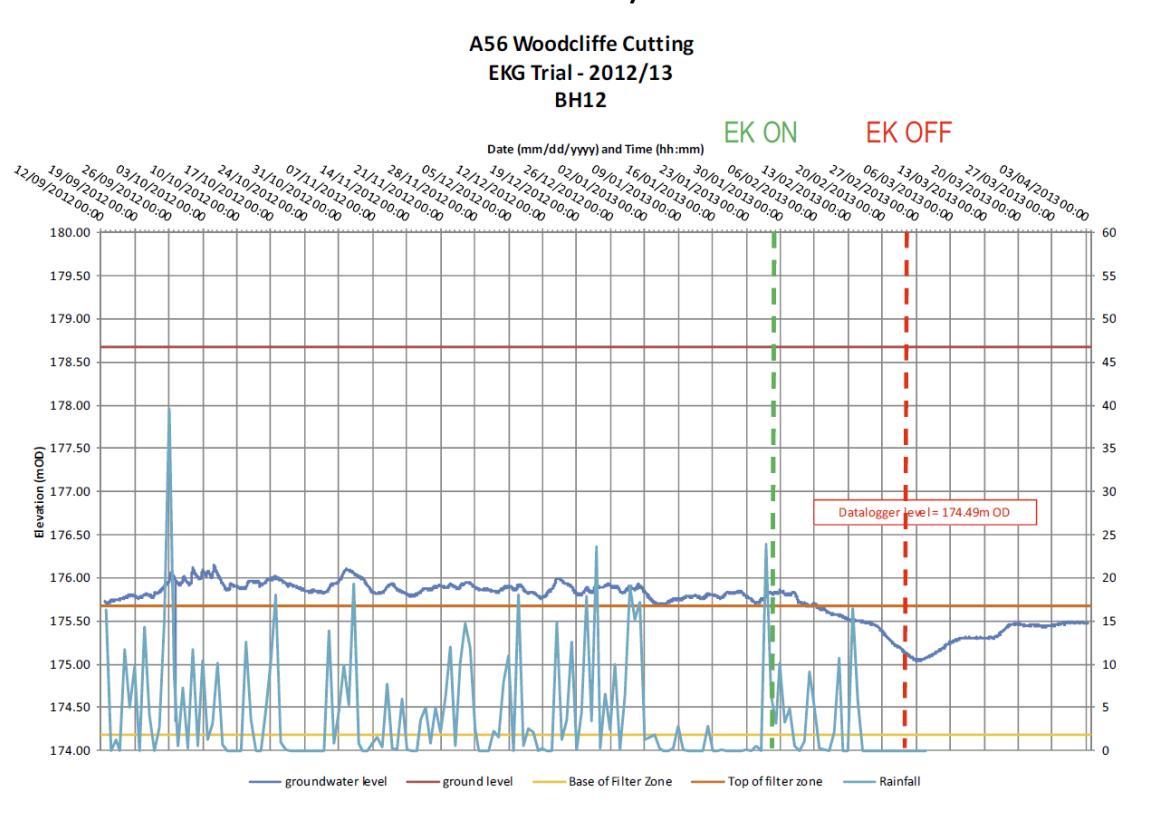
Figure 46: Plot of BH12 groundwater level against date and time. (after Electrokinetic Ltd 2013)

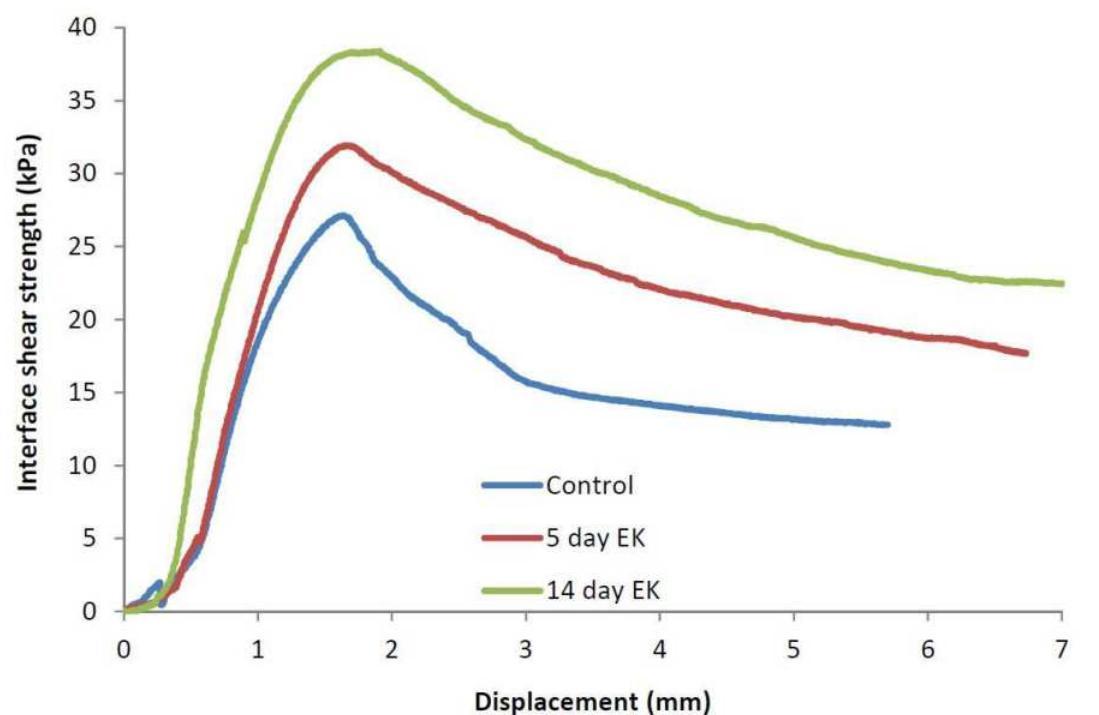
Figure 47: Plot of interface shear resistance against extension for the large cell anode pullout tests (Electrokinetic Ltd 2015a)

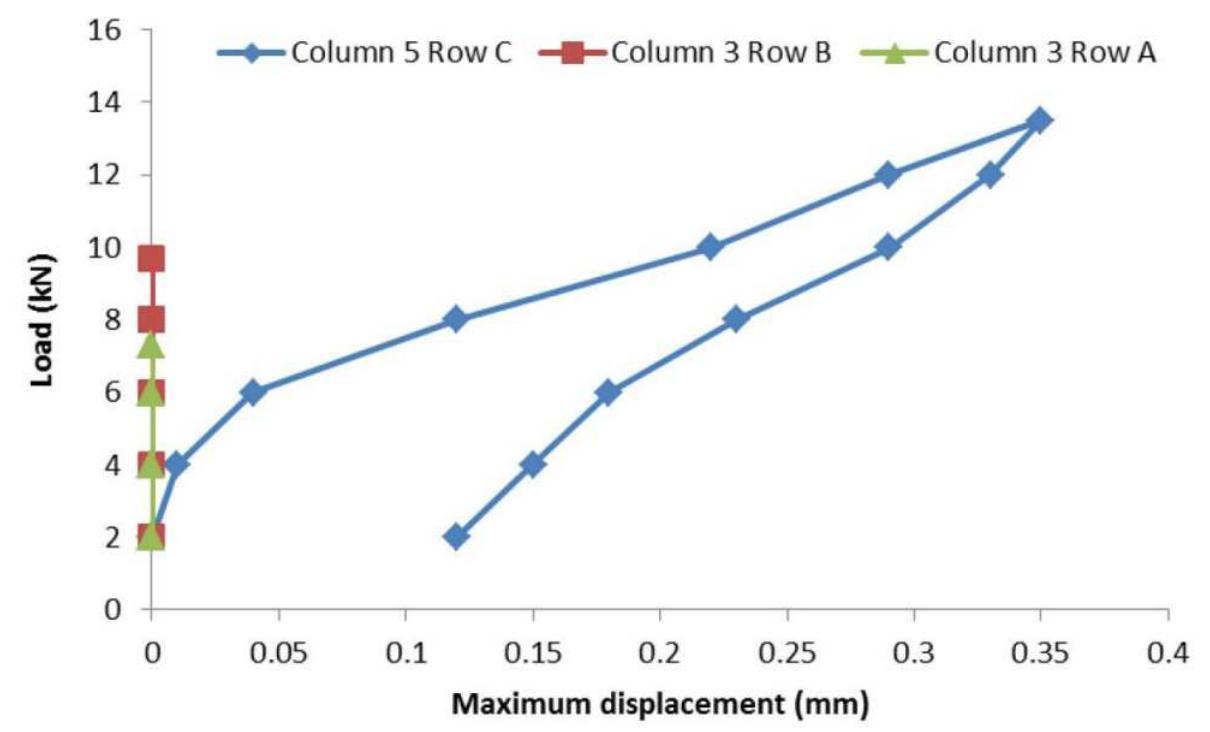
Figure 48: Load displacement testing data for the tested anode soil nails (Electrokinetic Ltd 2015b)

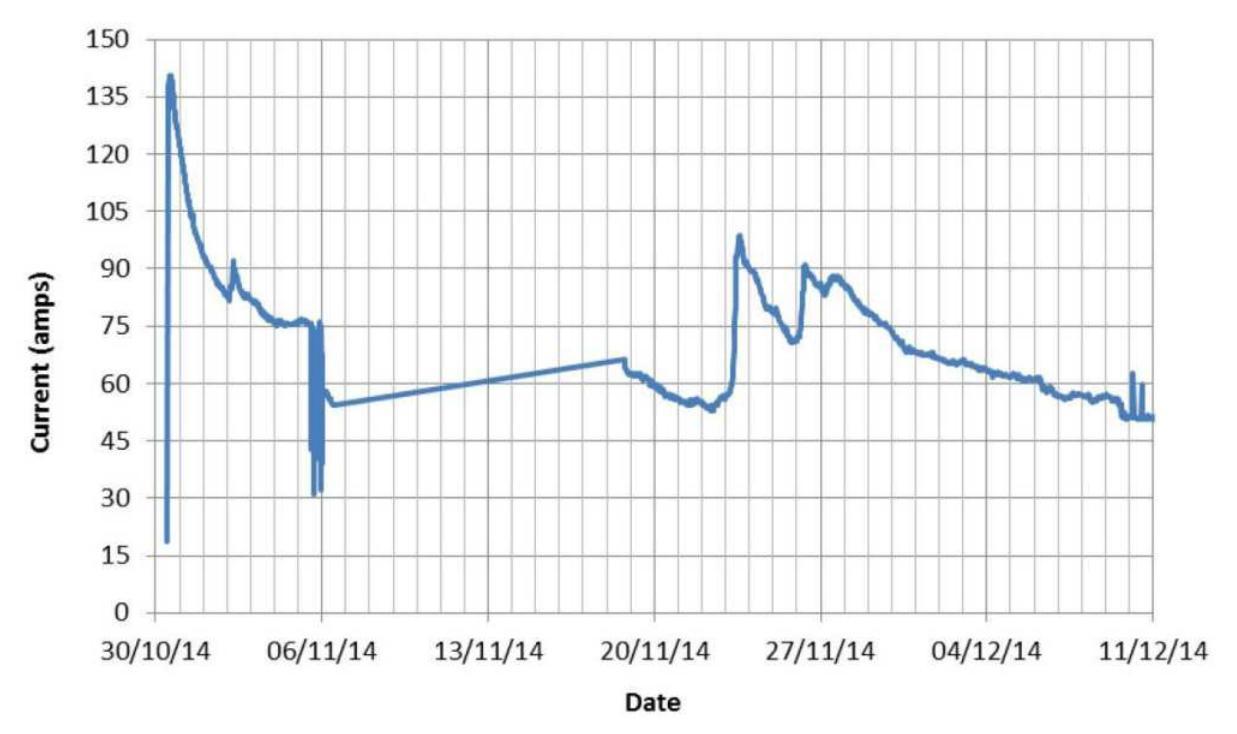
Figure 49: Plot of current draw against time for the EKG treatment (after Electrokinetic Ltd 2015b)

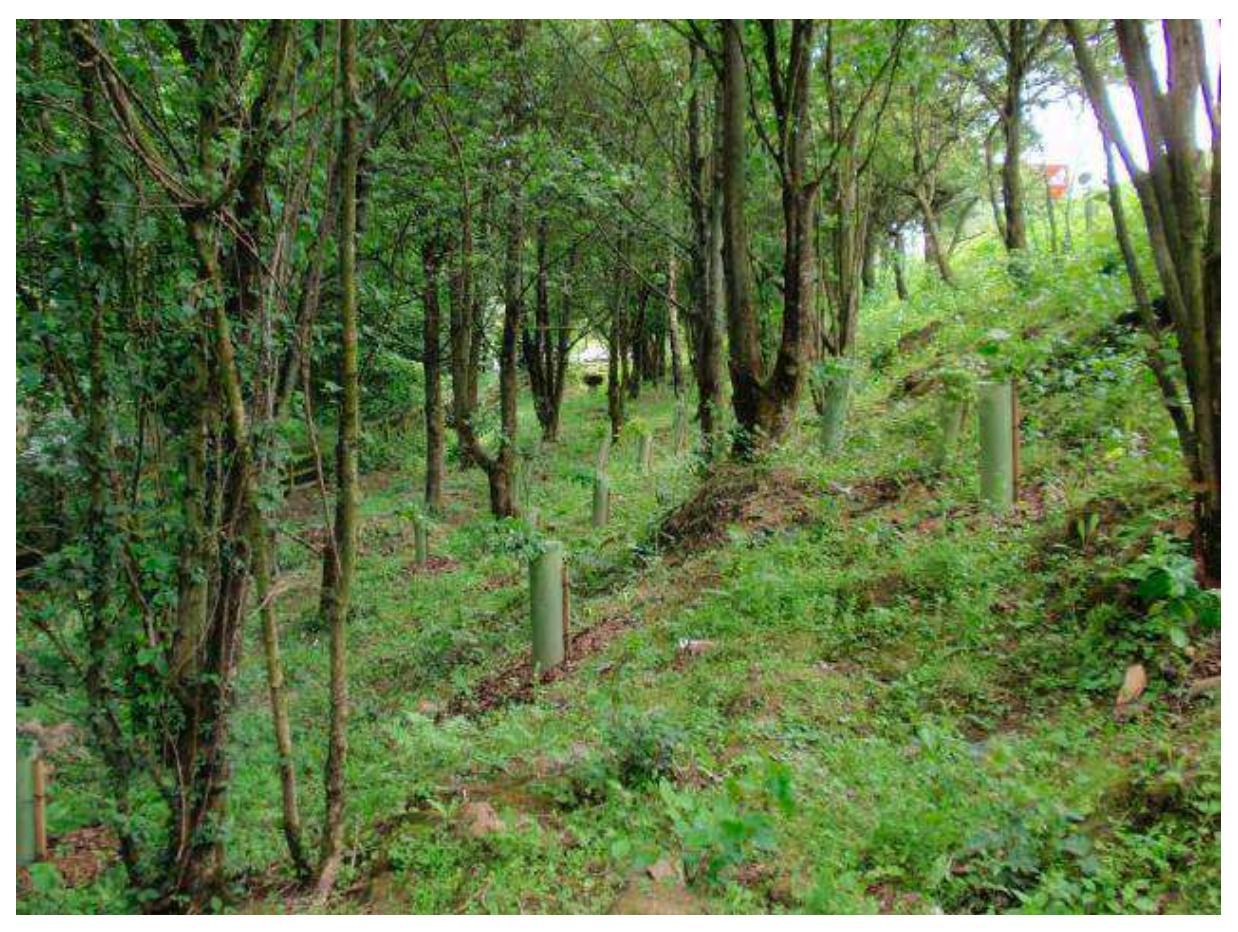
Figure 50: Stocks Green 1 site 12 months after EKG trial (BBMM 2014)
