## **PUBLISHED PROJECT REPORT PPR819**

Analysis of bus collisions and  
identification of countermeasures

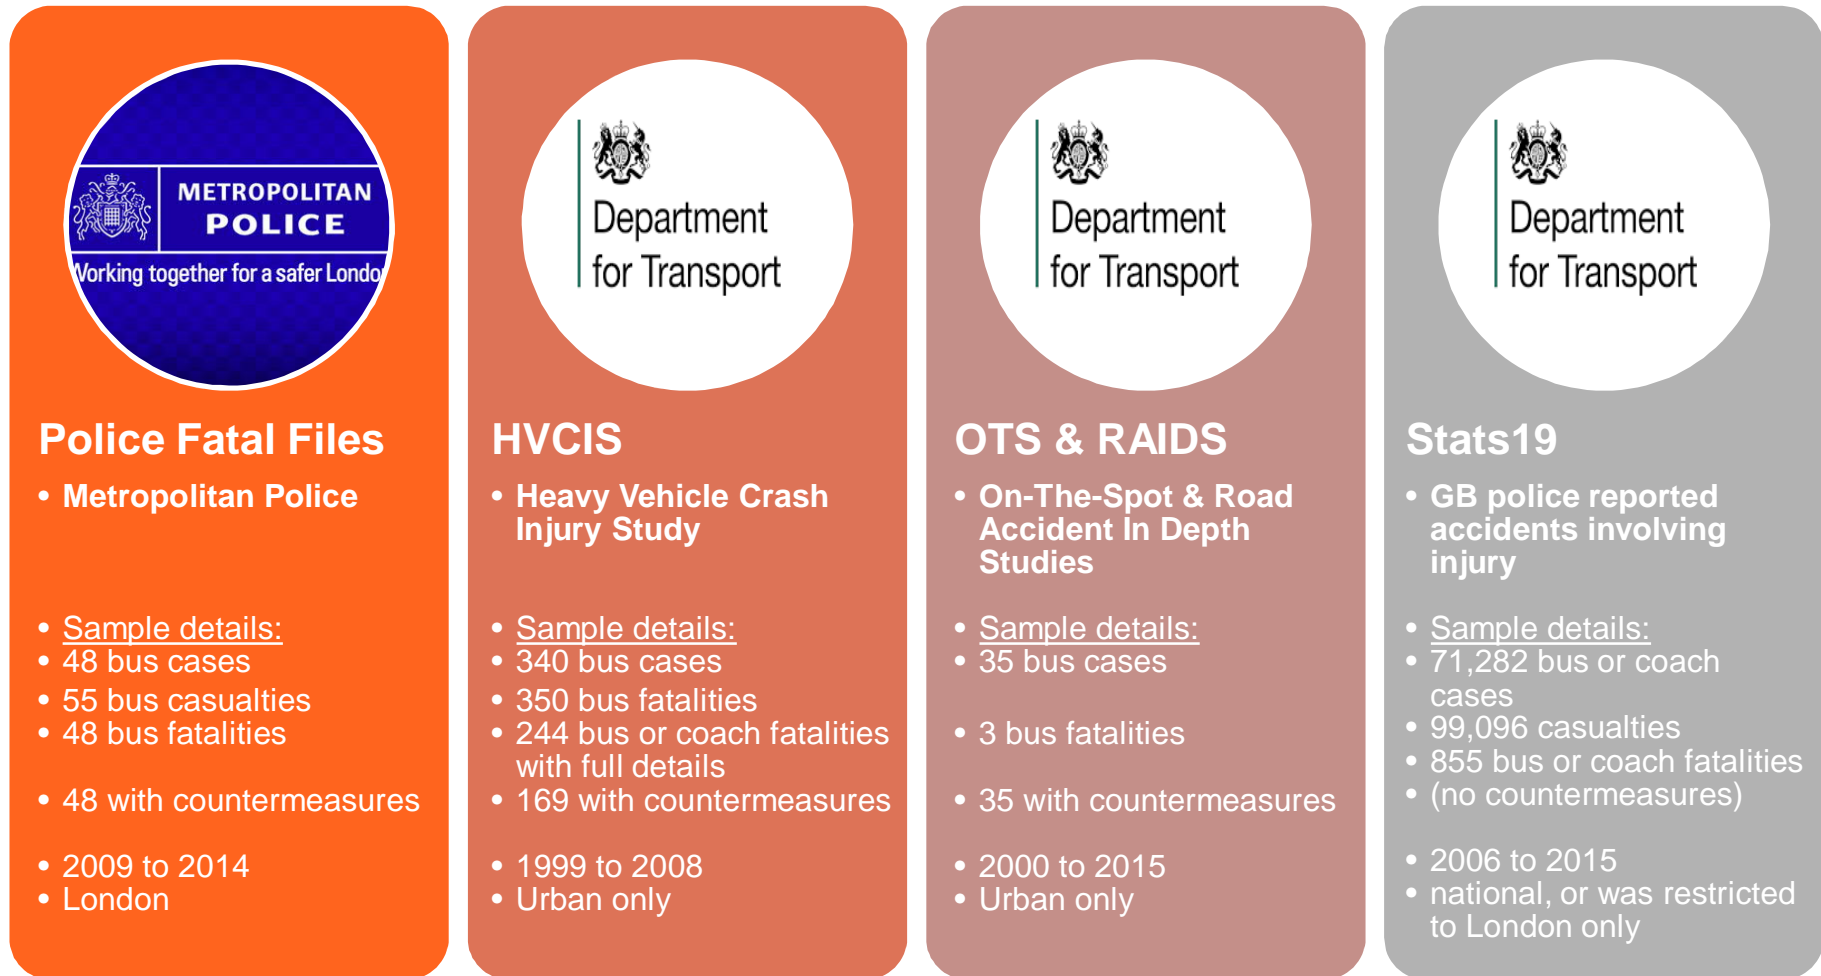
**Figure 3: Comparative summary of data sources: Police fatal files, HVCIS, OTS & RAIDS, Stats19.**

The process of determining which countermeasures will be effective begins with a full understanding of how a collision occurred. This can be broken down by considering the risks posed by the people, vehicles, and roads. To identify the collision and injury trends for buses there were various datasets available for analysis; these are described in more detail as in Figure 3 and the following sections.

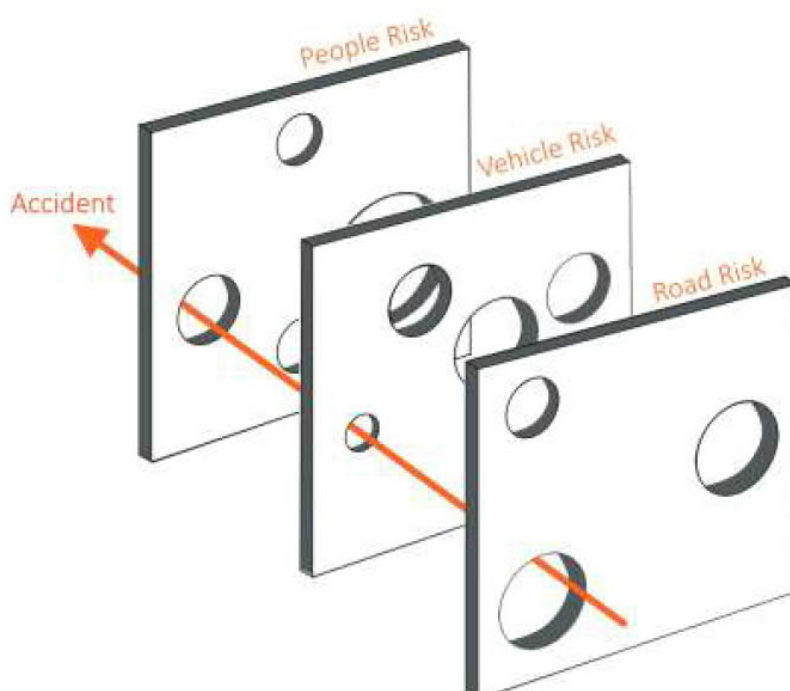
**Figure 9: Swiss cheese model of collision causation. Adapted from (Reason, 1990)**

Another way to visualise this issue is by considering the 'Swiss cheese model' of hazards first proposed by Reason (1990), as shown in Figure 9. This model proposes that failures (in this case collisions) occur only when all specific risks align to result in a collision. If one aspect is not conducive to the occurrence of the collision, it is prevented.

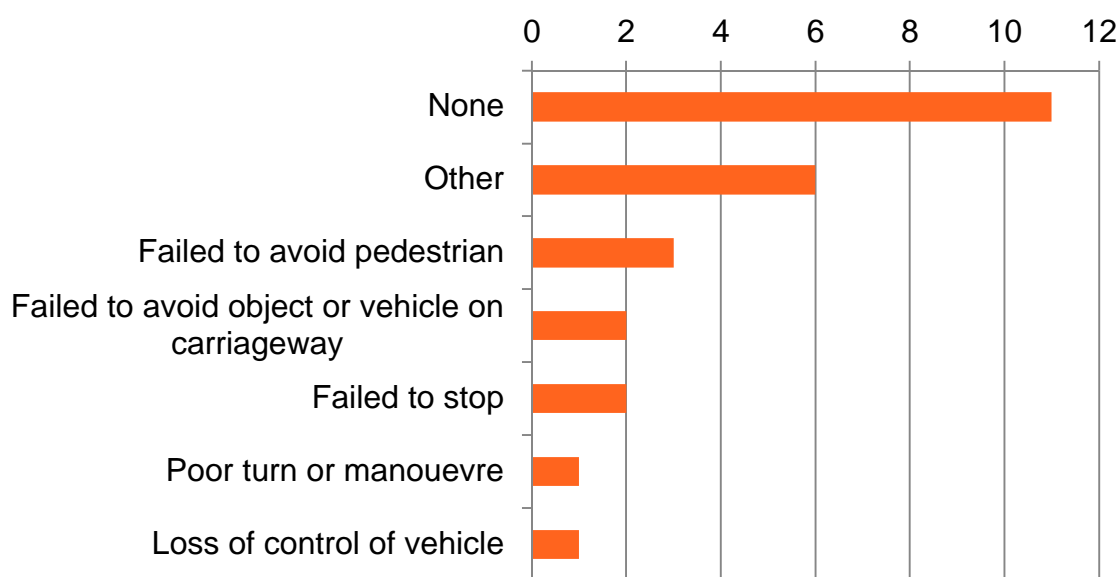
**Figure 13: Precipitating factors for bus drivers. Source data: Police fatal files.**

For the remaining 15 cases there was some precipitating factors for the bus drivers, although six of them were 'other'. Failing to avoid a pedestrian/vehicle, and failed to stop were the more frequent of the remaining factors as shown in Figure 13.

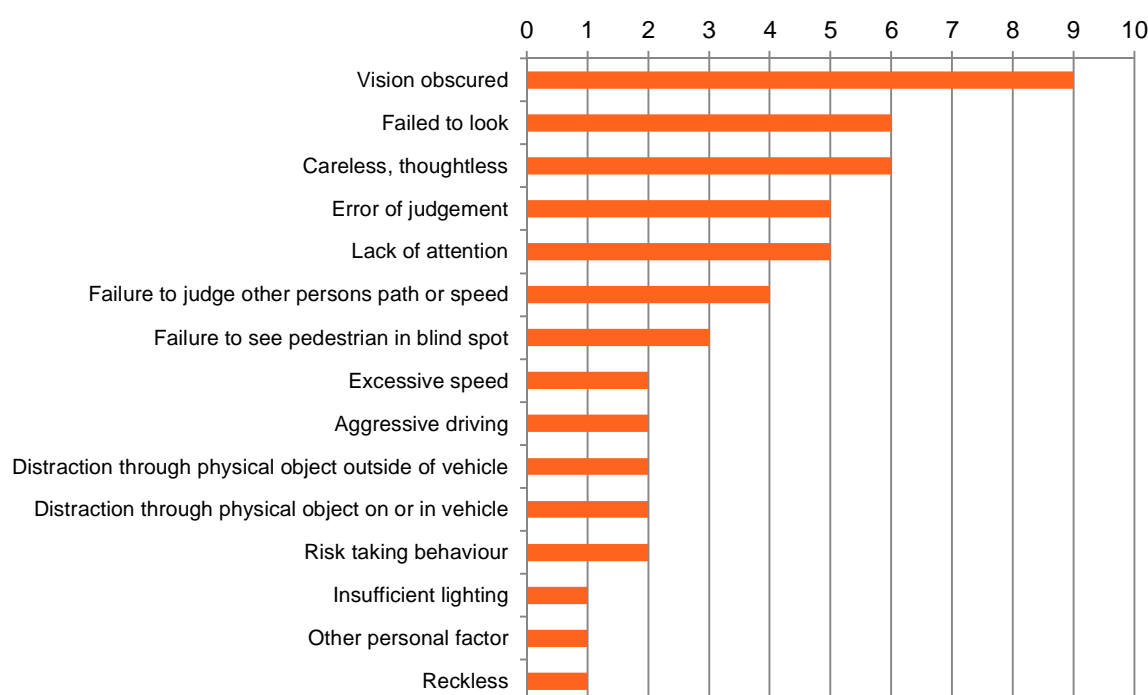
**Figure 14: Causation factors for bus drivers. Source data: Police fatal files.**

Figure 14 describes the distribution of the specific causation factors where the bus drivers were found to have contributed to the collision for the police fatal files. The most frequent causation factor was obscured vision, with vehicle geometry and parked vehicles being the most frequent cause as previously described. It would appear that an AEB system would be a beneficial countermeasure in addressing the top six of these causation factors, perhaps indicating the importance of AEB as a countermeasure.

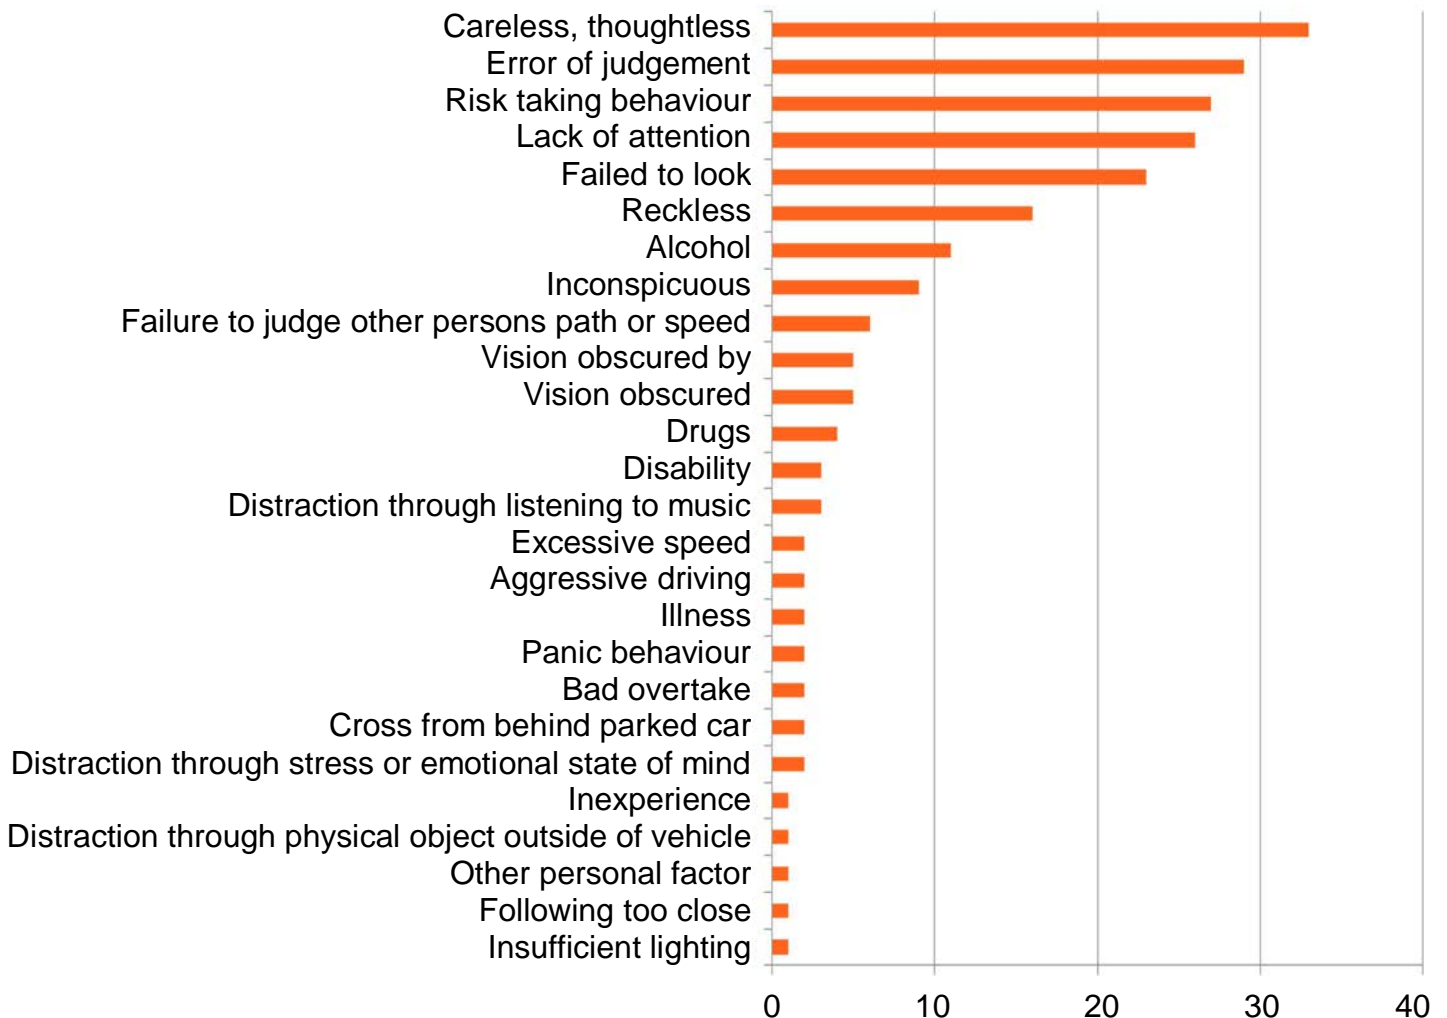
**Figure 16: Causation factors for other road users. Source data: Police fatal files.**

For the causation factors shown in Figure 16 for the police fatal files the majority were concerned with poor judgement in some form by the driver: carelessness, error of judgement, risk taking, lack of attention, failed to look, reckless, alcohol; all these have a frequency greater than 10. Obscured vision is much lower down the list for other road users then for bus drivers, and consists of obscuration by parked vehicles (two cases), other features (two cases) and the vehicle in front (one case).

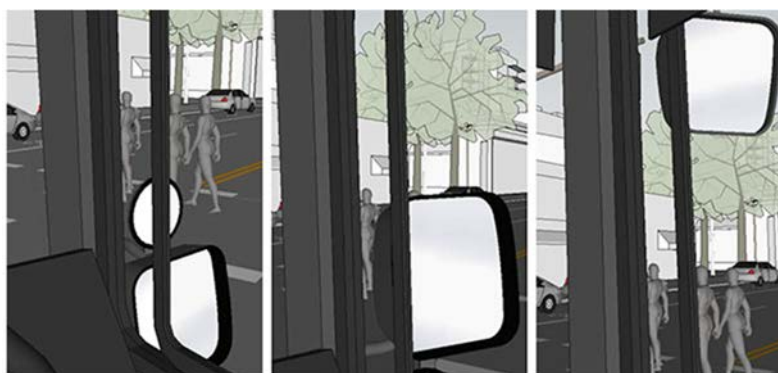
**Figure 17: A bus driver's view of a pedestrian crossing with three different mirror configurations: inverted mount (left); medium mount (centre); high mount (right) (Leverette, 2013).**

According to EU regulations buses must be equipped with mirrors but in the future the replacement of mirrors with a camera and display system could further reduce the issue of mirrors creating blind spots.

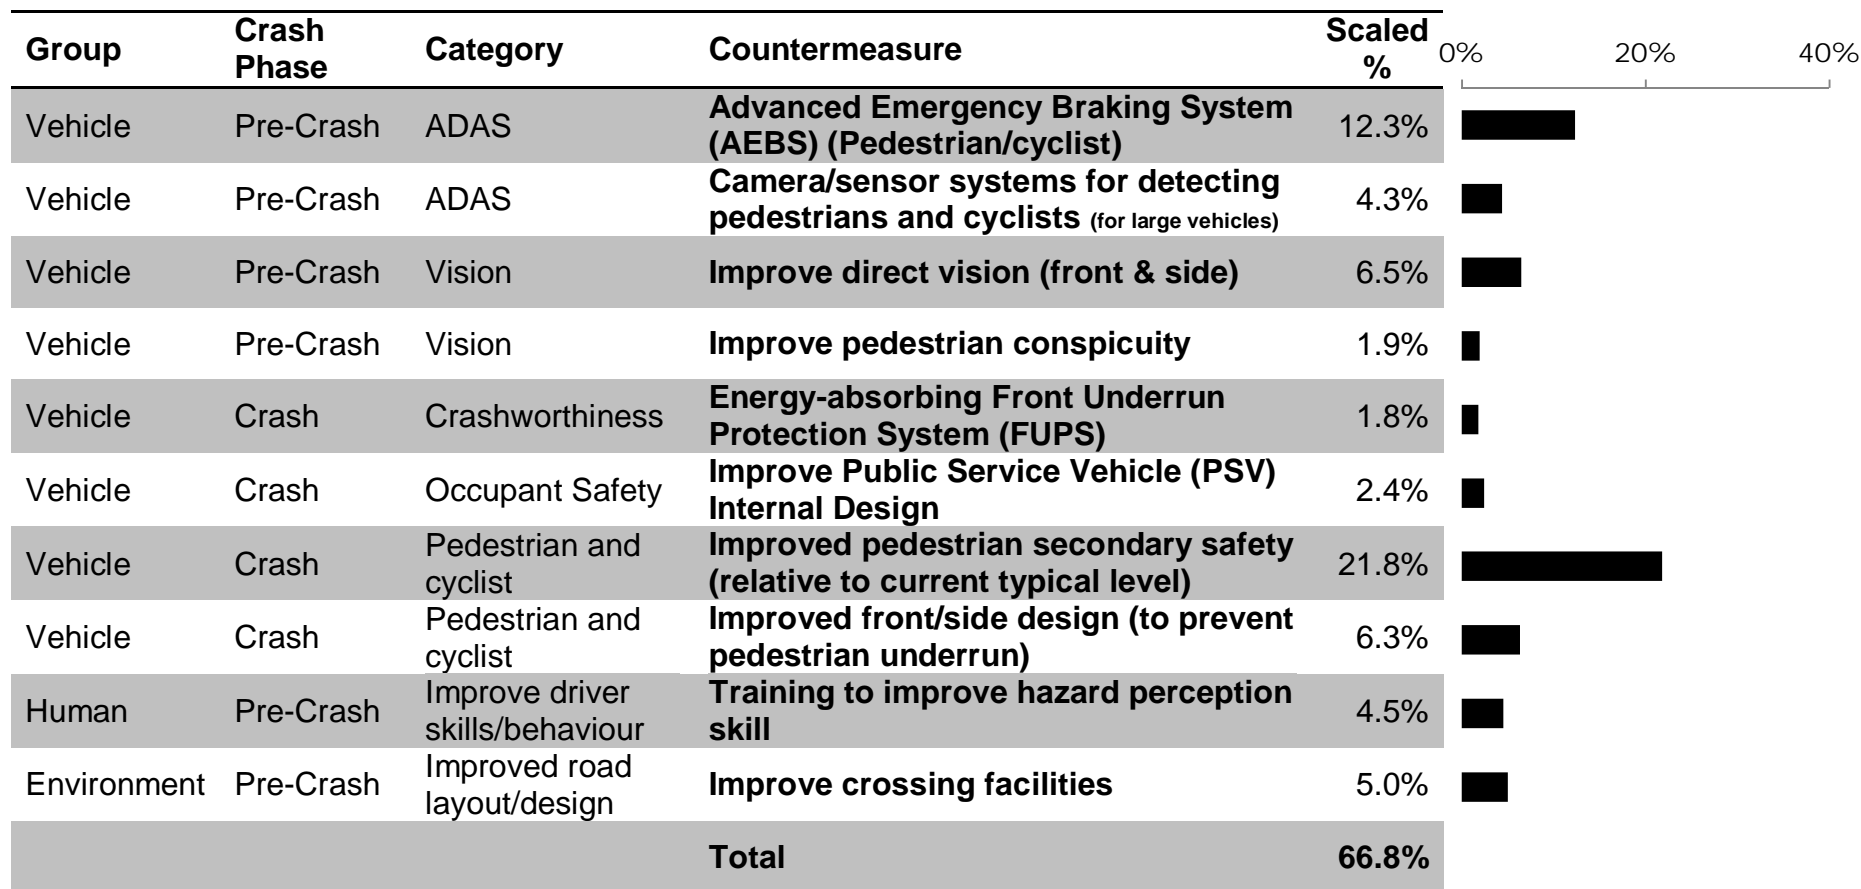
**Figure 25: Top ten bus fatality countermeasures from scaled aggregated datasets. Data source: HVCIS, police fatal files, OTS & RAIDS.**

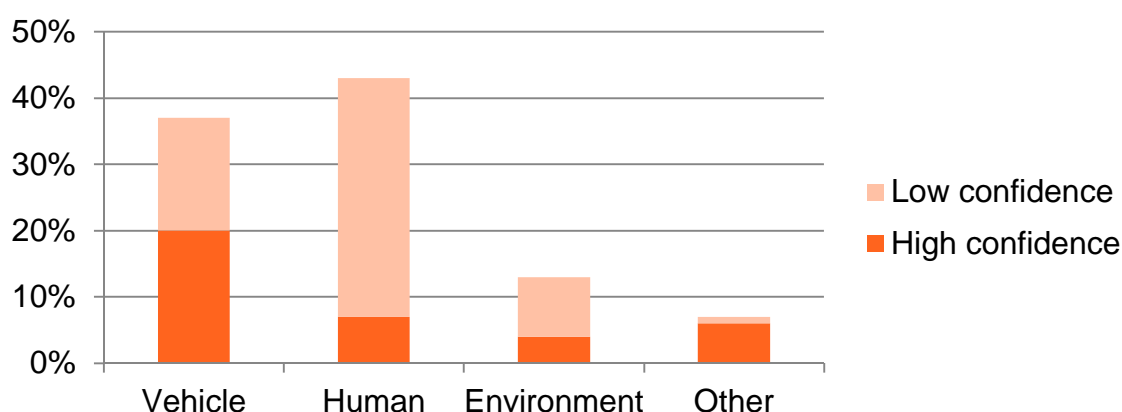
The categories of the countermeasures (vehicle, human or environment) are summarised in Figure 29 below for the police fatal files, which also provides a summary of the level of confidence in the countermeasure’s effectiveness as either high or low. The human countermeasures were the most frequent for the other road users, although mainly with low confidence. The countermeasures with the highest confidence were the vehicle related countermeasures. The ‘other’ countermeasures were mainly environment related and included:

**Figure 29: Other road user countermeasures by category and confidence level.**  
**Source data: Police fatal files.**

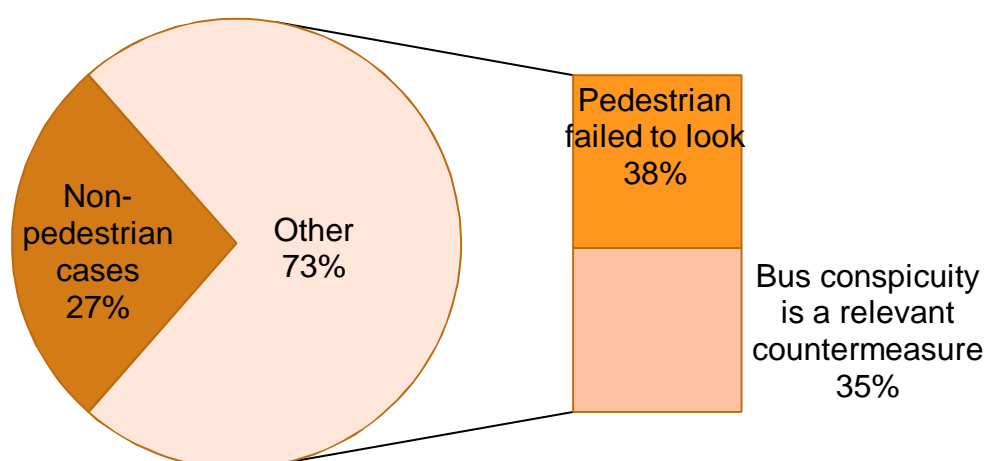
**Figure 30: Estimation of relevant pool of police fatal files for bus conspicuity.**  
**Source: Police fatal files**

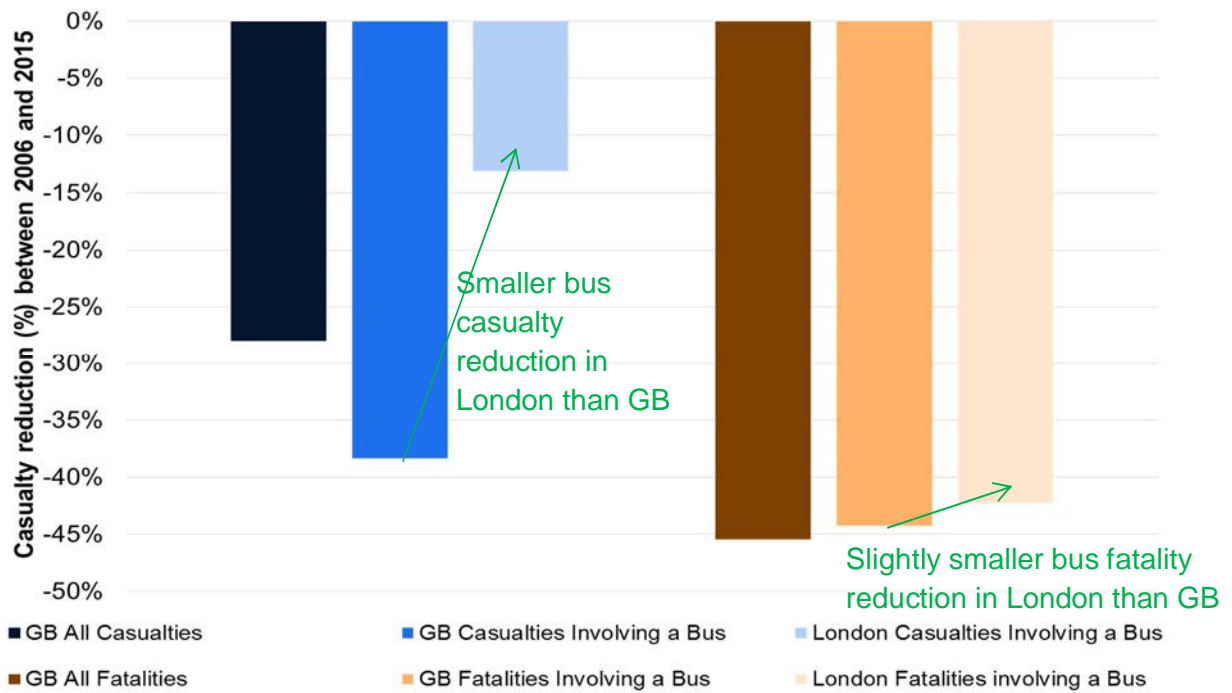
**Figure 31: Casualty reduction in percentage between 2006 and 2015: All casualties and fatalities. Source data: Stats19 (2006-2015) & transport statistics (2006-2015)**

It is also possible to look at the improvements in bus safety between 2006 and 2015. Over this period, road safety overall has been a success story. The bars in Figure 31 are negative, which indicates a reduction in casualties for the period. The dark blue bar on the left shows a 28% reduction in all casualties in GB (from collisions involving all types of vehicles). The mid blue bar next to it shows that nationally, buses have contributed more than average with a 38% reduction; i.e. a better casualty reduction than other forms of transport. However, the light blue bar suggests that when only London is considered, the reduction in casualties from collisions involving buses is much less (13%) than for the national equivalent (38%).

Overall the actions taken nationally have been more effective for fatalities than for less serious crashes. This is shown by comparing the right and left sets of bars in Figure 31, where the left (blue) set represent all casualties, and the right (orange) set represent fatalities; the reductions for fatalities (the bars on the right) are much greater. When all road fatalities in GB are considered, there has been a 45% reduction. Nationally, collisions involving buses have contributed to that reduction in line with other vehicle types. Fatality reduction on London's buses is only fractionally less than the national figure.

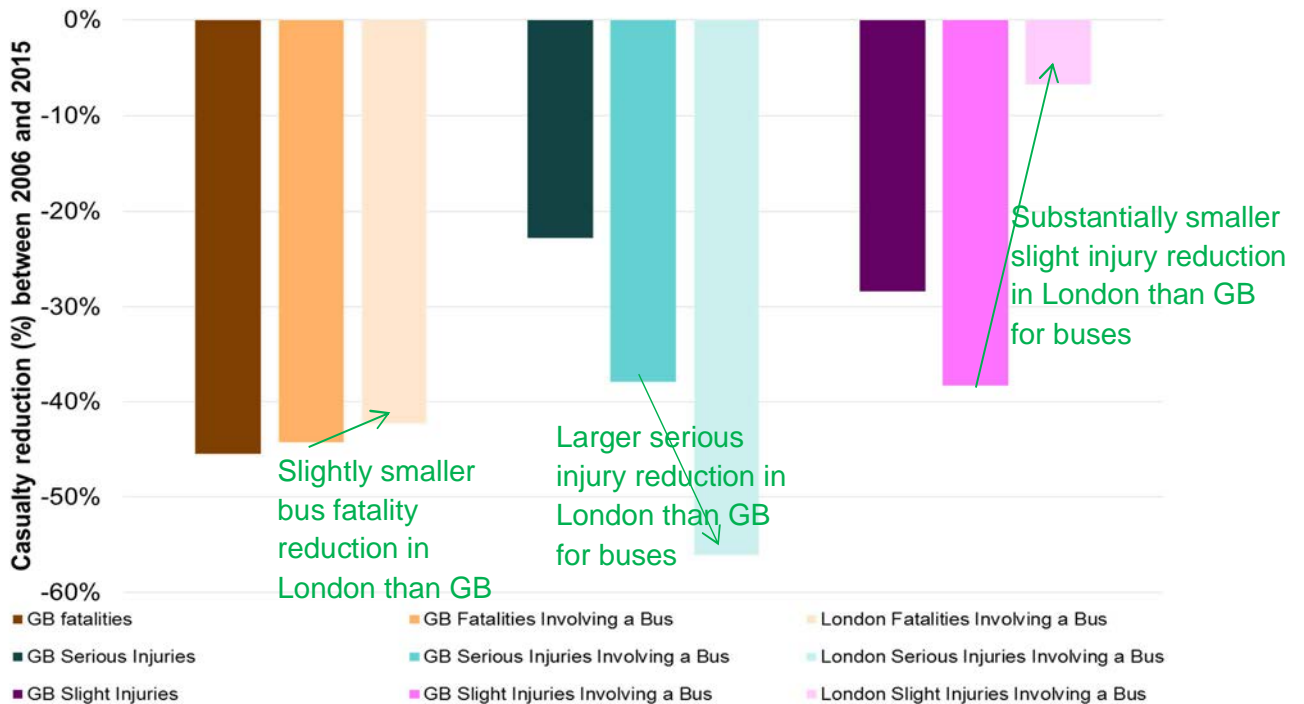
**Figure 32: Casualty reduction in percentage between 2006 and 2015: Fatal, serious and slight injuries. Source data: Stats19 (2006-2015) & transport statistics (2006-2015)**

If we consider the severity of casualties and their reductions, this reveals an explanation for the smaller reduction in casualties for London overall, as shown in Figure 32. The fatality reductions are relatively similar for GB compared to London. For serious injuries there is a much greater reduction in London (56%) than for GB (38%), which is very positive progress. However, for slight injuries the reduction in London is very small (6%) in comparison to GB levels (28%).

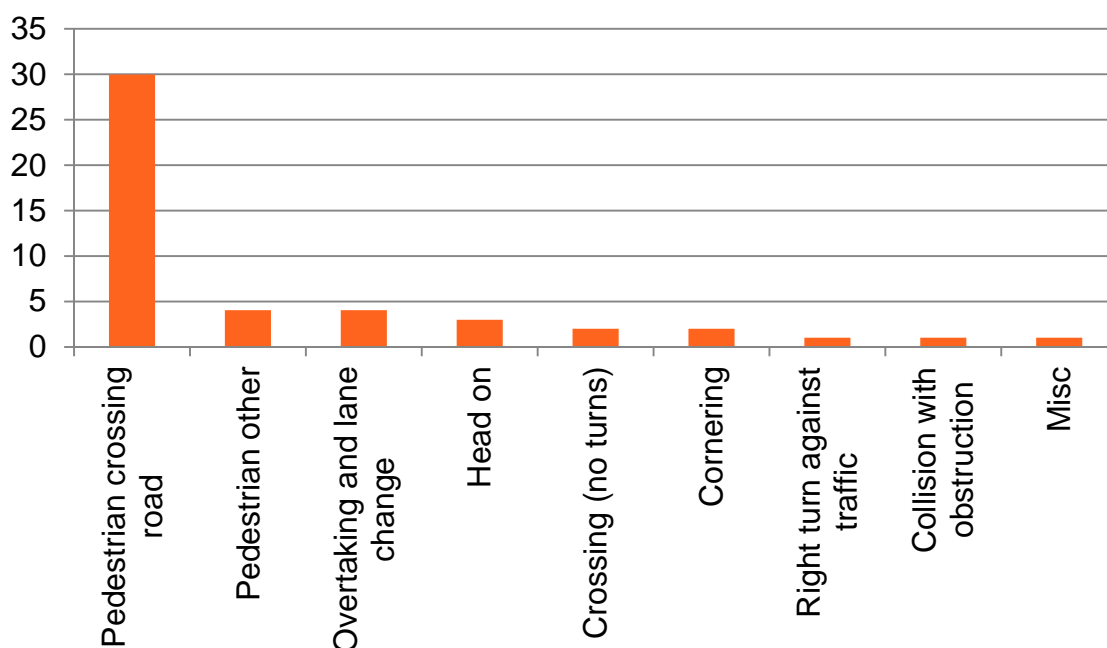
**Figure 46: Fatal collision type distribution. Source data: 48 Police fatal files**

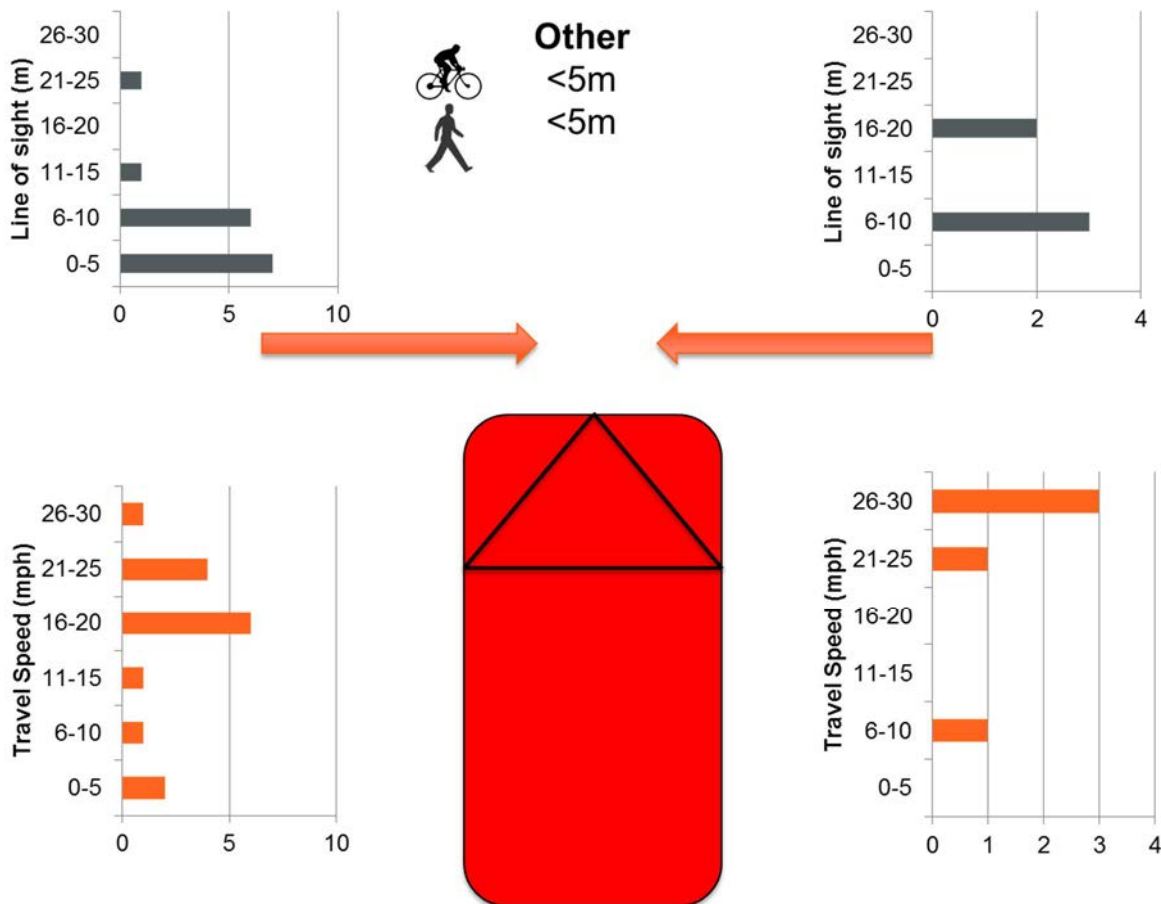
**Figure 57: Line of sight and bus travel speed. Source data: Police fatal files.**

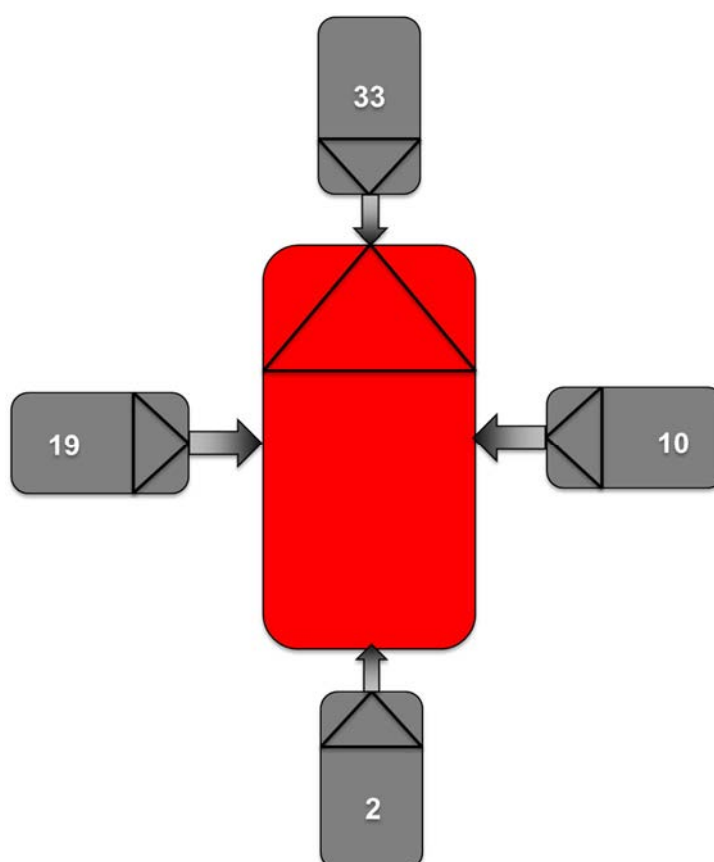
**Figure 60: Collisions involving car occupants: distribution around the bus.**  
Source data: HVCIS.

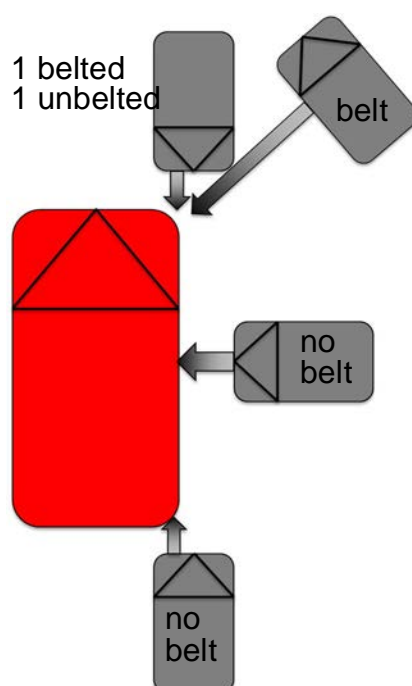
**Figure 61: Impact distribution for bus collisions involving car occupant fatalities. Source data: Police fatal files.**

Three of the car driver fatalities lost control of their vehicle; two of them were not wearing their seat belts and were travelling with excessive speed. In another case the loss of control occurred after an impact with a pedestrian island. In this case, vehicle deformation was very significant and the seat belt was not worn. However, the cause of death was attributed to a head strike with planks of wood inside the car.

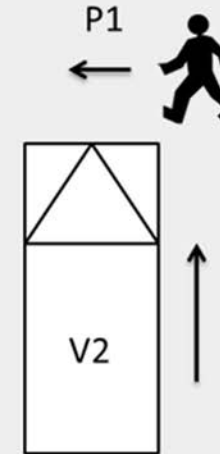
**Scene**

- A local bus (V2) was travelling along an A-road approaching some traffic lights on a pelican crossing.
- V2 driver saw flashing amber, but nobody was crossing, so he proceeded across the traffic lights.
- A child pedestrian (P1) stepped out right in front of V2 as it passed over the pelican crossing.
- V2 driver had no time to react and P1 hit the bumper and then the windscreen.
- P1 was thrown and dragged 17m as V2 braked to a halt.
- Hospital notes record that P1 was crossing the road behind another pedestrian.

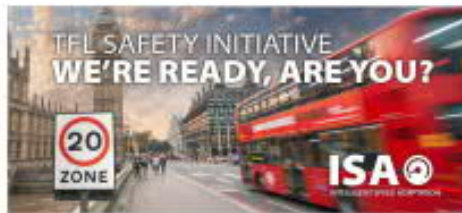
**Description:** A range of technologies to aid drivers in observing the appropriate speed for the road environment; either voluntary or mandatory

Example graph from Greenshield et al. (2016) Intelligent Speed Assistance on London Buses: A trial on two London bus routes, TRL for TFL

**Evidence:** speed limit compliance improved, marginal increase in journey time, models showed a £0.5M to £0.6M reduction in costs related to injuries

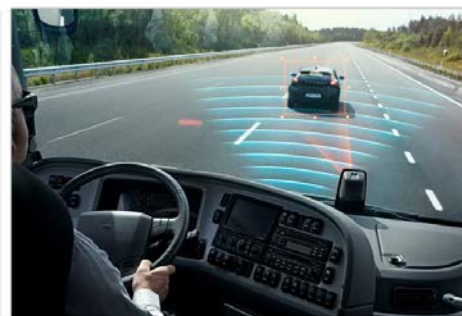
**Evidence:** Car occupant fatalities most often occur in collisions at the front of the bus

National Stats 19 data, 2006-2015, includes both bus and coach
